HISTORIC PROPERTIES REPORT

NEW CUMBERLAND ARMY DEPOT

PENNSYLVANIA

FINAL REPORT

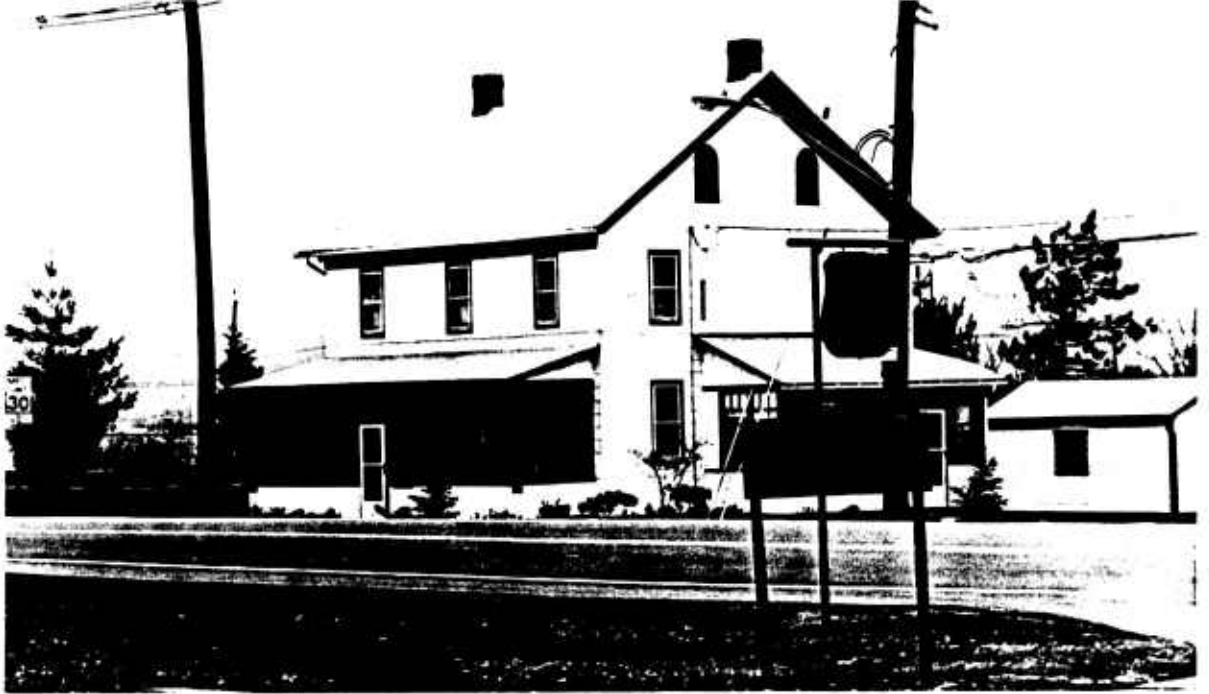
Illustration 2 View of Building 76. This two-story building, located on one of the farms acquired by the Army in 1918, was probably constructed during the last half of the nineteenth century. It has been altered considerably and now serves as housing. (Source: Field inventory photograph, 1984, Barbara Hightower, Building Technology, Inc.)

Before acquisition by the Army in 1918, the New Cumberland site consisted of eight farms. Following construction of the depot, the Army continued to use the farms' houses, barns, and associated structures, but most were demolished in the 1930s and 1940s. Only two pre-military buildings, a farmhouse and a barn, remain. The farmhouse (Building 76), which was probably built during the last half of the nineteenth century, is an undistinguished two-story, wood-frame building with a gable roof and scrolled eave brackets. (Illustration 2) The building has been altered considerably since the early 1940s and currently serves as family housing.³ The barn (Building 79), constructed around the turn of the century on the Jacob Haldeman farm, is a wood-frame structure with a stone foundation. Following acquisition by the Army, it was used to stable the horses and mules that pulled the depot's supply wagons. In 1942, the barn was remodeled and converted into the Officers' Club.⁴ (Illustration 3)

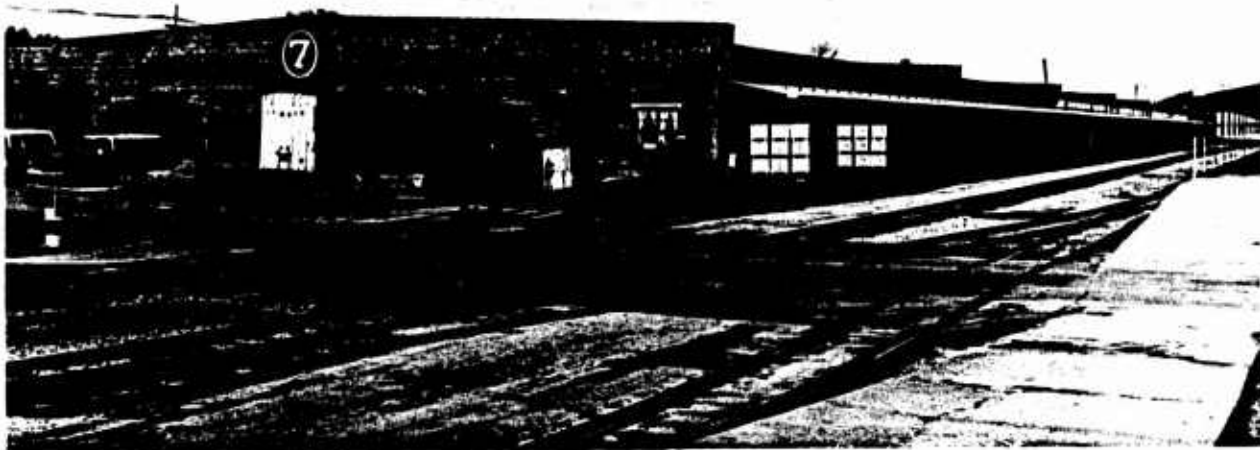
Illustration 4 View of Building 7. This brick and clay tile structure was one of eight warehouses built during the depot's initial phase of construction in 1918. (Source: Field inventory photograph, 1984, Barbara Hightower, Building Technology, Inc.)

Fourteen buildings remain from this initial phase of construction. Eight are one-story warehouses constructed with clay tile and brick walls on concrete foundations (Buildings 1-8). The principal elevations of these buildings are lined with freight doors for rail loading on one side and truck loading on the other. The northwest end of Building 1 is a two-story brick structure, the second floor of which originally contained administrative offices. Two open sheds (Buildings 9 and 10), built with heavy timber posts and trusses supporting slightly pitched roofs, complete the World War I storage facilities. The warehouses and open sheds are located in the storage area at the south end of the depot.⁶ (Illustration 4)

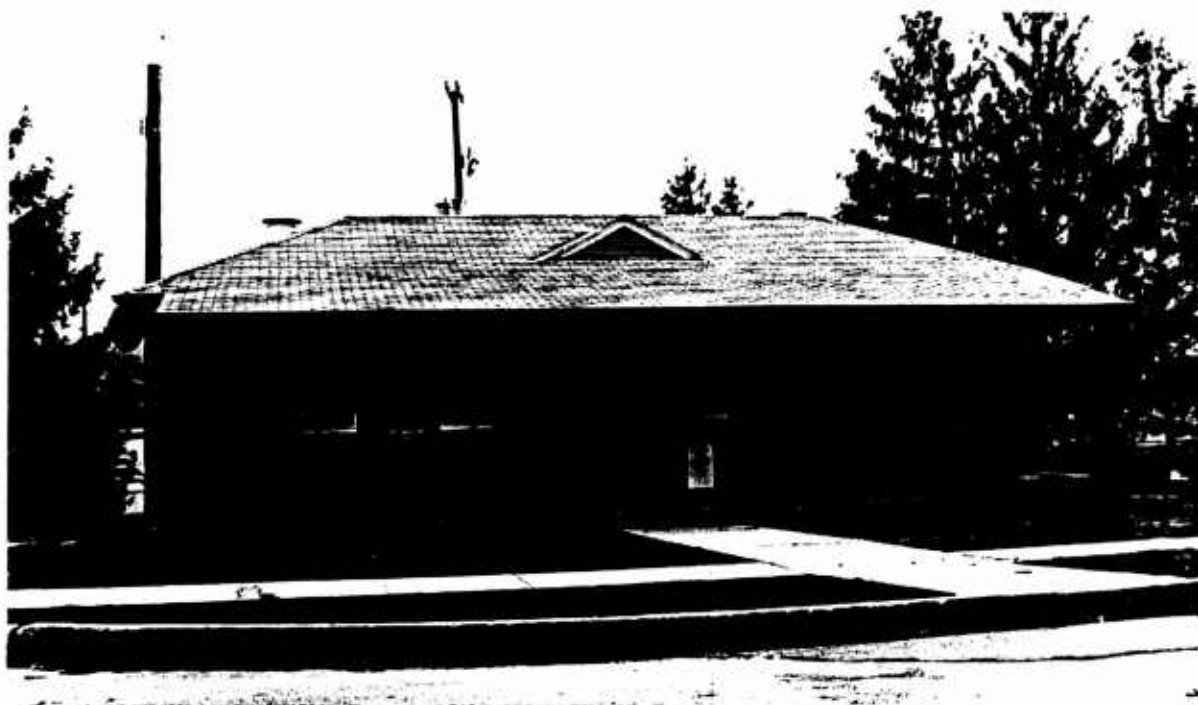
Illustration 5 View of Building 102. This stone building originally served as the guardhouse. It is one of 14 buildings remaining from the depot's initial construction in 1918. (Source: Field inventory photograph, 1984, Barbara Hightower, Building Technology, Inc.)

The remainder of the World War I buildings are located north of the warehouses in the present depot administration area. They include a one-story stone guardhouse (Building 102), a two-story brick electrical substation (Building 12), a gable-roofed, wood-frame structure originally built as the

depot bakery and converted to a garage in 1939 (Building 132), and a small brick magazine (Building 103). (Illustration 5)

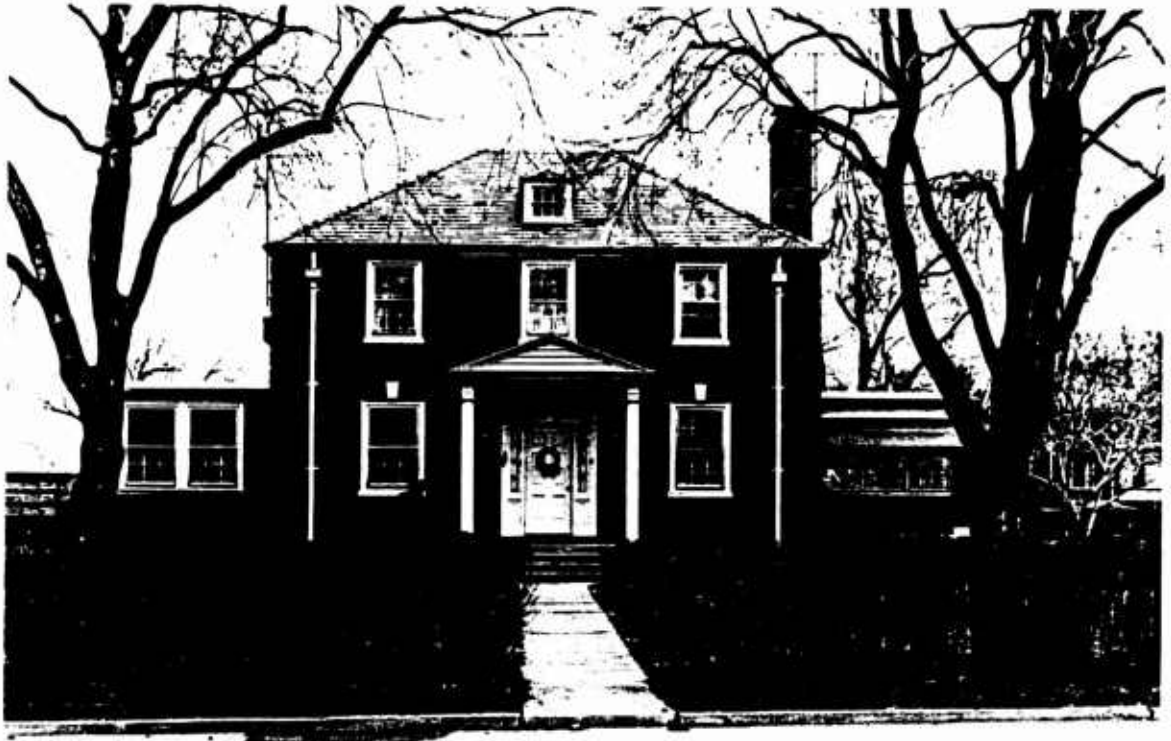
Illustration 6 Commanding Officer's Quarters (Building 30). This two-story Georgian Revival style house was built according to standard Army plans. It has served as the Commanding Officer's quarters since its construction in 1939. (Source: Field inventory photograph, 1984, Barbara Hightower, Building Technology, Inc.)

The Commanding Officer's Quarters (Building 30), a two-story Georgian Revival style house, was constructed in 1939. This brick structure, embellished with brick quoins and splayed brick lintels with keystones, has a hip roof covered with slate. It was built according to standard plans developed during the late 1920s, when the Army instituted a building program designed to improve its image and the quality of life for its personnel. These plans, which were used through the 1930s, were based on what were considered national architectural styles; the Georgian Revival style was adopted for construction on posts in the eastern United States.⁹ (Illustration 6)

- Background and significance. The Commanding Officer's quarters is a two-story Georgian Revival style house built in 1939. (See Chapter 2, The Period Between the Wars and Illustration 6.) This hip-roofed brick house is embellished with brick quoins at its corners and splayed brick lintels with keystones above the first-story windows. Since construction, the screened porch on the southeast side has been bricked in and the sun porch on the northwest side has been added. The original entrance, consisting of a segmental pediment supported by engaged columns, was replaced by a gabled entrance porch with wood paneled door, fanlight, and sidelights. The brick quoins on the main block are repeated at the corners of the porch. The house was constructed according to standard Army plans based on what were considered national architectural styles at the time. The Commanding Officer's quarters, the most architecturally distinctive building on the depot, is a Category III historic property because it is important as an example of standardized Army residential design and has served an important function as the residence of the Commanding Officer since its construction in 1939.

- Condition and potential adverse impacts. The building is in good condition and receives routine maintenance and repair. Although it has been altered, it still retains its basic architectural character. There are no current plans to alter or demolish this property.
- Preservation recommendations. Refer to the general preservation recommendations at the beginning of this chapter for Category III historic properties not eligible for nomination to the National Register.

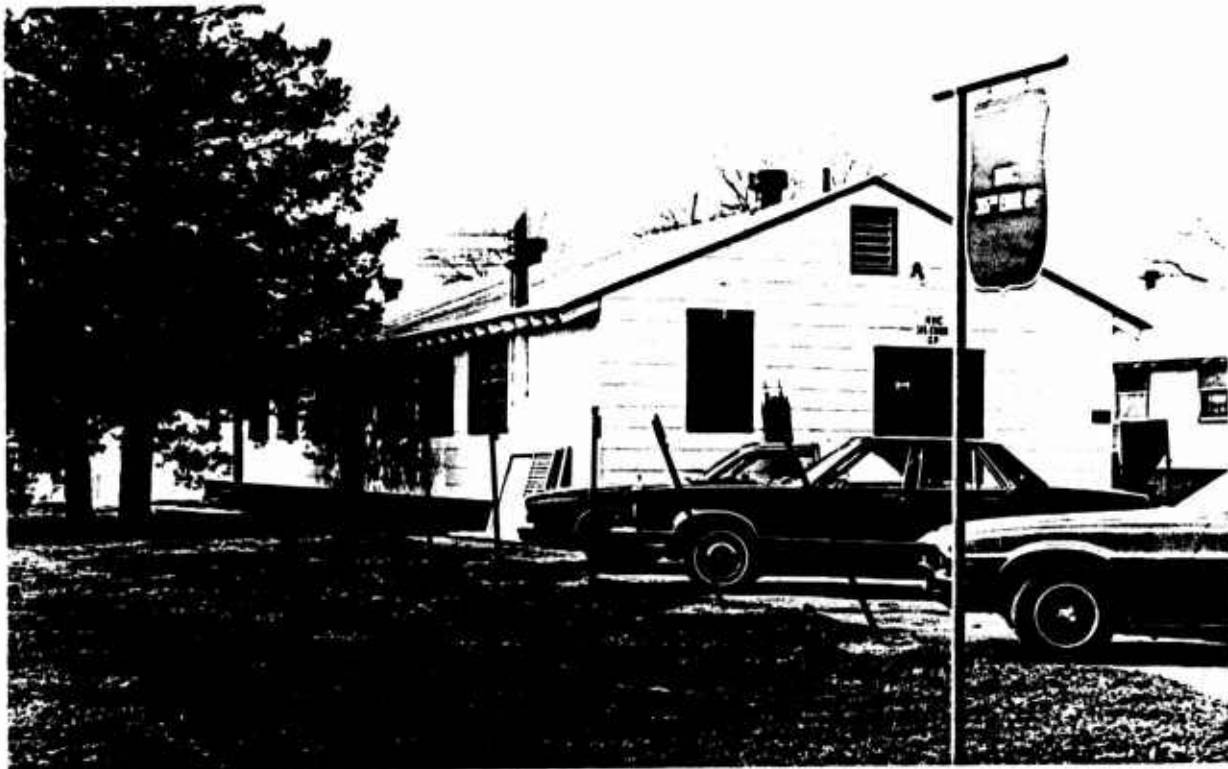
Illustration 10 View of Building 269. This one-story building housed the Reception Center's administrative offices. (Source: Field inventory photograph, 1984, Barbara Hightower, Building Technology, Inc.)

Pennsylvanians entering the Army--had been processed through New Cumberland. The Center expanded later in 1941 with construction of over 30 additional buildings, and again in 1942 when the adjacent Civilian Conservation Corps camp was transferred to the Army. In 1945 part of the Center's facilities housed German and Italian prisoners of war, and at the end of that year it was converted to a branch U.S. Military Disciplinary Barracks that remained on the depot until 1959. Many of the buildings were subsequently demolished; only 20 now remain (Buildings 251-253, 259-262, 268-271, 276-279, 285, 287, 290, 292, and 295).¹⁰ (Illustrations 7-10)
