ADVANCED ELECTROMECHANICAL ACTUATION SYSTEM (EMAS)  
FLIGHT TEST

William J. Norton, First Lieutenant, USAF  
Advanced Aircraft Systems Branch  
Aircraft and Avionics Division  
Directorate of Flight Test Engineering

June 1986

Final Report for Period July 1985 - March 1986

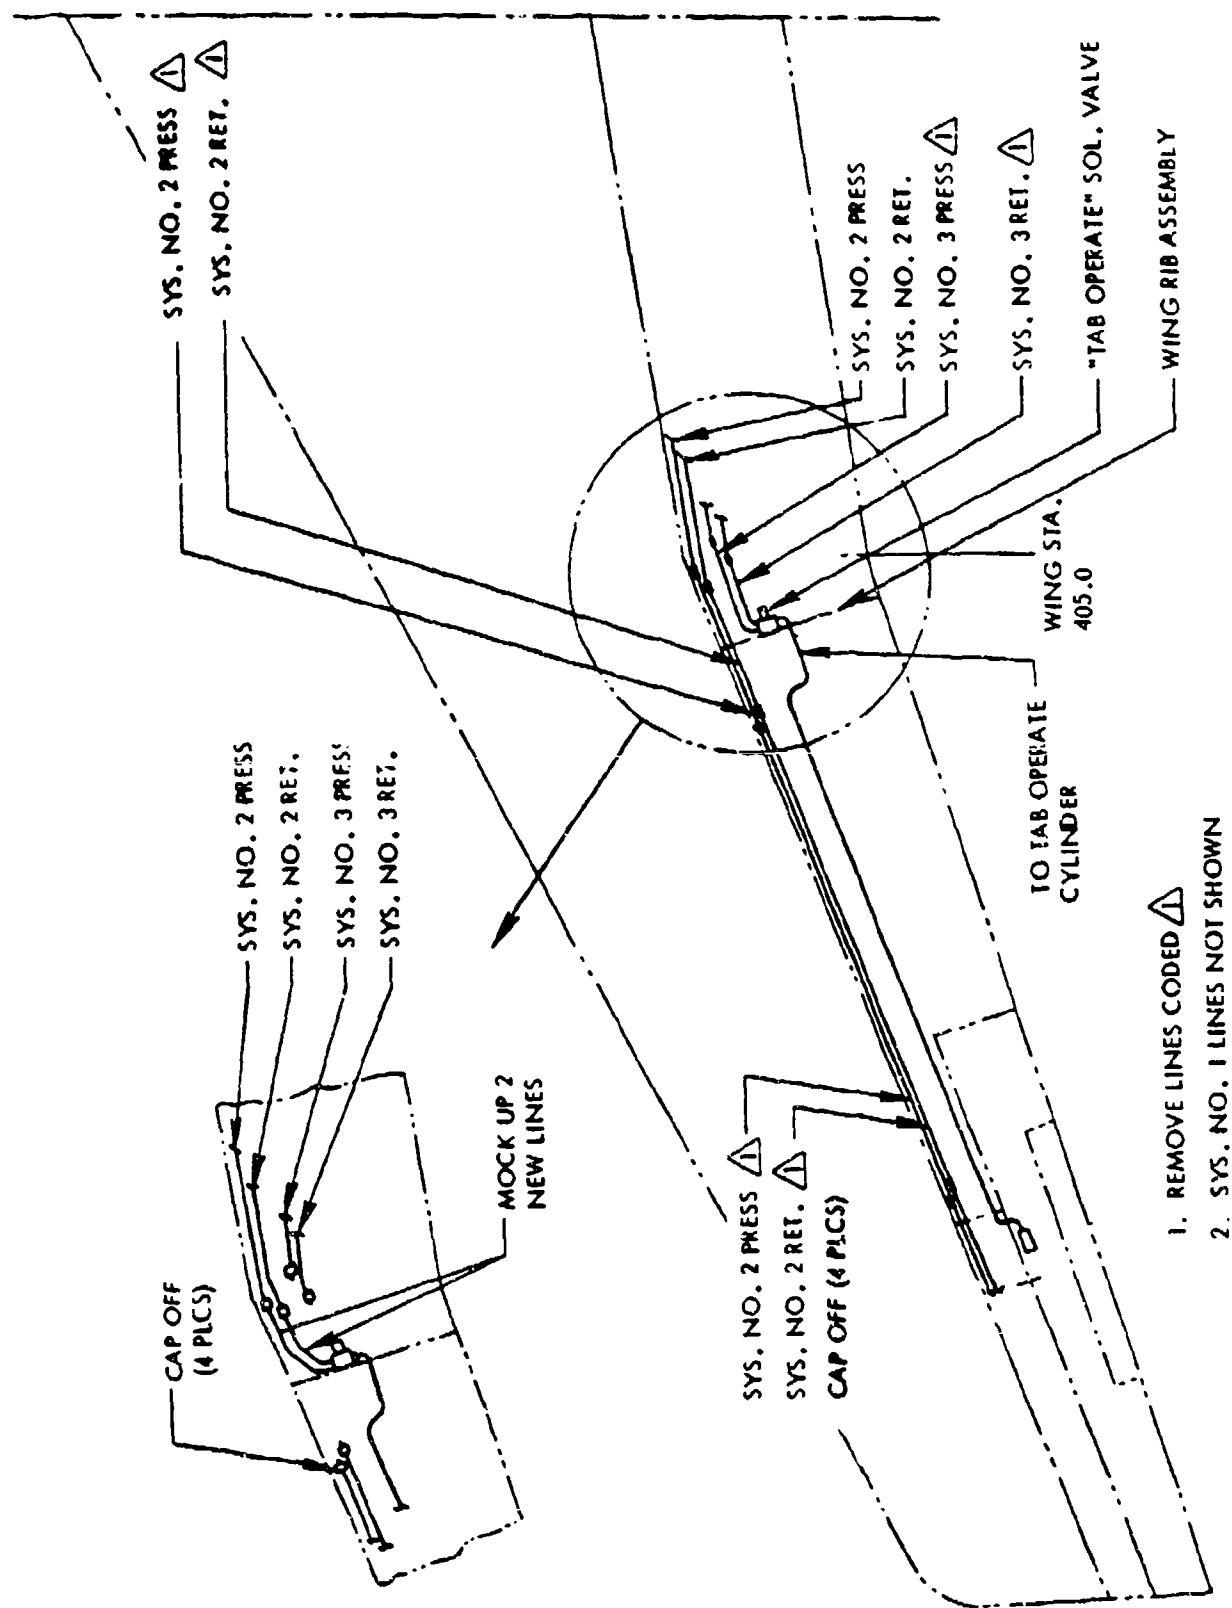
Figure 2-9 Hydraulic System Modification

b. Sections of the unused PCU hydraulic lines in the actuator bay were removed and capped to provide room for the EMA. In order to permit backup tab operation of the left aileron in the event of total electrical system failure, the tab operable solenoid valve was connected to the Number 2 hydraulic system in place of the Number 3 system (see Figure 2-9). This valve ports hydraulic fluid to a tab operate cylinder, unlocking the tab lockout actuator and moving a tab input bellcrank from an over-center position to permit control commands to deploy the tab and assist in moving the aileron with aerodynamic forces. The Number 3 hydraulic system is electrically dependent whereas the Number 2 system is engine driven and would continuously provide pressure to the solenoid in the event of an electrical failure. In addition, a relay between the emergency DC bus and the isolated DC bus was installed to ensure an uninterrupted source for the 28 VDC power used to hold open the solenoid valve, thus ensuring that this function could be performed in the event of a total electrical system failure or if the crew should need to shut down the isolated bus as part of the electrical fire checklist procedure. A calibrated outside air temperature probe was added to the aircraft to provide a precise source for this parameter.

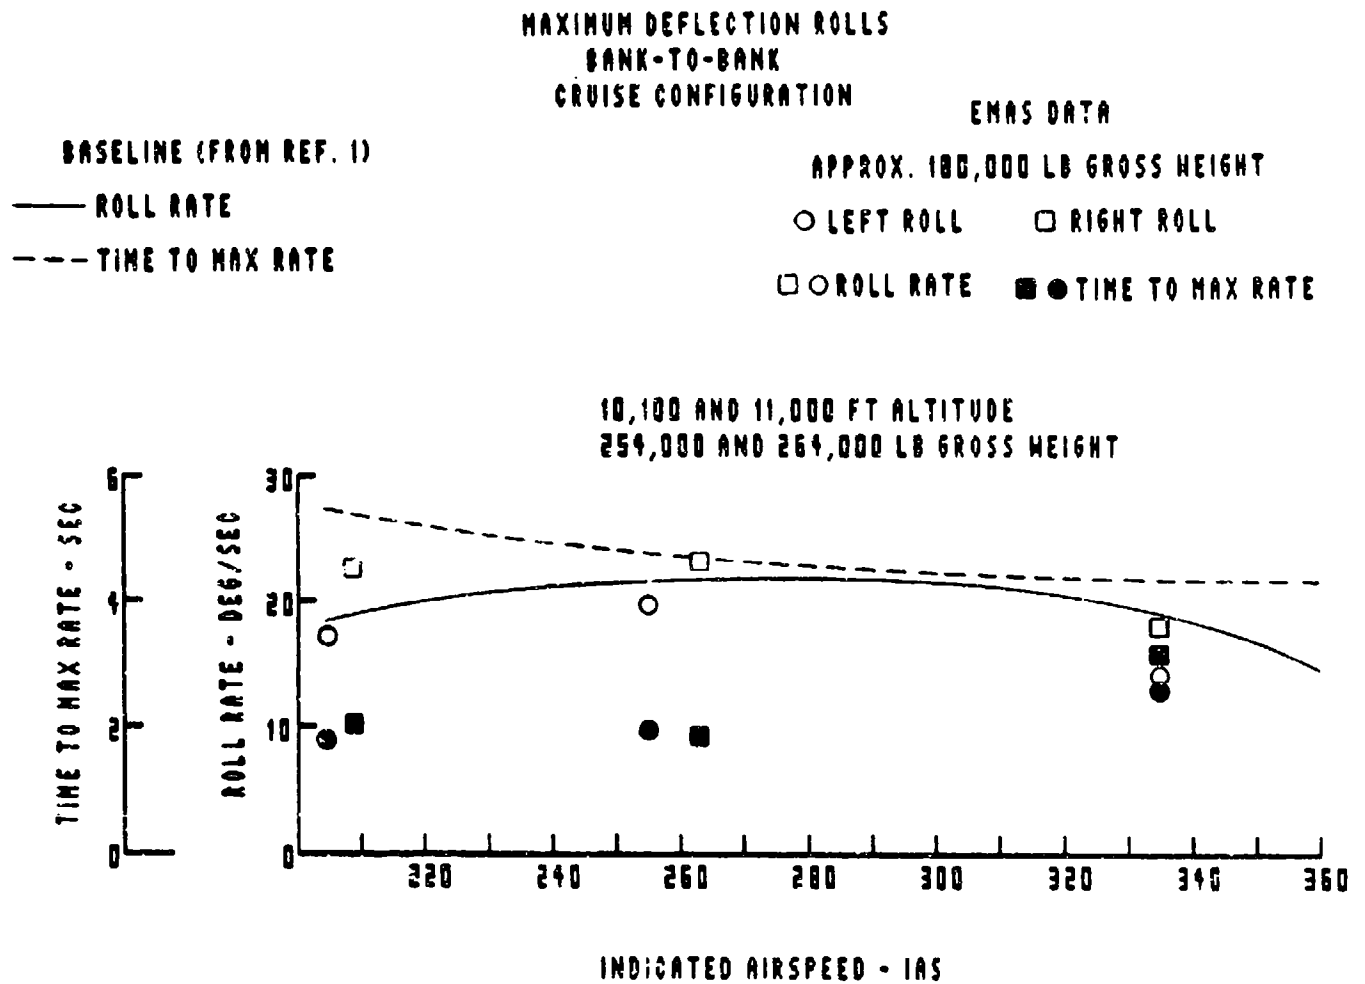
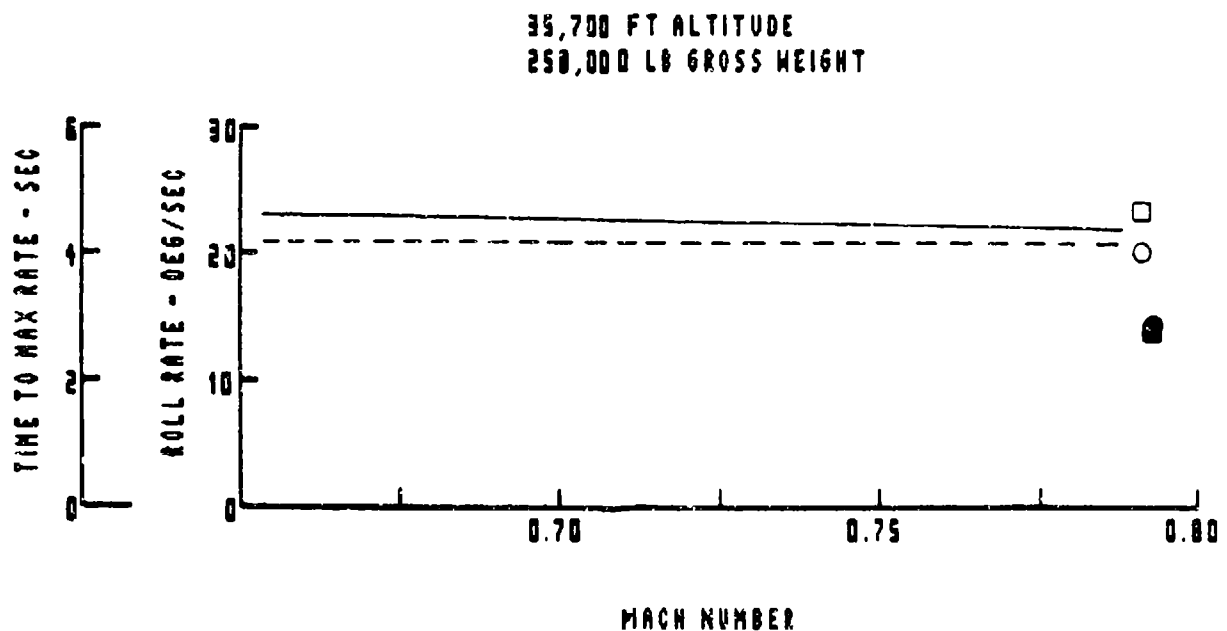
Figure 6-1 Baeeline/EMAS Roll Comparison

(2) Table 6-1 and examination of the maximum command roll time histories (see Figure A-2), reveal that the test aircraft rolled at a faster rate to the right than to the left. It is also apparent that the left aileron usually failed to reach the same aileron deflection as the right aileron for similar maneuvers and test conditions. This is attributable to the inability of the EMA to reach the normal aileron travel limits. Most maneuvers succeeded in driving the right aileron to the travel limits, so the left aileron would also be expected to reach the limit in the opposite direction. With the lower end travel deflection rate of the left aileron and the greater end travel deflection angle of the right aileron, the ailerons were consistently off the normal travel schedule near the end of travel. This resulted in a positive yaw rate in rolls in both directions, or proverse yaw in rolls to the right and adverse yaw in rolls to the left. Thus, right rolls had a higher roll rate than left rolls. When EMAS test data is compared with limited baseline data (see Figure 6-1, B-1, and B-2), right rolls are generally higher and left rolls lower than predicted. The difference in the time to maximum deflection angle from the baseline is attributed to the lower EMAS test aircraft gross weight. The average gross weight for all test points was 180,000 lbs, not varying by more than 15,000 lb during the course of a test, with an average mean aerodynamic chord center of gravity location of 31.0%. The inability of the EMAS to produce similar performance to the hydromechanical system was the result of the more pronounced slow down feature and the inability to reach the maximum travel limits. These departures from the baseline roll performance were not detectable by the pilots.

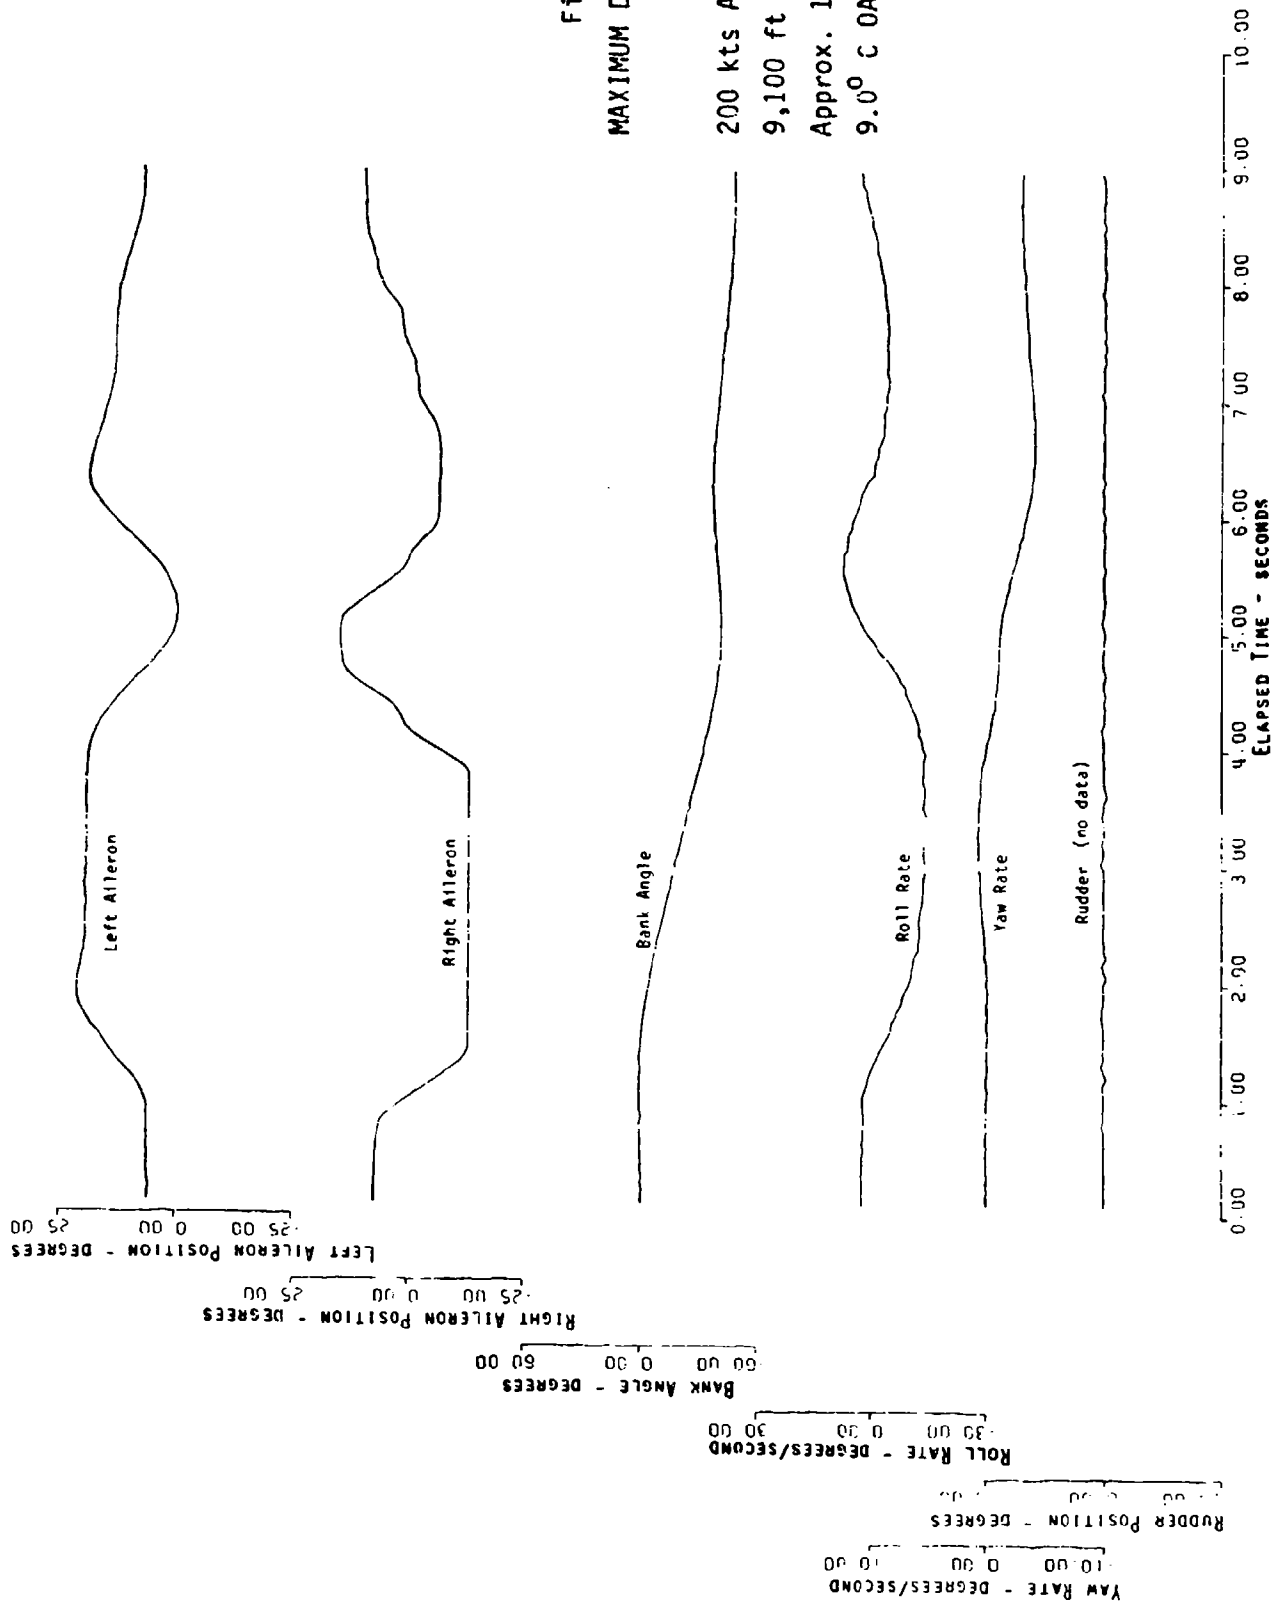
Figure A-6.1b  
MAXIMUM DEFLECTION TAB ROLL  
Left Tab

(2) Roll-off resulting from the selection and de-selection of tab was found to be similar in the two scenarios but for the final aileron position because of the higher backdrive force requirements of the EMA (see Figure A-6 and A-7). This roll-off is a consequence of the unpowered aileron floating to a zero hinge moment condition that is approximately eight deg trailing edge up.

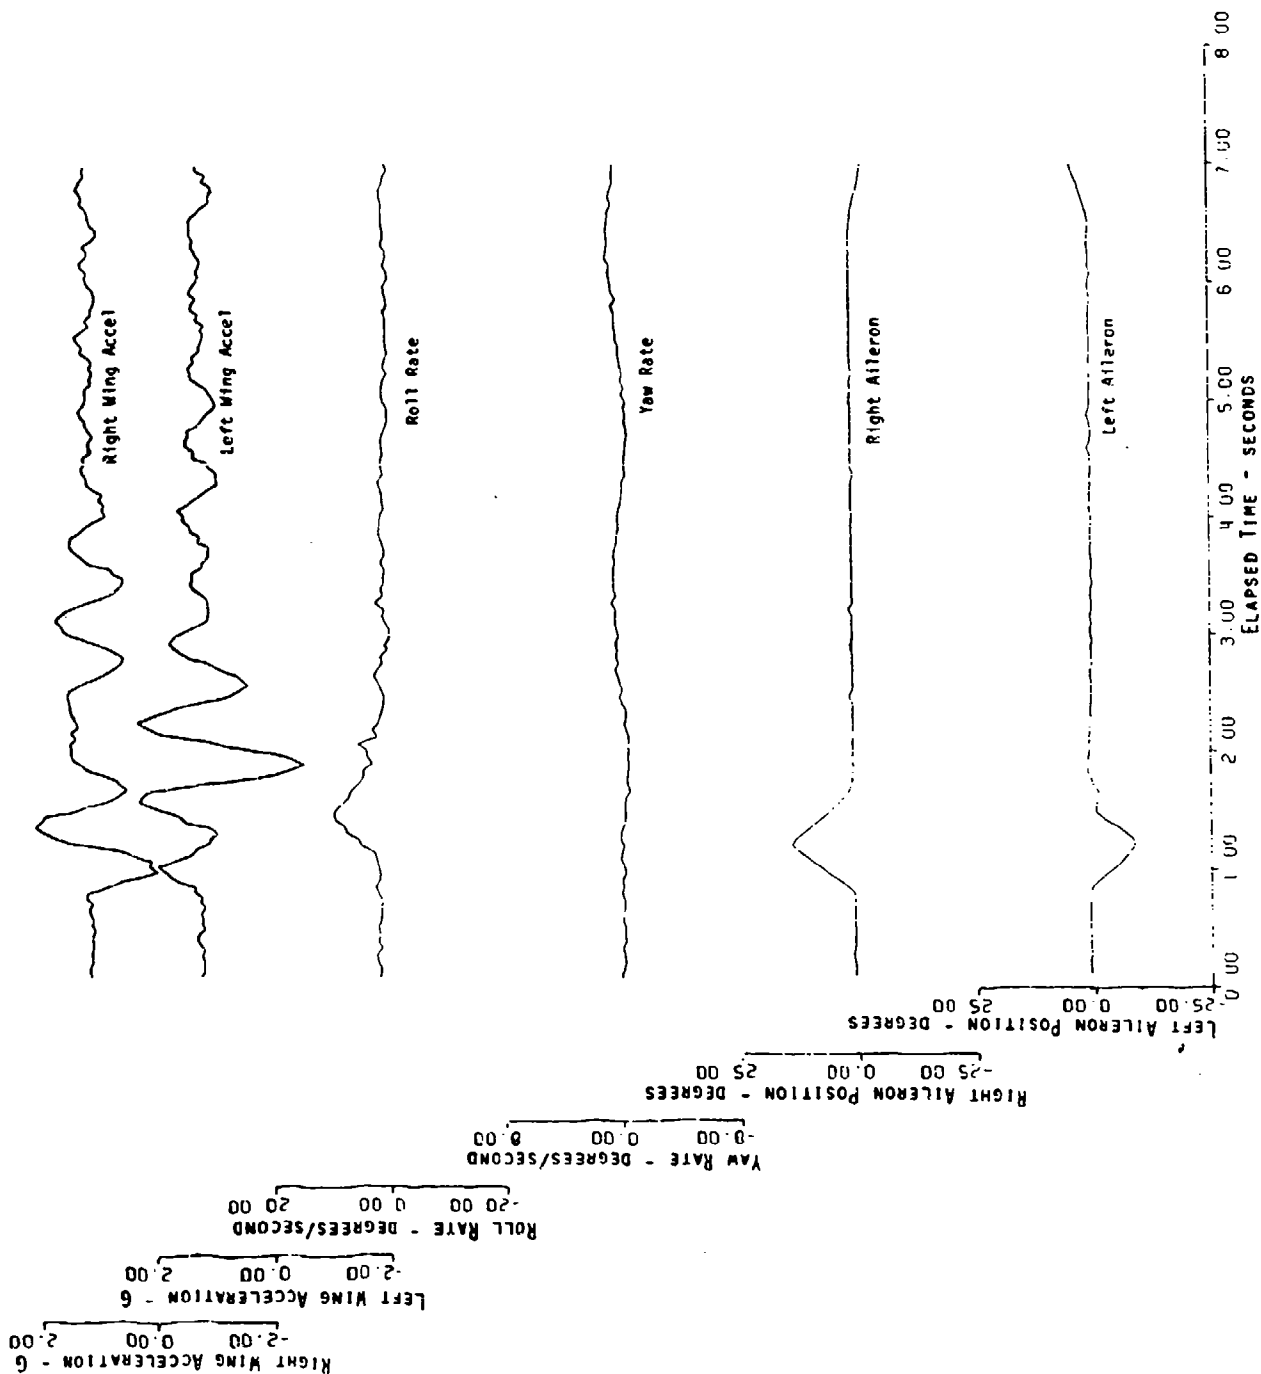
Figure A-9.1b  
AILERON PULSE  
335 kts Airspeed  
20,500 ft Altitude  
Approx. 180,000 lb G.W.  
-5.0° C OAT

(1) Aileron damping was found to be high or deadbeat at all test conditions (see Figure A-9). Wing accelerometer response to the aileron pulses and maximum command inputs showed evidence of a structural mode superimposed on the input response (see Figure A-9 and C-1). This was not considered critical. The initial part of the wing response show a high frequency oscillation superimposed on the wing trace. This is believed to be caused by vibration of the cantilever accelerometer mount. Wing response was considerably greater during maximum command rolls, however inertia overshoots are also included in these oscillations (see Appendix C).
