REPORT SD-TR-87-34

# Effects on Advanced Materials: Results of the STS-8 EOIM Experiment

M. J. MESHISHNEK, W. K. STUCKEY,  
J. S. EVANGELIDES, L. A. FELDMAN, and R. V. PETERSON  
Materials Sciences Laboratory  
Laboratory Operations

20 July 1987

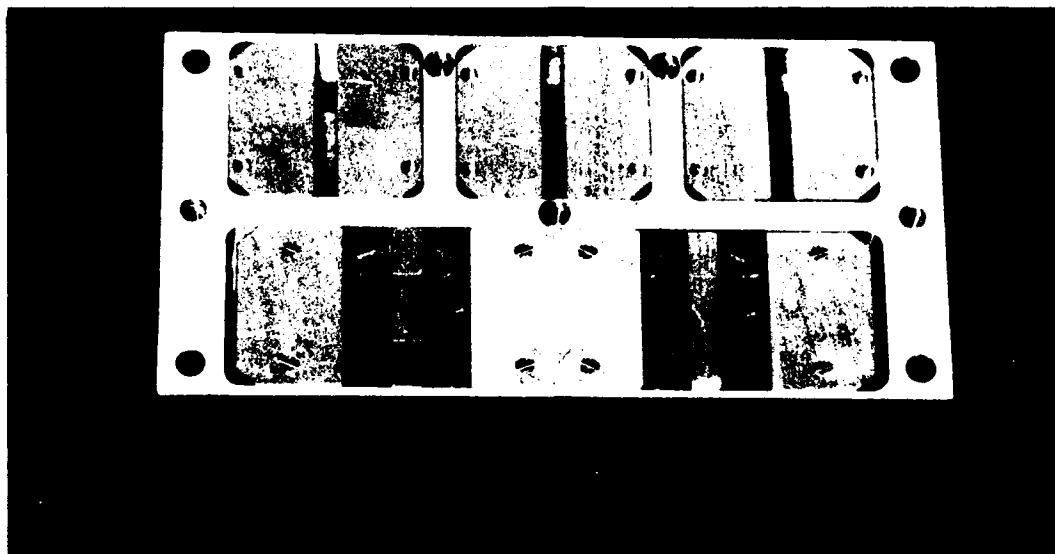
13 — KAPTON FILM  
 16 — EPON 1001 RESIN  
 10 — APIEZON L FILM  
 1 — G-9042 SILICONE FILM

14, 17, 3, 4 — COLLECTOR PLATES

Fig. 2. The Aerospace Organic and Metallic Thin-Films Tray.  
 (a) Photograph of the tray with the collimating cover removed. (b) Cross-sectional schematic of the sample layout.

A beam of atomic oxygen, collimated by slits in the tray cover, impinges on a germanium FTIR plate that contains a film. Close to the sample is another FTIR plate used to catch any sputtered material. Four of these sample-witness plate pairs (Figs. 2a and 2b, foreground) were used, and they occupied one half of the fixture. The other half of the fixture (Figs. 2a and 2b, background) contained the metal film experiment, wherein an oxygen beam, collimated by slits in the tray cover, strikes metal film targets and sputters metal atoms to the side collectors; here three such assemblies were used.

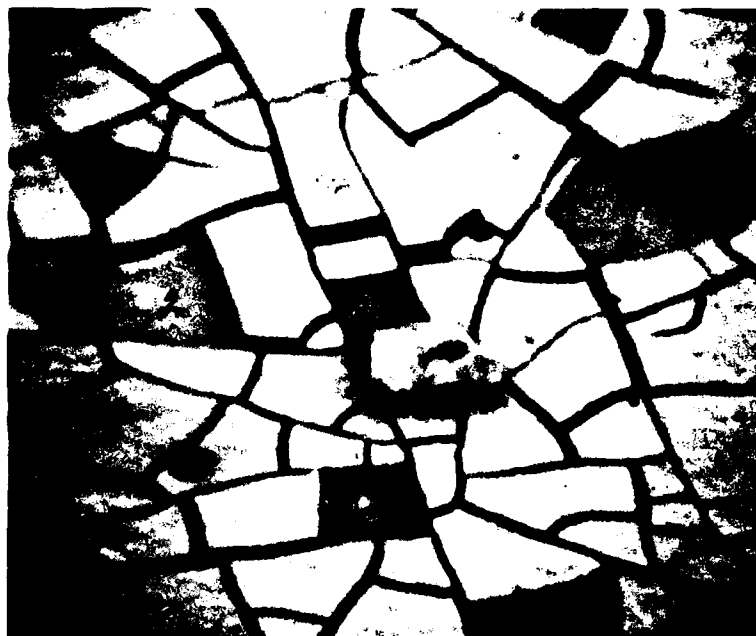
Fig. 38. Photomicrograph of Mo/Cr/Black Cr Sample, Showing Debonding of Surface Layer and Exposed Cr Undercoating

An unusual debonding phenomenon illustrating the difference in adherence of the black Cr coatings in the pre- and postflight samples was observed in the SAM under electron beam bombardment. Under irradiation by the electron beam at 10 kV, some of the surface scales of the posttest samples were seen to debond spontaneously and appeared to fly off the surface, leaving an exposed area of the Cr undercoating (see Fig. 38). This was not observed in the pretest samples. It is believed that this may indicate charging of the surface scale, along with low adherence, so that the scales fly off as a result of electrostatic repulsion from the substrate. This would require the electrical contact between scale and surface to be poor. However, the bright voltage contrast due to charging, which one would expect to see in SEM images of the area, was not observed.

to determine if the Mo was exposed. Another possible cause of debonding under the beam may be local heating, leading to thermal stresses that might also cause detachment of the scale when there is a reduced adherence to the surface. In summary, adherence changes are seen in the oxygen ram-exposed samples, but no major induced microstructural or compositional effects are found. Thus, the cause of the reduced adherence is not fully apparent.
