AEFA PROJECT NO. 86-14

AIRWORTHINESS AND FLIGHT CHARACTERISTICS TEST OF A SKI ASSEMBLY FOR THE UH-60A BLACK HAWK HELICOPTER

FINAL REPORT

AVIATION ENGINEERING FLIGHT ACTIVITY

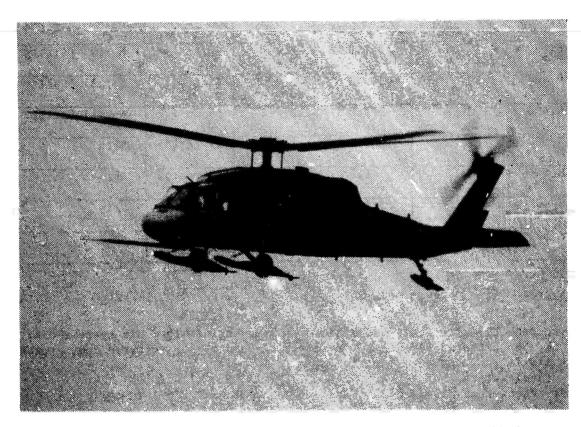
Photo 1. UH-60A Helicopter with the Ski Assembly Installed

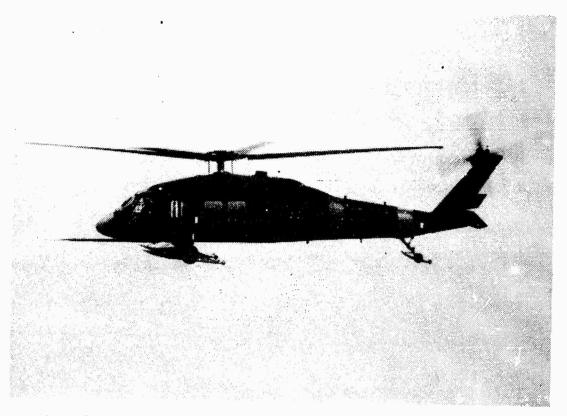
Photo 3. Left Sid. View - UH-60A Helicopter with Skis Installed

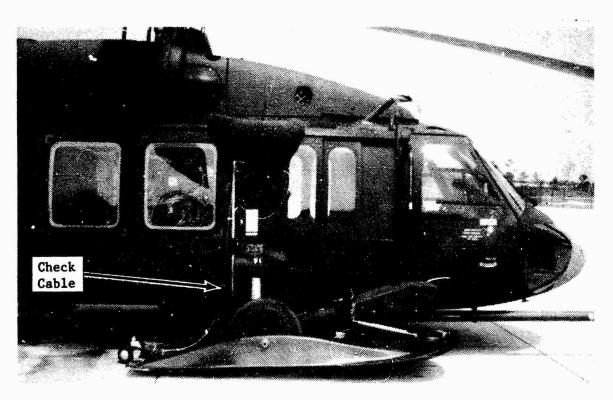
Photo 5. Right Side View - UH-60A Main Landing Gear Ski Assembly
