INSTALLATION RESTORATION PROGRAM TECHNICAL SUPPORT
DOCUMENT FOR RECORD OF DECISION CAPE MERRIMAN AFS (U)
WOODWARD-CLYDE CONSULTANTS ANCHORAGE AK 18 JAN 88

**Technical Support Document
For Record Of Decision
Cape Newenham, AFS**

January 18, 1988

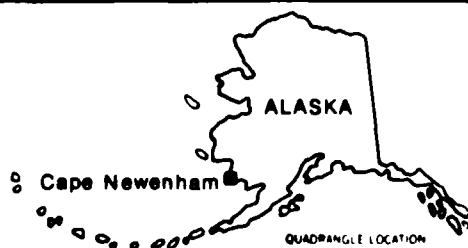
Figure
1

CAPE NEWENHAM AFS
TOPOGRAPHIC MAP

The Cape Newenham AFS is located on a small peninsula on the southwest coast of Alaska about 770 km southwest of Anchorage (Figure 1). The Air Force Station consists of approximately 950 hectares surrounded by the Togiak National Wildlife Refuge (NWR). The nearest settlement is Platinum, a Native Alaskan mining community about 50 km to the northwest. The topography in the vicinity of the cape is steep and rocky. One unnamed drainage is found within the boundaries of the installation. The creek flows through the valley, past the airstrip and into Kuskokwim Bay. The rugged terrain of the area supports a dwarf, shrubland, alpine tundra.

The upper valley in section 7 of Cape Newenham AFS (see Figure 1) is the principal recharge zone of ground water for the installation. Water collects and drains northward, downslope, into shallow aquifers and surface streams. The valley near the Lower Camp (el. 212 m) consists of a thick zone (approx. 30 m) of permeable, coarse grained talus and alluvium. This material generally contains ground water at shallow depths which may occur under artesian conditions (Eng. Sci. 1985). Permafrost may occur as isolated lenses, but is restricted to fine-grained, unconsolidated sediments (Eng. Sci. 1985).
