MISCELLANEOUS PAPER HL-89-1

# LOWER GRANITE FISH GUIDANCE EFFICIENCY STUDY SNAKE RIVER, WASHINGTON

Hydraulic Model Investigation

Prepared for US Army Engineer District, Walla Walla  
Walla Walla, Washington 99362-9265

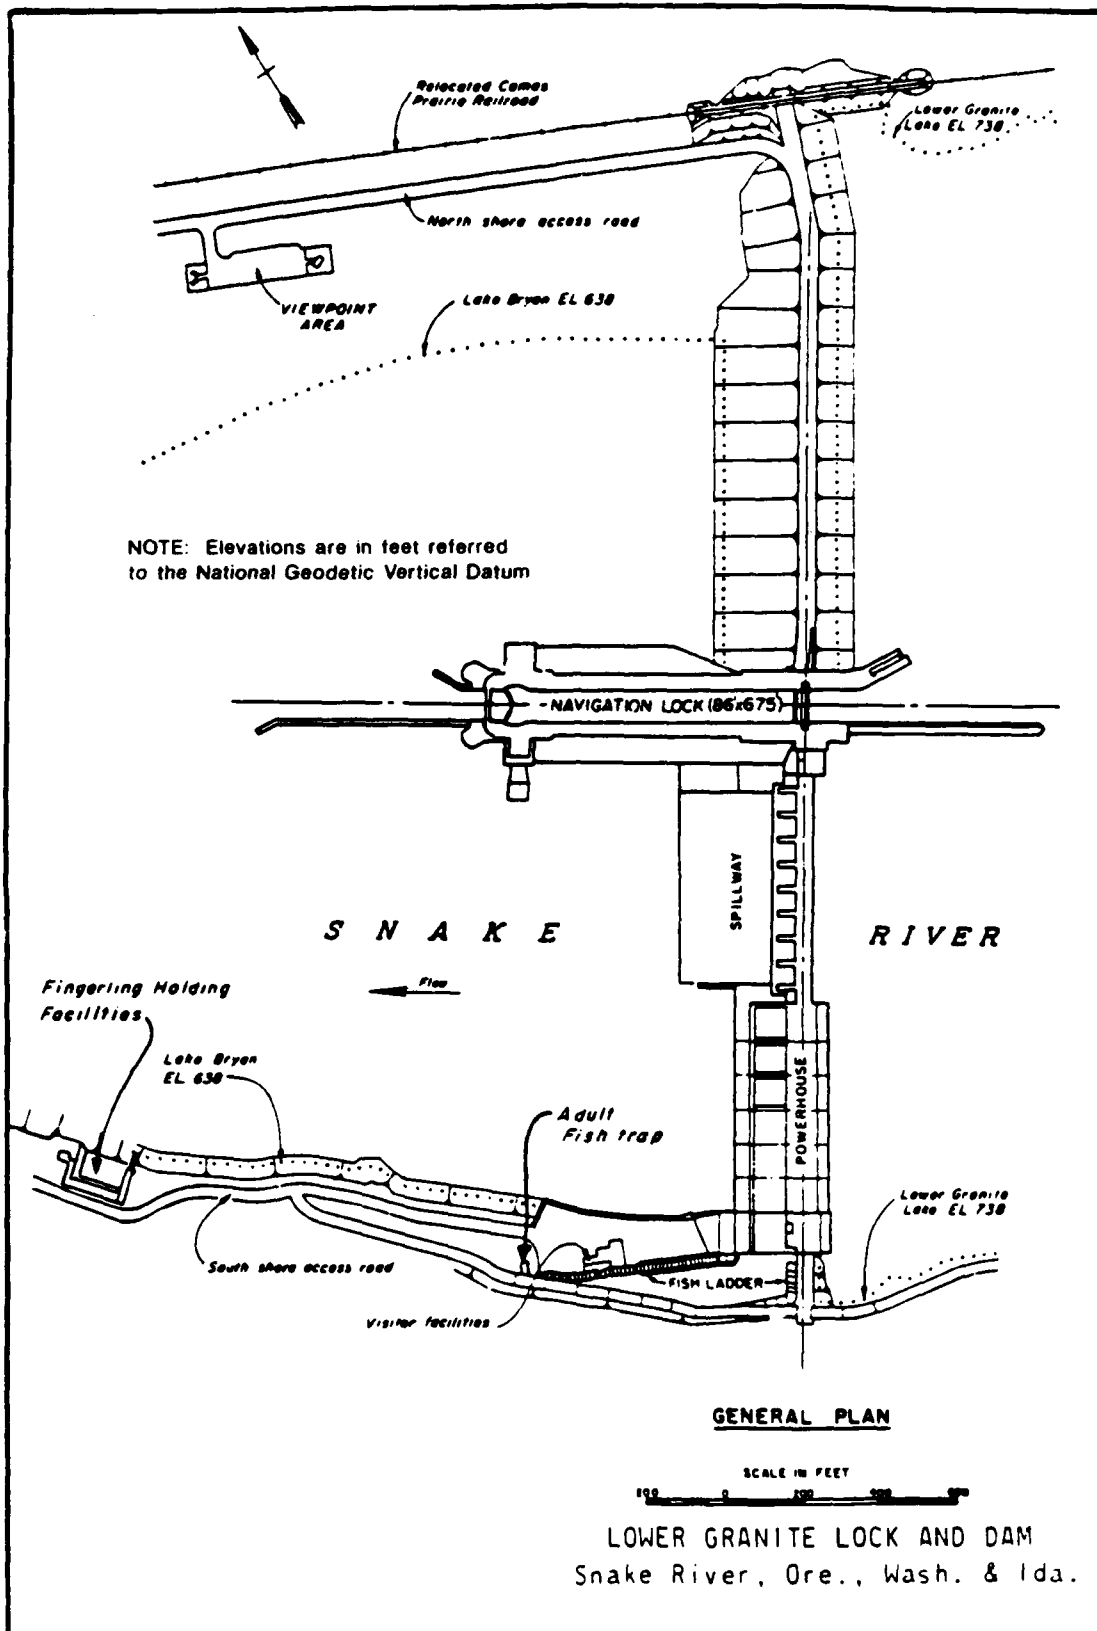
Figure 2. Project layout

1. The Lower Granite Project is located on the Snake River 37.2 miles\* upstream from Little Goose Dam and 107.5 miles upstream from the confluence of the Snake and Columbia rivers (Figure 1). The project consists of an eight-bay tainter-gate-controlled spillway, a six-unit powerhouse having an overload capacity of 931,500 kw, an 86-ft-wide by 675-ft-long navigation lock, and a 20-ft-wide fish ladder (Figure 2).

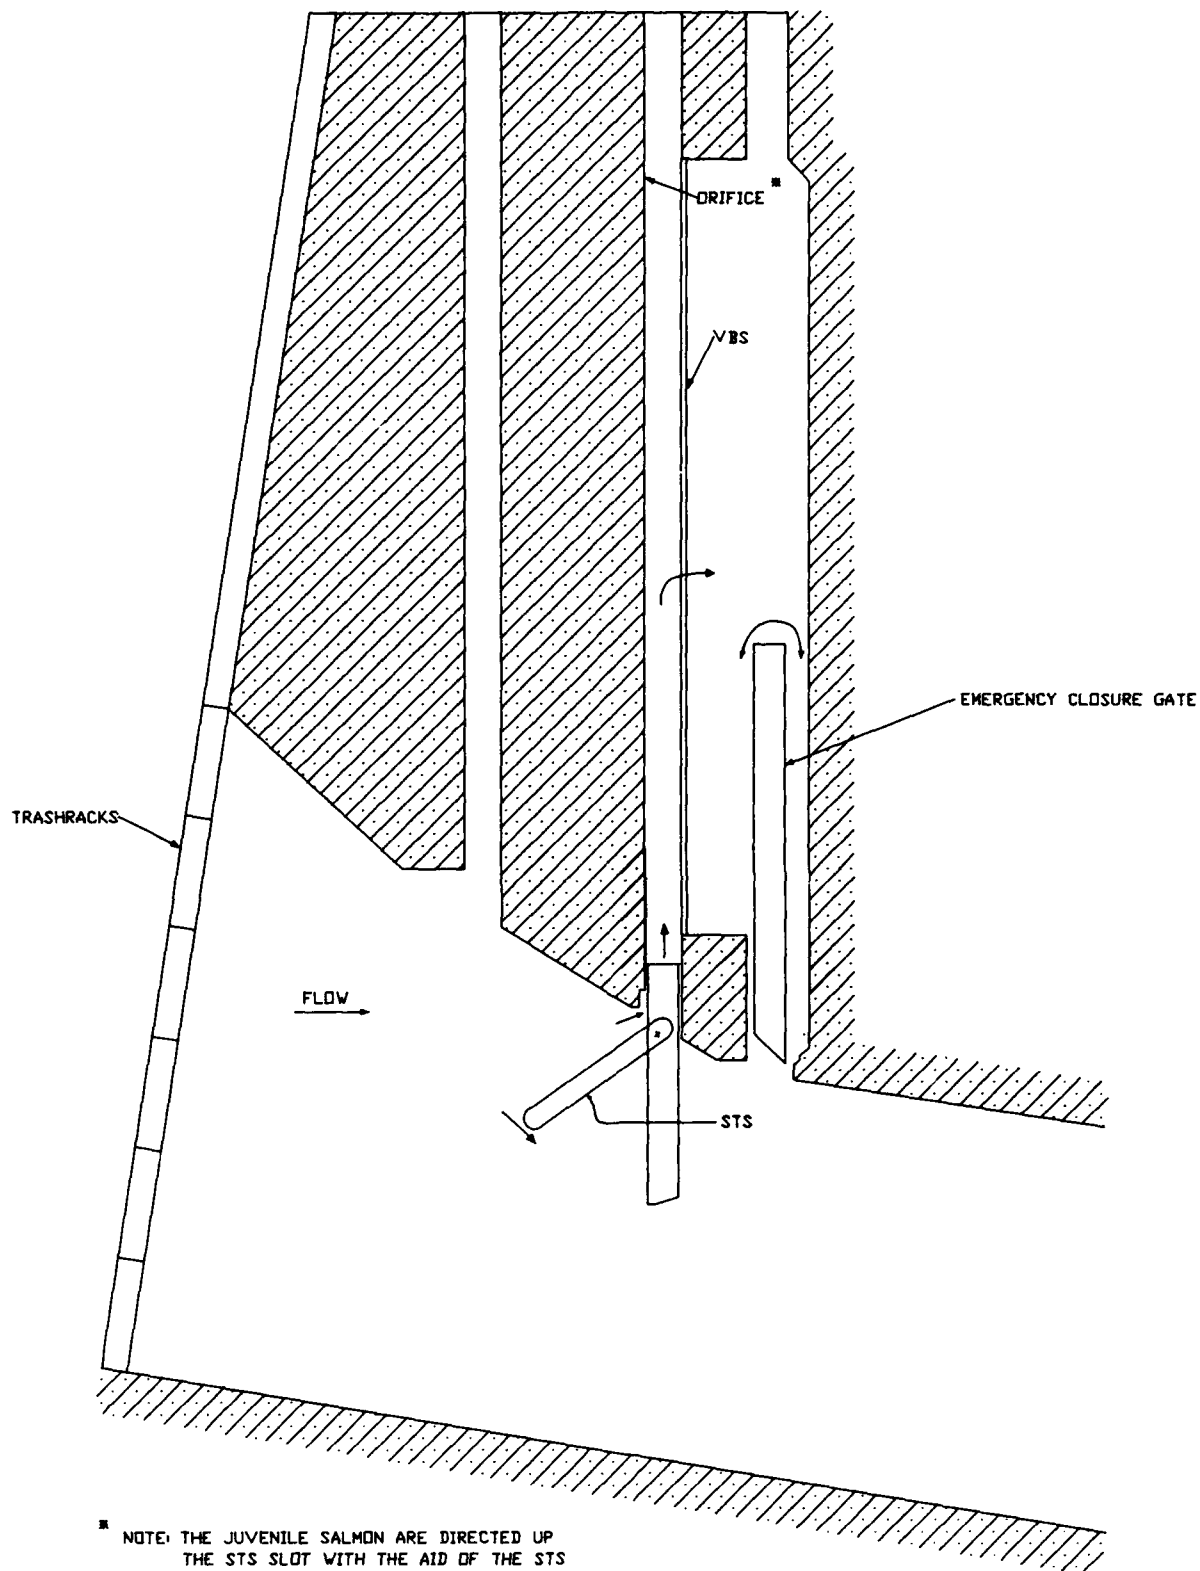
Figure 6. Juvenile bypass system

\* NOTE: THE JUVENILE SALMON ARE DIRECTED UP THE STS SLOT WITH THE AID OF THE STS WHERE THEY WILL TRAVEL UP TO AND THROUGH THE ORIFICES TO BE COLLECTED

5. The JBS (Figure 6) consists of an STS, a bulkhead slot, a VBS, a pair of orifices, and a collection channel. The STS intercepts the flow in the upper portion of the intake where a large percentage of juveniles are located. The fish are then guided into a bulkhead slot and up to the two orifices, which pass the fish into a collection channel. The fish are then transported to the holding facility at the tailrace level. The VBS (Figure 7 shows the probable configuration of the VBS) prevents the fish from passing into the emergency gate slot and back into the intake.

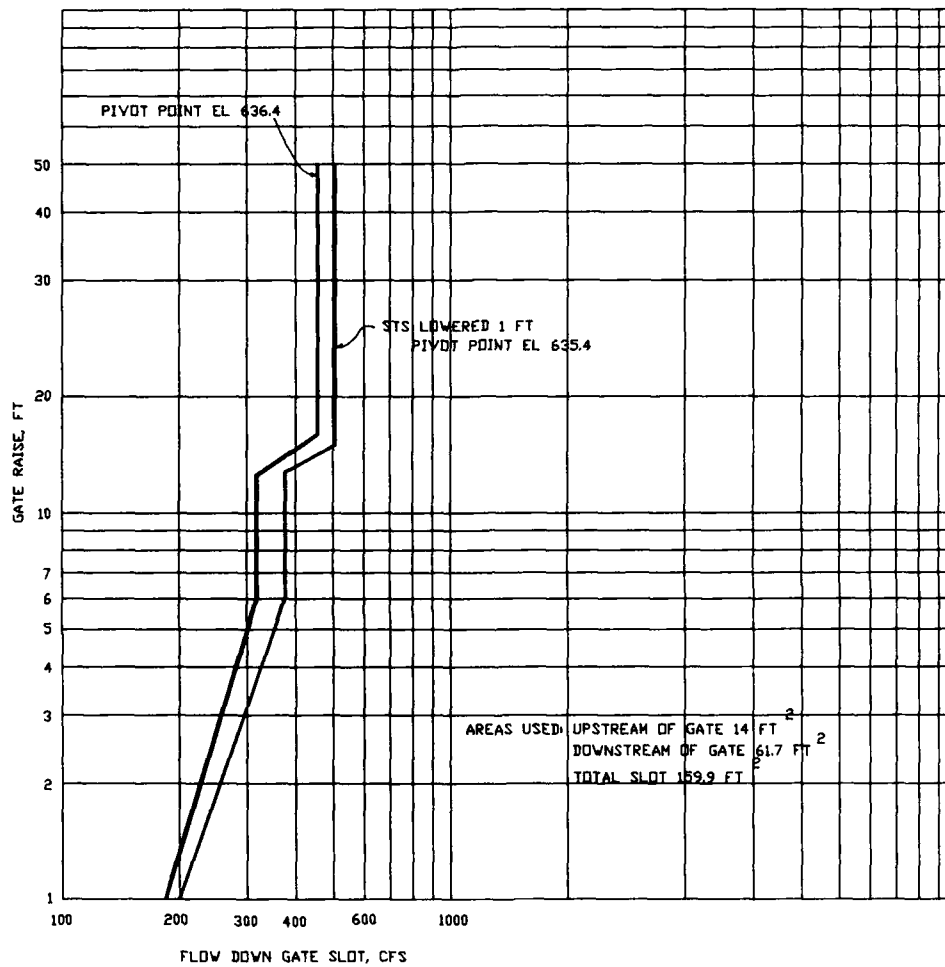
LOWER GRANITE FGE STUDY  
GATE RAISE vs FLOW DOWN SLOT

13. The emergency closure gate was tested at various elevations to determine the effect of raising the gate on flow down the emergency closure gate slot. Test results indicated that flow down the gate slot increased when the gate was raised. The flow increased from 185 cfs with the gate in the normal storage position to 455 cfs with the gate raised 16 ft. No additional increase in flow down the gate slot was obtained for gate raises greater than 16 ft. A plot of flow down the gate well versus the intake gate elevation is shown in Plate 6. No additional flow was intercepted by the STS as a result of raising the emergency closure gate, as can be seen by comparing Test 1 with Test 2 in Table 1. Velocities obtained from Test 2 are shown in Plate 7.

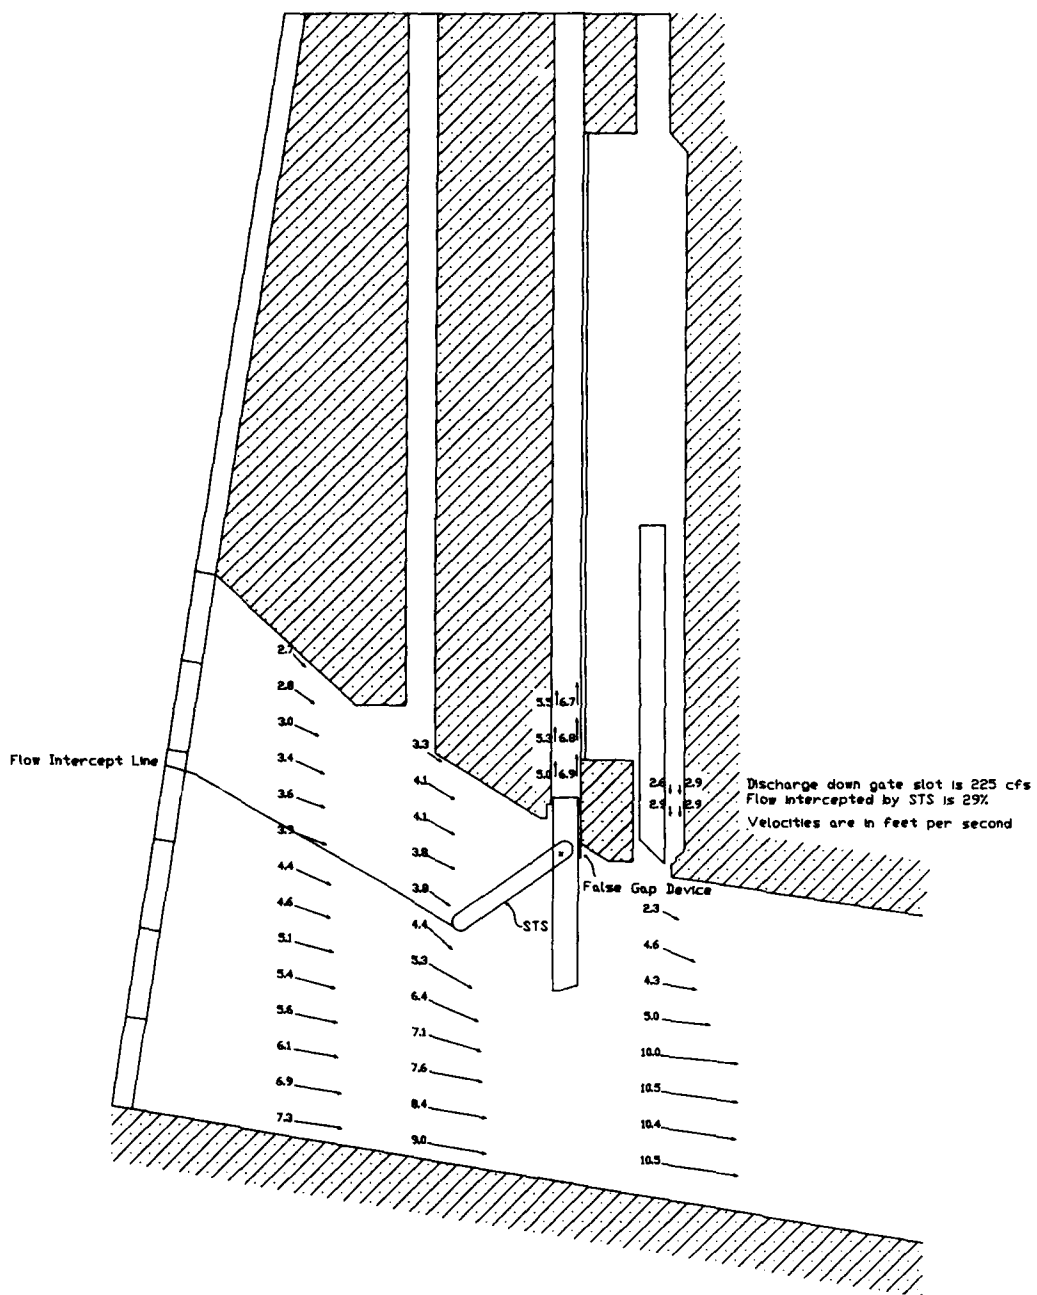
LOWER GRANITE FGE STUDY  
Test 3 Velocities  
55-deg STS Lowered 2 FT  
False Gap Device  
Pivot EI 634.4

14. Tests were conducted with the STS lowered 2 ft and 4 ft (Photo 2). A false gap device installed in the model partially blocked flow at the top of the STS (Tests 3 and 4). Results from these tests are shown in Plates 8

and 9, respectively. These tests indicated that a greater percentage of flow can be intercepted by lowering the STS. A larger flow is directed up the STS slot with the false gap device in place and the STS lowered (compare Test 1 with Tests 3 and 4 in Table 1).

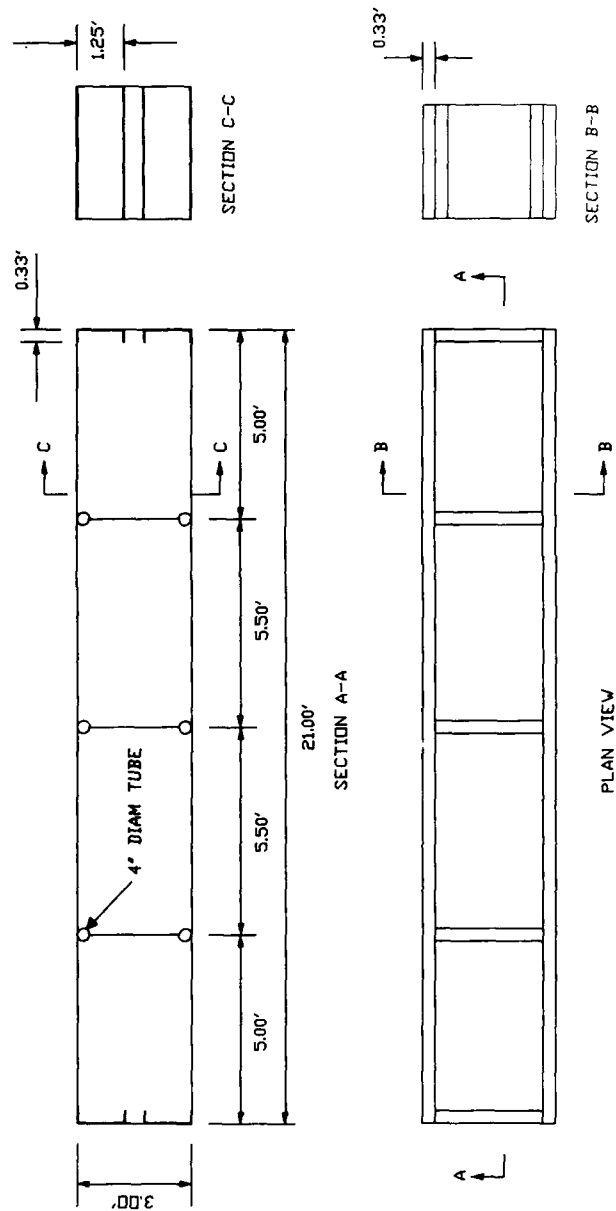
MODIFIED STS UPPER SUPPORT BEAM

16. The following modifications were added to the JBS: a modified STS upper support beam (Plate 12), a skin plate and orifices added to the upstream side of the emergency closure gate (Photos 3 and 4 and Plates 13 and 14), and a rounded gate well beam. These modifications were tested with the STS in the normal operating position and with it lowered 2 ft and 4 ft (Tests 7-9). Velocities obtained from these tests are shown in Plates 15-17, respectively. Note that the false gap device was added in Tests 8 and 9. Little change in overall flow conditions was observed (compare Test 9 with Test 5 in Table 1).

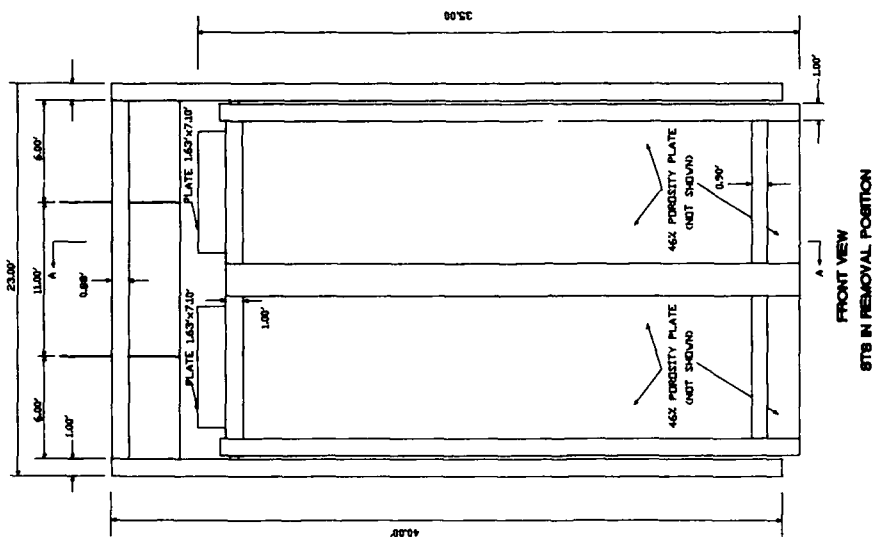
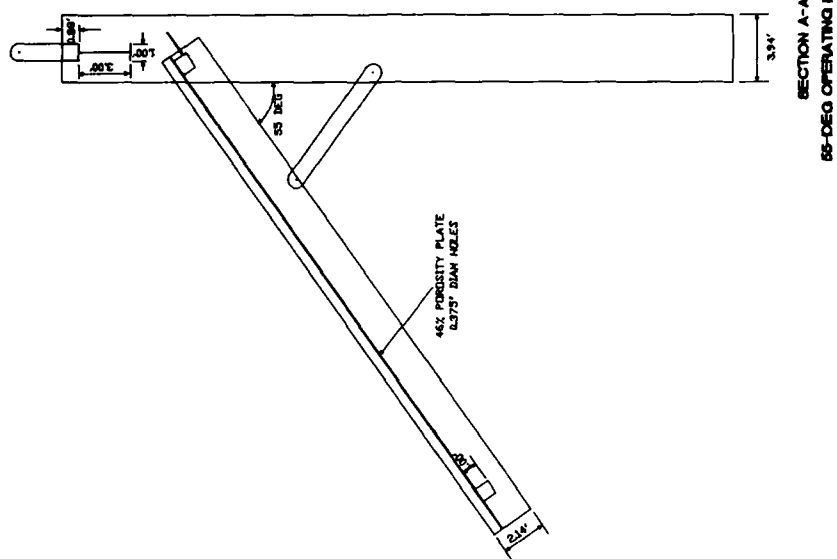
LOWER GRANITE FGE STUDY  
EXTENDED STS

19. An extended STS with a length of 35 ft was installed in the model (Plate 22 and Photo 6). The extended STS simulated either a longer STS or the placement of a deflector immediately upstream of the existing STS through the fish screen slot. It was tested with the emergency closure gate in its normal storage position and with it raised 5 ft and 20 ft (Tests 14-16, respectively). Data obtained from these tests are shown in Plates 23-25, respectively. A substantial increase in the percentage of flow intercepted by the FGE and a slight increase in flow down the emergency closure gate slot was observed (compare Test 1 with Test 14 in Table 1).

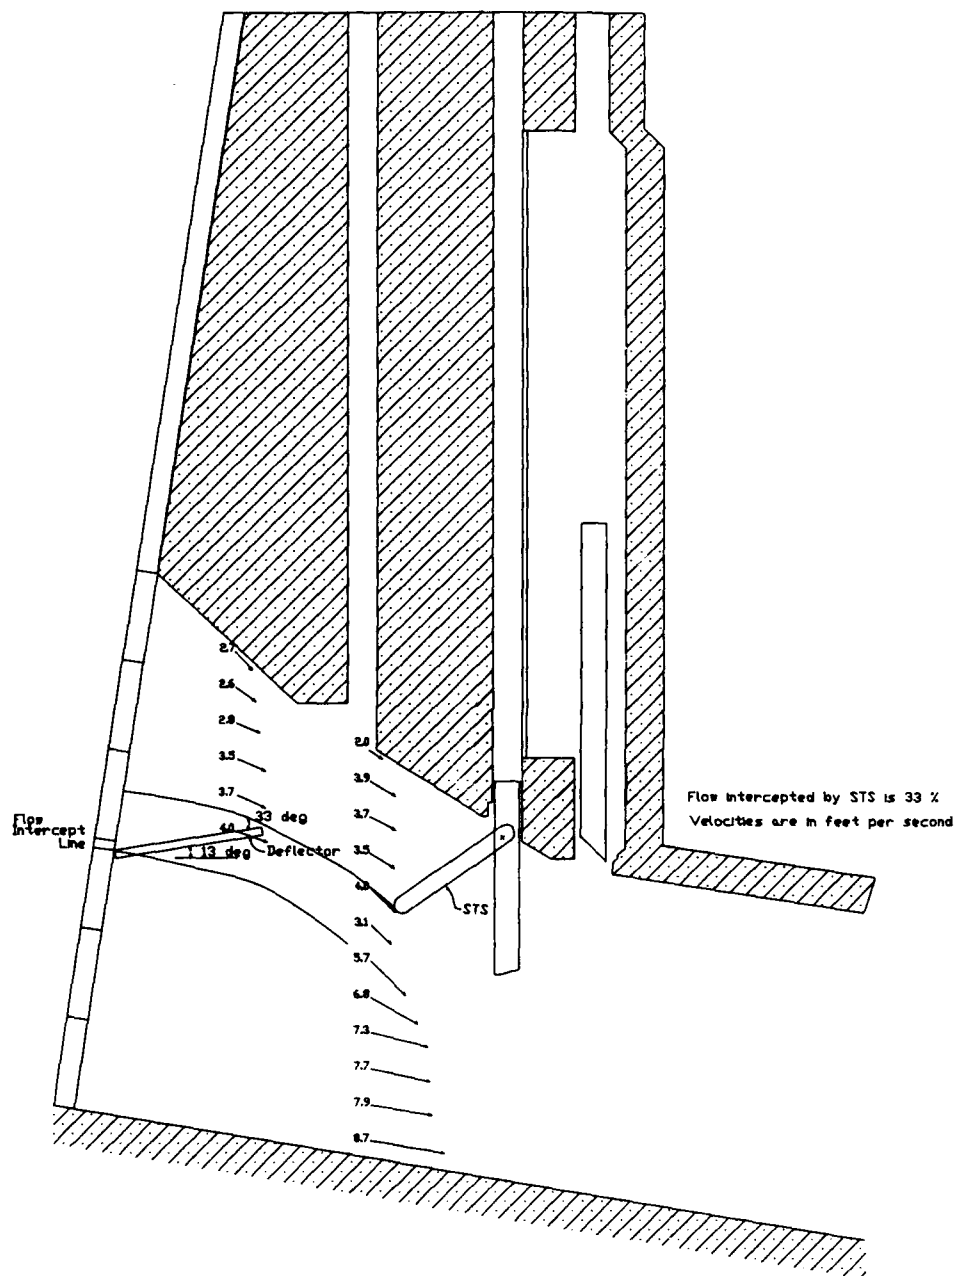
LITTLE GOOSE FGE STUDY  
 Test 20 Velocities  
 55-deg STS  
 Deflector Attached at El 636.4  
 Pivot El 636.4

21. A series of four tests employing deflectors attached to the trashrack were conducted as a potential prototype configuration for Little Goose Dam, whose intake section is similar to that at Lower Granite. The STS was tested with a deflector attached to the trashracks at el 636.4 at an angle of 13 deg to the horizontal (Test 20, Table 1). Velocities obtained from this test are shown in Plate 29. Thirty-three percent of the flow was intercepted by the FGE. This was an improvement over the original design (compare Test 1 with Test 20 in Table 1). The impact angle at which flow struck the deflector was found to be 33 deg. This angle borders on being too severe for the

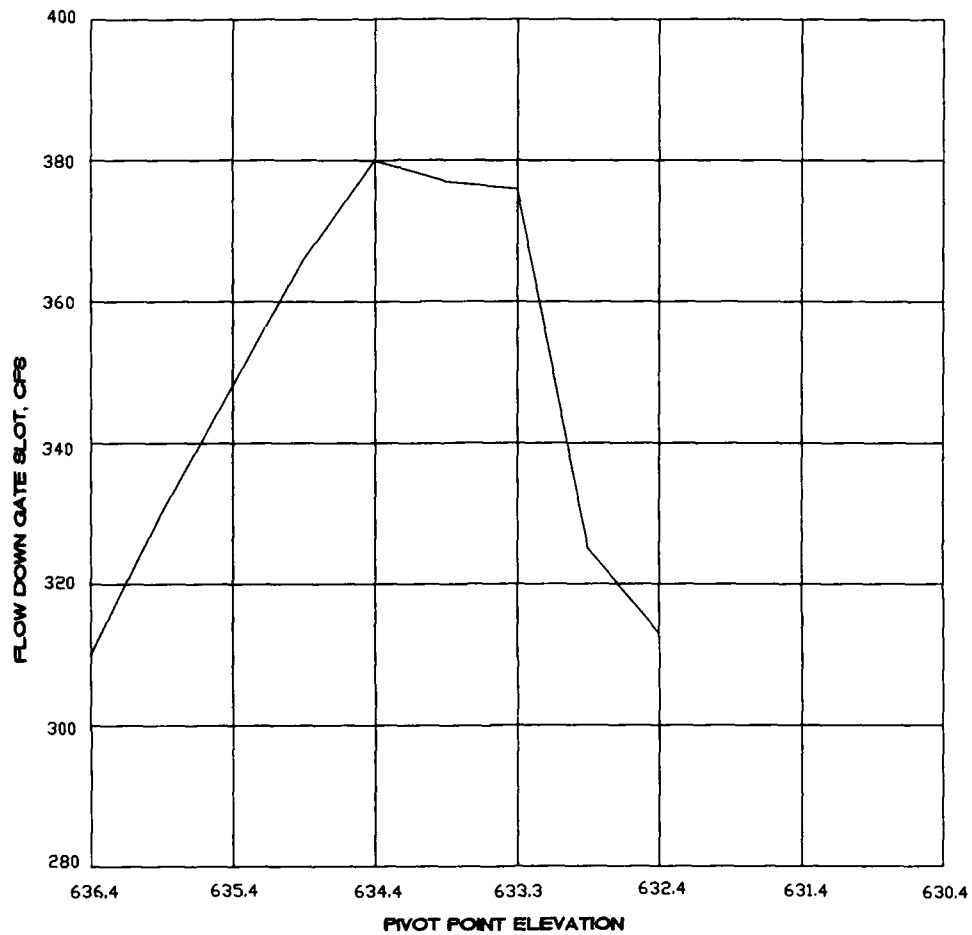
NOTE: EMERGENCY CLOSURE GATE  
IS RAISED 5 FT

STS PIVOT POINT ELEVATION  
 $V_8$   
FLOW DOWN GATE SLOT

25. The STS was tested at different elevations without a false gap device to determine the operating elevation that would maximize flow down the emergency closure gate slot without the use of a false gap device. A plot of STS elevation versus flow down the gate slot is provided in Plate 33. The optimum elevation was with the STS lowered 2 ft.

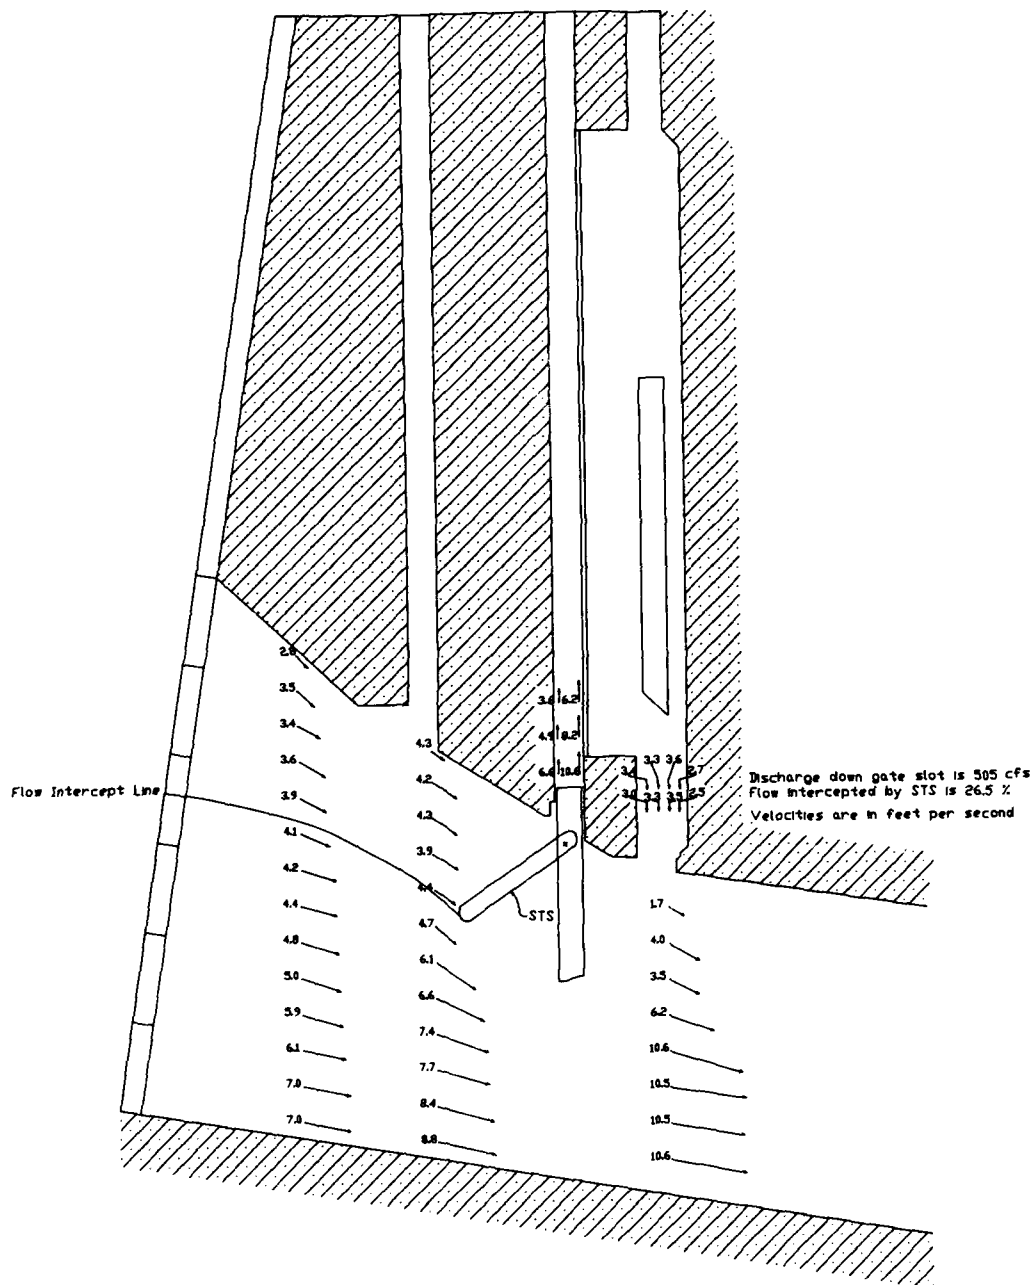
LOWER GRANITE FGE STUDY  
Test 25 Velocities  
55-deg STS Lowered 1 FT  
Gate Raised 20 FT  
Pivot EI 635.4

28. Tests were conducted with the STS lowered 1 ft with the emergency closure gate in the normal storage position and with it raised 20 ft. Velocities obtained from these tests are shown in Plates 34 and 35, respectively. There was no appreciable increase in interception over the test condition with the STS in its normal position, but there was an increase in flow down the emergency closure gate slot (compare Test 1 with Tests 24 and 25 in Table 1).

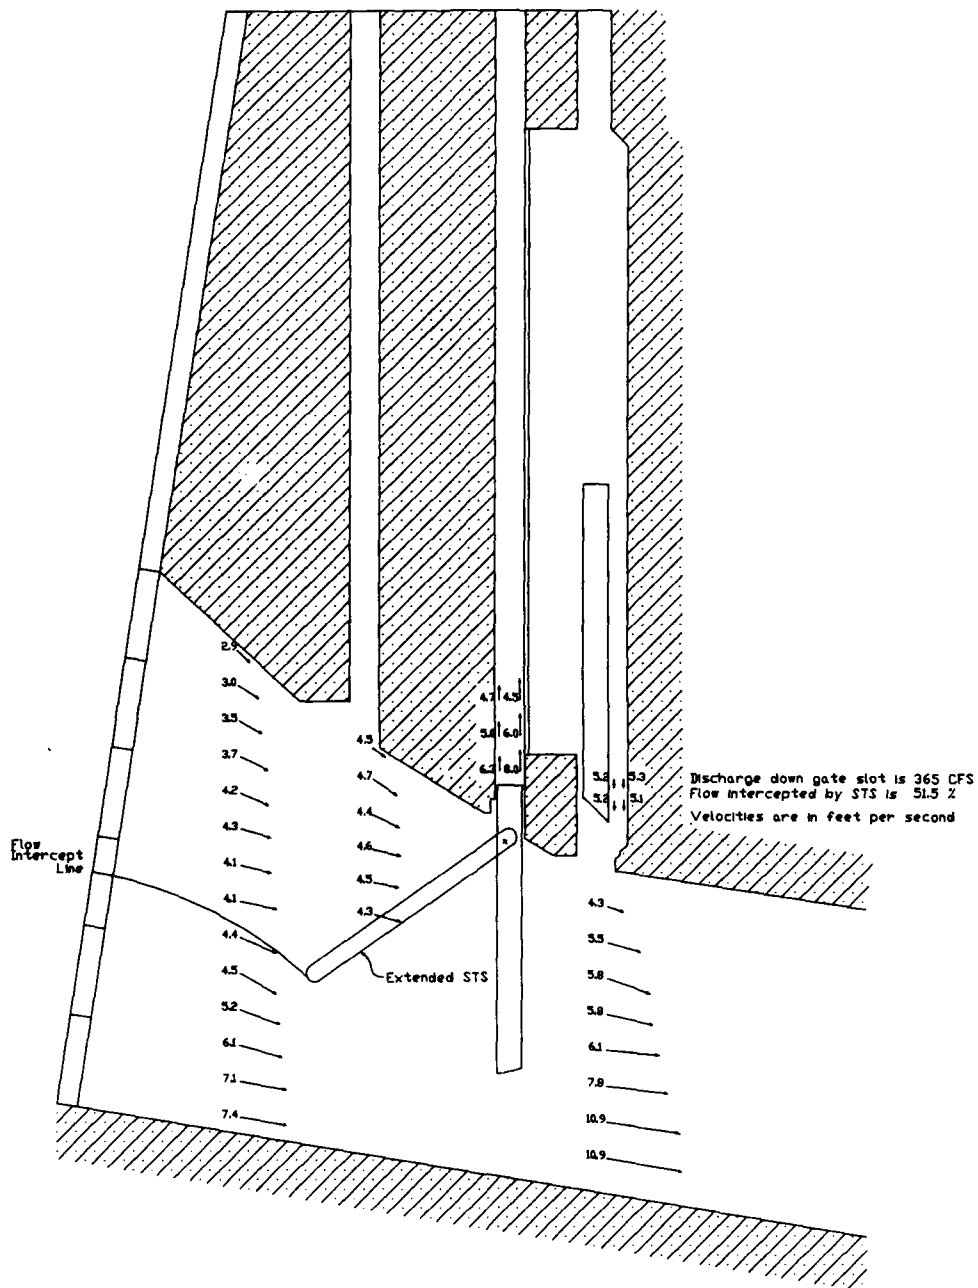
LOWER GRANITE FGE STUDY  
Test 29 Velocities  
55-deg Extended STS Lowered 1 FT  
Gate Raised 5 FT  
Pivot EI 635.4

31. Tests 15, 18, and 19 were repeated with the extended STS lowered an additional foot (Tests 29-31). Velocities obtained from these tests can be seen in Plates 39-41, respectively. Data obtained from these tests indicated a slight increase in flow down the emergency closure gate slot but no noticeable improvement in interception (compare Tests 15, 18, and 19 with Tests 29-31 in Table 1).

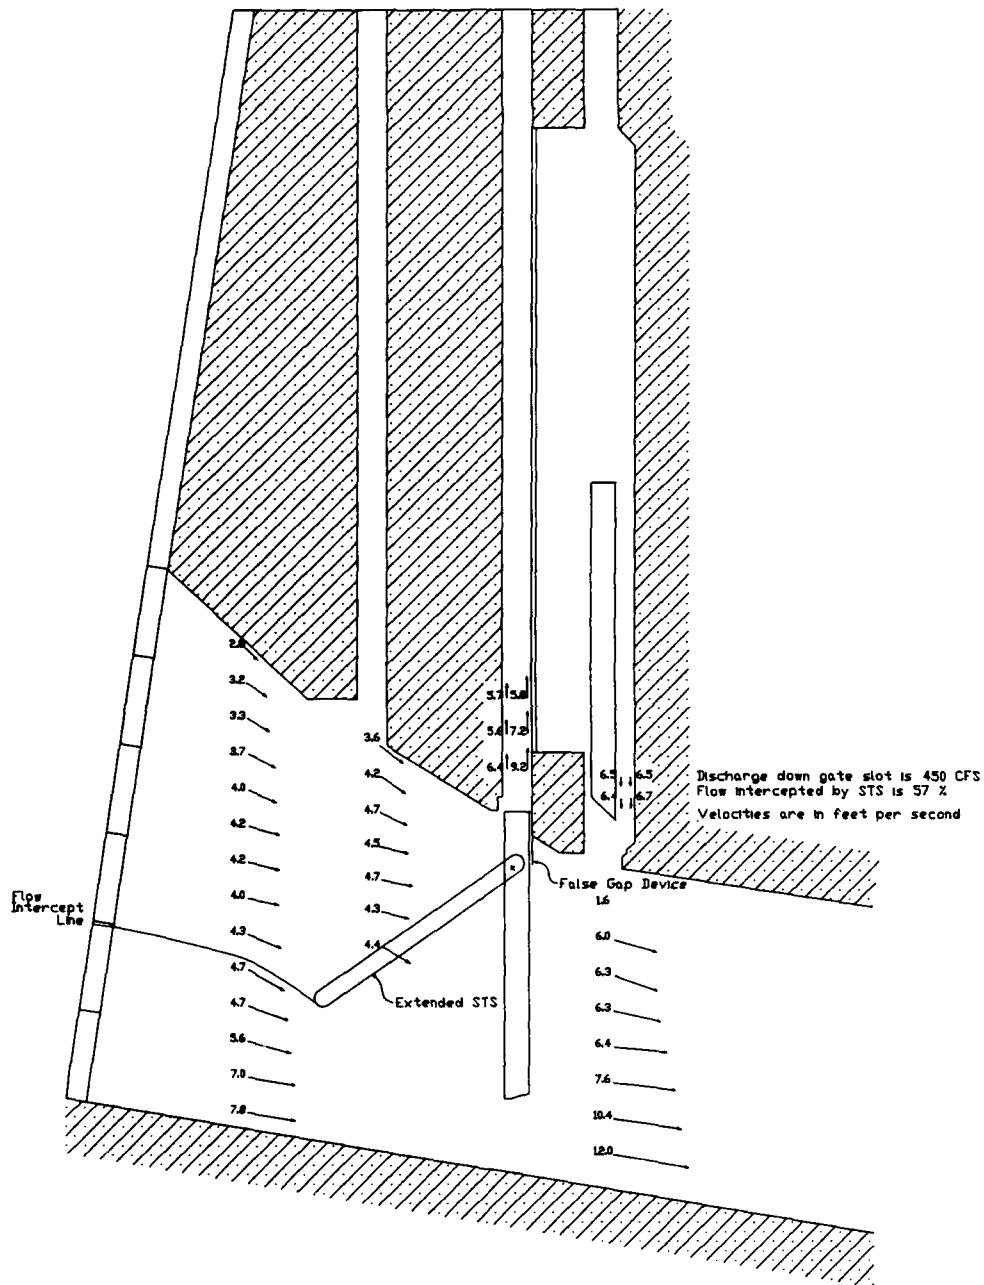
LOWER GRANITE FGE STUDY  
 Test 30 Velocities  
 55-deg Extended STS Lowered 5 FT  
 False Gap Device  
 Gate Raised 5 FT  
 Pivot EI 631.4
