EVT 1-88

TRANSPORTABILITY TESTING OF LIGHT ARMORED VEHICLE-LOGISTICS (LAV-L)

US ARMY DEFENSE AMMUNITION
CENTER AND SCHOOL

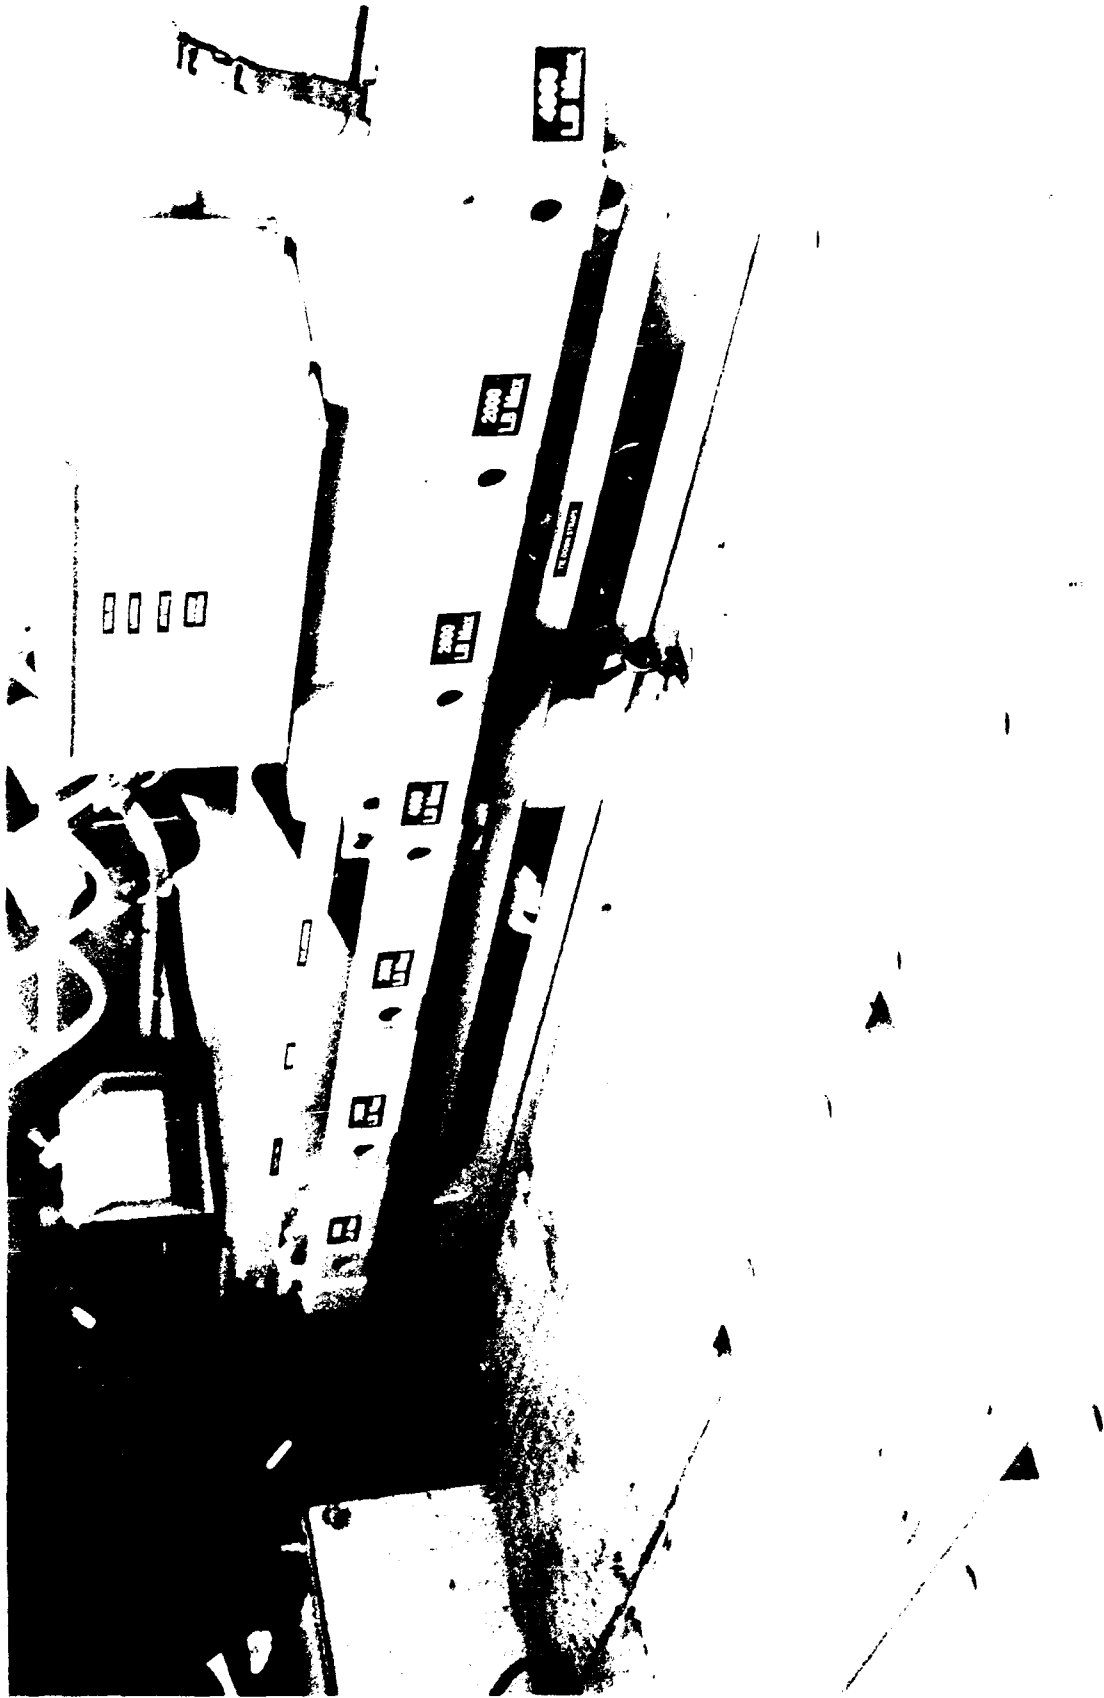
Photo 3. View of the cargo carrying compartment of the LAV-L showing the web strap attachment points on the floor and wall with the ratings of the various points. Note the type of fixture on the ends of the six tiedown straps issued with the LAV-L.

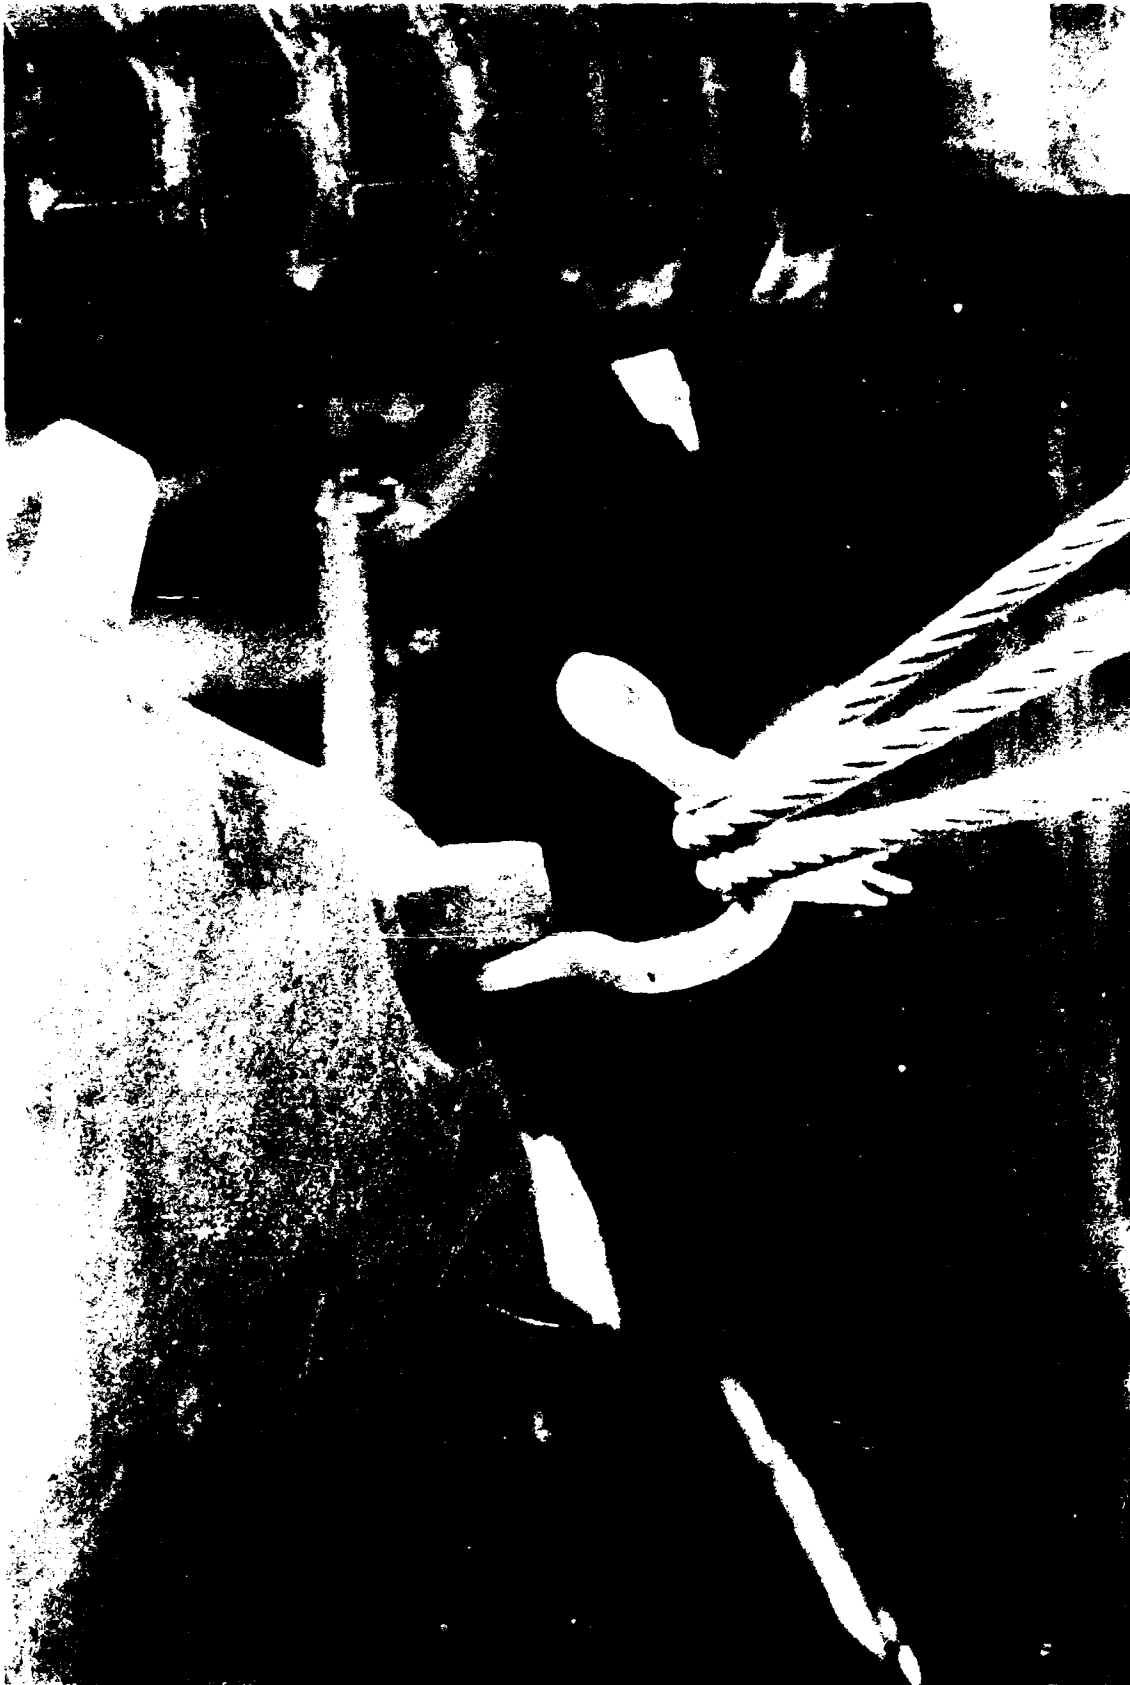
D. FINDINGS. In the initial rail impact test, a pin in the vehicle tiedown system on the driver's side of the front of the LAV-L failed during the 6 mph rail impact. Two other pins in the tiedown assemblies on the front of the LAV-L were damaged and bent directly into the vehicle front elevis pin during the 6 mph rail impact. The 4, 6, 8, and reverse 8 mph rail

During the six mph (6.42 mph actual speed) rail impact, the pin in the vehicle tiedown clevis located on the driver's side on the front of the LAV-L failed. The pin failed through the throat of the first thread from the head side of the pin of the clevis.

Photo 6. View of the failed vehicle tieddown clevis located on the driver's side of the front of the LAV-L.

(1) It is recommended steps be taken to assure that proper vehicle tie-down clevises are used on the LAV-L when the vehicle is cabled to a railroad flatcar. Permanently attaching the proper clevises to the LAV-L is also recommended.

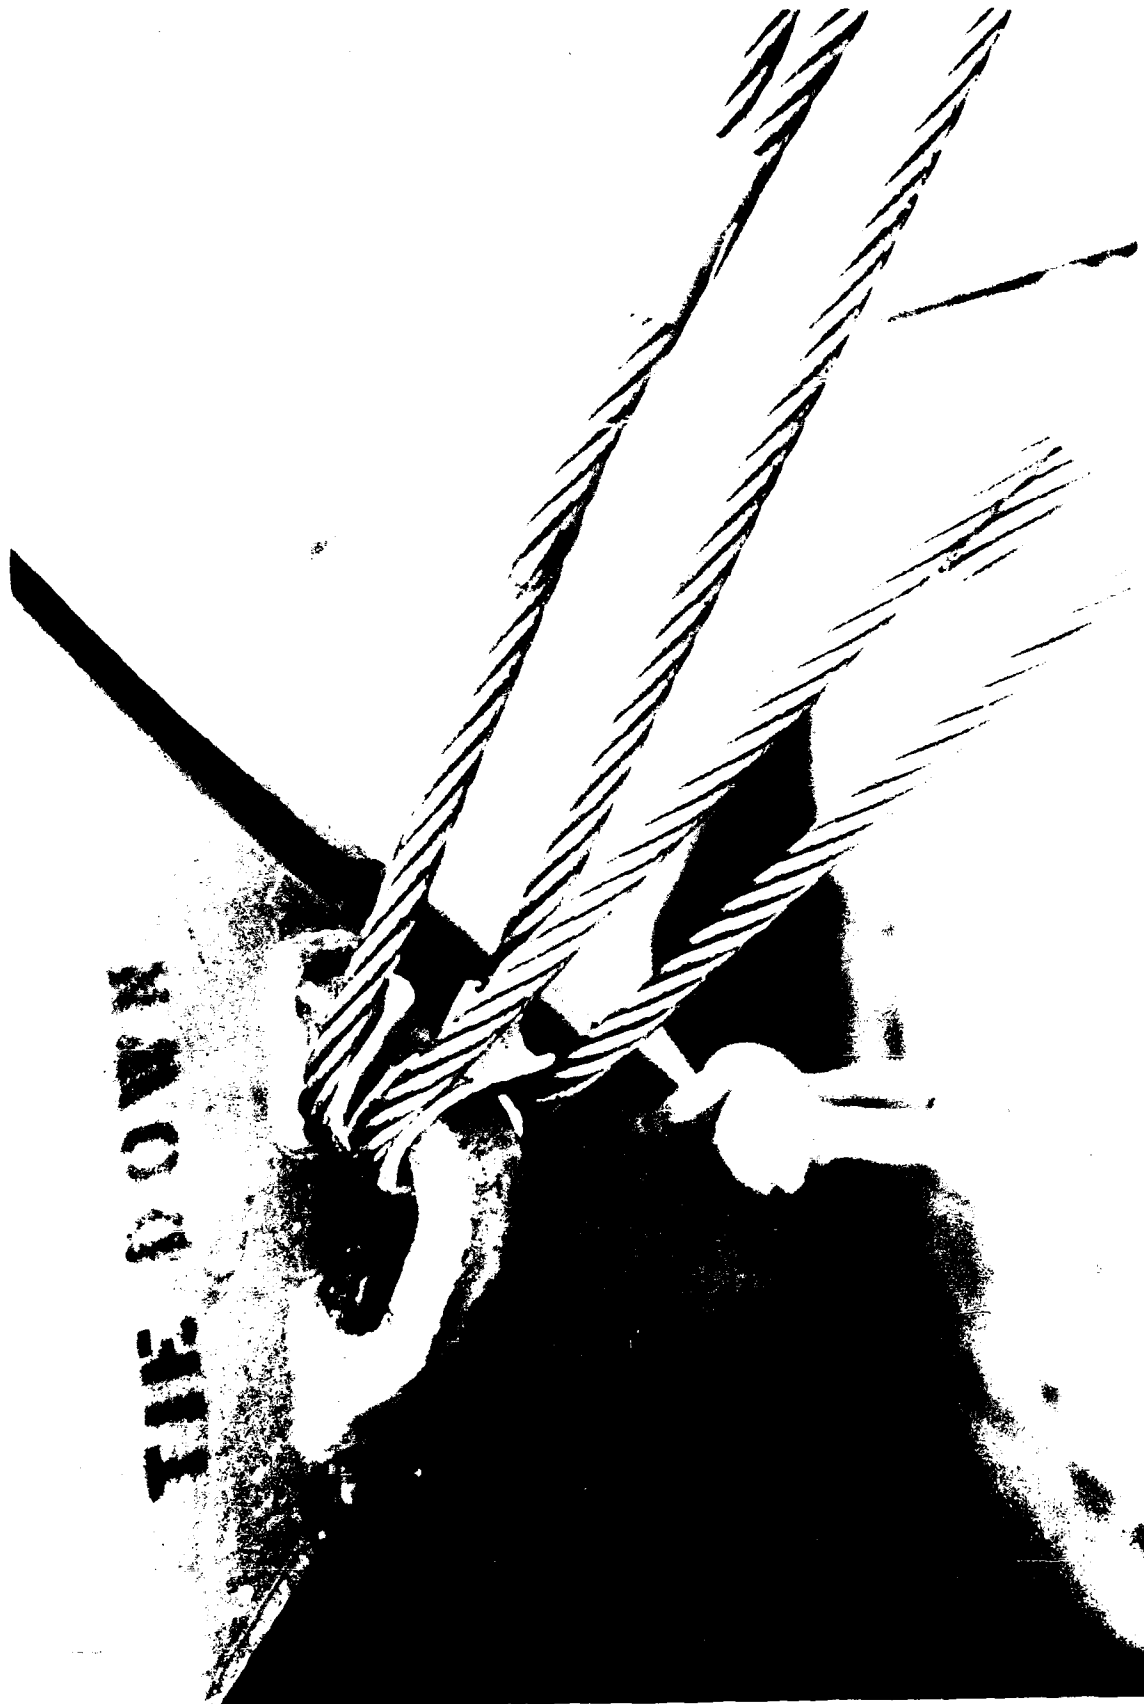
After failure of the clevis in the six mph rail impact of the LAV-L and with no replacement clevis available, both clevises were removed from the front tiedown provisions of the LAV-L and the two 5/8-inch cables were placed directly through the alternate vehicle front tiedown provisions without the use of a clevis. The rear cabling remained as tested in the previous test.

Photo 10. View of LAV-L tiedown provision used in retest. Note the location of the previous test clevis tiedown.
