Enhanced Preliminary Assessment Report:

Rocky Point Army Housing Units
Rocky Point, New York

November 1989

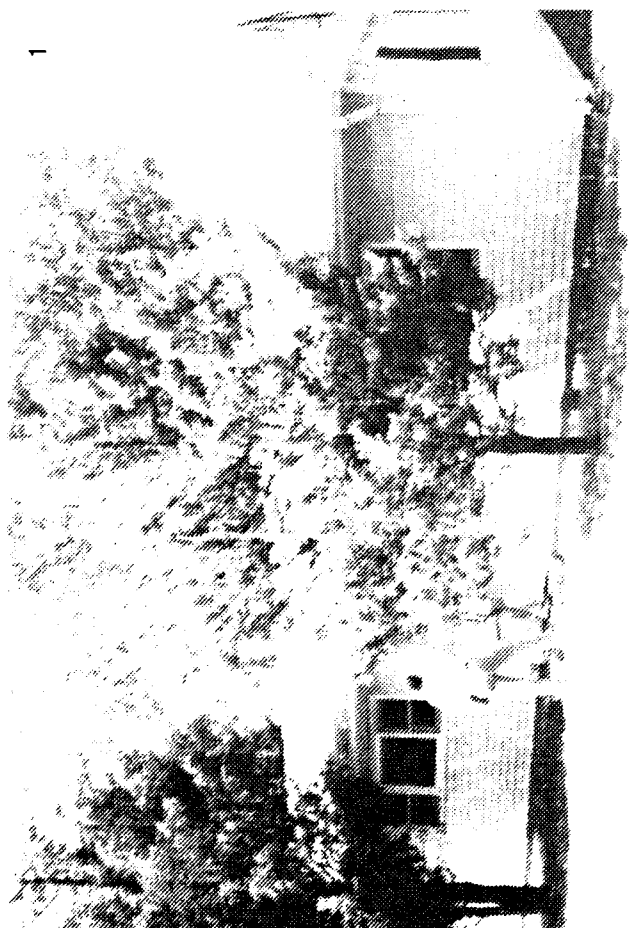
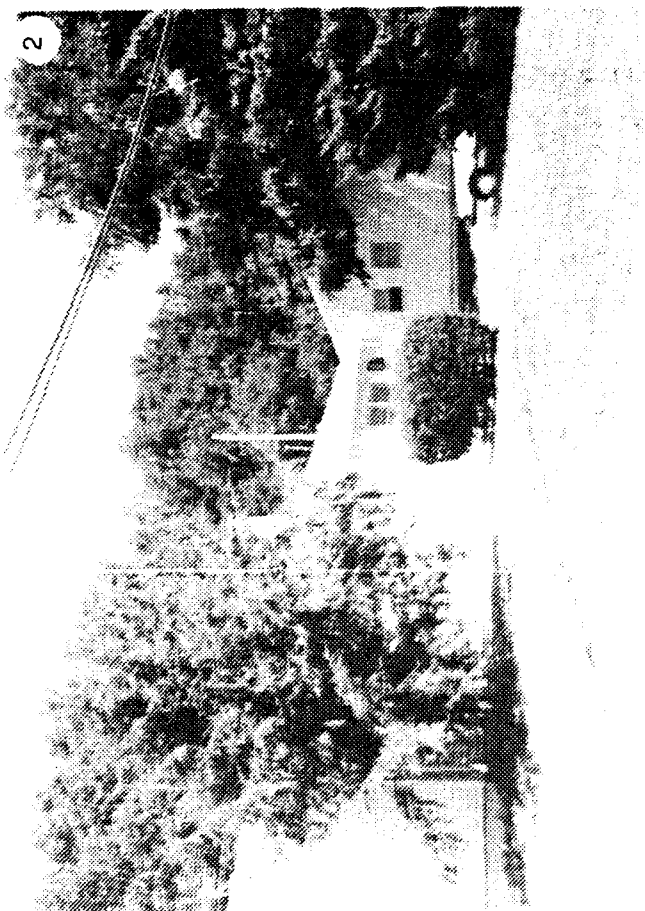
1. Typical unit at Rocky Point housing; note concrete slab foundation.
2. Typical unit at Rocky Point housing; property east and west of housing site is primarily undeveloped county property.
