DTIC  
ELECTE  
NOV 22 1989Feasibility of a Super High Energy Density Battery  
of the Li/BrF<sub>3</sub> Electrochemical System

Technical Report

Wilson Greatbatch Ltd.  
10,000 Wehrle Drive  
Clarence, NY 14031

Michael F. Pyszczek, Steven J. Ebel, Christine A. Frysz

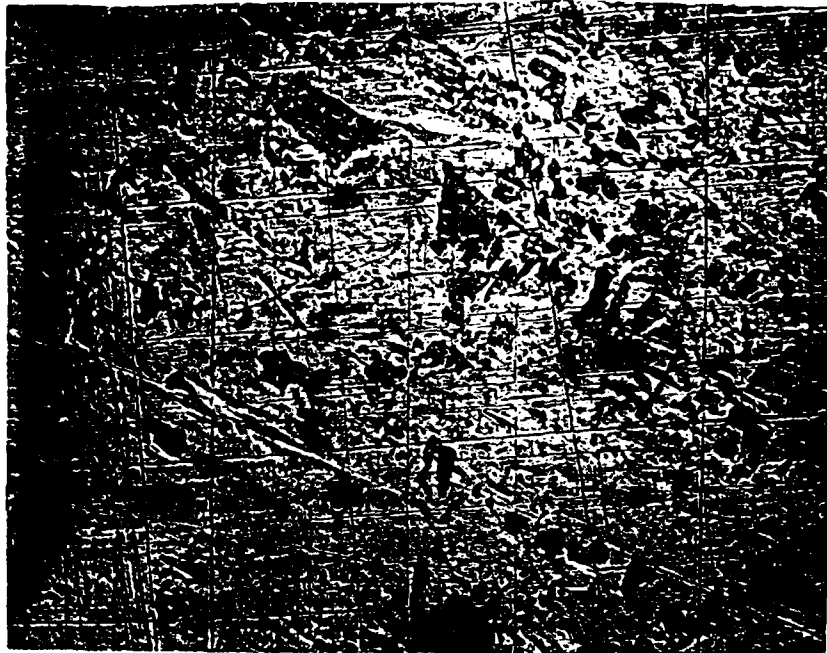
FIGURE 19: VIRGIN MONEL ~600X

Table 1 lists the results for the metals tested. After two days of bromine trifluoride exposure, pre and post weight changes were insignificant. Mild steel, 304 and 316 L SS showed visible signs of general corrosion, see Figures 1 through 6. Surface discolorations were observed for nickel 200, Superferri<sup>®</sup> and Shomac<sup>®</sup>, see Figures 7 through 12. The discolorations coincided with small particles retained on the surface after cleaning. It is speculated that these particles may be fluorides since elemental composition was undetectable by WGL's present EDX system. Aluminum alloy 1145-0, Hastelloy<sup>®</sup> G30, 29-4-2, and Monel<sup>®</sup> appeared to be unaffected, Figures 13-20.

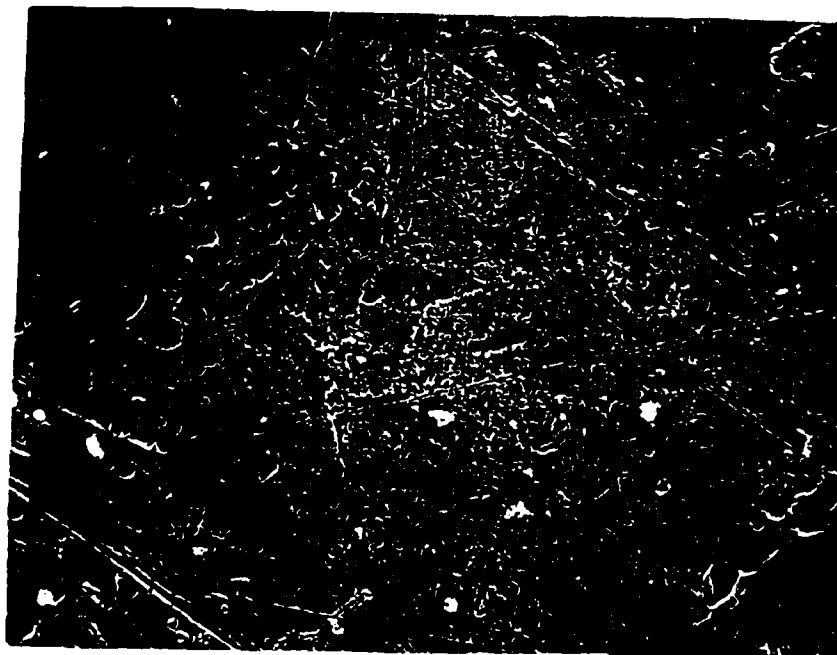
FIGURE 20: MONEL - 2 DAY EXPOSURE TO BrF<sub>3</sub> ~600X
