Task Order 2 Enhanced Preliminary Assessment

# FORT HOLABIRD CRIME RECORDS CENTER BALTIMORE, MARYLAND

### ENHANCED PRELIMINARY ASSESSMENT REPORT

### FORT HOLABIRD CRIME RECORDS CENTER

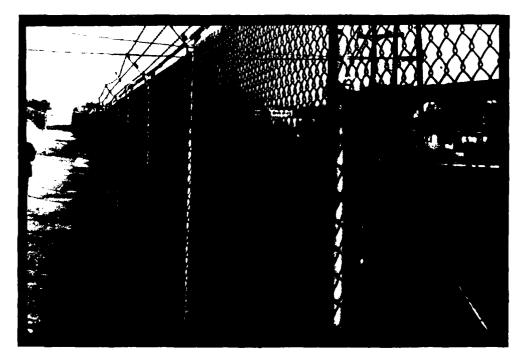
5. SITE OF FORMER INCINERATOR

An incinerator used to burn paper was formerly located on the cleared strip of land located east of Building 305 (photo 5) in or near former Building 302. The incinerator, along with another small building, was demolished in the early 1970s.

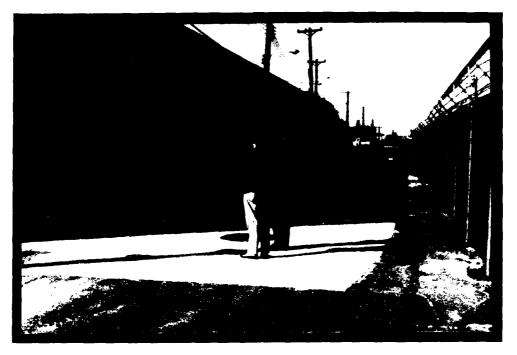
8. NEW UST LOCATION

A newly installed (1989 construction), 4,000-gal underground storage tank (UST) is located just north of the northeastern corner of Building 305 (photo 8). This tank replaced the in-ground storage tank that was formerly located adjacent to the northeastern corner of this building. The new tank stores No. 2 fuel oil used to fuel the boiler in the building. In contrast to the three former in-ground storage tanks, this tank is double-walled steel, cathode protected, resin/tar-coated, and wrapped. Even though the new tank has passed a leak test, its annular space is currently monitored for leakage by a new fluid detection system. It has continuous automatic sensing equipment to detect liquid hydrocarbons or hydrocarbon vapors (photo 9). In addition, the new tank has three new monitoring wells, one on its western end and two on its eastern end, that can be used to manually sample groundwater.

There is no evidence of any present spills/leakage from the new tank. However, the location of this tank is in close proximity to the location of the former 6,000-gal in-ground storage tank that leaked an undetermined amount of fuel oil in the past. Nevertheless, no contamination has been detected from samples drawn from the monitoring wells nor from the continuous automatic sensing equipment.

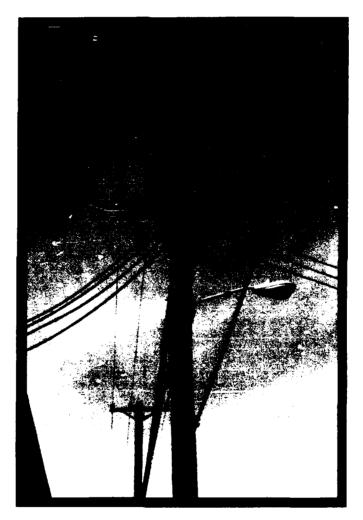
11. TRANSFORMER

There is only one electrical transformer at the CRC site. The transformer is Army owned and is located northeast of Building 305. Due to the age of the transformer, it may contain PCBs. Although the overall condition of the transformer is good, it is scheduled to be replaced by Fort Meade's Facilities Engineering and Maintenance Division.

There is no evidence of any past or present spills in this area. In addition, no transformer oil leaks or stains were observed on the pole or around its base.
