MTL TR 90-61

THE BSU-86/B BOMB FIN ASSEMBLY FIRST ARTICLE CONFORMANCE TESTING

MARC S. PEPI, VICTOR K. CHAMPAGNE, Jr., and
CATHERINE M. ZOLLER
MATERIALS TESTING AND EVALUATION BRANCH

December 1990

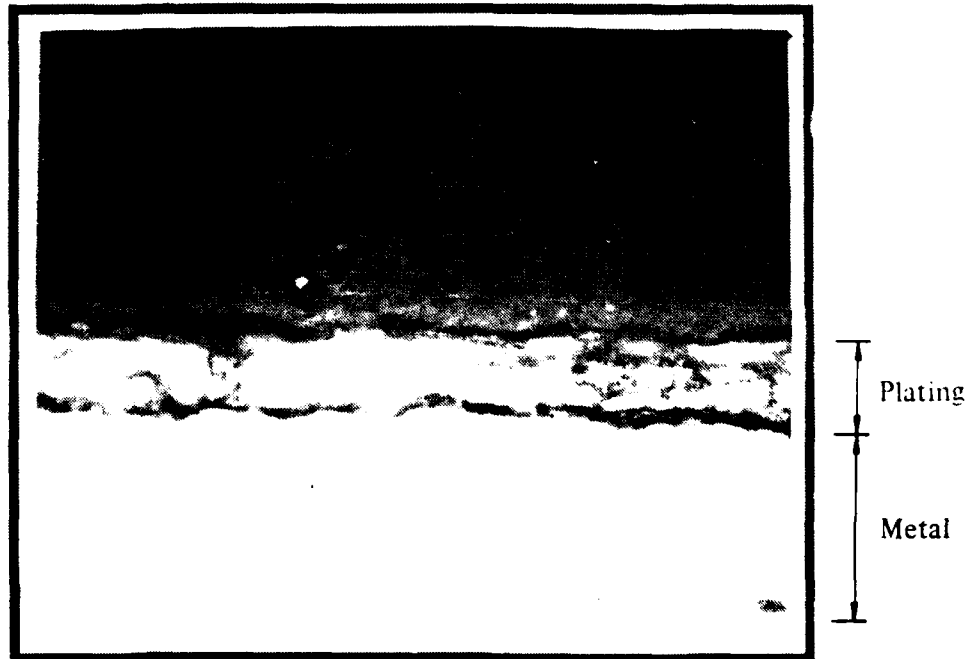
Figure 41. Optical micrograph of the self-locking nut revealing a plating thickness of 0.001 inch. MAG 500X

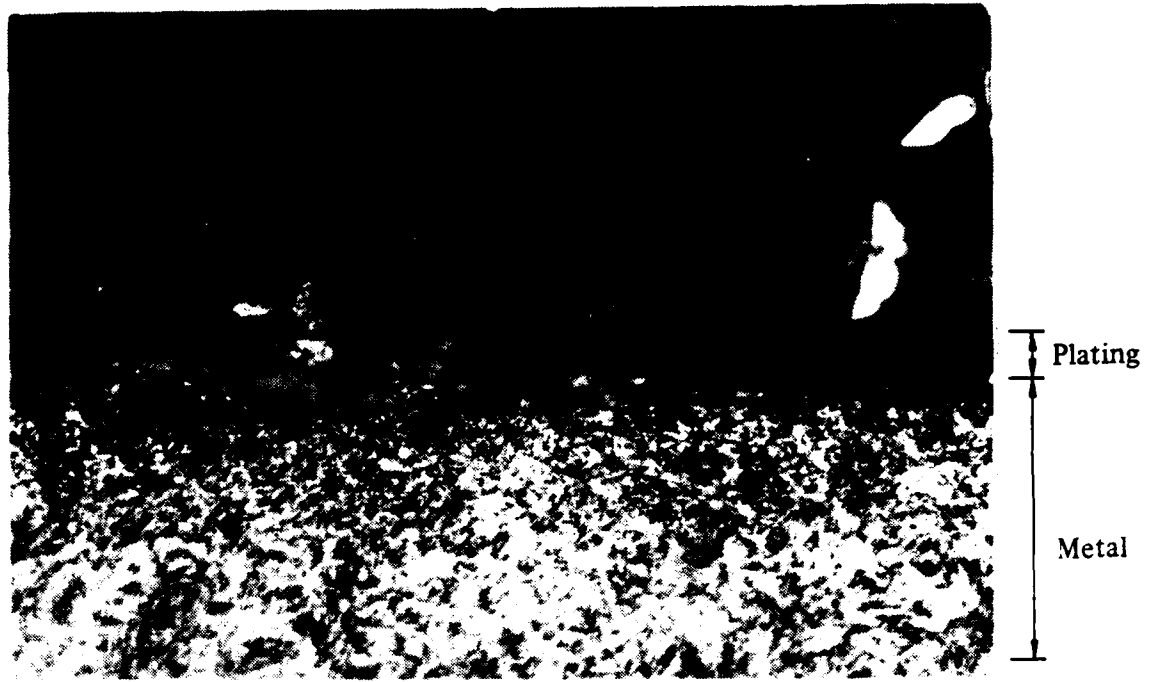
Figure 42. Optical micrograph of the setscrew revealing a plating thickness of 0.0005 inch. MAG 800X
