MICROSTRUCTURE-BASED FATIGUE LIFE PREDICTION METHODS FOR NAVAL STEEL STRUCTURES

FIRST ANNUAL REPORT
July 15, 1991-July 15, 1992
SwRI Project No. 06-4414
ONR Contract No. N00014-91-C-0214

Office of Naval Research
800 N. Quincy Street
Arlington, VA 22217-5000

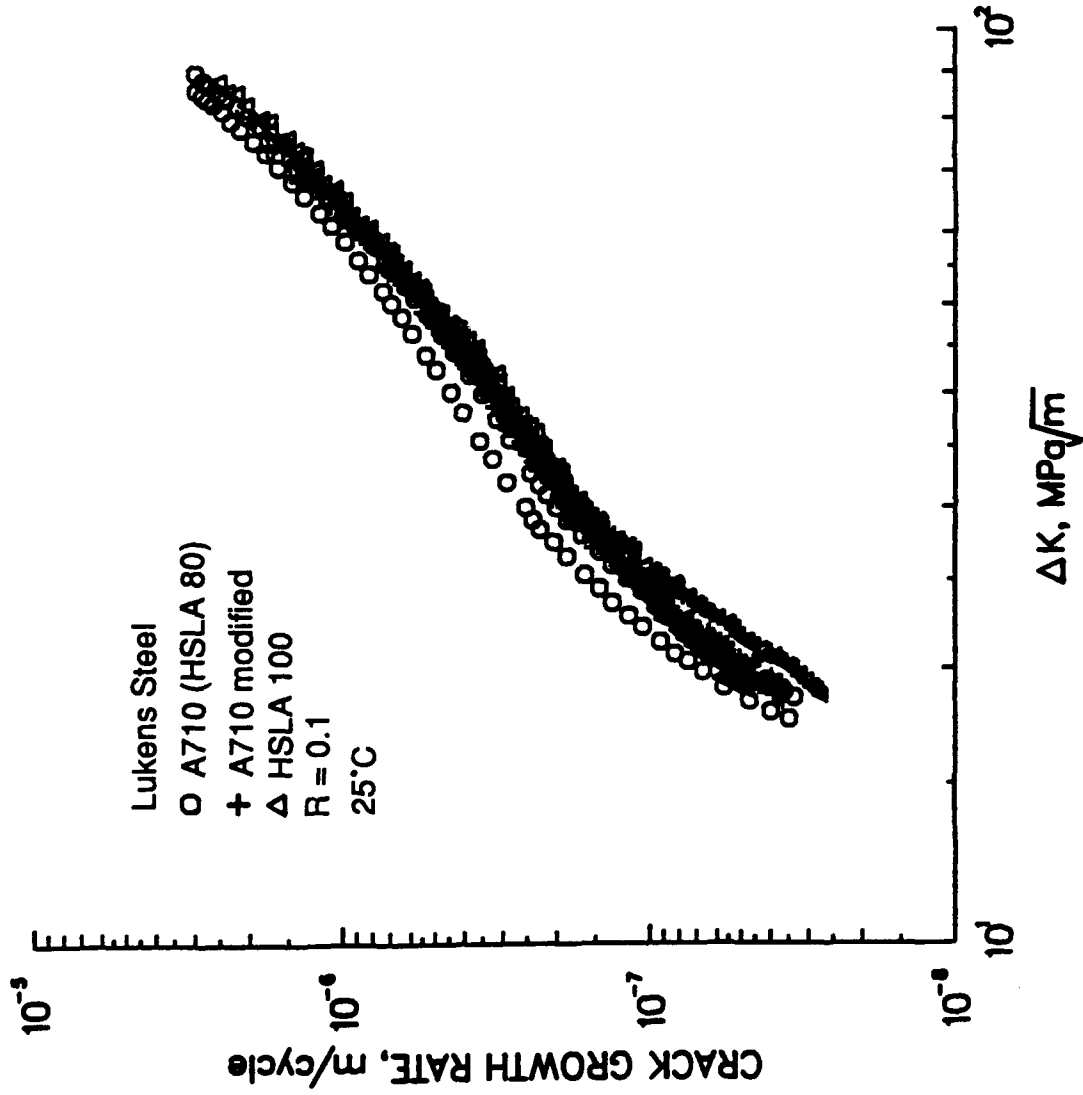
Figure 2. Comparison of fatigue crack growth data of A710 [5], A710 modified [5], and HSLA 100 steels [15].

In order to understand the relatively large variations in fatigue crack growth rates observed in Figure 2, two small pieces of HSLA 80 specimens (GAH and FZZ) were obtained from DTNSRDC. These specimens were also characterized for their microstructure. The microstructures of these two materials as revealed by optical microscopy consisted mostly of polygonal and accicular ferrites, as shown in Figure 4.

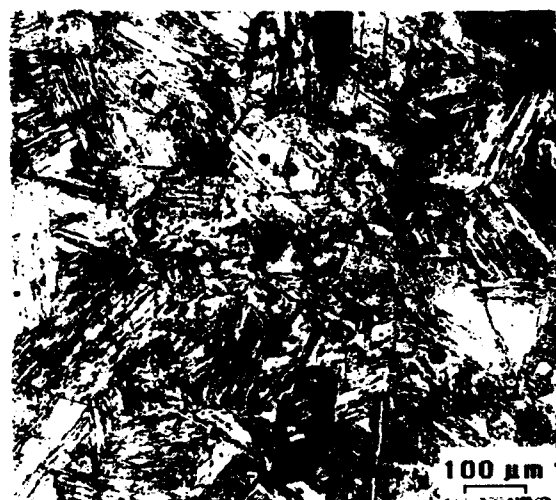
Figure 3. Microstructures of materials tested in fatigue. (a) as-received, sp. 353, (b) HT#2, sp. 357, (c) HT#3, sp. 358, and (d) weld, sp. 359.

The microstructures of both the as-received and heat-treated materials were characterized by optical and transmission electron microscopies. Optical micrographs of the HSLA steel in the as-received, heat-treated (HT#2), heat-treated and aged (HT#3), and weld materials are presented in Figure 3, respectively. The as-received microstructure consisted mostly of fine polygonal and accicular ferrite grains with sulfide inclusions. The heat-treated materials exhibited a lath-like microstructure, which is similar to those observed in modified A710 and HSLA 100 steels. The weld microstructure, shown in Figure 3(d), appeared to contain coarse ferrite grains and small particles embedded within the ferrite grains. The nature of these embedded particles had not been identified.

In the as-received microstructure (Lehigh material), Figure 3(a), cracks initiated from inclusions in almost every incidence. The size of the inclusions and their frequency of occurrence are shown in Figure 10, which is the result of the analysis of 86 inclusions. Inclusion size thus provides a lower limit to the smallest size of a crack that may be studied in this microstructure.

If the microstructure contained lath-like features, Figures 3(b) -(d), cracks no longer initiated at inclusions, but along the lath-like features instead. This shift in initiation site is illustrated in Figure 13. All parts of this illustration are at the same magnification, so it is possible to directly see the relationship between microstructural feature size and crack size near to the point of crack initiation.

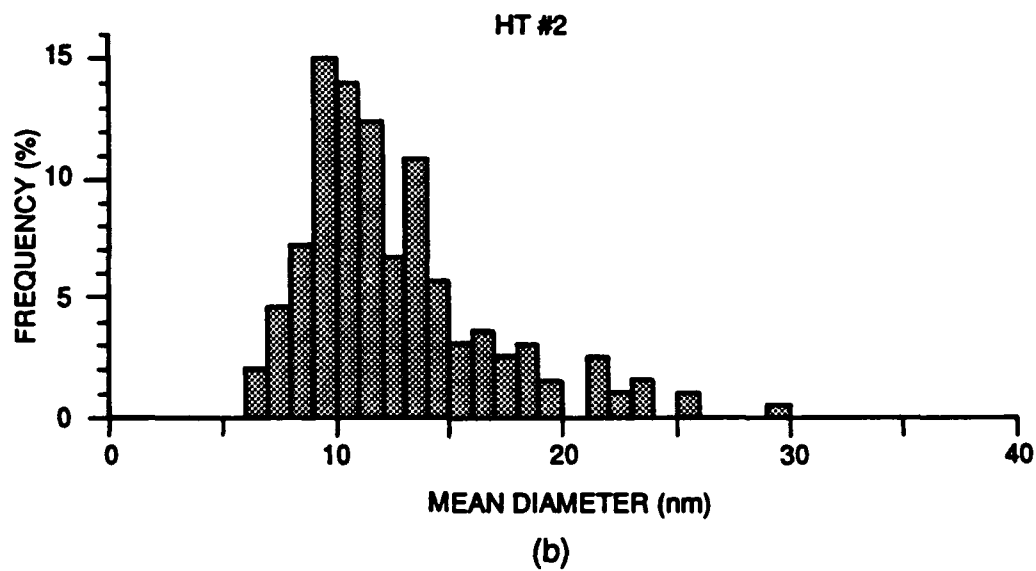
Figure 7. Distribution of ϵ -copper precipitates in HSLA steels: (a) as-received, (b) HT#2, (c) HT#3, and (d) weld.

The size distribution and volume fraction of the precipitates in the HSLA-steels were characterized using quantitative metallography. The measurement technique involved making a set of stereo-pairs of TEM micrographs of the representative microstructure. Precipitates in the TEM micrographs were traced on clear transparencies, which were then analyzed using a Tracor Image Analyzer to obtain the size distribution, the apparent area fraction, A' , and the mean precipitate diameter, d . The size distributions of ϵ -copper precipitates in the various microstructures of the Lehigh material are shown in Figure 7, while those for the GAH and FZZ materials are shown in Figure 8. A summary of the mean diameter and apparent area fraction, A' , is presented in Table 3.

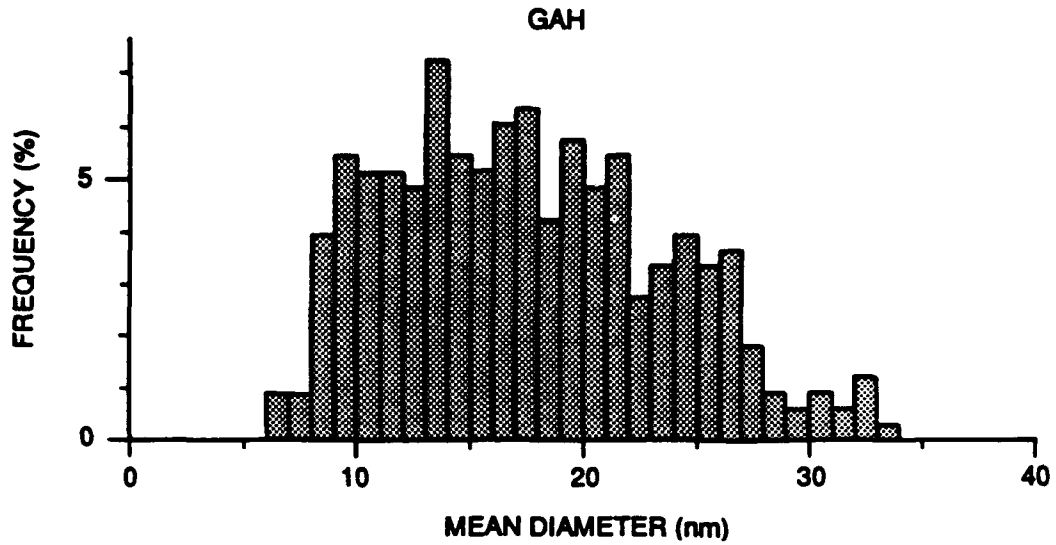
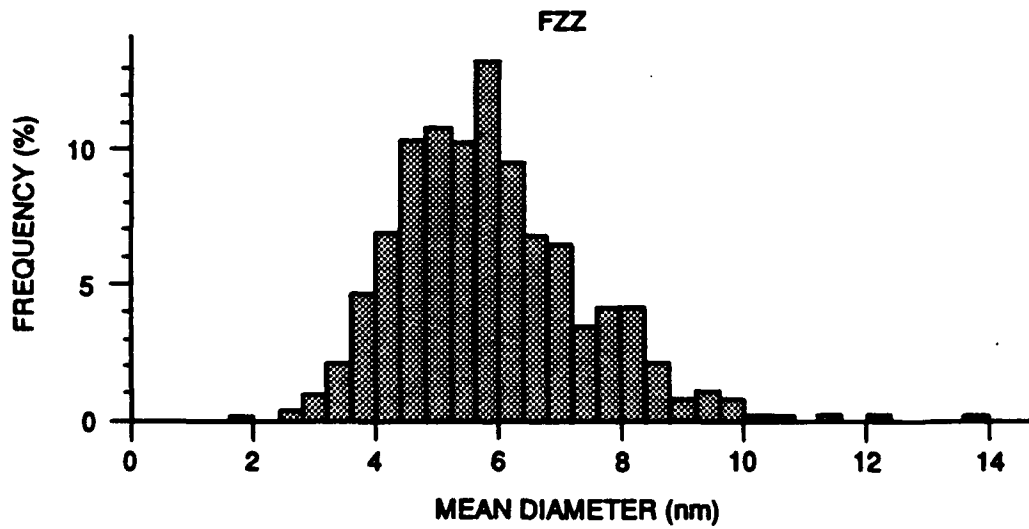
Figure 8. Distribution of ϵ -copper precipitates in HSLA 80 specimens from NTNSRDC: (a) GAH plate, and (b) FZZ plate.

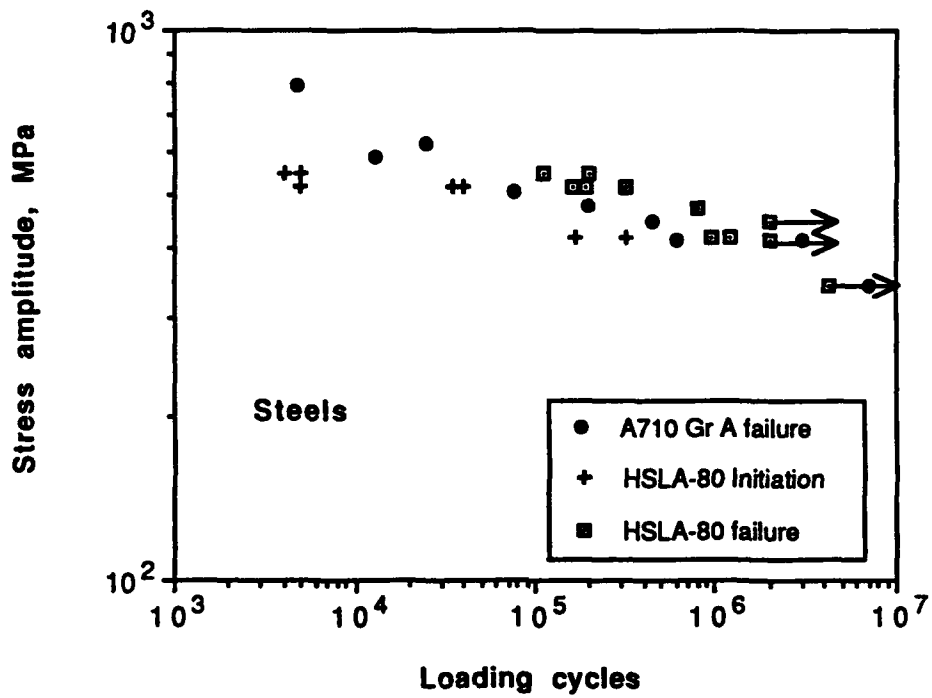
Figure 12. Stress-cycles to crack initiation and growth to 2-mm length. Data points with arrows are for specimens that did not initiate cracks.

An overview of the test results can be gained from examining how the number of cycles to initiation, N_i , and total number of cycles to grow the cracks to a length of 2 mm, N_f , varied as a function of stress. The relation between stress amplitude and N from the present tests, which encompasses a number of microstructures, is compared to previous work [1], which considered only the as-received microstructure, Figure 2. Data from the current work are comparable to previous results, and data from the rectangular beam specimens are comparable to those from the rotating beam specimens. Test results are listed in Table 4 for all the experiments conducted. The heat treatments shown in Table 4 by number are given in more detail in Table 2. Microstructure greatly affected the sites at which fatigue cracks initiated in this steel and the number of cracks that initiated. The microstructures tested are shown at low magnification in Figure 3, to give an overview of the various sizes of the features comprising each microstructure.

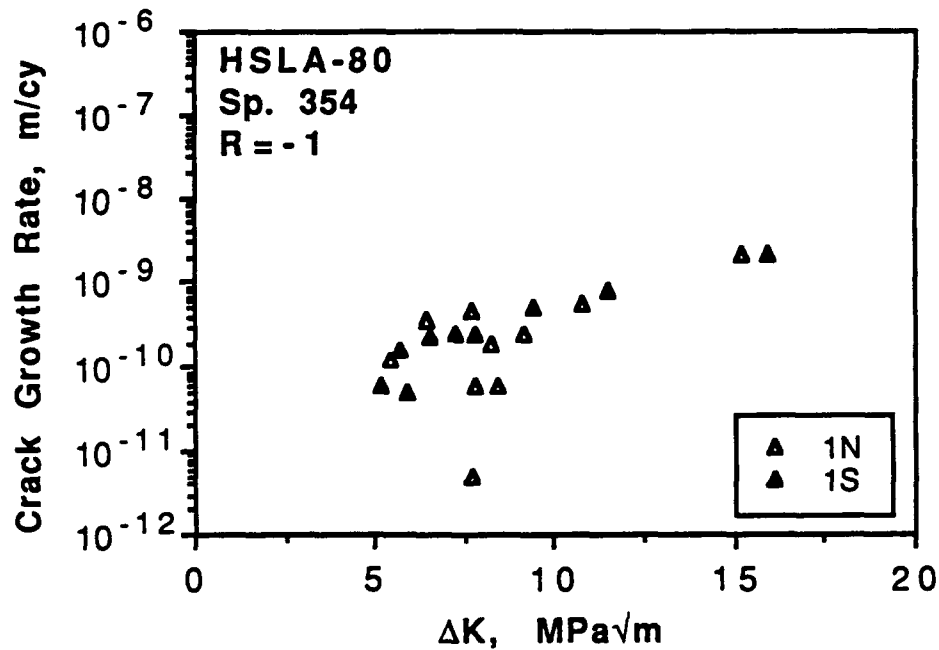
Figure 21. Fatigue crack growth rate for as-received material (Lehigh plate) from rotating beam test, sp. 354, stress amplitude = 520 MPa.

Fatigue crack growth rates for the microstructures studied are shown in Figures 18-24. Crack length change, Δa , was measured at each end of the crack from replicas, and crack growth rate was calculated by dividing Δa by the number of cycles between replicas, ΔN . Periods when the crack was not growing are generally not shown. The minimum detectable crack growth rate, based on the resolution of the optical system used, was about 8×10^{-12} m/cycle. The cyclic stress intensity factor, ΔK , correlated with crack growth rate at cycle N was determined from half the total surface crack length, a , and the applied stress range, $\Delta\sigma$, using the relationship

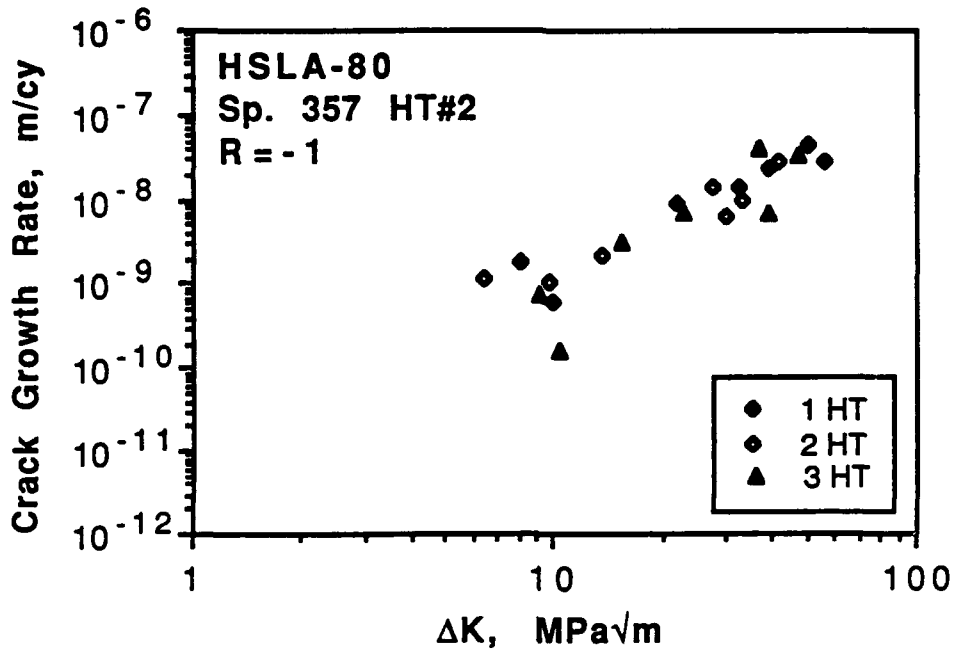
Figure 22. Fatigue crack growth rate, rotating beam test, for sp. 357, HT#2.

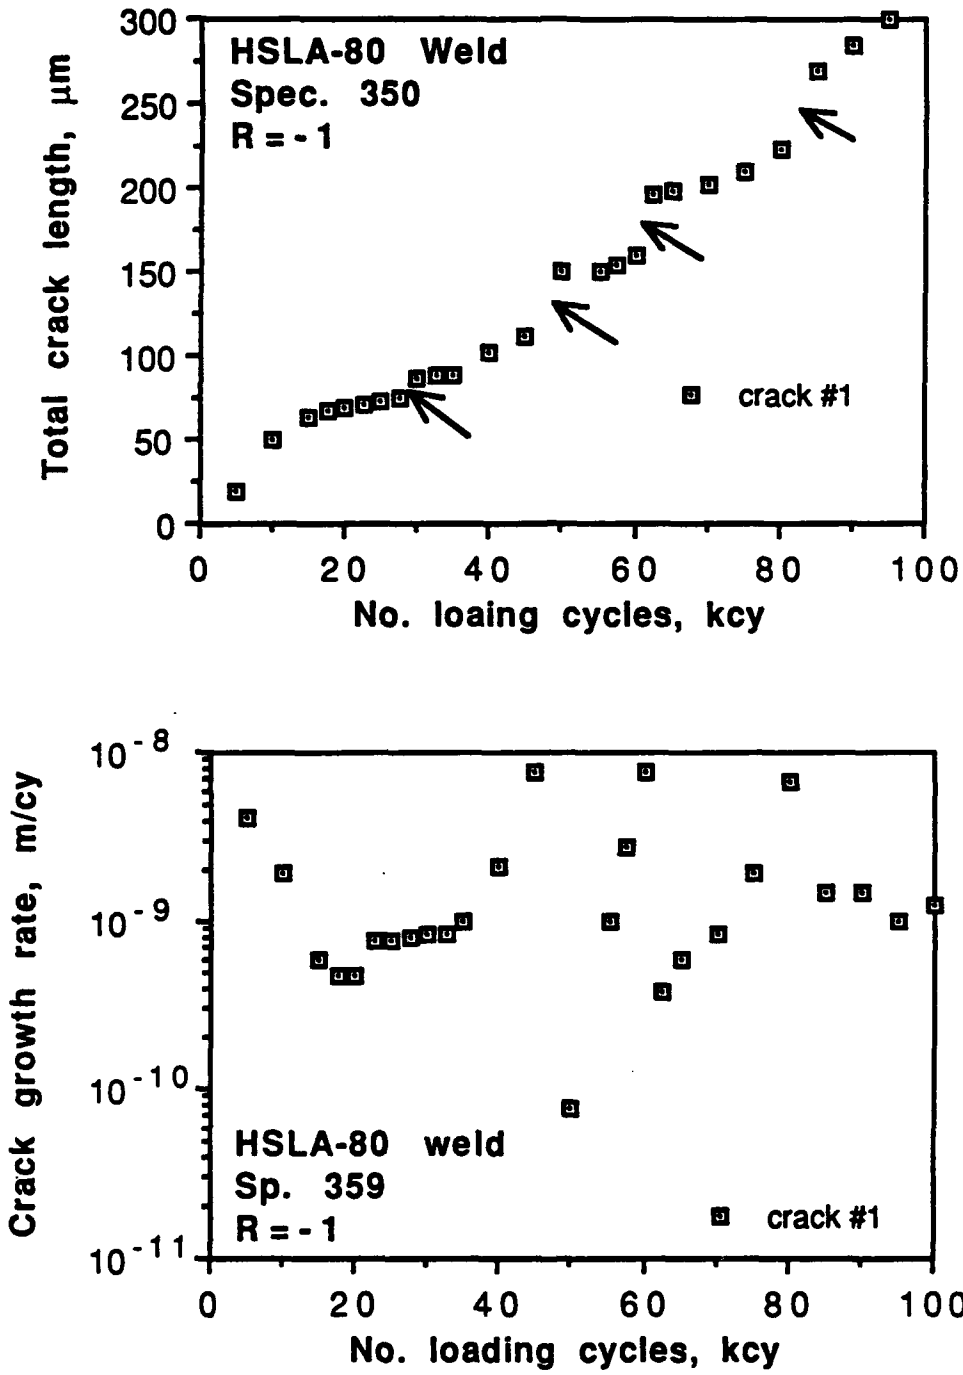
Figure 25. Weld metal specimen 359—comparison of the changes in crack length and crack growth rate as a function of loading cycles. Arrows indicate locations where cracks growth rate accelerated.

Growth rates of microcracks in the welded structure, Specimen 359, are affected by microstructure. This is illustrated more clearly in Figure 25 than in Figure 24. However, the usual interaction between microstructure and microcracks reported previously causes crack growth to be retarded by features like grain boundaries. For the weld microstructure the effect is opposite: crack growth is periodically accelerated. It may be that crack growth acceleration is due to the linking of several microcracks. Work is underway to examine the microstructural origins of this effect.

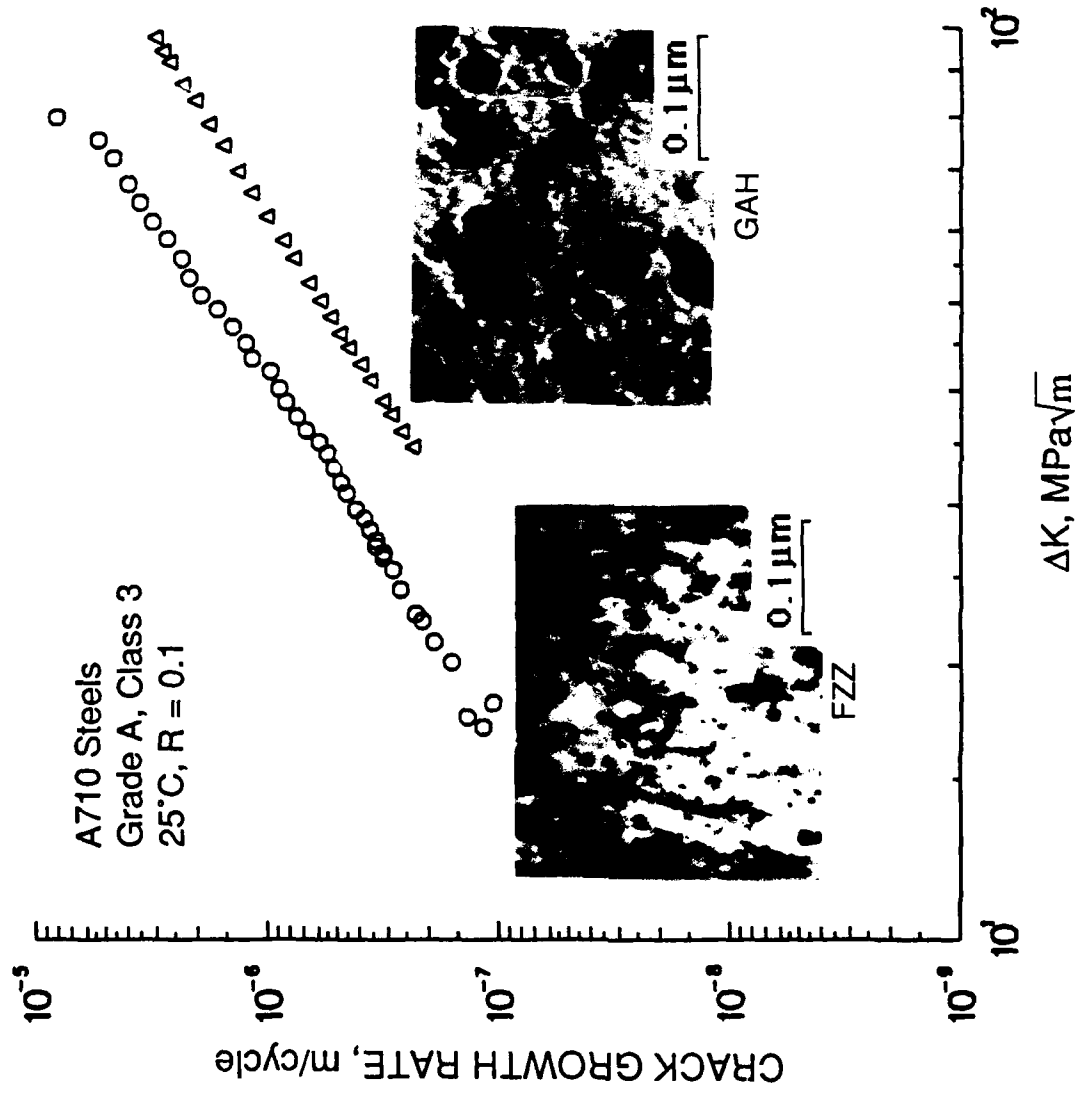
Figure 29. Dependence of fatigue crack growth rate on the size of ϵ -copper precipitates in FZZ and GAH plates.

One possible microstructural effect has been identified for fatigue crack growth in HSLA steels. Recall that in the power-law regime, the fastest crack growth rate among the HSLA 80 shown in Figure 1 is the FZZ steel, while the slowest corresponds to the GAH steel. Comparison of microstructure and fatigue crack growth behavior for these two steels in Figure 29 reveals that the higher crack growth rate in FZZ is associated with fine precipitates, while the slower crack growth rate in GAH is associated with larger precipitates. The difference in precipitate sizes is consistent with a higher strength, but lower toughness, for the FZZ steel. Assuming that the precipitates in FZZ and GAH are both ϵ -Cu precipitates, this result suggests that fatigue crack growth in HSLA steels is somewhat sensitive to the size and distribution of precipitates. This microstructural effect will be incorporated into the fatigue crack growth model to be developed in this program.

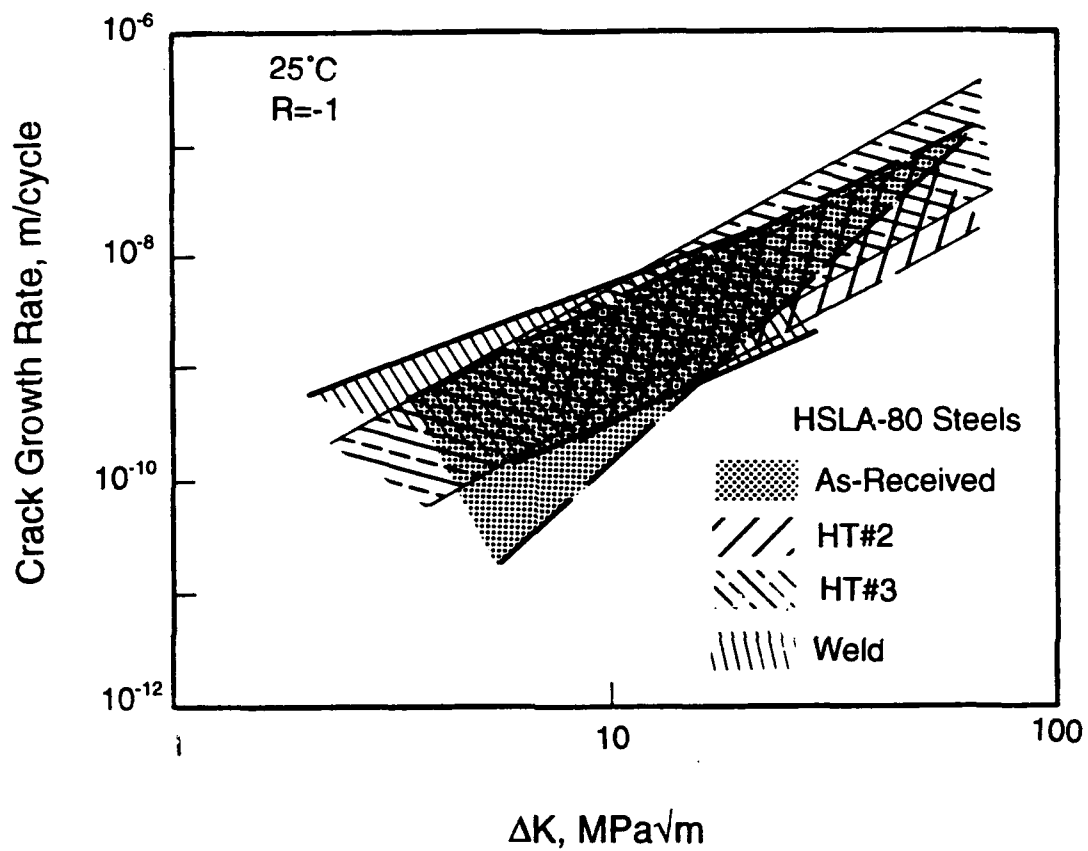
Figure 30. Comparison of fatigue crack growth responses of microcracks in HSLA-80 steels and weld.

Results obtained in this study indicated that fatigue crack growth rates of microcracks in HSLA steels are only mildly dependent on microstructure. Figure 30 shows the approximate central tendencies of microcrack growth rates for four microstructures (without the more rigorous smoothing and statistical analysis currently underway). The relatively small effects of microstructure on fatigue crack growth of microcracks are consistent with the large crack results shown in Figure 2 for A710, A710 modified, and HSLA steels. In both figures, crack growth rates for materials with the polygonal and accicular ferrite microstructure (typical of HSLA 80 and A710 steels) are compared with the lath-like microstructure (typical of A710 modified and HSLA 100 steels). The ramification of the results shown in Figures 2 and 30, and that in Figure 29, is that fatigue crack growth rate in these steels is insensitive to the morphology of the ferrite matrix, but is affected by size, volume fraction, and possibly the mean free path of the ϵ -copper precipitates. Since the copper content in these steels is specified to within a small range (1 to 1.3 wt. %), the microstructural parameters pertaining to the precipitates accordingly also lie within a small range and then, therefore, result in only small variations of crack growth rate with microstructure, as observed in Figures 1, 2, 29, and 30.
