**US Army Corps  
of Engineers**  
Construction Engineering  
Research Laboratory

USACERL Technical Report FM-92/05  
August 1992  
EPDM Roofing

## **Cleaning Aged EPDM Rubber Roofing Membrane Material for Patching: Laboratory Investigations and Recommendations**

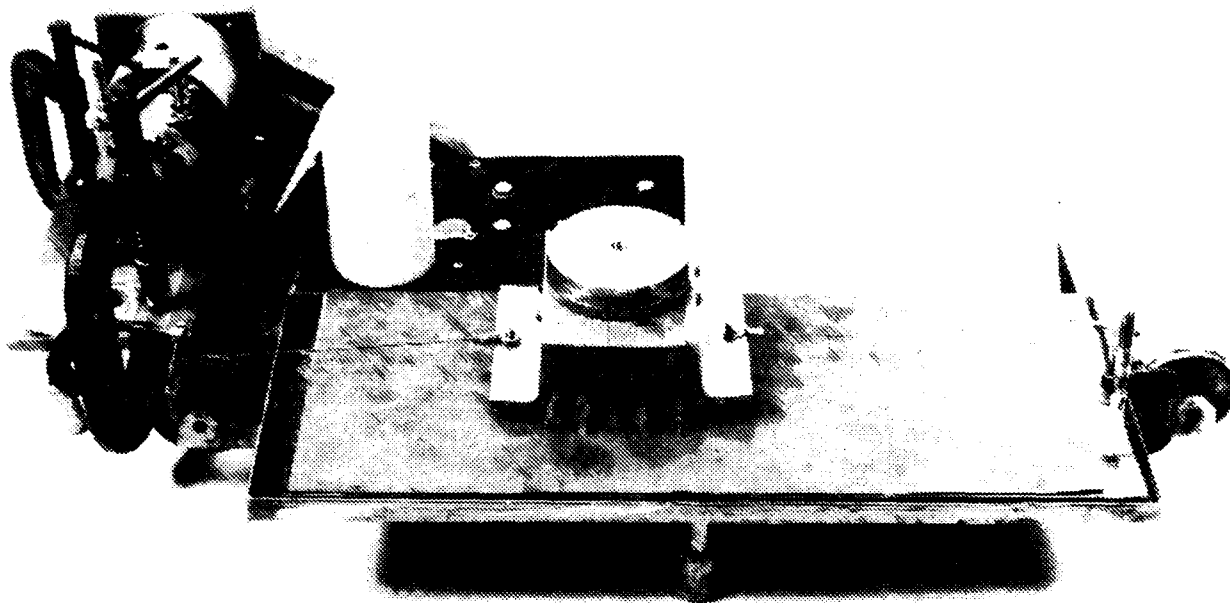
**Figure 1. Abrasion Cleaning Device for EPDM Samples.**

The contact area of the abrader surface with the sample surface measured 70 x 112 mm (2 3/4 x 4 1/2 in.). Two types of abraders could be clamped to the cleaning device: (1) a synthetic absorbent laboratory cleaning cloth and (2) a brush with stiff nylon bristles (Figure 1). In both cases, the mass of the abrader-clamp assembly was 1.1 kgm (2.5 lbm). Throughout cycling, the surface of the EPDM sample was kept wet with the cleaning agent, which was applied from a laboratory wash bottle. In general, over the course of an 80-cycle cleaning (i.e., the number used in most experiments), about 50 ml of a water-based detergent solution were used, or about 200 ml of organic solvents.

The cloth abrader was used when the primary cleaning agent was an organic solvent. A cloth was only used for 10 cycles after which it was replaced with another clean one.

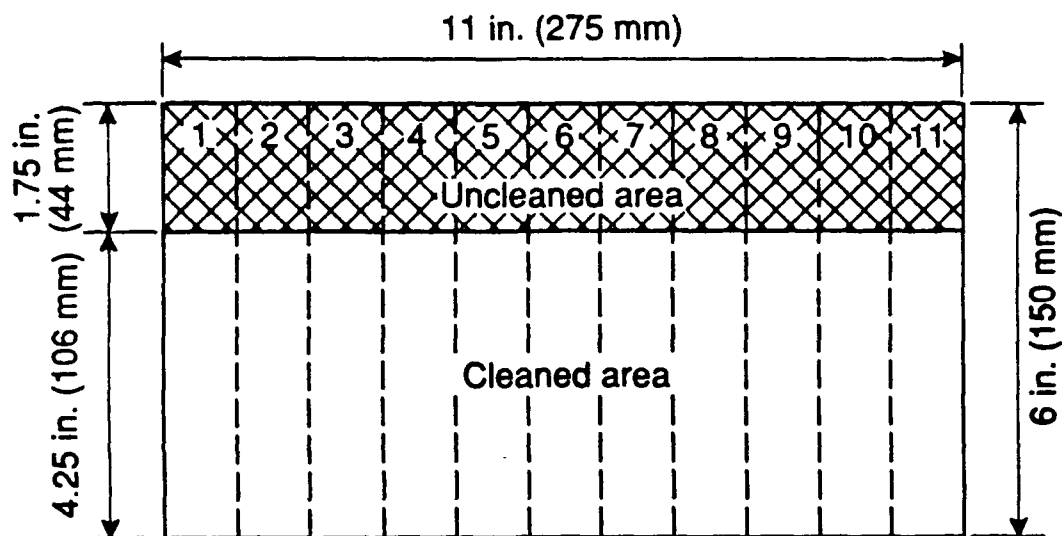
Note: Strips were randomly selected for peel testing, contact angle measurement, FTIR spectroscopy, and SEM observation.

Figure 2. Sampling Pattern for Cleaned EPDM Specimen.

A 150 x 275 mm (6 x 11 in.) section of the EPDM sample removed from the abrasion apparatus was cut so its cleaned surface area measured 106 x 275 mm (4.25 x 11 in.), as shown in Figure 2. The uncleaned portion of this section was used for handling and labeling. The section was divided into 11 strips, each with dimensions of 25 x 150 mm (1 x 6 in.). Four strips were randomly selected for peel tests, one was used for contact angle measurements, and another was used for FTIR spectroscopy and SEM observation.

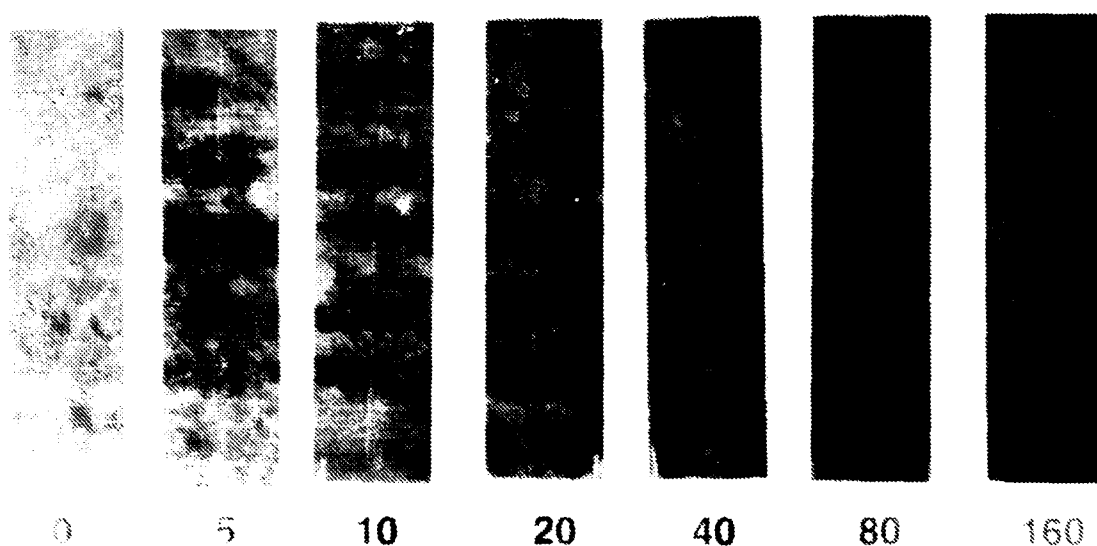
**Figure 3. Surface Appearance of EPDM Specimens as a Function of Cleaning Cycles.**

The effect of increasing the number of cycles was visually apparent: as the number of cleaning cycles increased, the surfaces became noticeably cleaner (Figure 3).

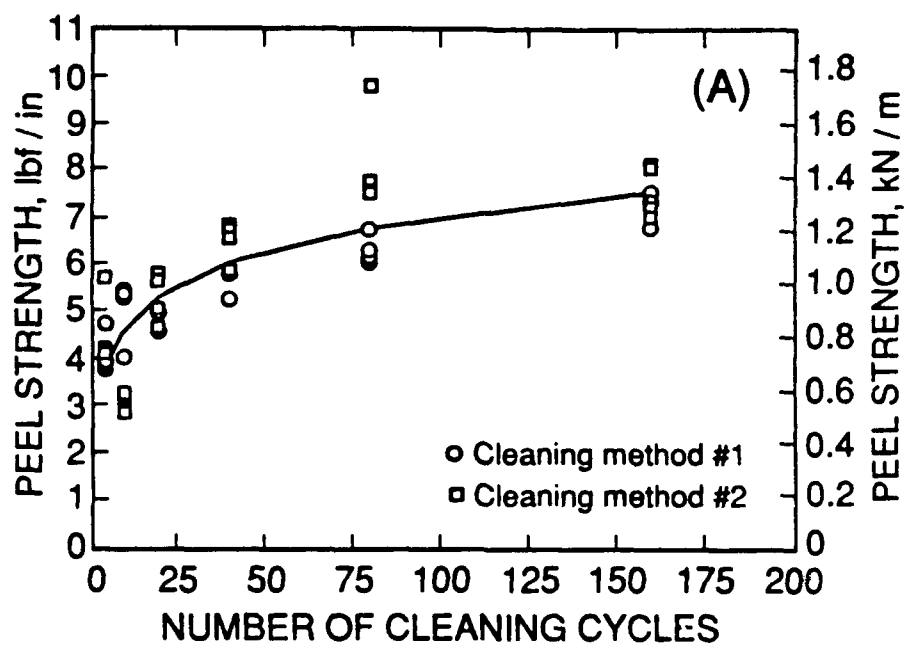
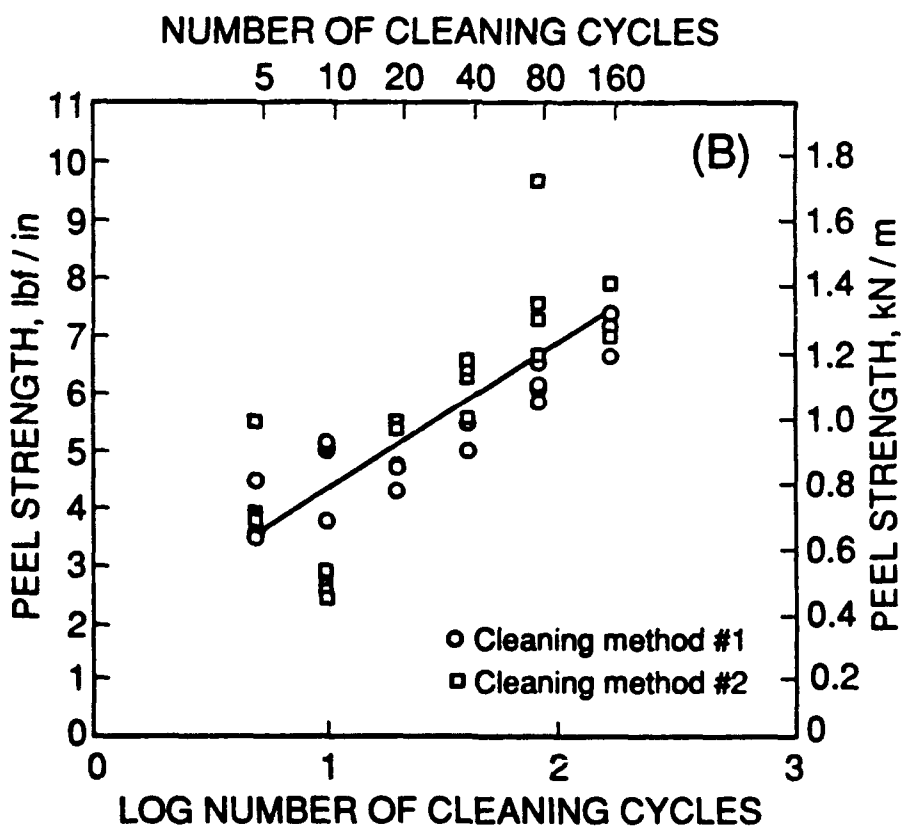
Figure 4. Peel Strength of Joint Specimens for Various Cleaning Methods.

The results for the preliminary experiment are given in Figure 4, where the peel strength of the joint specimens is plotted versus the number of cycles (Figure 4a) and the log of the number of cycles (Figure 4b). As is evident in these figures, joint strength increased as the number of cycles increased. No data are given for 0 cycles (i.e., the material as received from the roof) because the tape would not bond to the uncleaned EPDM surface. Statistical analysis of the data indicated that, for the total data set, there was no significant effect attributable to the cleaning method. As a consequence, only a single curve or line was fit to the data points in Figure 4. The data analysis showed a linear relationship between strength and the log of the number of cycles over the range of cycles employed. In general, each time the number

of cycles was doubled, an incremental increase in strength of about 0.1 kN/m (0.8 lbf/in.) occurred. This finding suggested that cleaning at 320 cycles would further improve joint strength. This idea was not carried out, however, because given the cycling rate of the abrasion cleaning device (four cycles per minute), it was not practical to extend the cleaning to such large numbers of cycles.

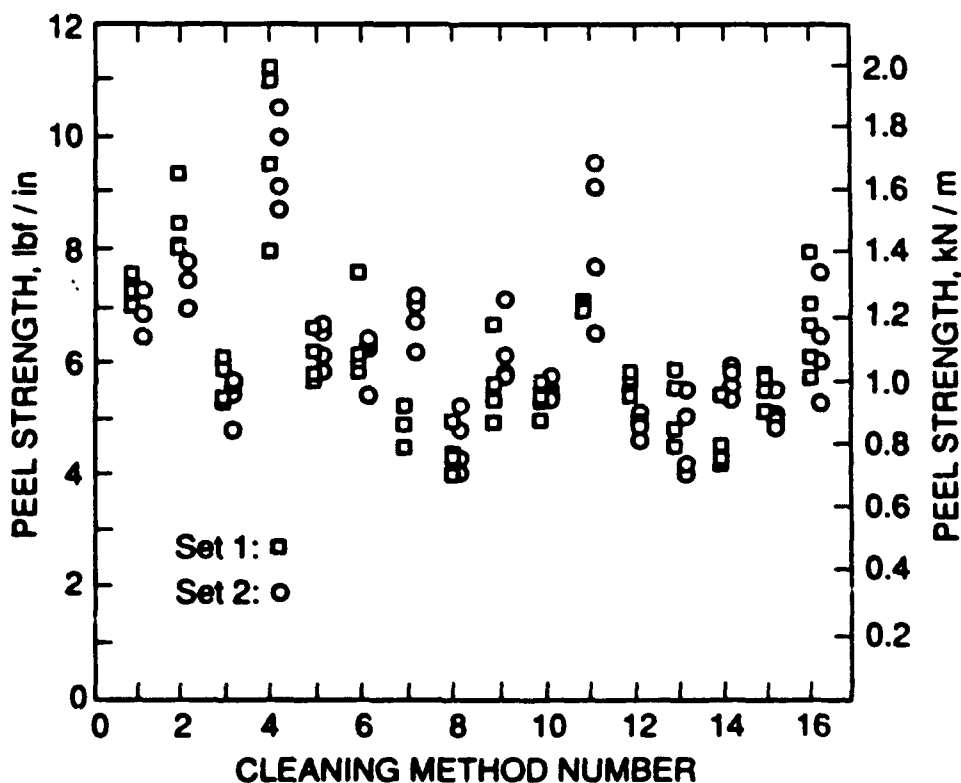
Figure 5. Peel Strength for Each Cleaning Method.

The results of the peel strength measurements are given in Figure 5 for each set of tests for each cleaning method. An analysis of variance was performed on the data set, and indicated significant differences in peel strength among the various surface cleaning methods. Moreover, there were significant differences in strength between some sets for the same cleaning method. However, examination of the

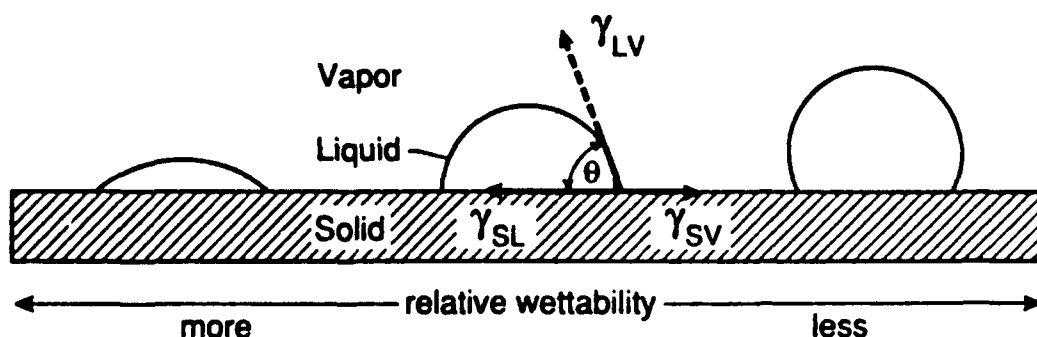
Note:  $\theta$  — contact angle;  $\gamma_{LV}$  — liquid/vapor interfacial tension;  $\gamma_{SV}$  — solid/vapor interfacial tension;  $\gamma_{SL}$  — solid/liquid interfacial tension.

Figure 6. Contact Angle and Interfacial Tensions for a Drop of Liquid Resting on a Solid Surface.

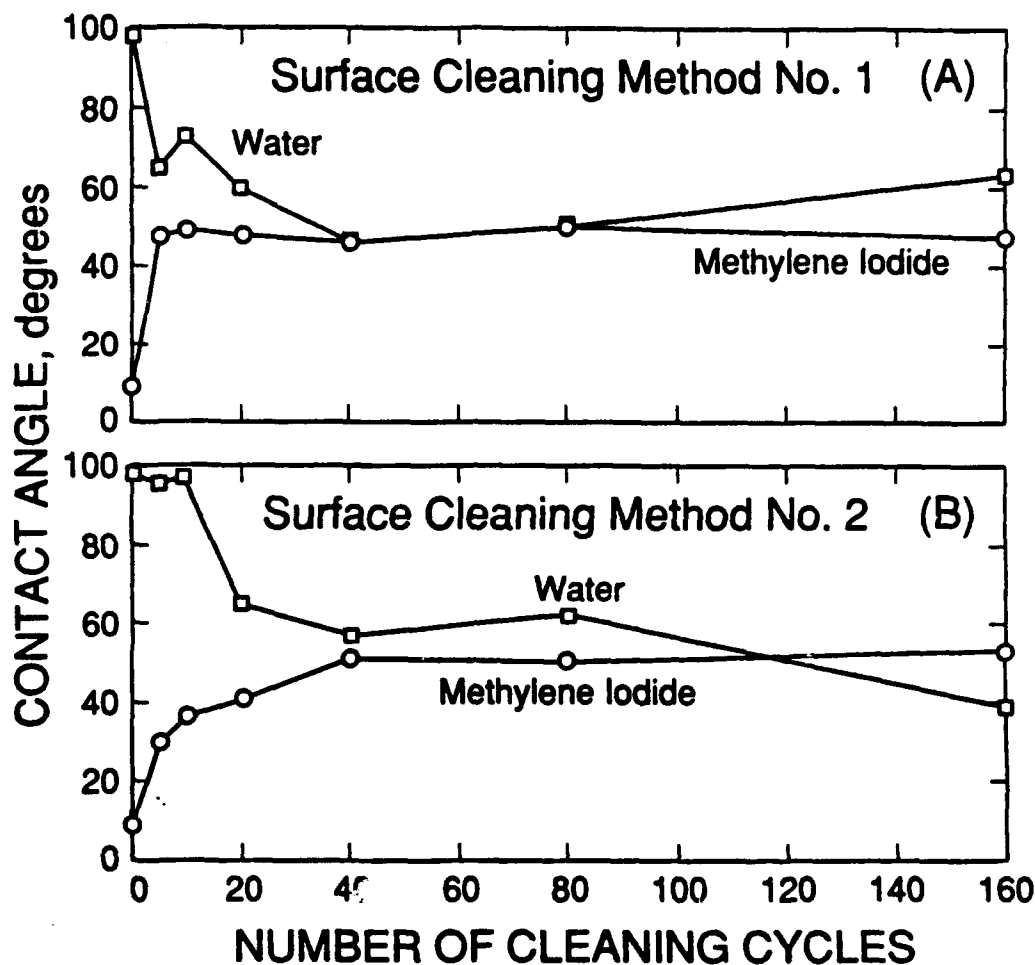
**Figure 7.** Contact Angles for Water and Methylene Iodide as a Function of Number of Cleaning Cycles.

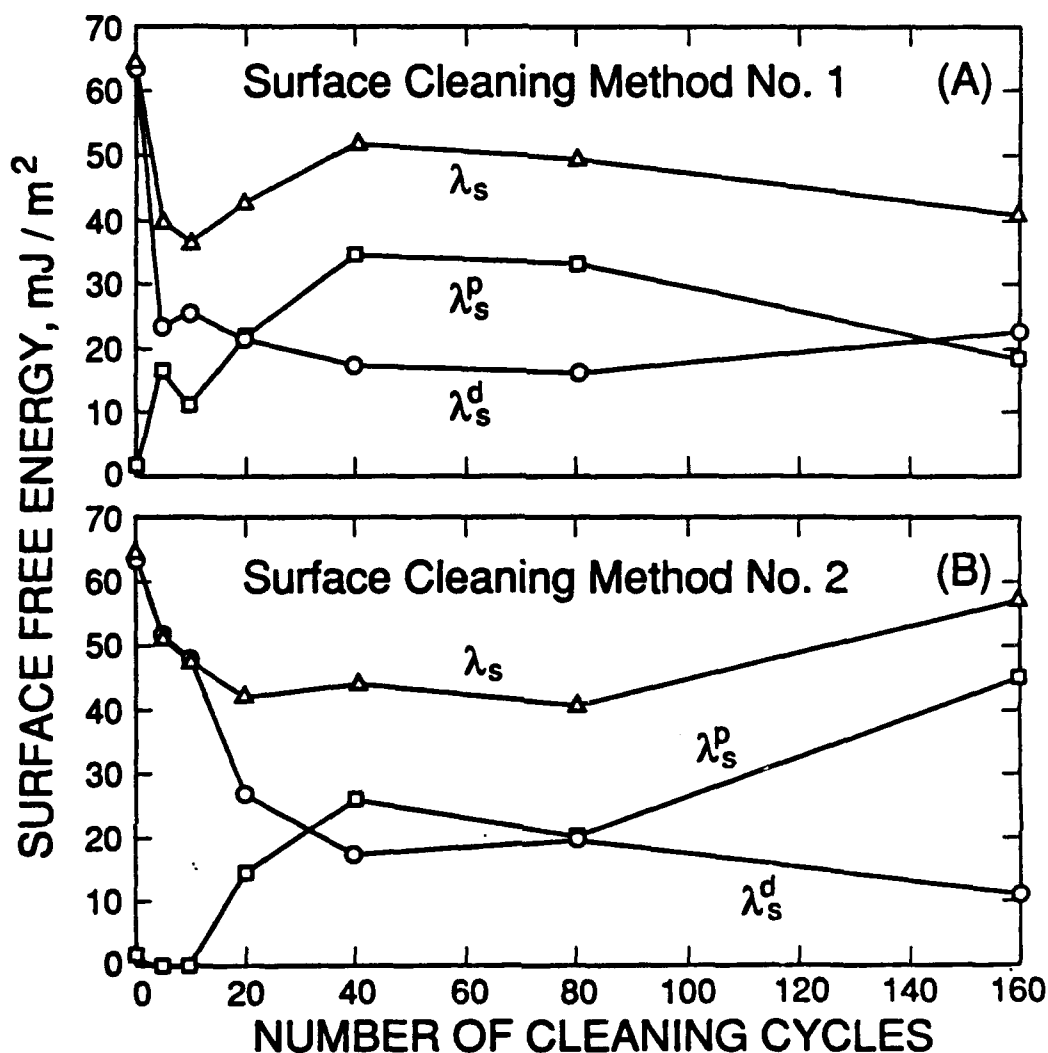
Figure 8. Surface Free Energies of Aged EPDM as a Function of Number of Cleaning Cycles.

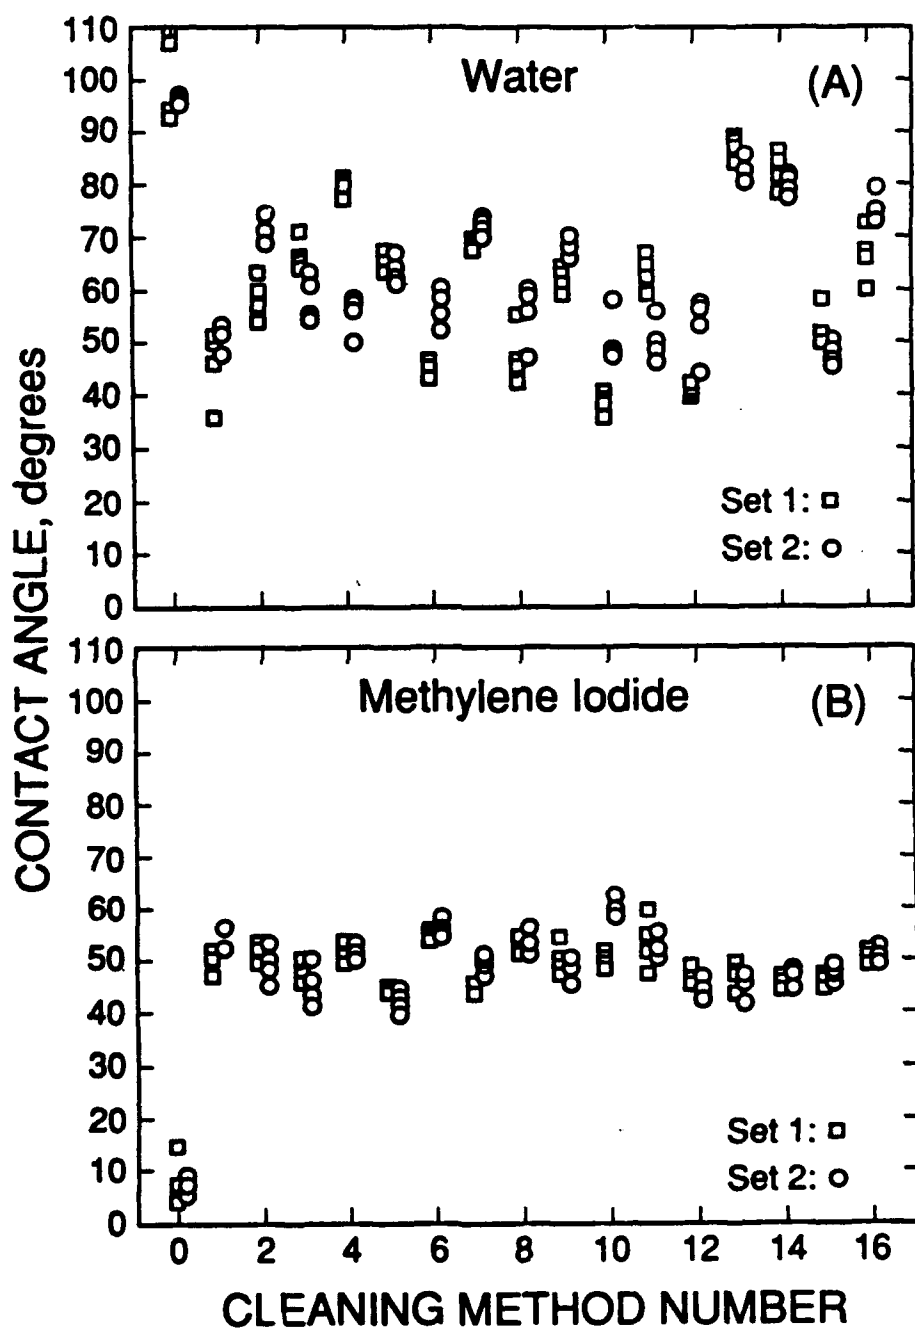
Figure 9. Relationship of Contact Angle to Cleaning Method for Two Liquids.

Figure 9 presents the results of the contact angles of water and methylene iodide on the aged EPDM rubber after cleaning by the 16 different methods. The contact angles shown are the individual values from the Set 1 and Set 2 samples, and indicate the reproducibility of the measurement within and between the sets.\* Within any of the sets, the coefficients of variation were 15 and 10 percent or less for water and methylene iodide, respectively. More variability was observed between sets for water than for methylene iodide. For most of the cleaning methods, the two data sets for water contact angles were statistically different (0.03 level or less). Only for methods No. 1, 5, and 14 were no differences between sets found. In contrast, for the methylene iodide contact angles, no statistical differences (0.07 level or greater) were observed, except for cleaning methods No. 1, 7, and 10. Overall analysis of the data indicate that there were no significant differences between the two sections of rubber from which Set 1 and Set 2 were cut. In analyzing the data shown in Figure 9, no relationships between contact angle and cleaning method were found.

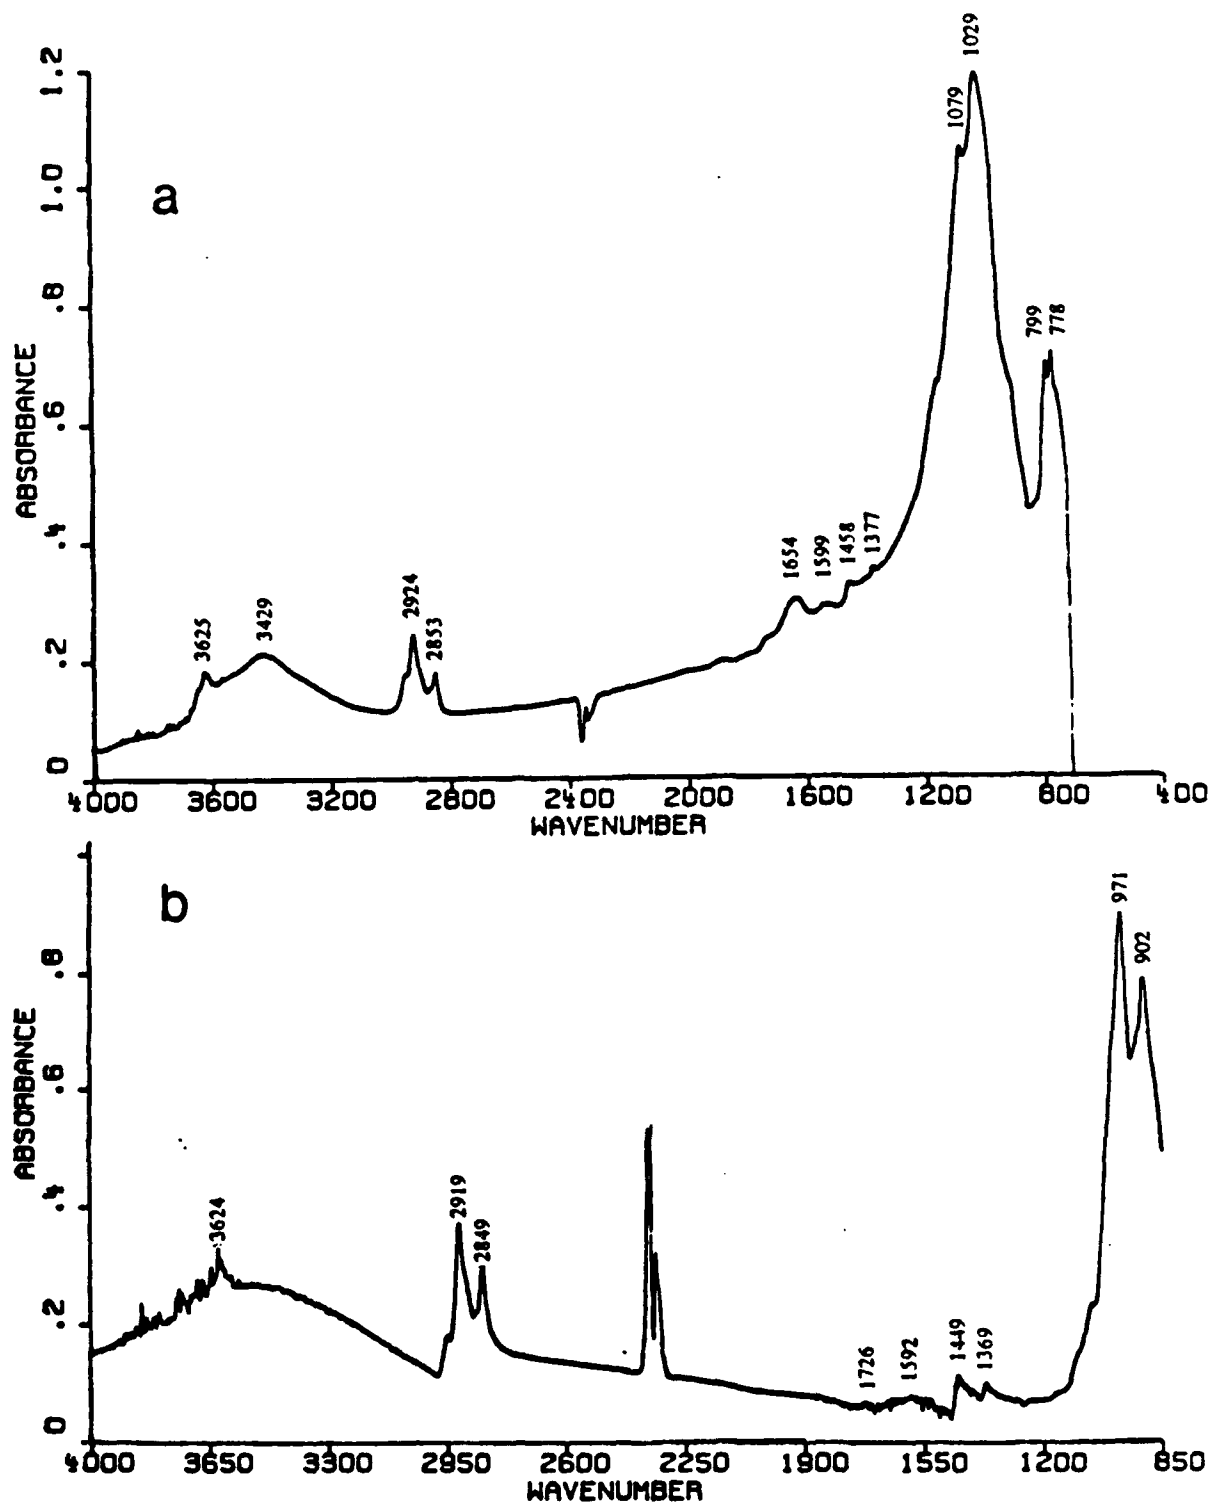
Figure 10. Example of FTIR Spectra for (a) Contaminants Removed From Surface and (b) Cleaned Surface of EPDM.

Before conducting FTIR analyses on the cleaned EPDM rubber specimens, the chemical nature of the contaminants and the contaminant-free, aged EPDM surface were investigated. Figure 10a presents the FTIR transmission spectrum of the removed contaminants. The spectrum showed the bands between 2800-3000 cm<sup>-1</sup>, due to CH stretching of hydrocarbons. This finding indicates that the contaminants included organic materials, an interpretation consistent with the wettability data. The broad bands between 3200 and 3500 cm<sup>-1</sup> are normally due to the OH (and NH) stretching, which indicates that the contaminants probably contained polar materials having hydroxyl groups. The presence of these bands supported the wettability data that showed the high polar component and high polarity after removing the nonpolar organic contaminants from the surface of the aged EPDM rubber. The sharp band near 3625 cm<sup>-1</sup> in Figure 10a is probably due to isolated, adsorbed water molecules on the inorganic contaminants; bands associated with hydrogen-bonded adsorbed water molecules occur in the 3200-3500 cm<sup>-1</sup> region. Finally, the broad bands near 1000 cm<sup>-1</sup> are normally characteristic of silicates and phosphate inorganic materials.

Figure 10b is the FTIR-ATR spectrum of aged EPDM rubber cleaned by method No. 11. The surface of this specimen was essentially free of platelet particles and the rubber being quite visible, as shown from its SEM image (in the following section). Figure 10b shows strong absorption bands in the 2800-3000 and 850-1050 cm<sup>-1</sup> regions. Again, the bands in the 2800-3000 cm<sup>-1</sup> region are due to the CH stretching. The band peaking at 970 cm<sup>-1</sup> may be due to the CH out-of-plane deformation of the

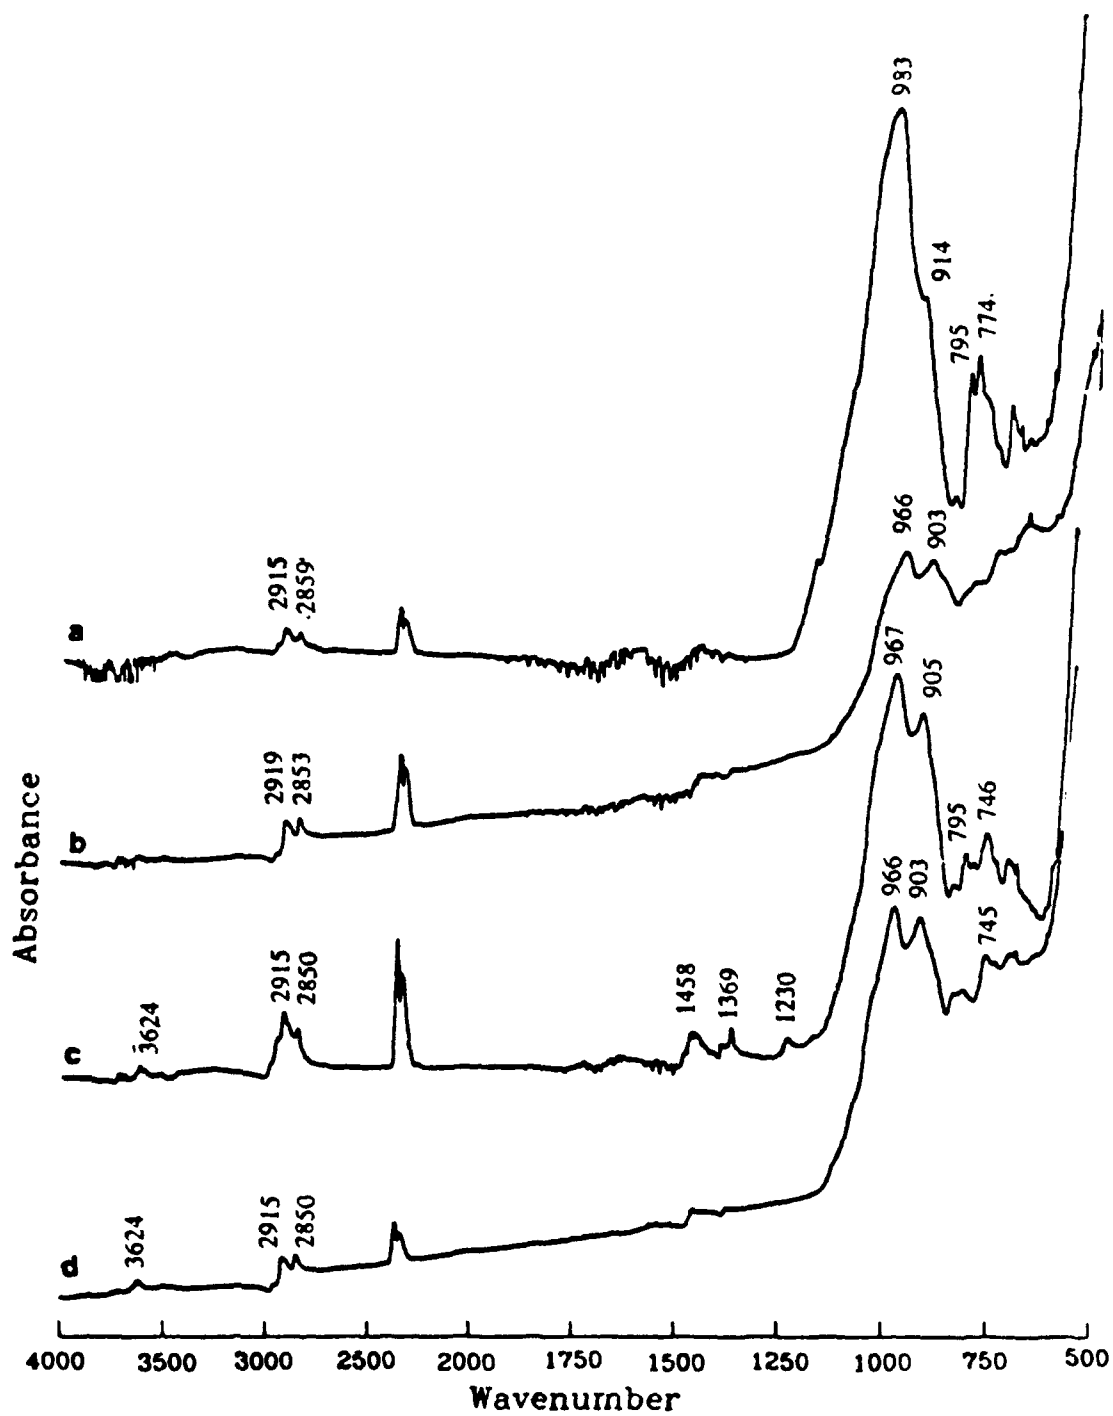
Figure 11. FTIR-ATR Spectra of Aged EPDM Cleaned by Four Different Methods.

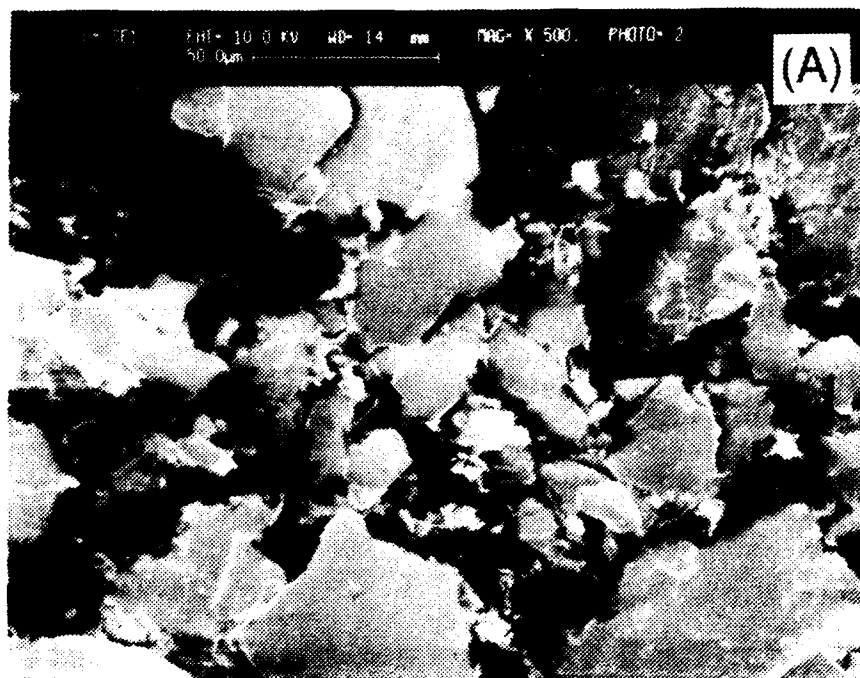
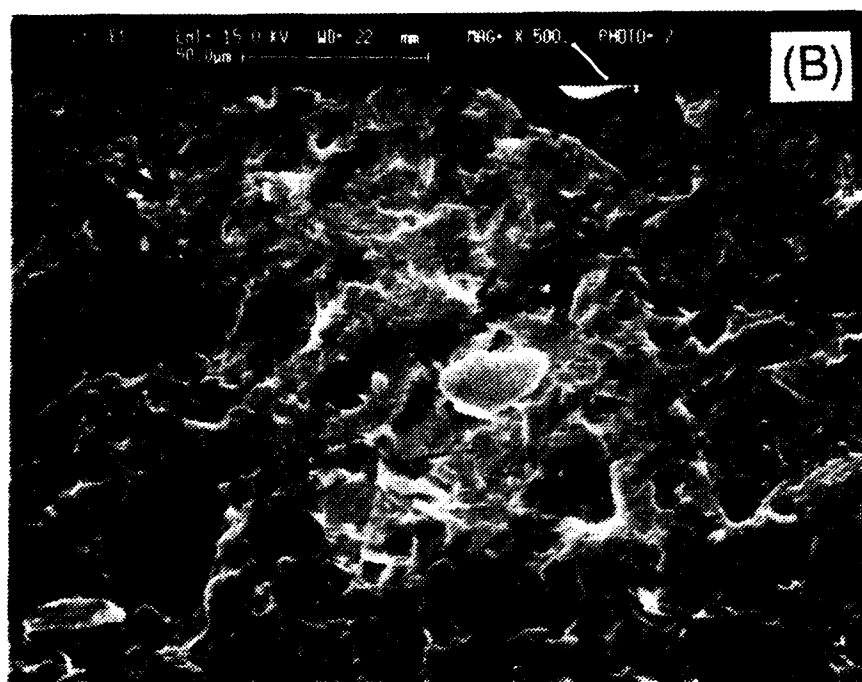
**Figure 12. SEM Photomicrographs of EPDM Specimens.**

For the specimens that had been cleaned using methods No. 4 and 12, SEM analyses indicated that a coating, which generally covered the release agent particles, had been deposited on the specimen surfaces (Table 7). The tape used to form the peel specimens was adhered to this coating. For cleaning method No. 4, the coating apparently had a positive effect in that the average peel strength of these specimens was the highest of any measured for any of the cleaning methods (Table 4). In contrast, the average peel strength of the specimens cleaned under method No. 12 was among the lowest measured for the specimen sets.

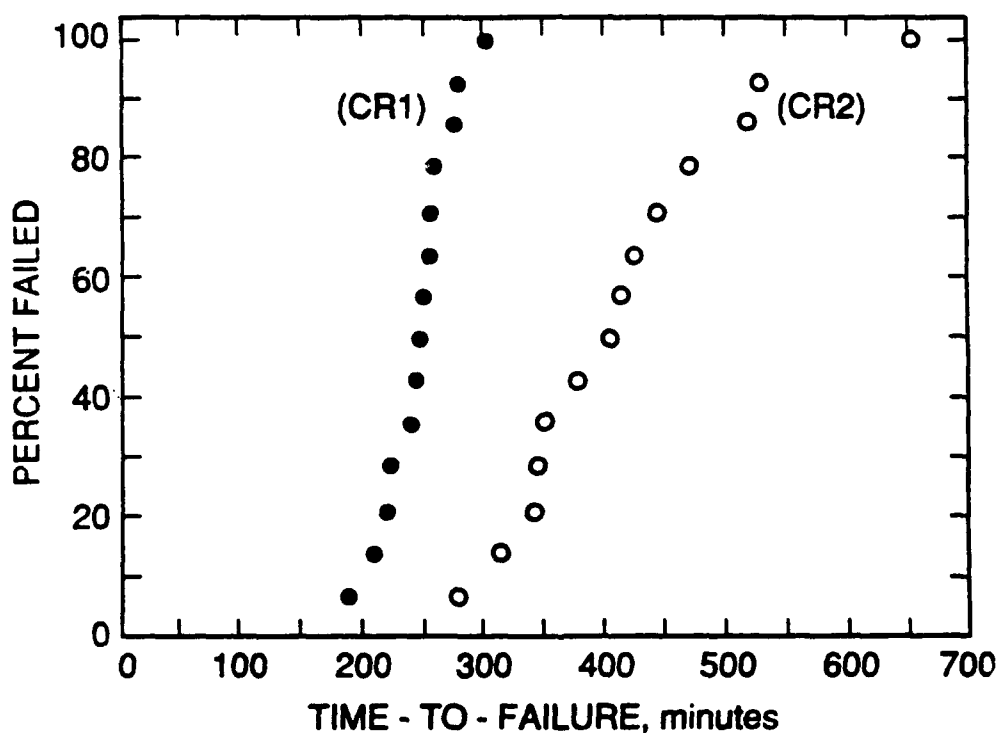
Figure 13. Graph of Creep-Rupture Experiment Results.

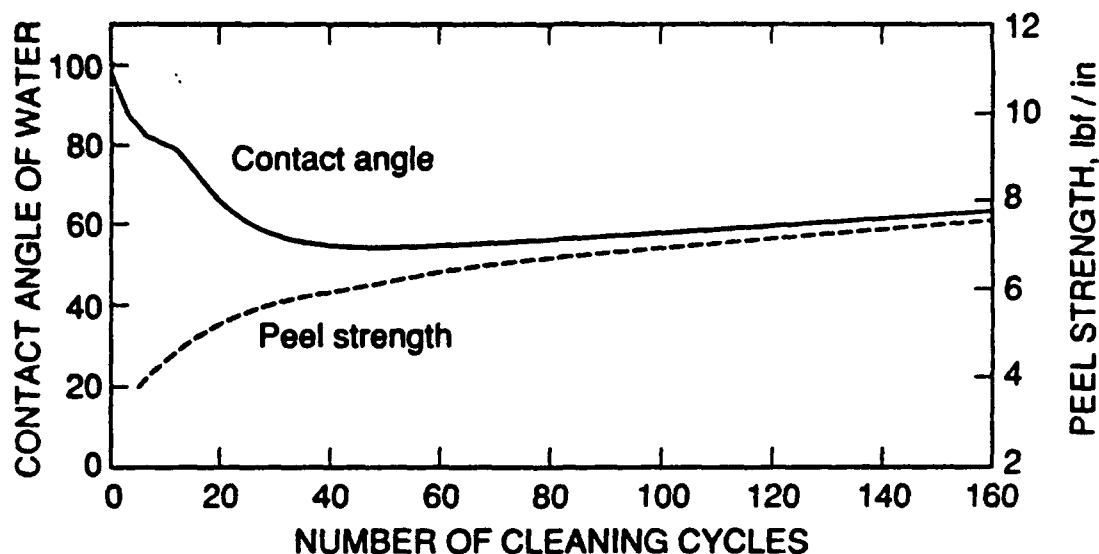
Figure 14. Relationship Between Peel Strength and Water Contact Angle as a Function of Cleaning Cycles.

The data in Figure 14 suggest that the contact angle of water might be useful in the field to assess the bonding condition of the EPDM surface after cleaning. Based on these data, after removal of the substantial amount of loose surface particles and other contaminants, the water contact angle on the

cleaned rubber should be greater than 55 degrees. However, the direct use of such a criterion is not practical because there is no simple method for estimating the contact angle of a liquid on EPDM rubber in the field.

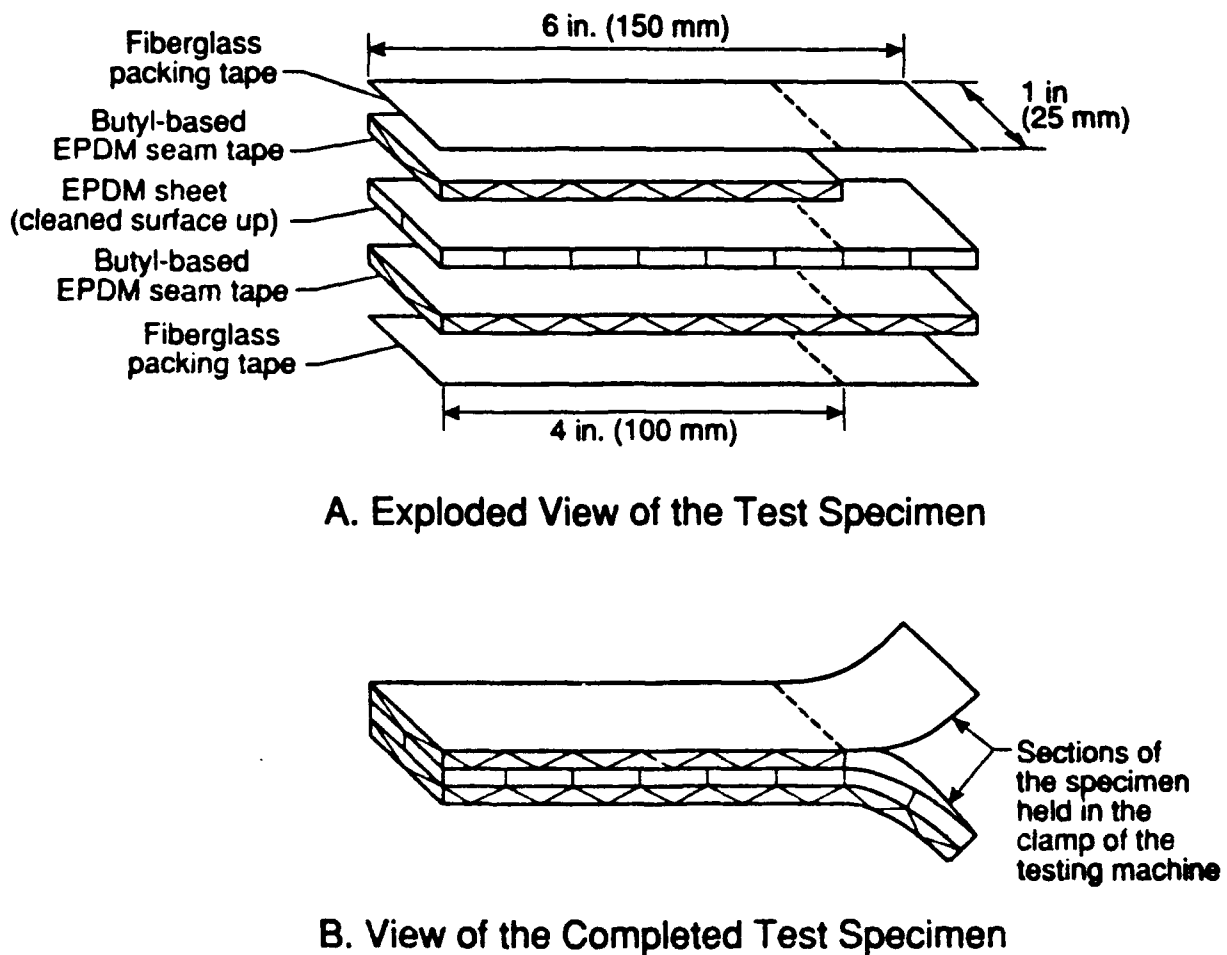
**Figure B1.** Configuration of the Test Specimen Used for Short-Term T-Peel Strength Measurements.

For these reasons, a tape was selected for preparing joint specimens. Using the joint specimen configuration shown in Figure B1, the specimens failed interfacially between the cleaned rubber surface and the tape. Preliminary experiments using new EPDM rubber cleaned by method No. 16 were conducted (data not shown) to determine the key parameters that needed to be controlled in the preparation of the specimens. Strength was found to depend on the pressure and the time over which it was applied during joint formation, and also the dwell time (i.e., time elapsed between joint formation and peel testing). Specimen preparation conditions were based, in part, on the results of the preliminary tests. Optimization of these three parameters was beyond the scope of this study. It was shown, however, that the strength of joint specimens having 7-day dwell time was not significantly different from those having a 4-day dwell time.

**Peel Tests.** T-peel test specimens, measuring 150 x 25 mm (1 x 6 in.), were prepared using the cleaned rubber strips and the commercially available butyl-based tape (Figure B1). The dimensions of the bonded area delaminated in peel were 25 x 100 mm (1 x 4 in.). To prepare a test specimen, 25 x 100 mm (1 x 4 in.) and 25 x 150 mm (1 x 6 in.) pieces of butyl-based tape were adhered to the cleaned and uncleaned surfaces of an EPDM rubber strip, respectively. The release paper was left in place on the surfaces of the tape that were not adhered to the EPDM strip. The resulting rubber/tape composite was placed in a laboratory press at 1.4 MPa (200 lbf/in.<sup>2</sup>) for 5 minutes. After removal from the press, it was allowed to remain at ambient laboratory conditions (about 22°C, or 72°F, and 45-50 percent relative humidity RH) for 7 days. Then, the release paper was removed from the two exposed surfaces of the butyl tape, and replaced with strips of fiberglass packing tape. The fiberglass tape was used to prevent excessive elongation of the specimens during peel testing.

As shown in Figure B1, the specimen was clamped in a universal testing machine such that one grip held only a section of fiberglass packing tape, while the other grip clasped a section comprising the cleaned rubber strip, butyl-based tape, and fiberglass packing tape. When the specimen was subjected to peel delamination in the testing machine, the failure was interfacial between the cleaned surface of the rubber strip and the 25 x 100 mm (1 x 4 in.) piece of butyl-based tape. Peel tests were conducted at ambient laboratory conditions at a rate of 50 mm/min (2 in./min). The universal testing machine was equipped with microcircuitry that calculated the average peel strength.

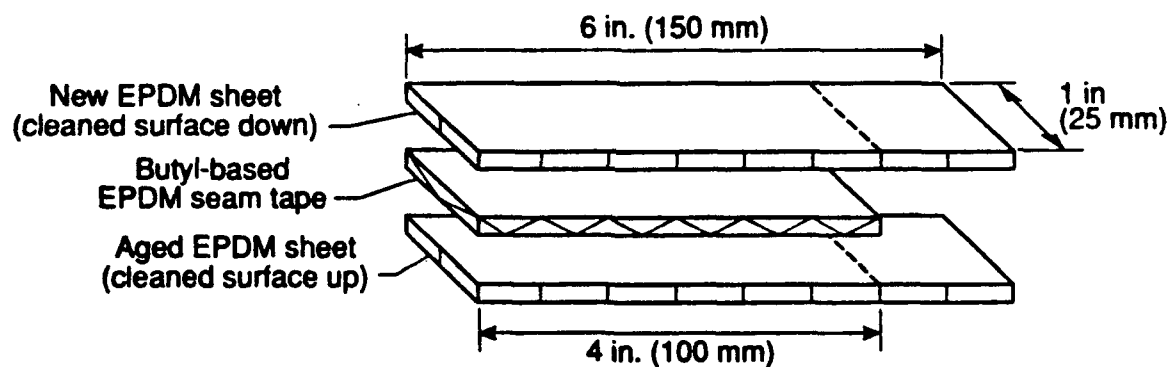
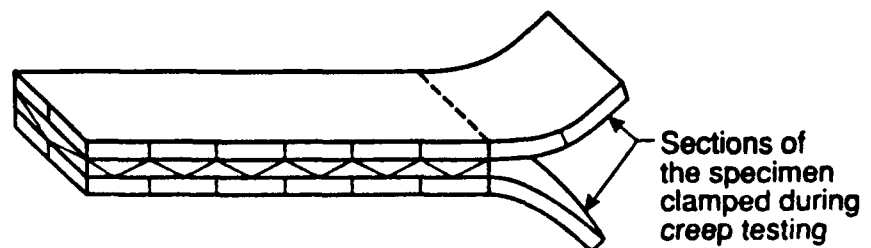
**A. Exploded View of the Test Specimen**

**B. View of the Completed Test Specimen**

**Figure B2. Configuration of the Test Specimen Used for the Long-Term Creep-Rupture Measurements.**
