AEROSPACE REPORT NO.  
TR-0091(6935-03)-1

## Space Environmental Effects on Silvered Teflon Thermal Control Surfaces

15 September 1991

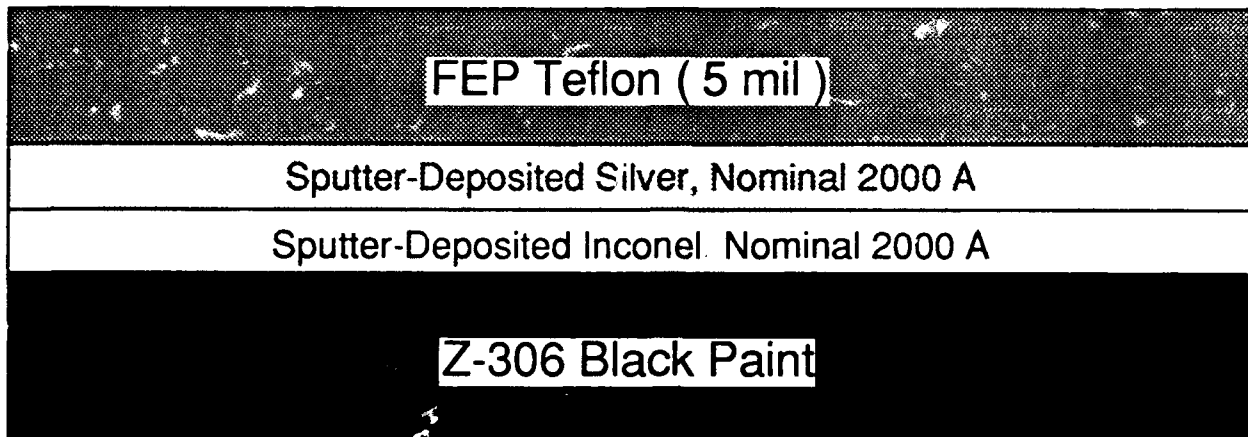
Figure 2. Schematic of 5-mil silvered Teflon thermal blankets.

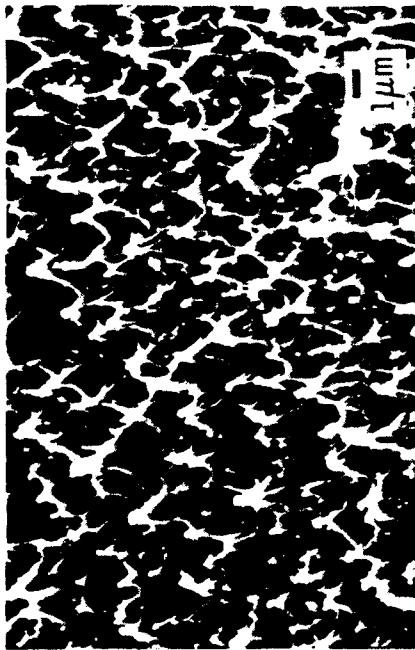
LDEF TRAY C11 EXPOSED TEFLON

CONTROL TEFLON SURFACE

Figure 3. Leading edge sample of Ag/FEP compared to control sample. Typical results of analyses with SEM and XPS.

The leading edge samples were uniform in appearance from rows 7 through 11. Typical results of analyses with SEM and XPS are shown in Figure 3. The control surface, which is a non-flight FEP surface, is featureless in the SEM while the flight sample shows a typical erosion pattern in FEP for high velocity atomic oxygen erosion. The XPS data for the control surface shows carbon and fluorine only. The XPS analysis of the exposed surface shows that the surface composition of the FEP remaining after the erosion is indistinguishable in carbon and fluorine composition from the control, with trace amounts of some contaminants (Si, N, S, and Cl) and measurable oxygen present. This oxygen could be from the atomic oxygen interaction or from water adsorption from the atmosphere after retrieval. Water adsorption could be enhanced on the erosion-roughened surfaces, which have much higher surface area than the control surfaces. Some variations in the erosion pattern on leading edges were observed as shown in Figure 4.

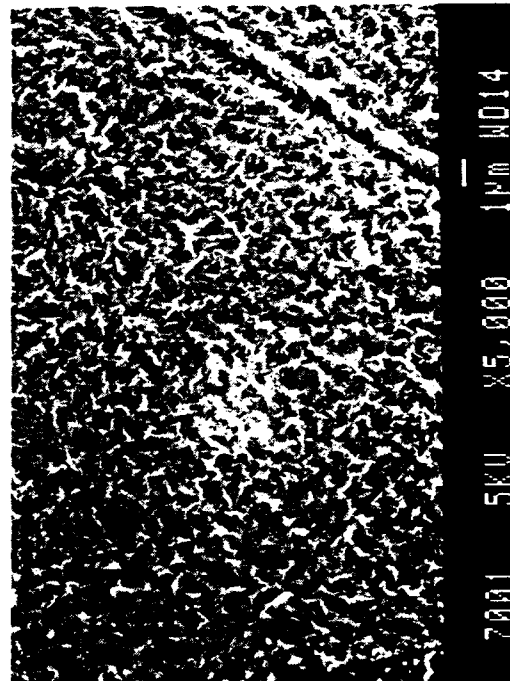
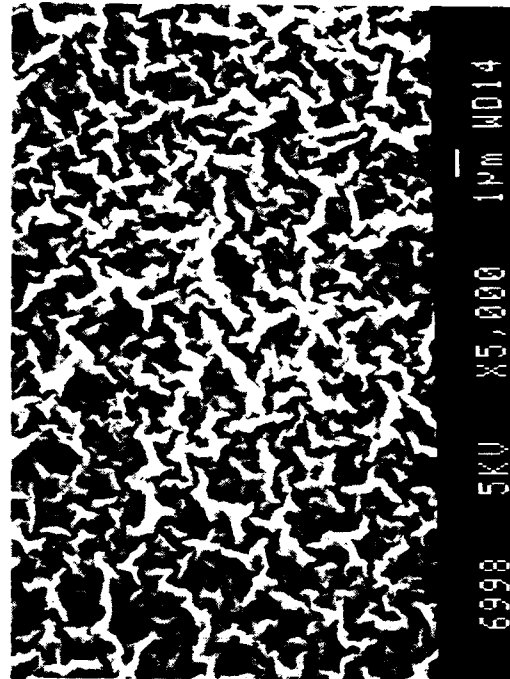
F2: Exposed Trailing  
Edge Surface

Clear

Cloudy

Figure 5. Exposed trailing edge surface from F2 showing morphology changes by SEM in adjacent clear and diffuse areas of Teflon.

Exposed trailing edge samples were found to have developed a wide variety of surface morphologies, very distinct in appearance from the featureless control surface and the atomic oxygen eroded surfaces. The blanket surface areas that appear fogged or cloudy on the trailing edge have become sufficiently diffuse to change visibly. Many of the clear, visibly unaffected areas, however, also have morphology changes, as seen in Figure 5. Within short distances on some trailing edge samples both the surface morphology and surface contamination levels were observed to change dramatically. This is shown in Figure 6. Silicon, detected as  $\text{SiO}_2$ , is one of the most significant contaminants on trailing edge Ag/FEP surfaces. It is currently not clear if any causal relationship exists between observed morphology type and surface contamination build-up. It is possible that some morphologies will have a higher probability of trapping or adsorbing outgassed or backscattered species, thereby leading to greater surface contamination buildup. Some additional morphology types observed on exposed trailing edge FEP surfaces are seen in Figures 7 and 8. Figure 7 shows a series of closely spaced bands on a section of the thermal blanket from bay A of row 2 (A2). Figure 8 shows that some trailing edge surfaces are still relatively smooth; this was most typical of samples at larger angles to the trailing edge, e.g. rows 1, 5 and 6. EDS analysis showed the bright spots to be relatively high in Si concentration.

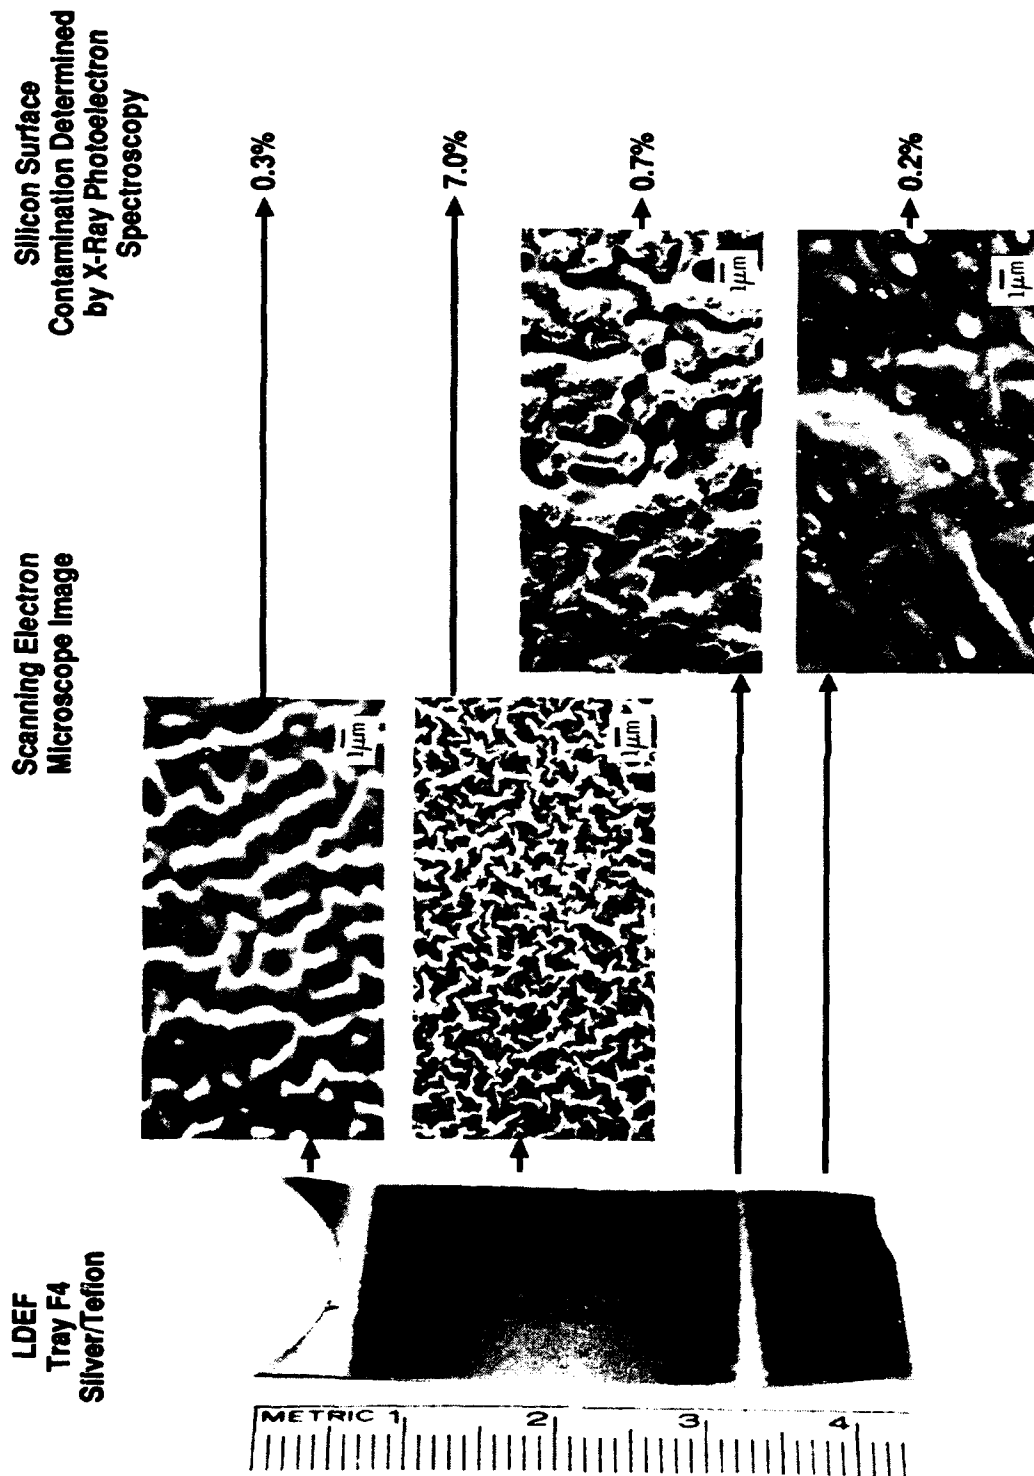
Figure 6. Changes in Teflon surface morphology and surface contamination level, as represented by Si concentration, for a series of adjacent bands on an exposed trailing edge surface from F4.

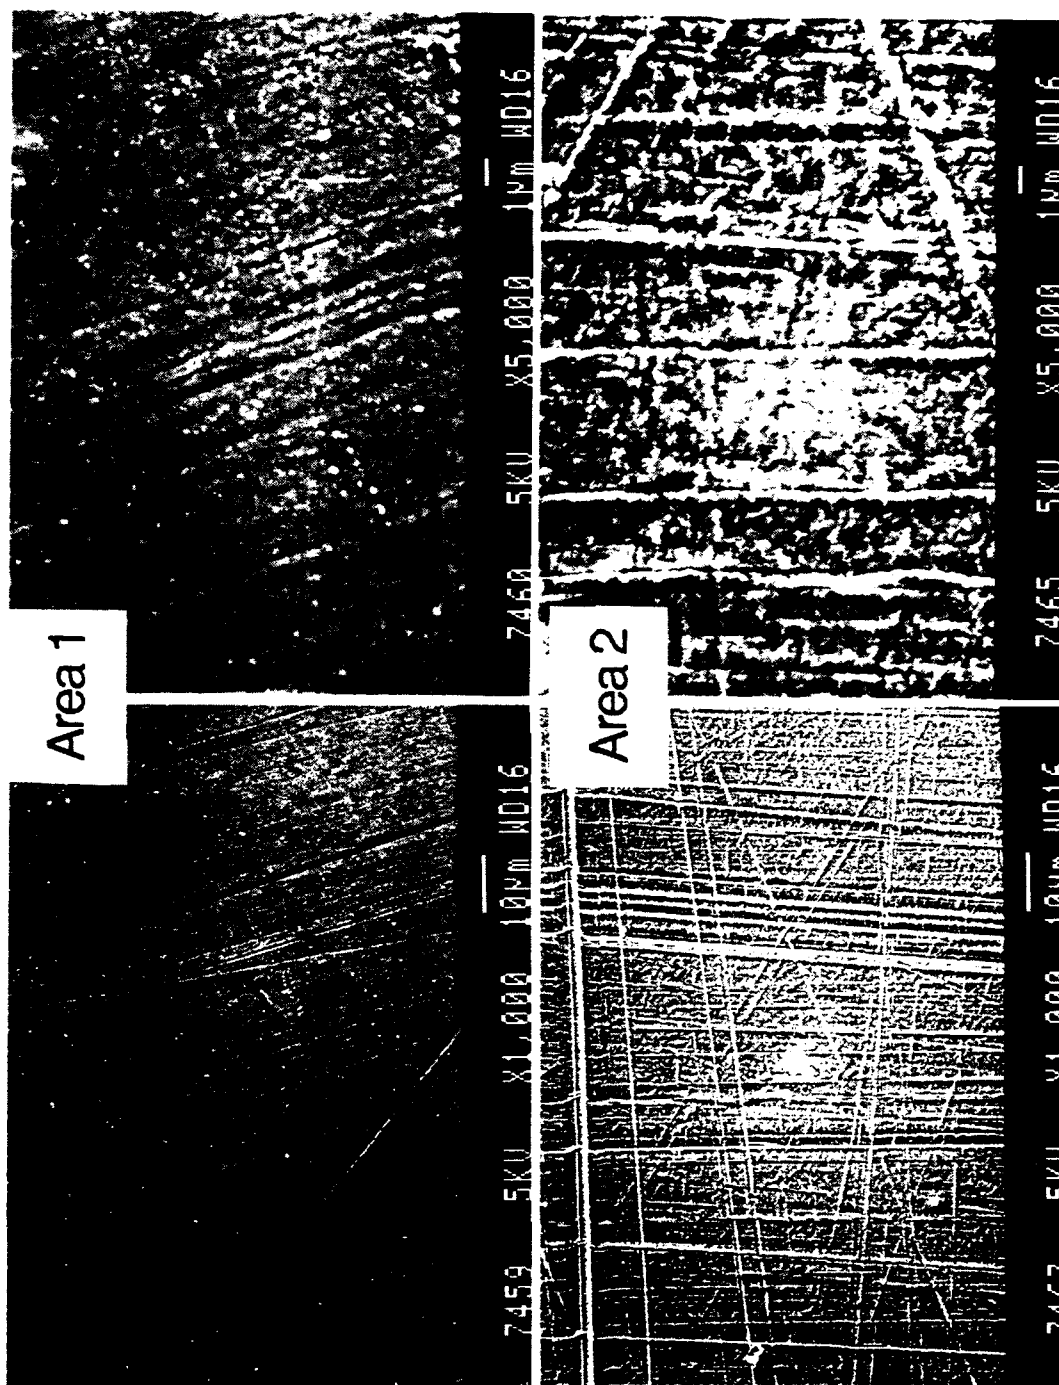
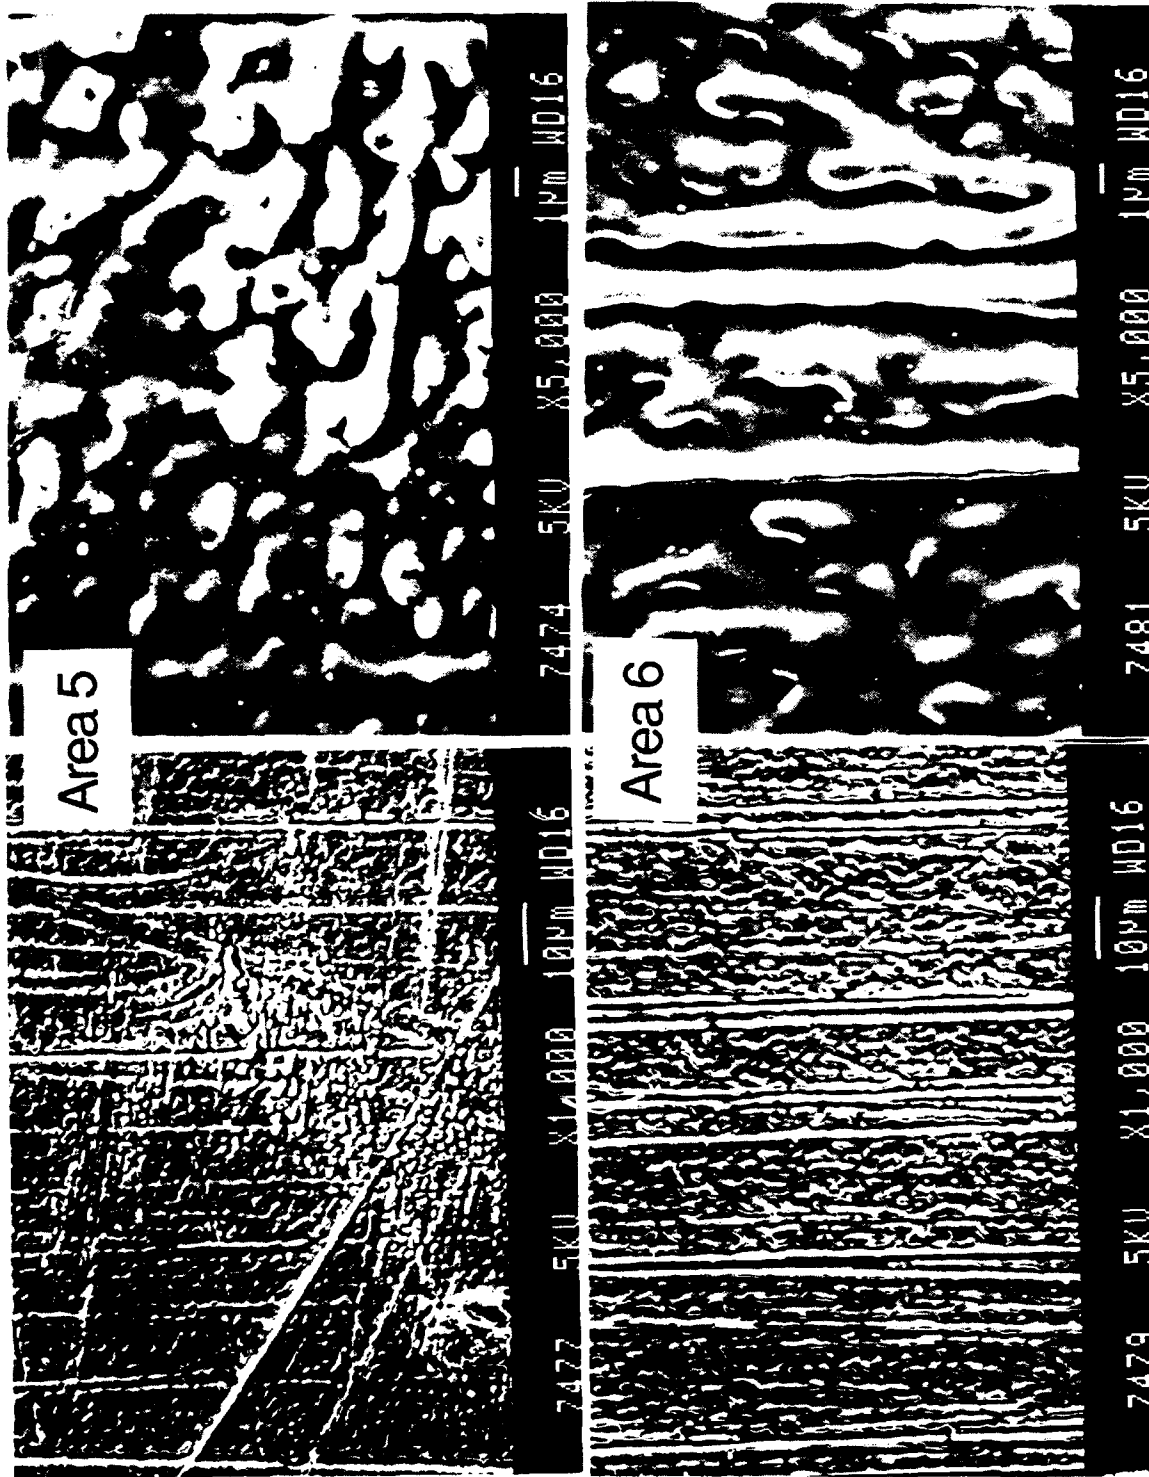
Figure 7 (Areas 1 and 2) Figure 7. SEM images of morphologies in a series of 6 closely spaced bands on a section of exposed Teflon from trailing edge A2.

Figure 7 (Areas 3 and 4)

Figure 7 (Areas 5 and 6)

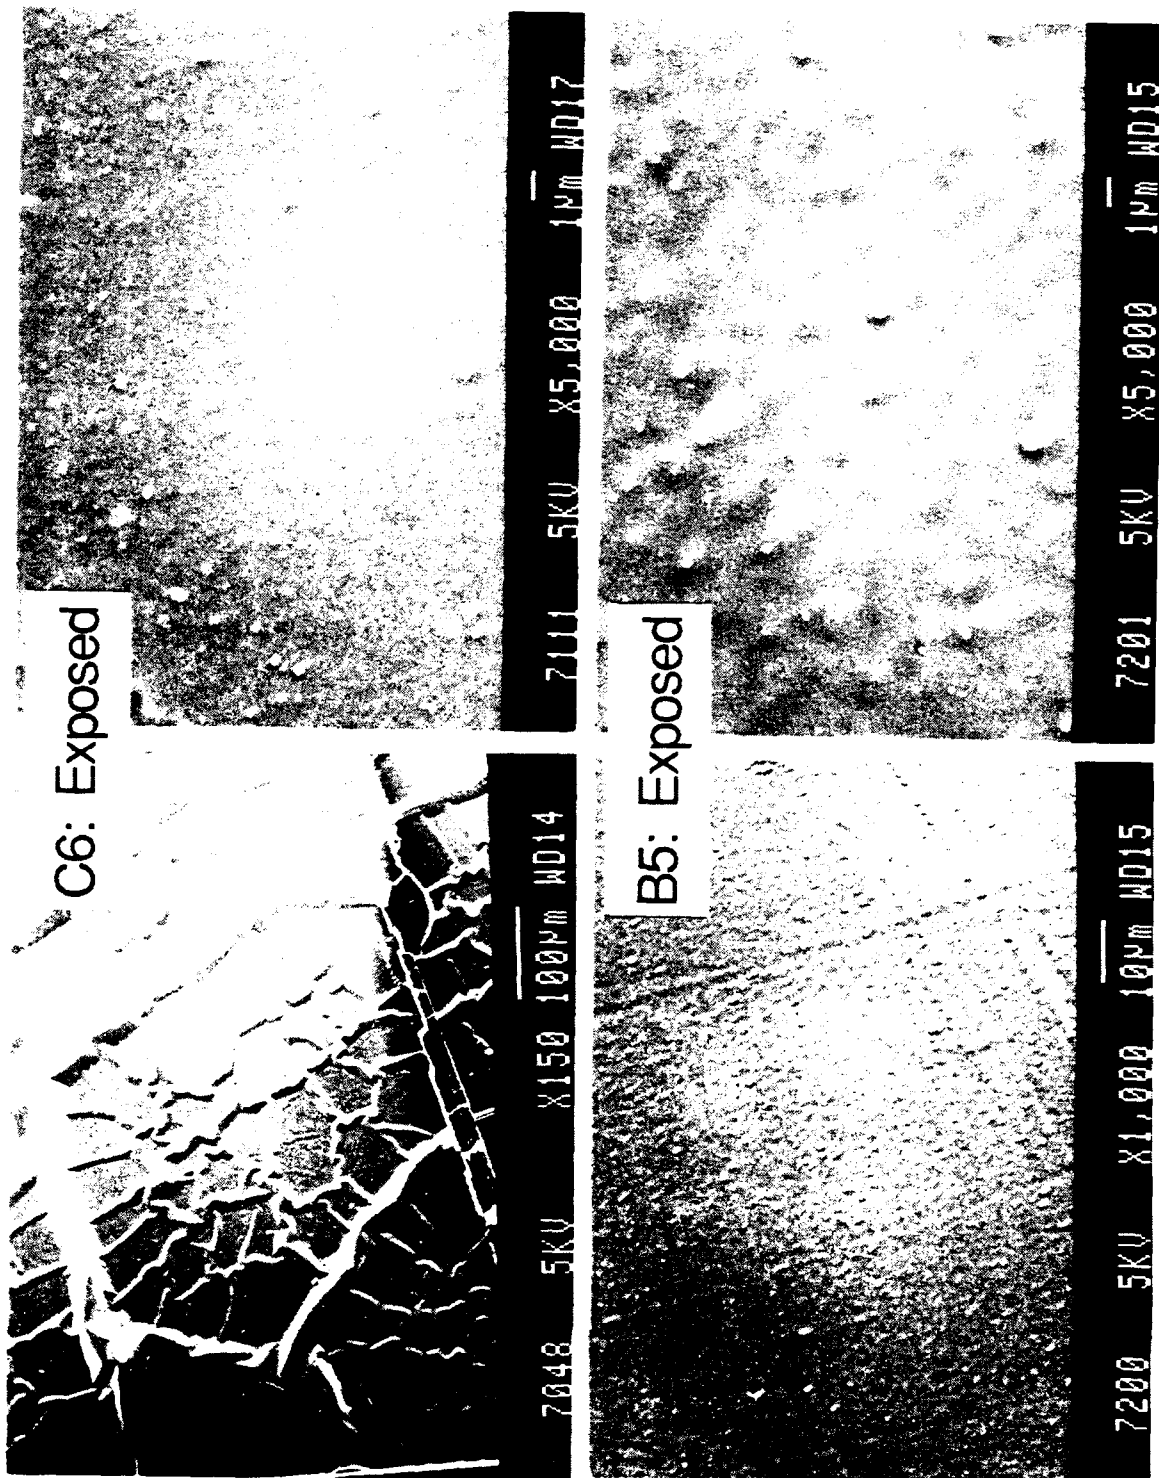
Figure 8. Exposed trailing edge surfaces that are still relatively smooth. Bright spots are relatively high in Si concentration.
