**US Army Corps  
of Engineers**

Construction Engineering  
Research Laboratory

USACERL Interim Report FM-93/05

## **Three-Year Field Test Summary for Experimental Modified Bitumen Roofing at Fort Polk, LA**

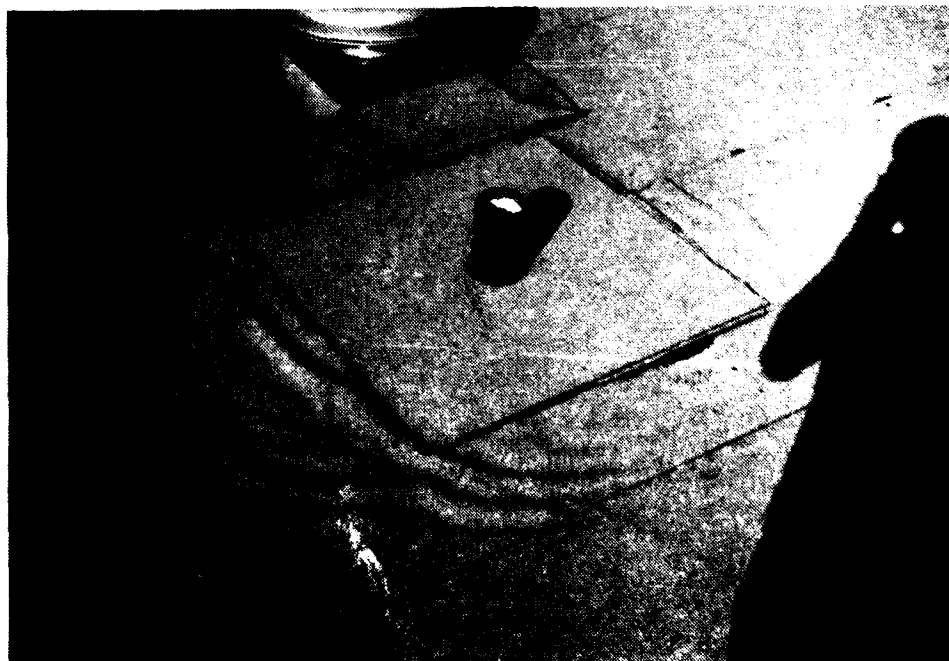
In October of 1988, 1 year after construction was completed, the torch-applied APP modified bitumen (membrane A) and the self-adhering modified bitumen (membrane C) were in excellent condition. No visible changes were noted. However, the hot-mopped SBS modified bitumen (membrane B) had several problems, all of which seemed to be caused by the membrane plys slipping down the roof slope.

**Figure 13. Wrinkles and Dishmouths due to Slippage.**

The test roofs were reinspected in July of 1989. Membranes A and C remained in excellent condition; no changes in appearance were noticed. No problems were noted with the flashings and only minor wrinkling was apparent in some areas of the membrane. The slippage of membrane B had progressed approximately 1 in. since the previous inspection. Upon taking field measurements, researchers determined the entire membrane was slipping as a unit. At this time, it had become evident that the roof membrane would have to be anchored to prevent any further slippage.

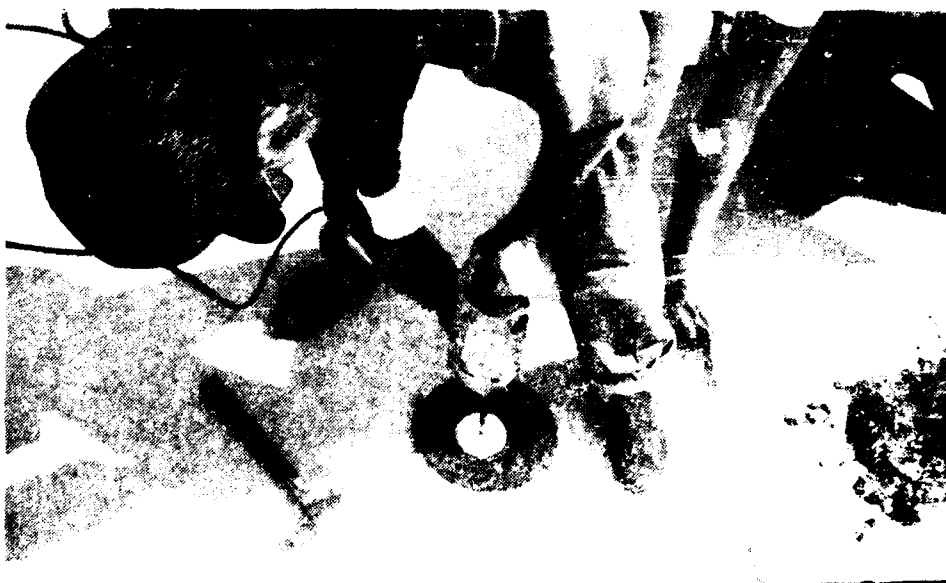
Figure 15. Placing the Fasteners through Membrane B.
