FINAL REPORT  
APRIL 1990

REPORT NO. EVT 17-90

COMPARISON OF STANDARD  
ISSUE AND ANCRA  
INTERNATIONAL MILVAN  
RESTRAINT BEAMS IN STATIC  
AND DYNAMIC ENVIRONMENTS

VALIDATION ENGINEERING DIVISION  
SAVANNA, ILLINOIS 61074-9639

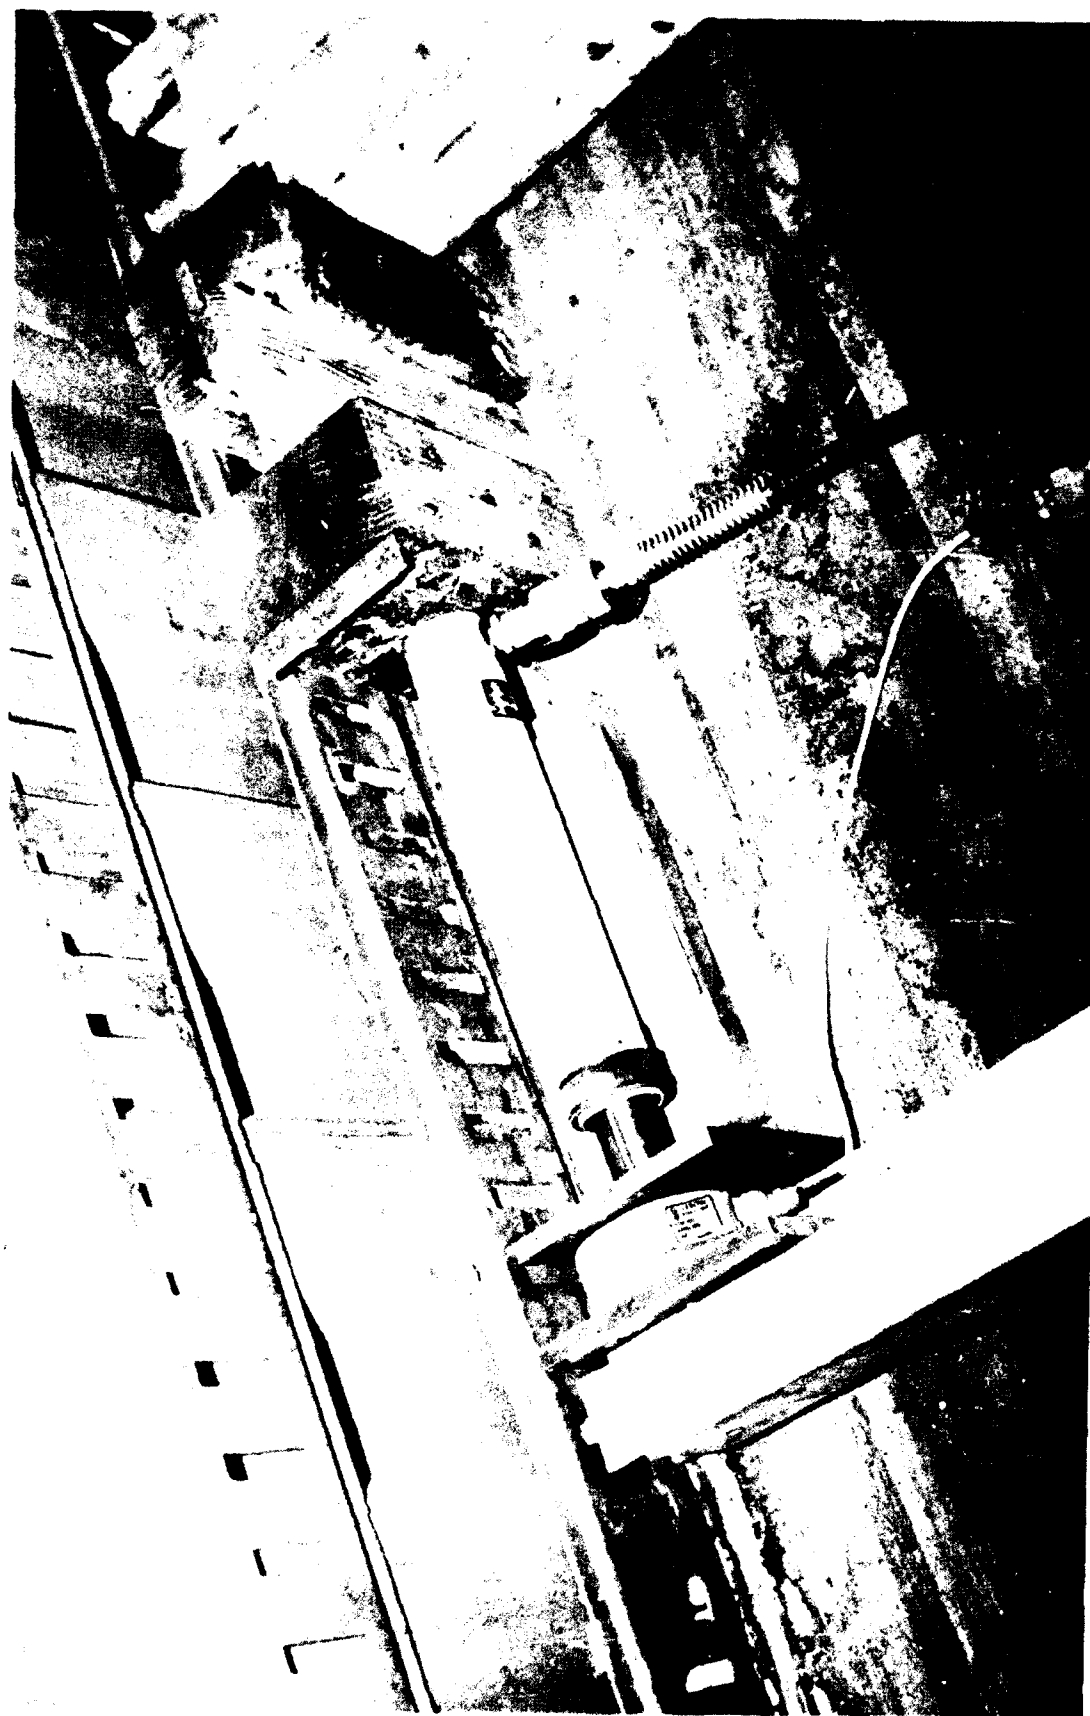
Photo No. A0317-SPN-90-229-3025. This photo shows the original issue restraint beam, sample no. 3, before end loading. The hydraulic cylinder was extended until belt rail failure.

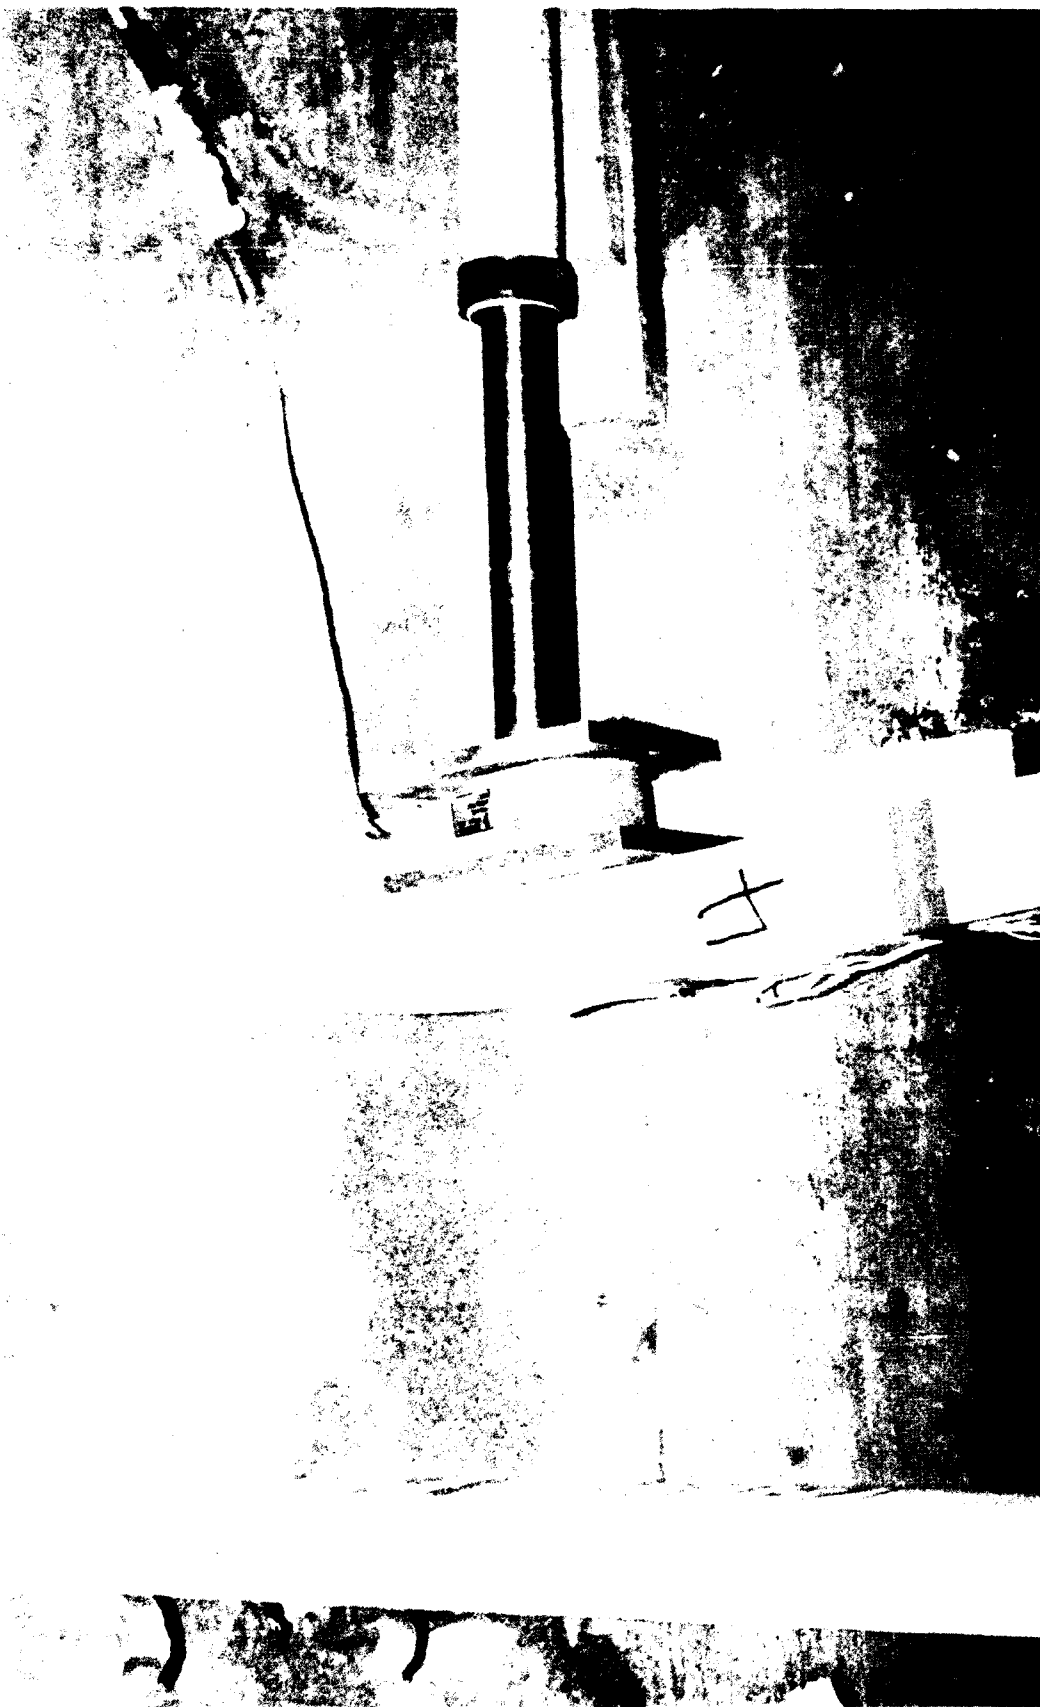
Photo No. A0317-SPN-90-229-3031. This photo shows the original issue restraint beam, sample no. 4, after point loading. The hydraulic cylinder was extended until permanent deformation of the restraint beam occurred.

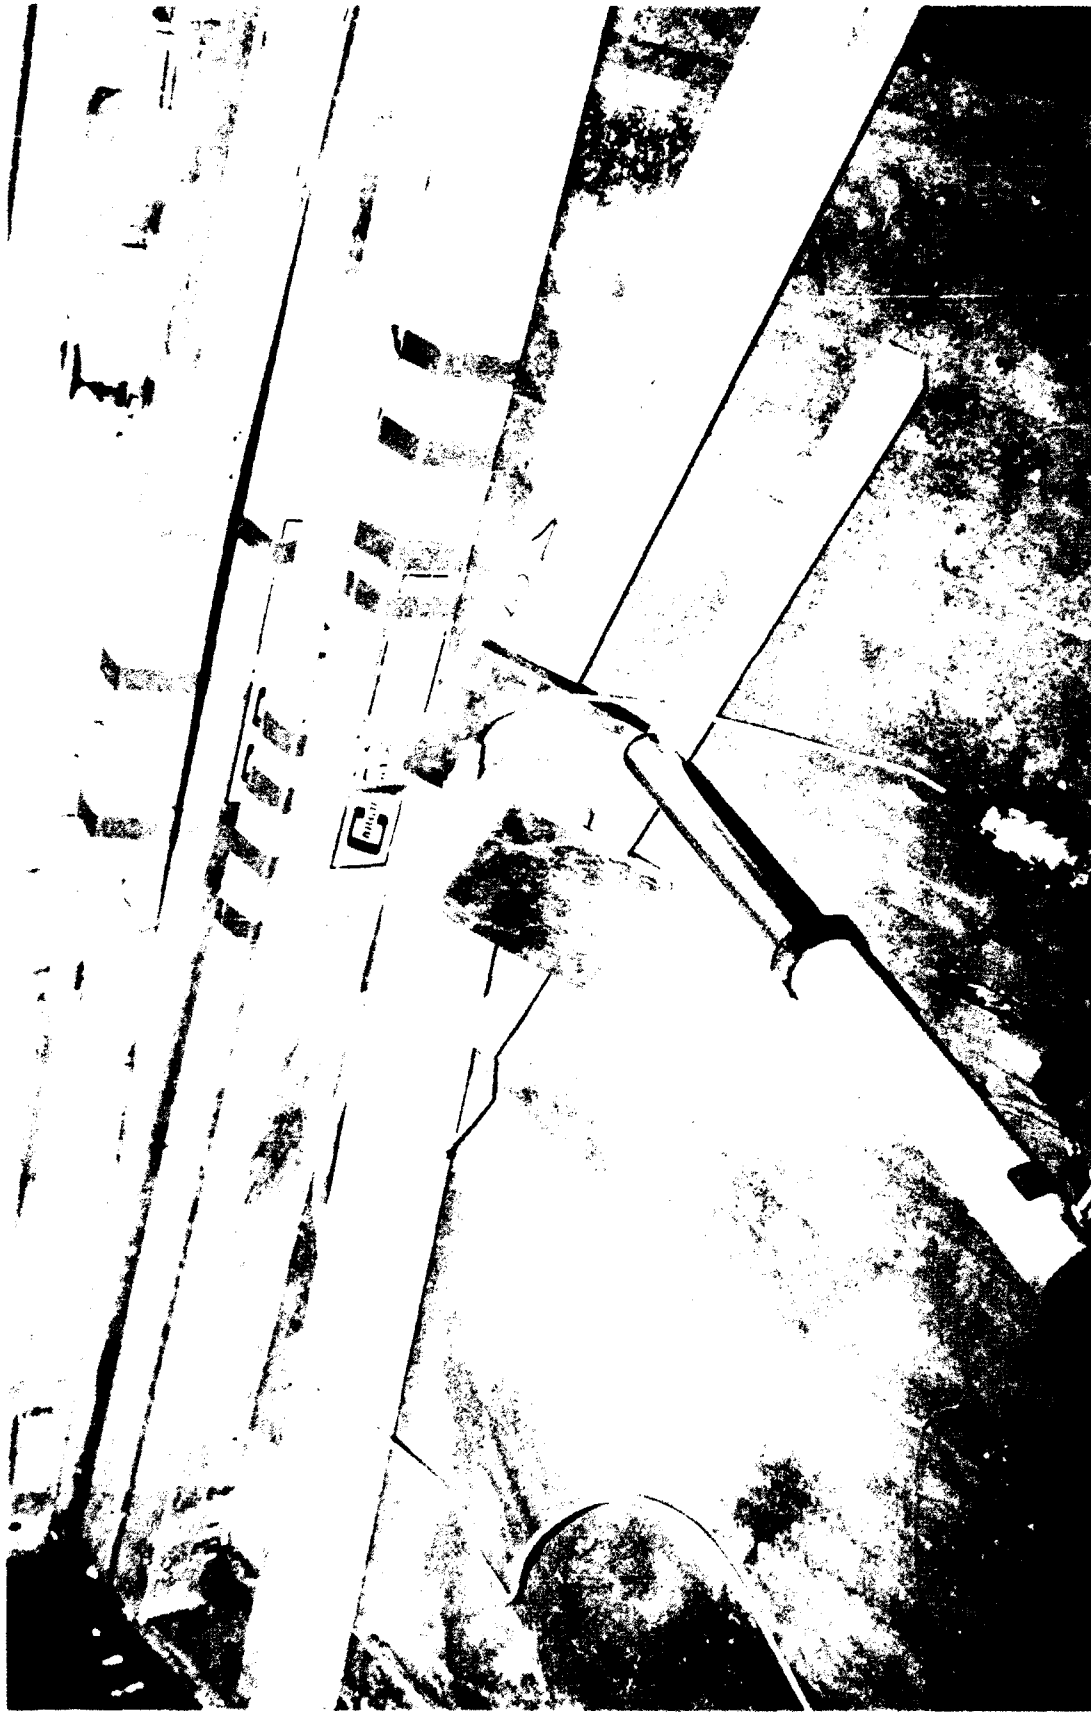
Photo No. A0317-SPN-90-229-3033. This photo shows the original issue restraint beam, sample no. 5, after point loading. The hydraulic cylinder was extended until permanent deformation of the restraint beam occurred. This sample pulled out of the belt rail.

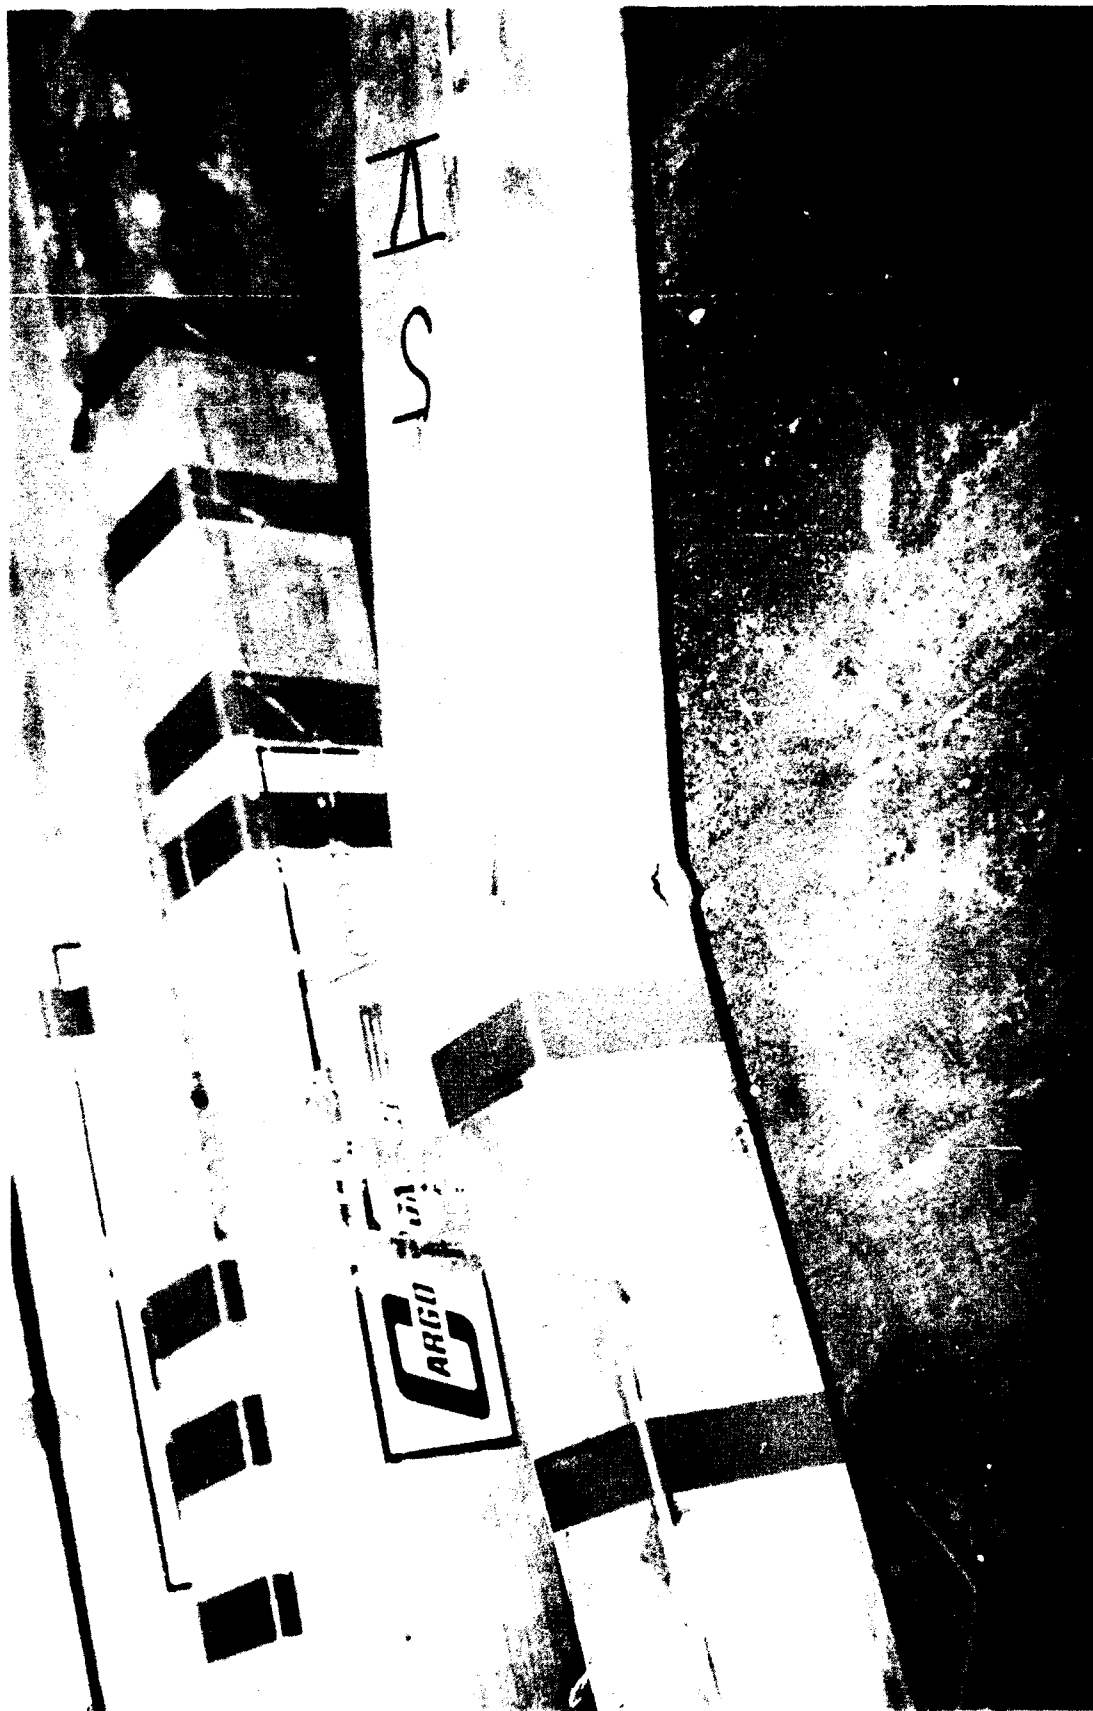
| Photo No. A0317-SPN-90-229-3035. This photo shows the original issue restraint beam, sample no. 5, after point loading. This sample pulled out of the belt rail. | |

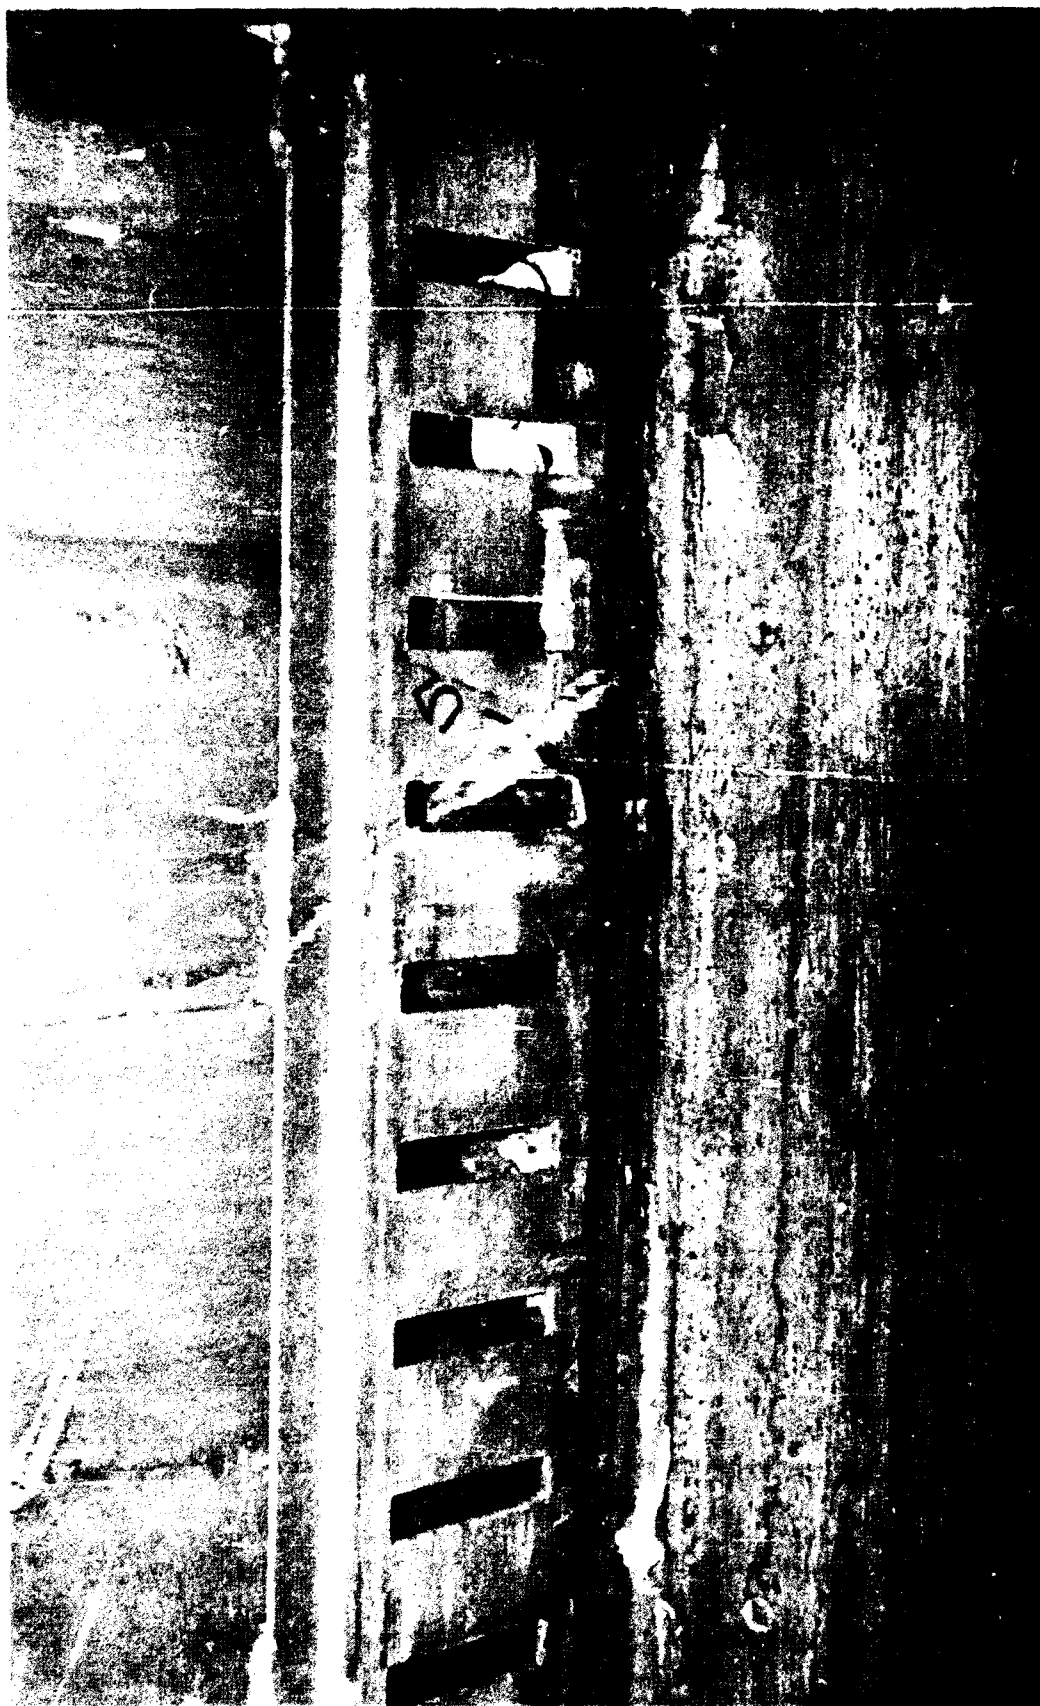
Photo No. A0317-SPN-90-229-3034. This photo is a closeup of the belt rail where sample no. 5 pulled out. Note damage to the lower part of the interlock from the restraint bar hook.

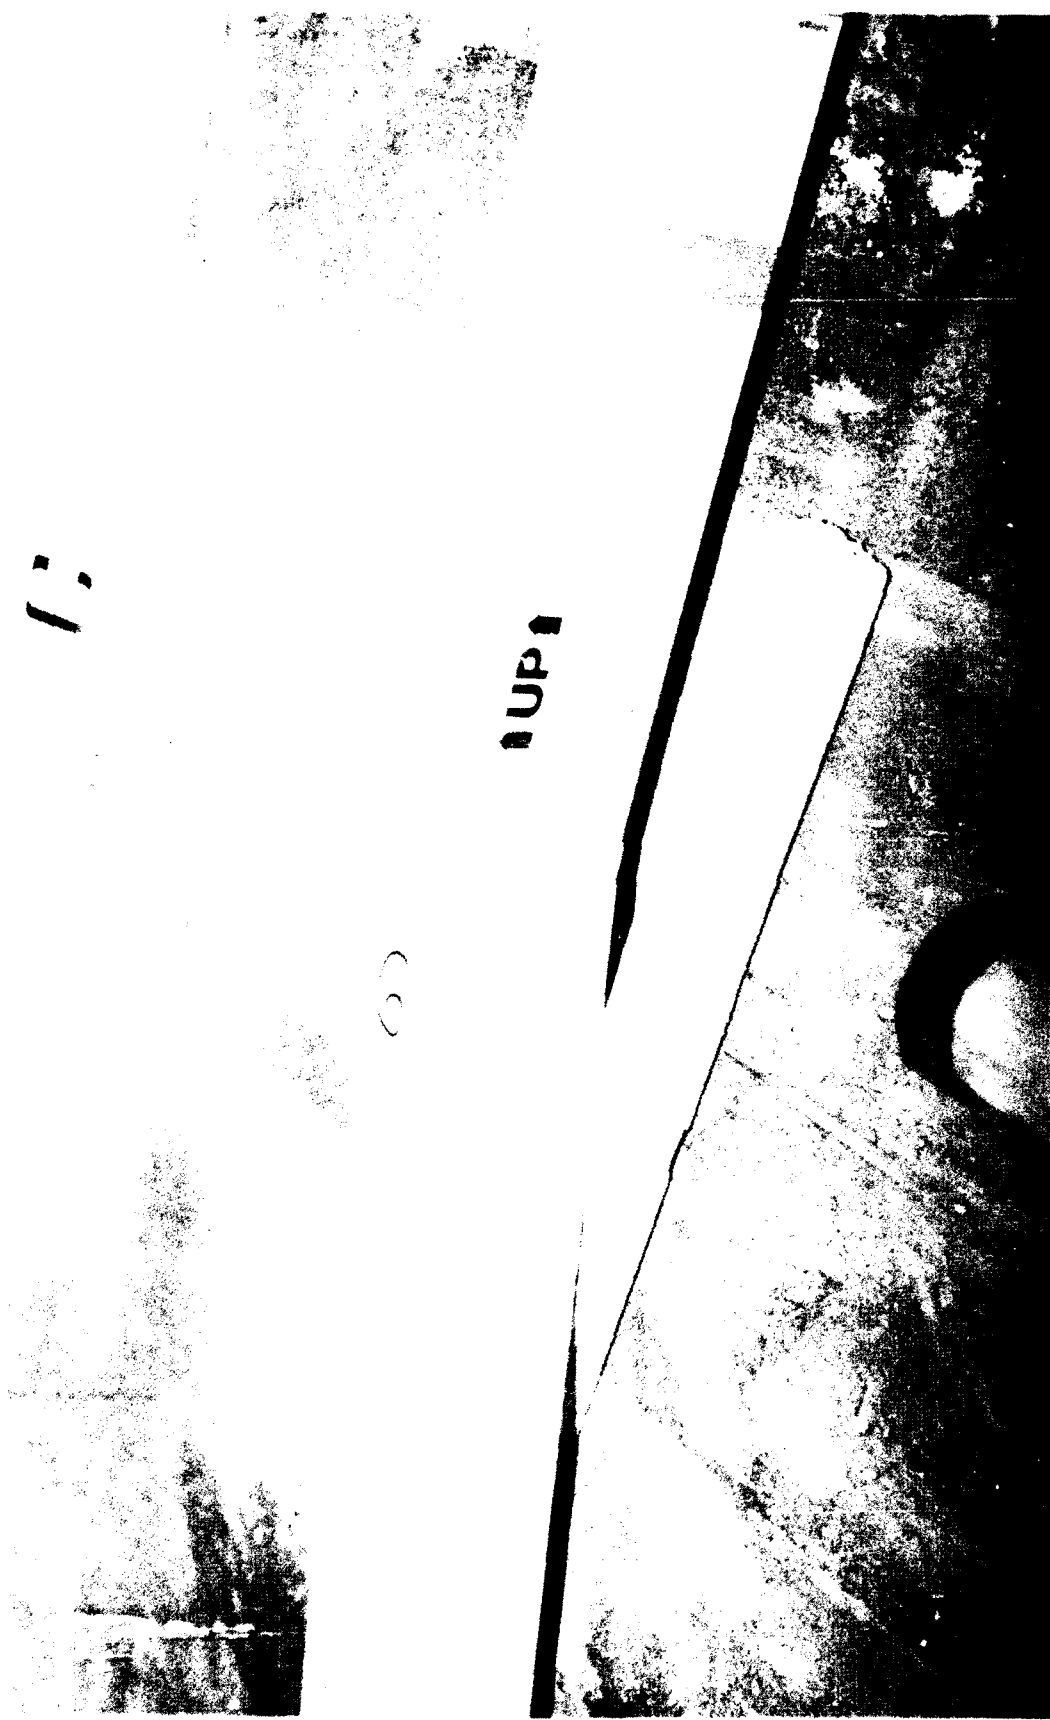
| Photo No. A0317-SPN-90-229-3037. This photo shows the original issue restraint beam, sample no. 6, after applying a point load. |

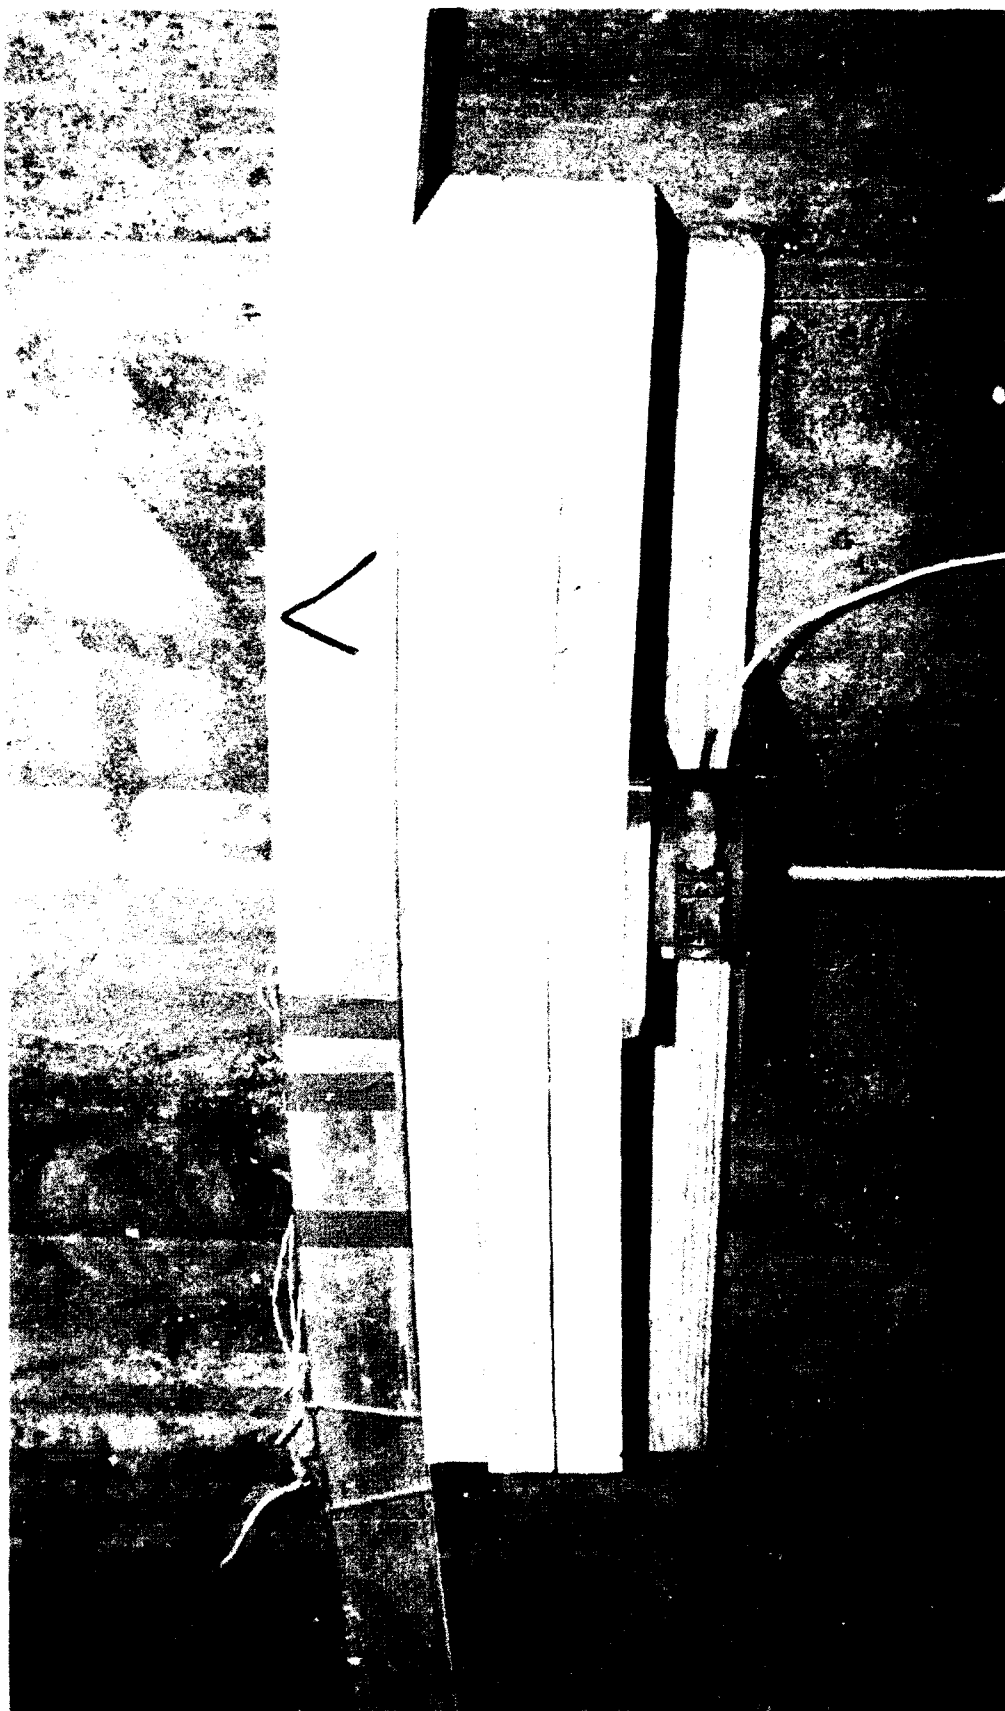
Photo No. A0317-SPN-90-229-3040. This photo shows the original issue restraint beam, sample no. 7, with a load applied.

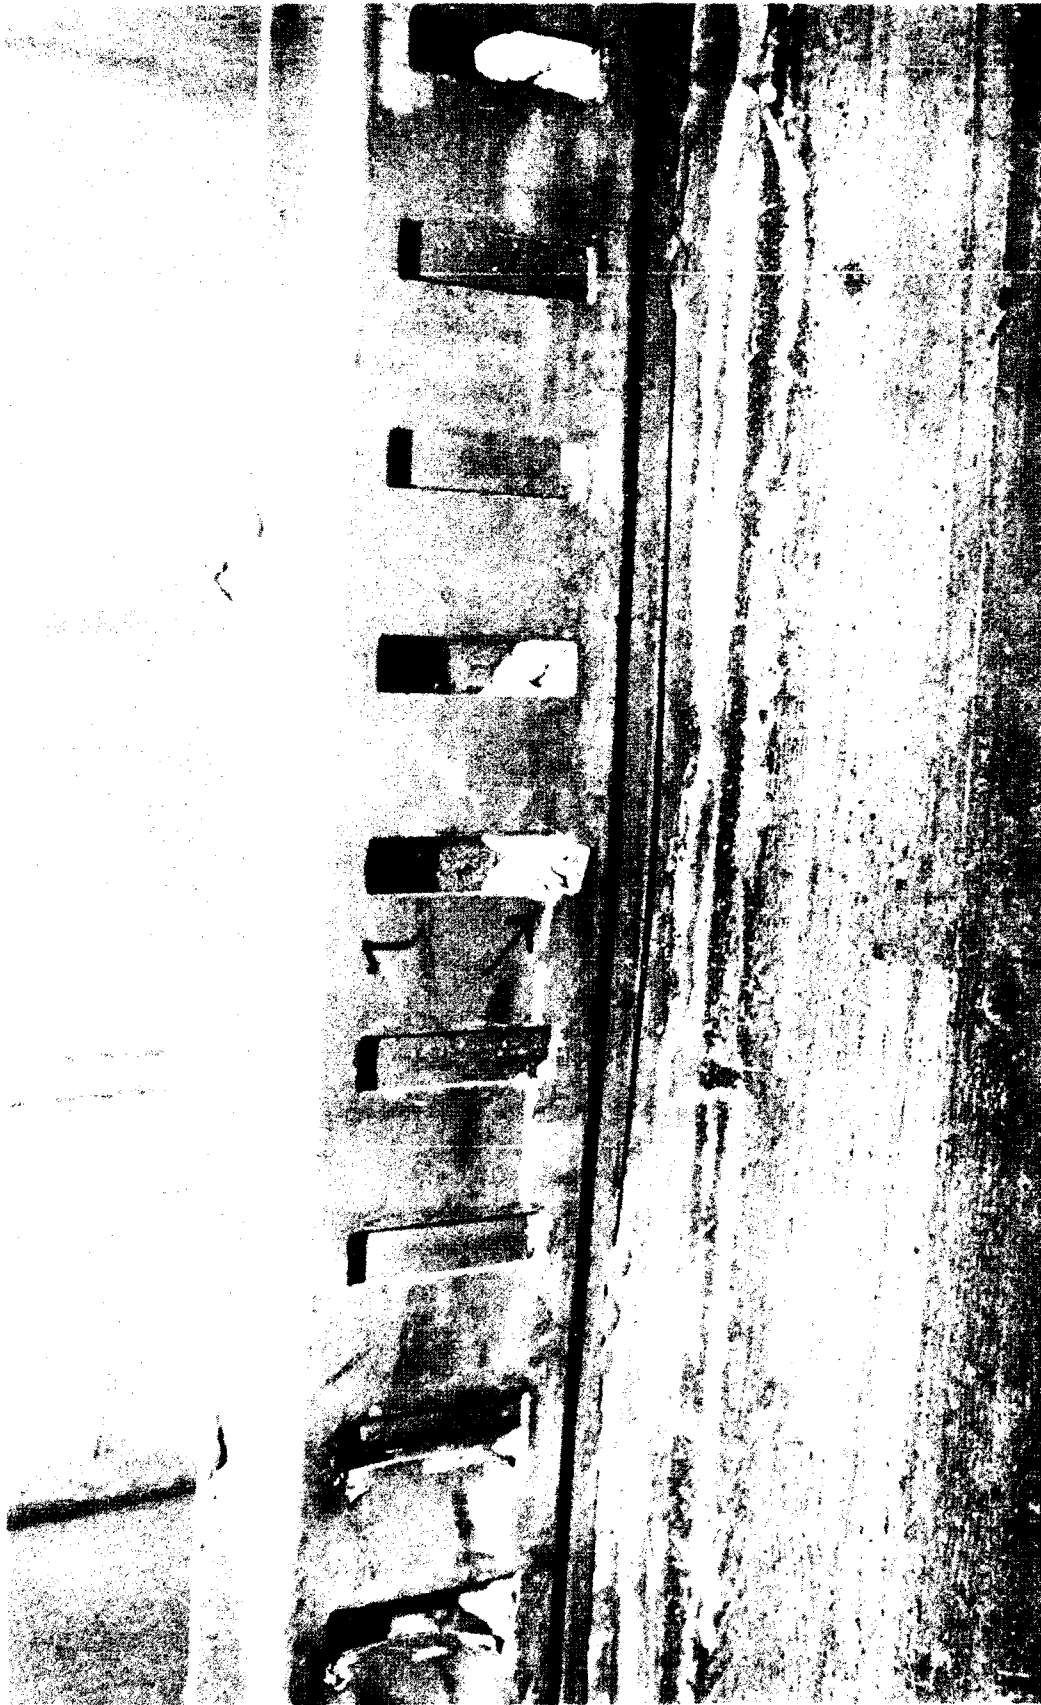
Photo No. A0317-SPN-90-229-3044. This photo shows the original issue restraint beam, sample no. 7, after the loading test. This photo shows where the restraint beam clamp disengaged from the belt rail.

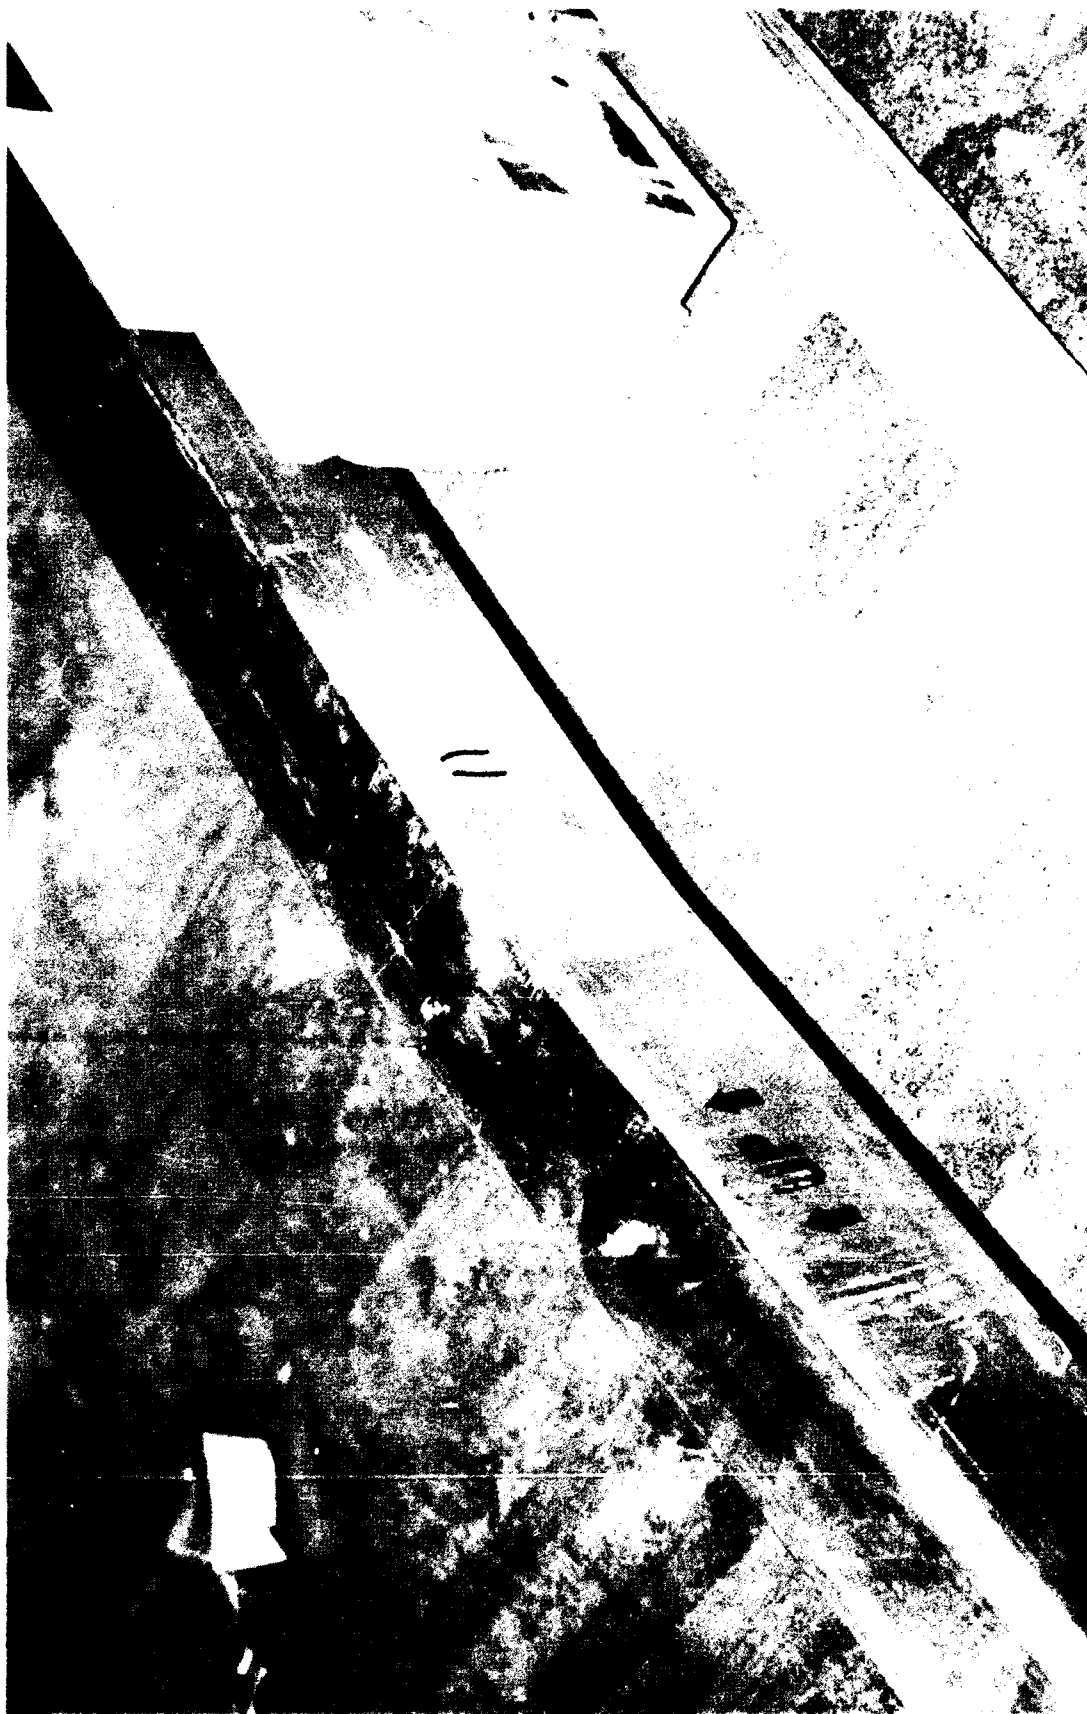
Photo No. A0317-SPN-90-229-3067. This photo shows test sample no. 11 after load testing.

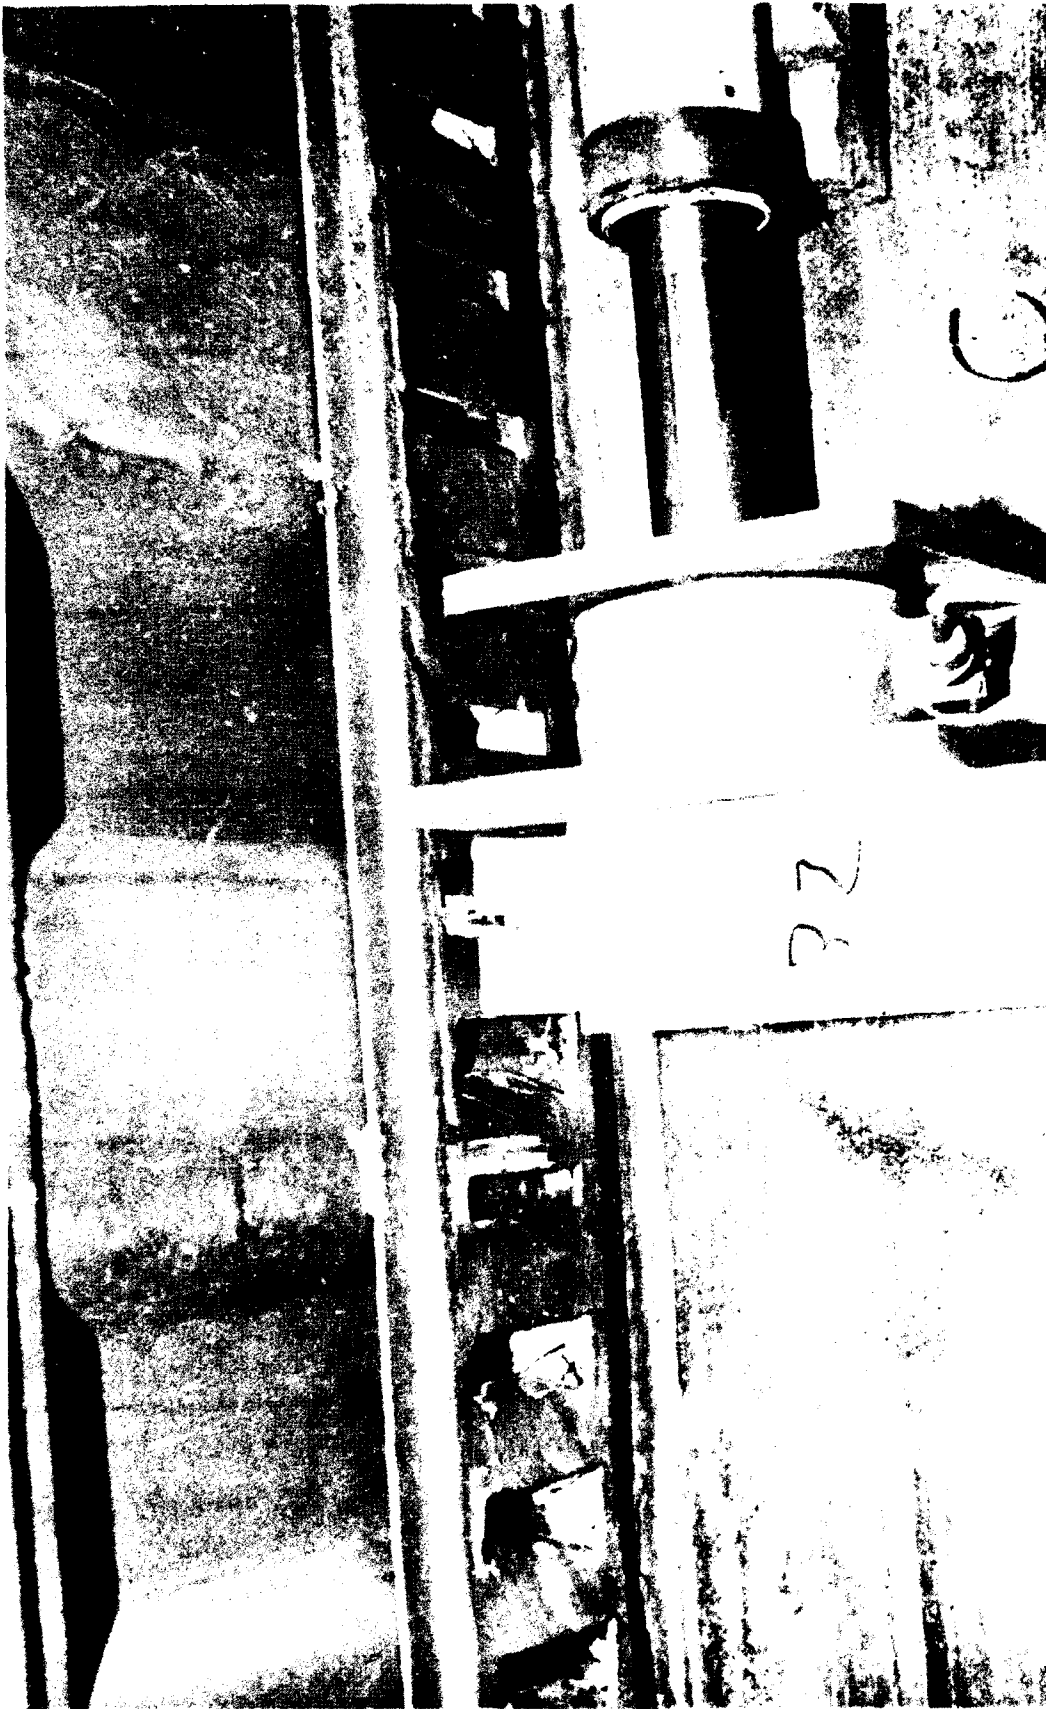
Photo No. SPN-90-229-3086: This photo shows an ANCRA International restraint beam, sample no. 32, with an end load applied to a force just below failure.

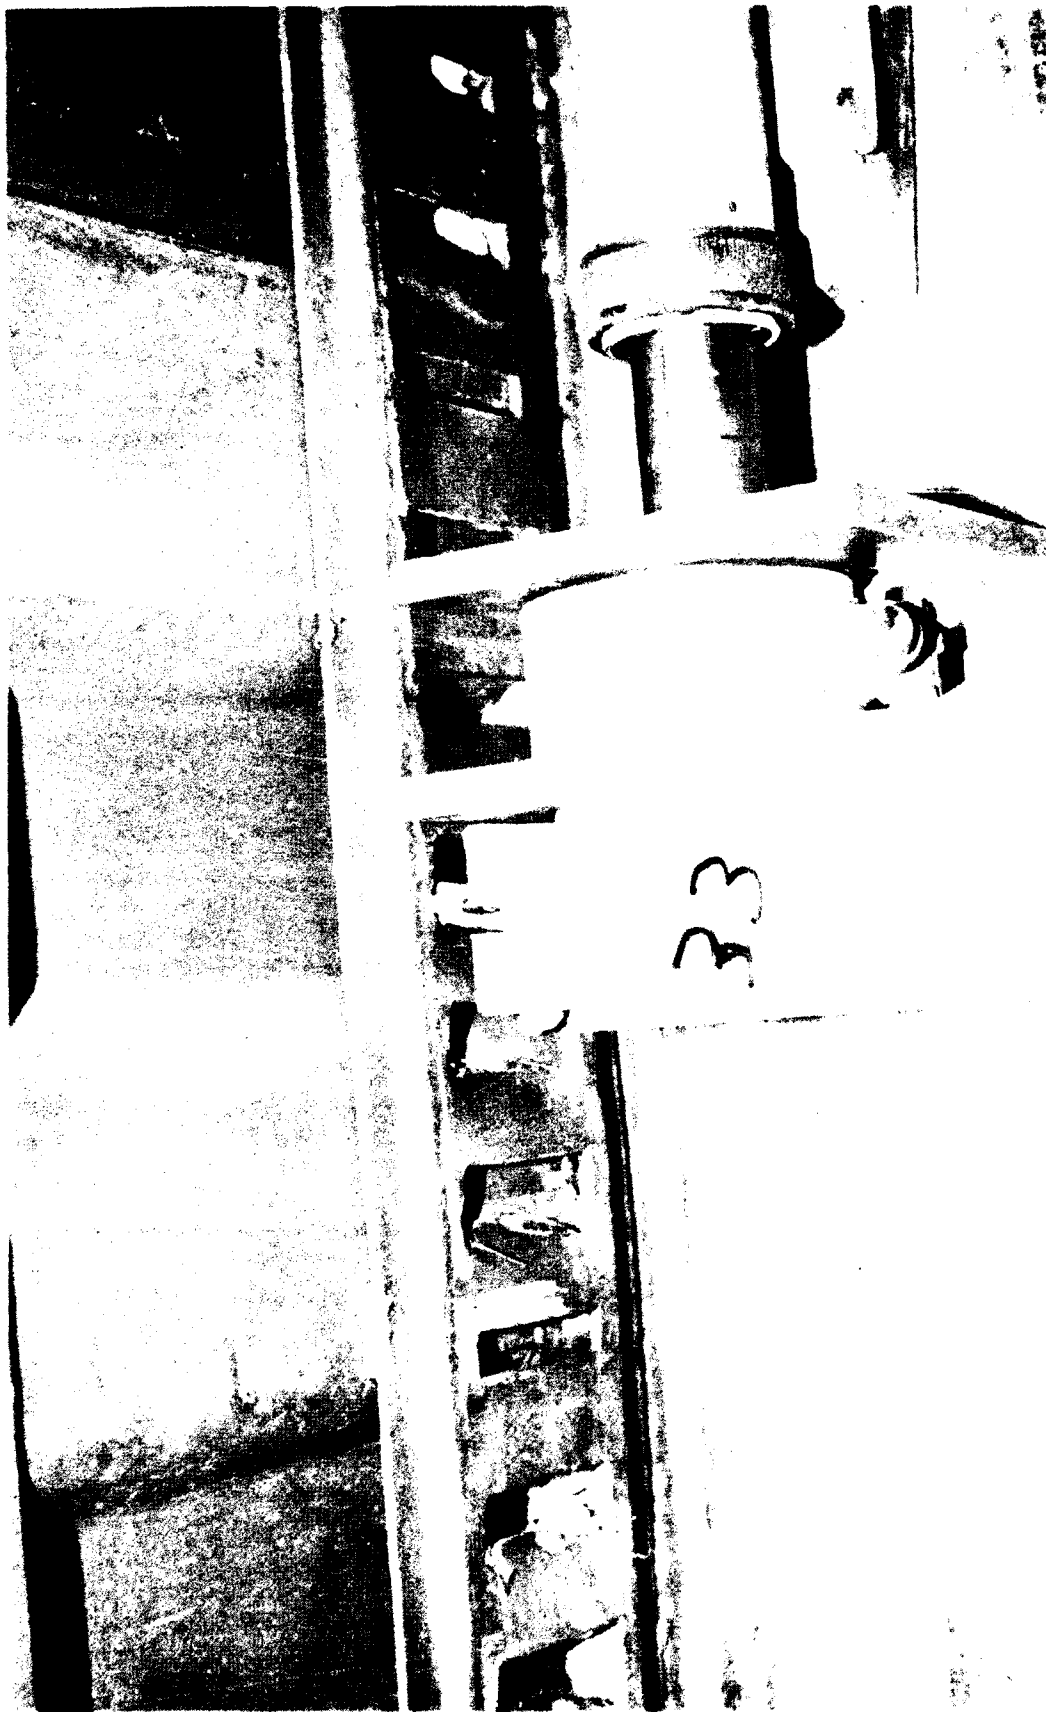
| Photo No. SPN-90-229-3087: This photo shows an ANCRA International restraint beam, sample no. 33, with an end load applied to a force just below failure. |

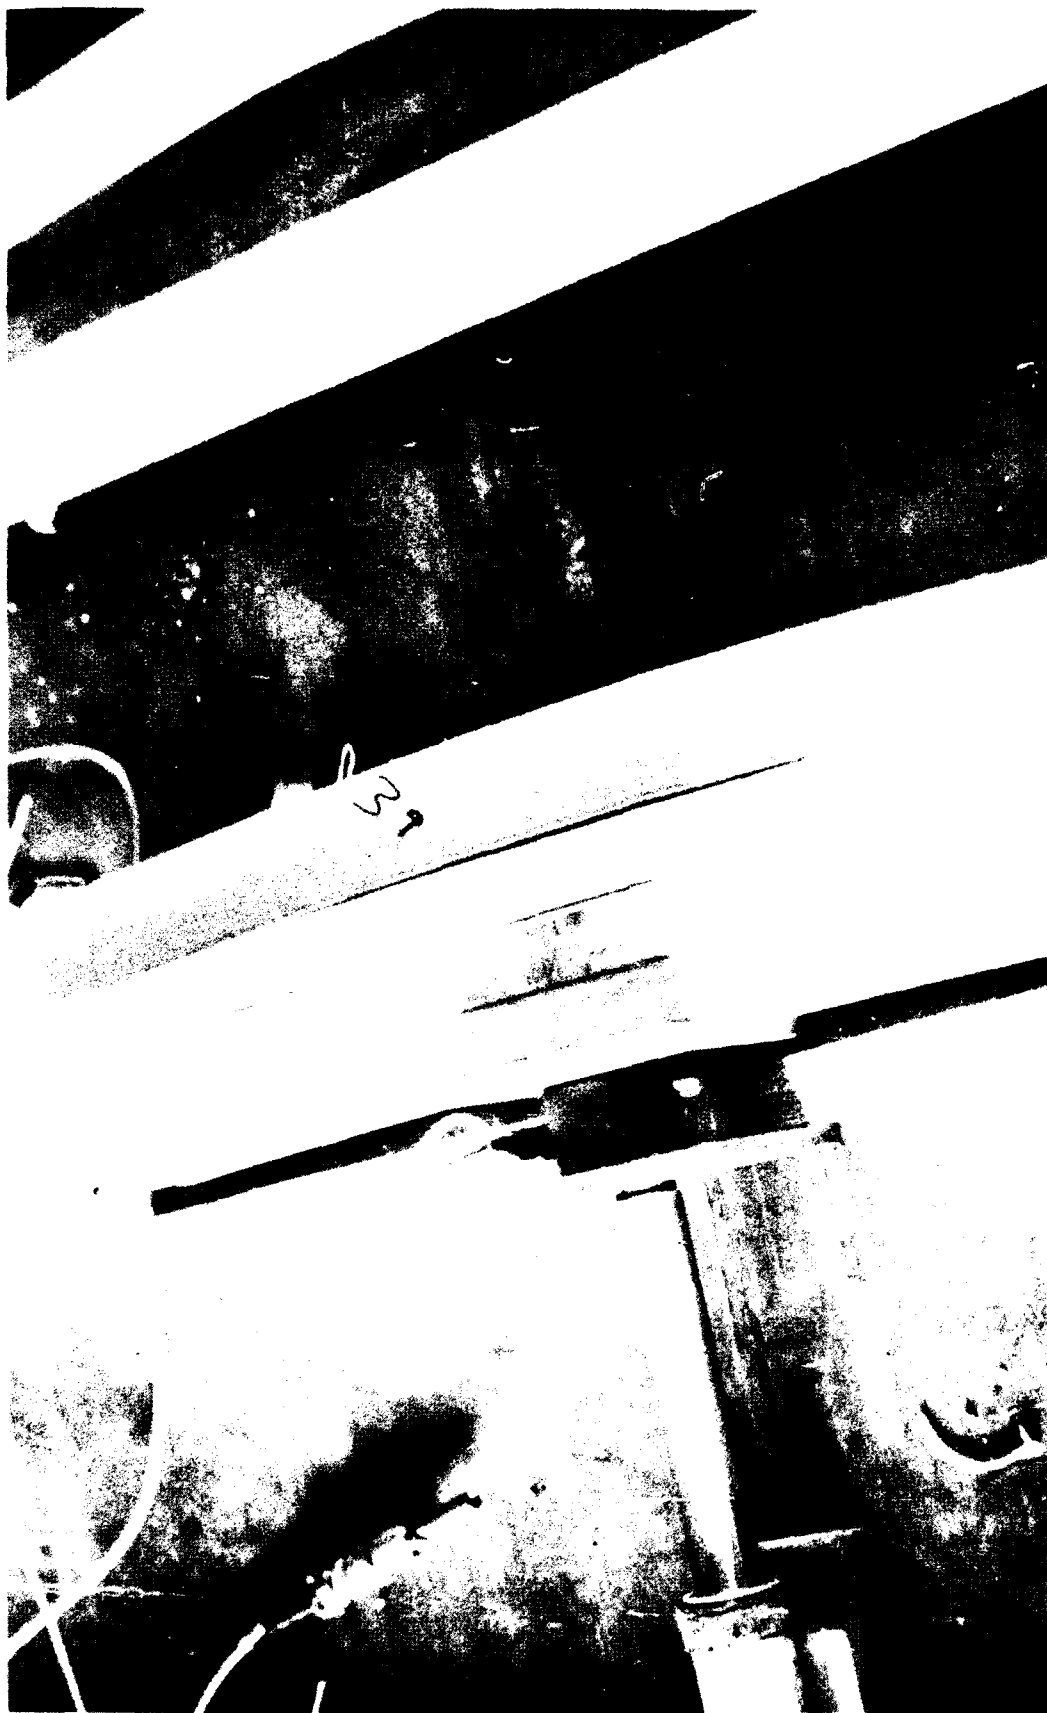
Photo No. SPN-90-229-3105: This photo shows an ANCRA International restraint beam, sample no. 39, after testing with a spread load. The spread load is modeled with the three 2-by 6-inch boards cut to approximately one-third the length of the beam. Failure occurred at the point where the beam ends in contact with the beam. Note bow at beam center. End points of the wooden beam act as pivots.

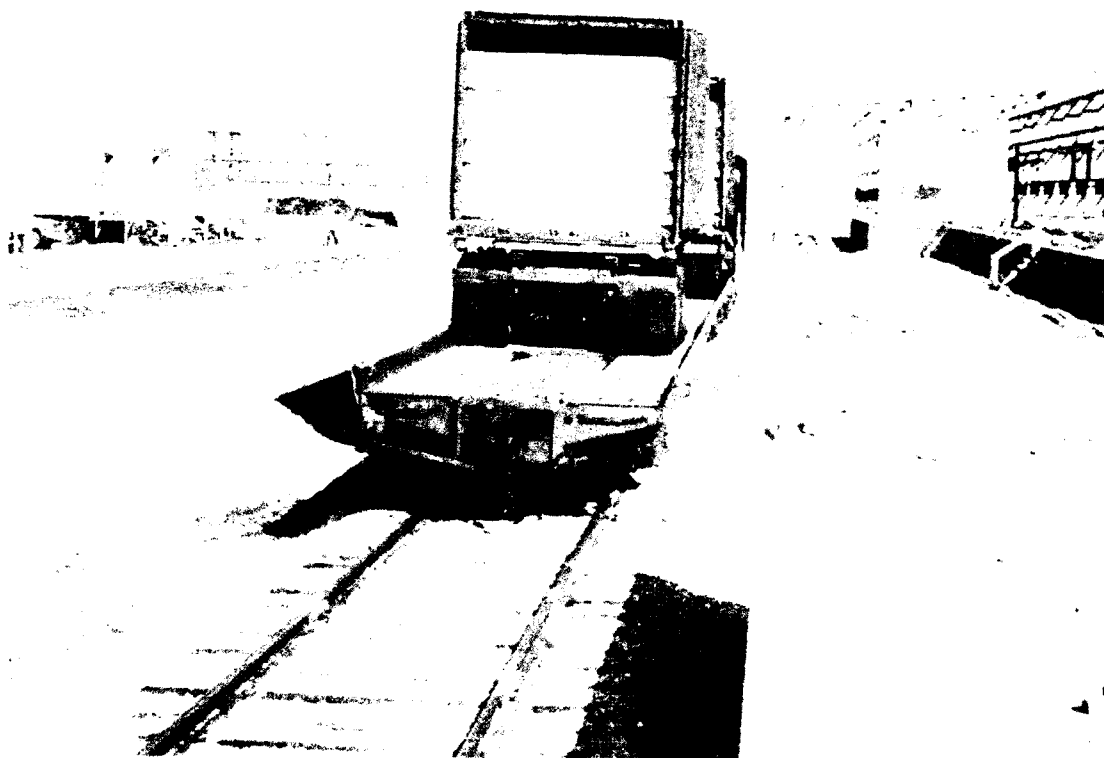
| <p>Photo No. A0317-SPN-90-230-3112. This photo shows two MILVANs loaded with inert 155MM ammunition being restrained by standard issue restraint beams and ANCRA International restraint beams. The TOFC is shown approaching the anvil cars.</p> |
