FINAL REPORT  
APRIL 1990

REPORT NO. EVT 17-90

COMPARISON OF STANDARD  
ISSUE AND ANCRA  
INTERNATIONAL MILVAN  
RESTRAINT BEAMS IN STATIC  
AND DYNAMIC ENVIRONMENTS

VALIDATION ENGINEERING DIVISION  
SAVANNA, ILLINOIS 61074-9639

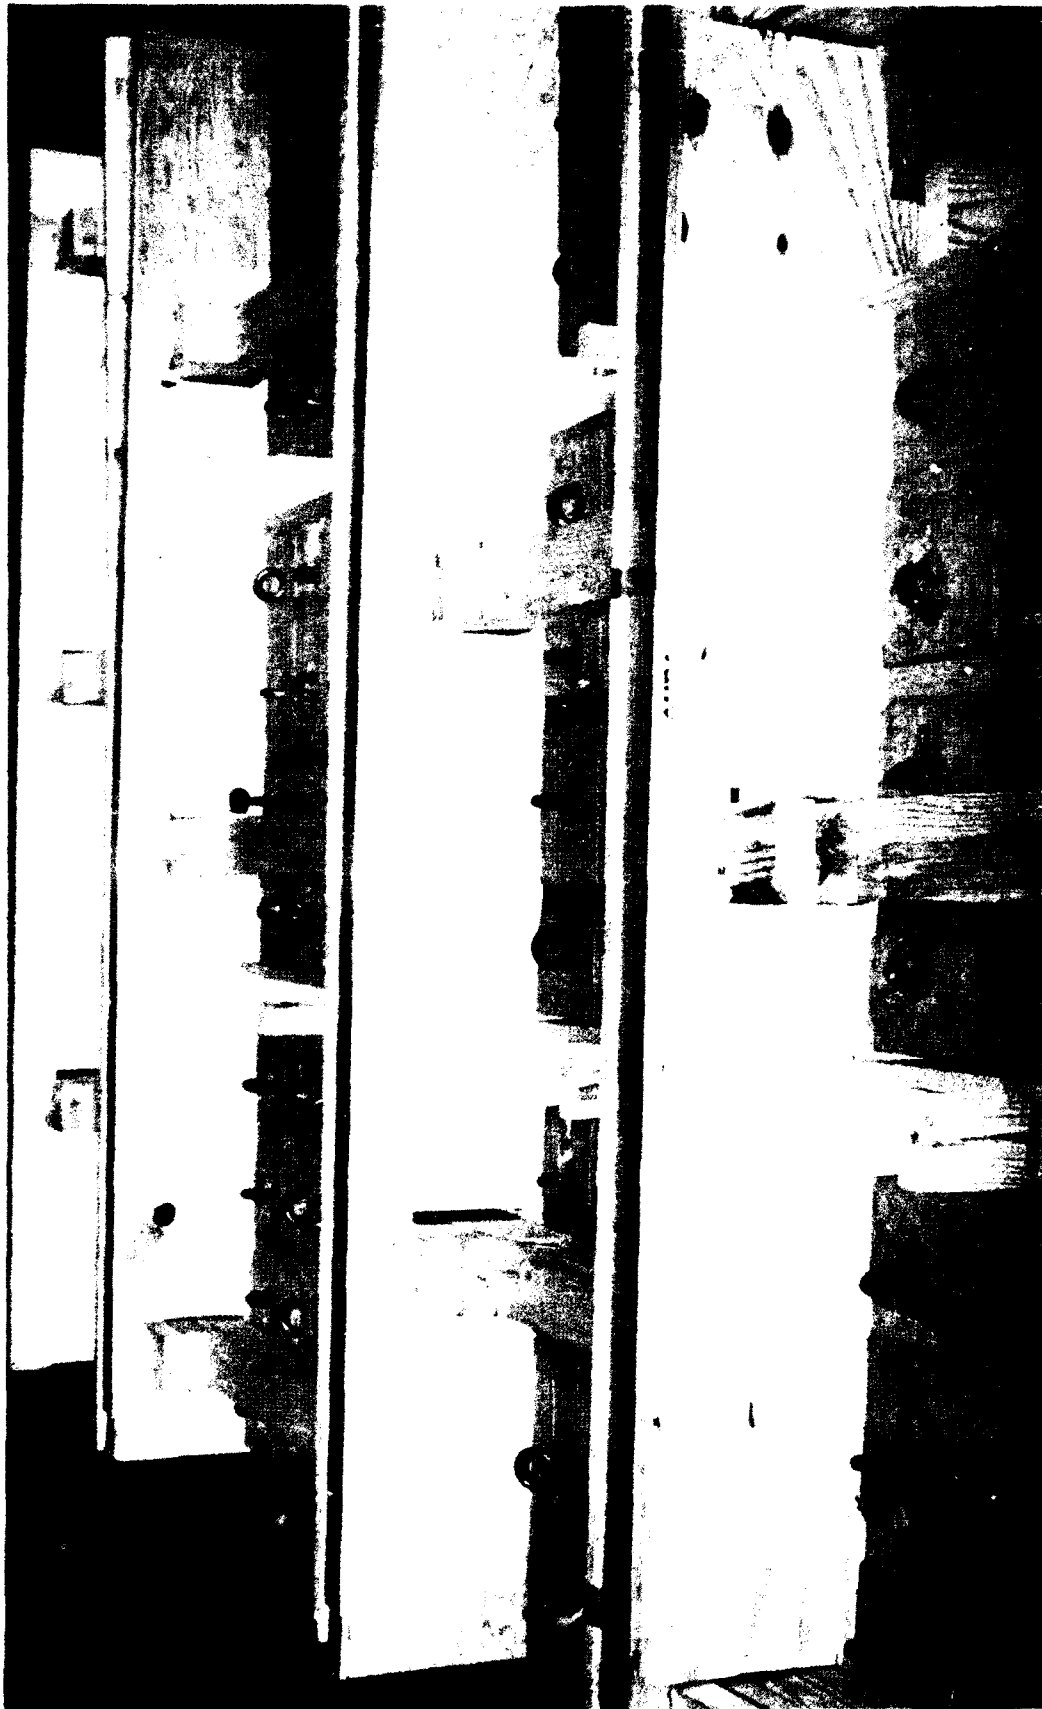
| Photo No. A0317-SPN-90-230-3092. This photo shows a MILVAN loaded with inert 155MM ammunition being restrained by ANCRA International beams after rail impact. Note the bow in the restraint beams as compared to the plywood fillers. |
