## HIGH TEMPERATURE HYDRAULIC SEALS

K. R. Williams  
McDonnell Douglas Aerospace  
Transport Aircraft  
3855 Lakewood Blvd  
Long Beach, CA 90846-0001

May 1993

Final Report for Period October 1987 - November 1992

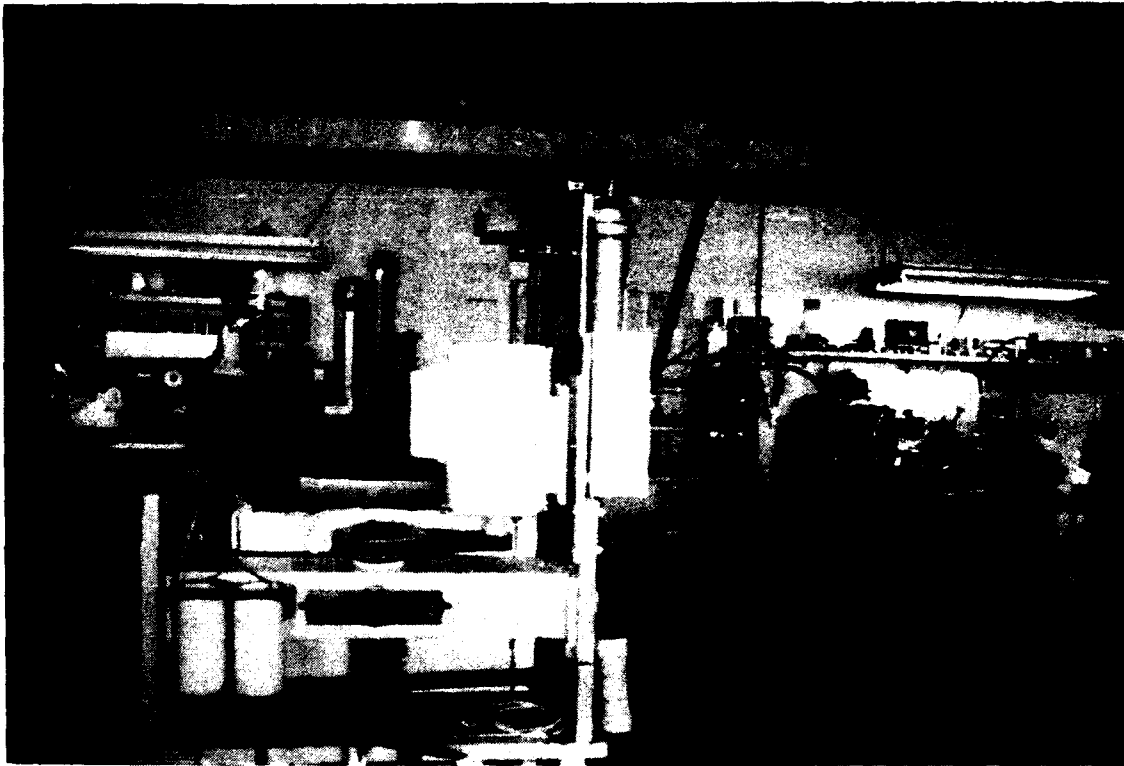
FIGURE 10 - VIEW OF PRE-SCREEN TEST FIXTURE

Figure 10 is a photograph of the test fixture. In this view the dither mechanism can be seen.

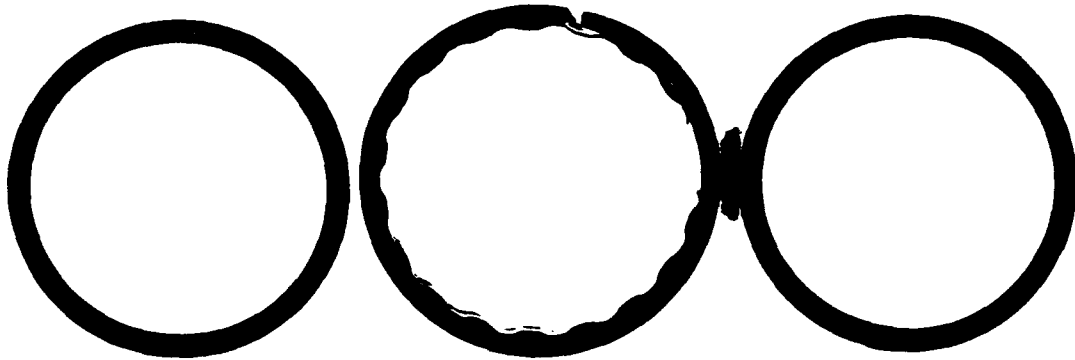
FIGURE 29 - FURON SPLIT PISTON RING ASSEMBLY  
PART NO. 60706-01048

No change in the seals or hardware occurred during the evaluation.
