DOT/FAA/RD-93/23

# Performance of Prefabricated Geocomposite Subdrainage System in an Airport Runway

Barry J. Dempsey  
Professor of Civil Engineering  
University of Illinois  
Urbana, Illinois 61801

Final Report

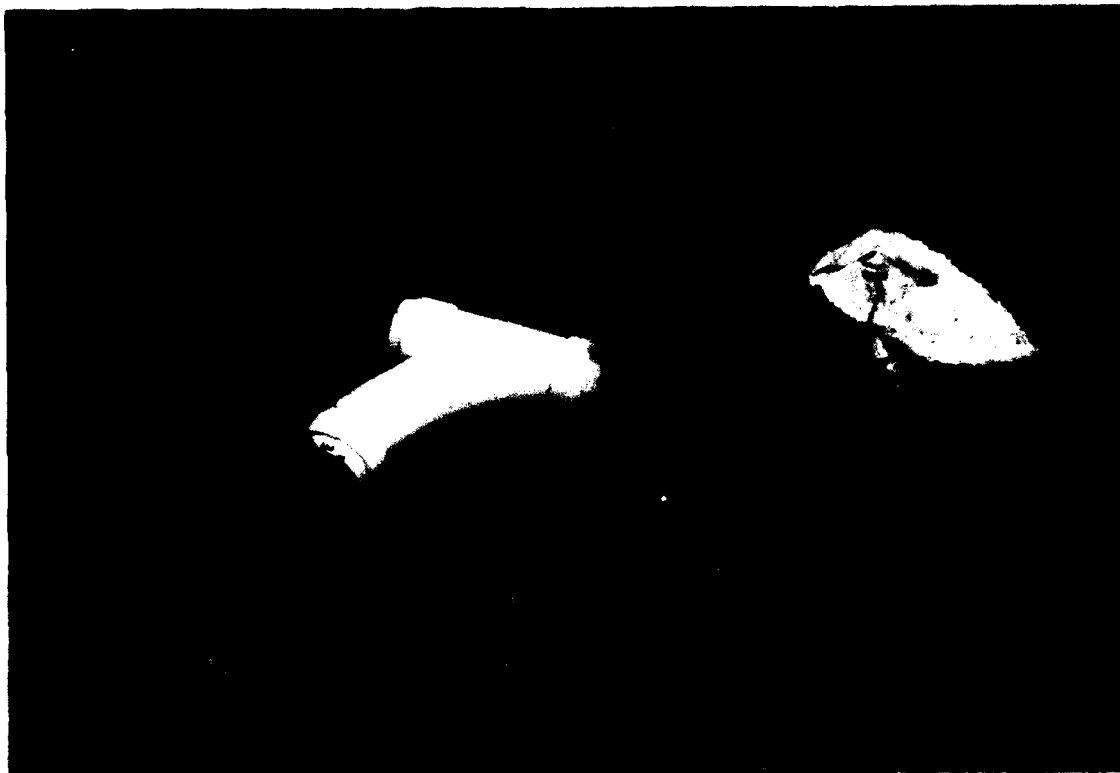
Figure 17. Method for Connecting Several PGS Systems Together.

Figures 17 and 18 show a method of using standard outlet fittings for interconnecting several GPS sections. It is important during construction to use the proper Tee outlets, end outlets, and end caps to insure that soils and materials cannot infiltrate through a hole into the GPS core. In most cases the Tee outlet and end outlet fittings are attached to a circular pipe which then carries water to a ditch or to a storm drain.

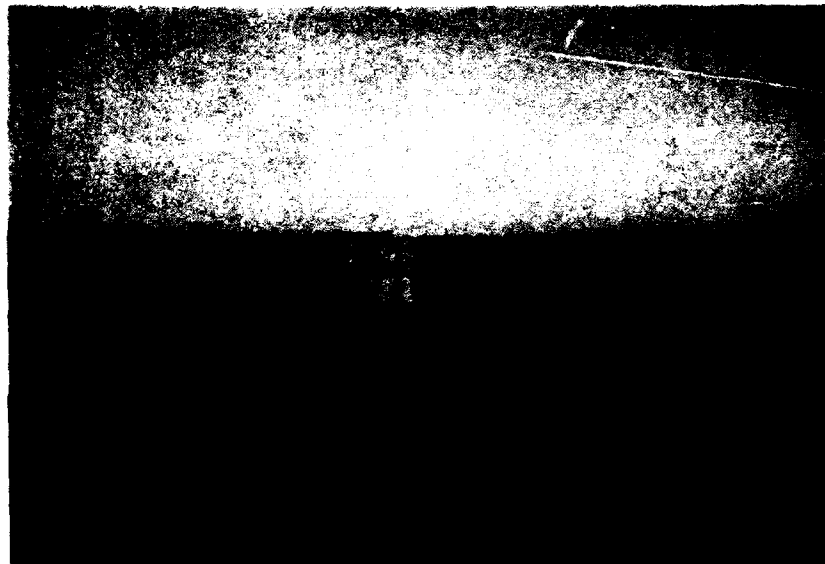
Figure 28. View Along Centerline of Runway 09-27  
(Note PGS Installation Joints Parallel  
to the Centerline).

asphalt concrete plug placed back into the 4 in. wide cut made to install the PGS system 12.5 ft on either side of the runway centerline. Figures 28 and 29 show the good condition of the asphalt concrete plug approximately three years after installation of the PGS system. It was felt that the in-runway installation of the PGS system did not create any safety hazards to aircraft operating on the runway pavement.
