**DOT/FAA/RD-93/40,1**

# **Synthetic Vision Technology Demonstration**

## **Executive Summary**

**December 1993**

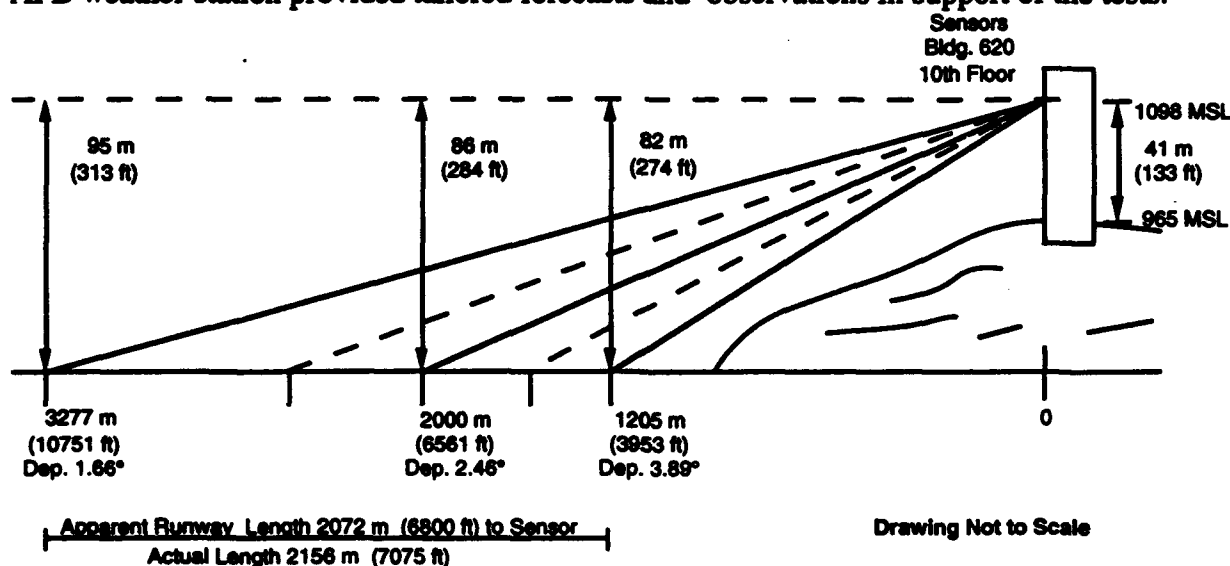
Figure 6. Elevation drawing of test area.

The scene dimensions, feature locations, and surface materials were surveyed to provide precise ground truth for comparison with sensor performance.

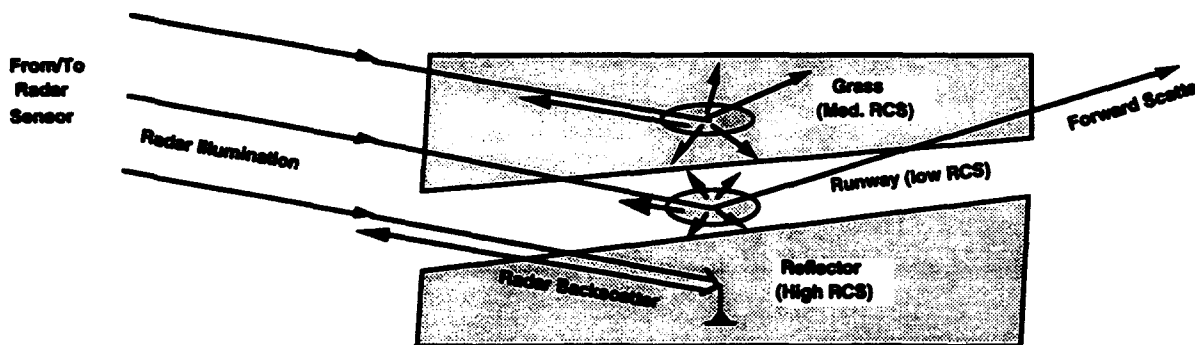
Figure 9. MMW radar detection of a runway.

A millimeter-wave (MMW) radar sensor exploits the differences in radar cross section between paved runway and bordering grass surface areas to image a runway scene, as shown in Figure 9. Radar cross section (RCS) is a measure of a target's ability to reflect radar waves. At the low incident angles encountered by an synthetic vision (SV) radar, most of the radar illumination energy is forward scattered from the smooth, low-RCS runway, and very little is backscattered to the radar receiver. The "rougher" grass areas have medium RCS and return a higher portion of the incident radar energy. A radar reflector is designed specifically to have high RCS and backscatters a large portion of the incident radar energy.

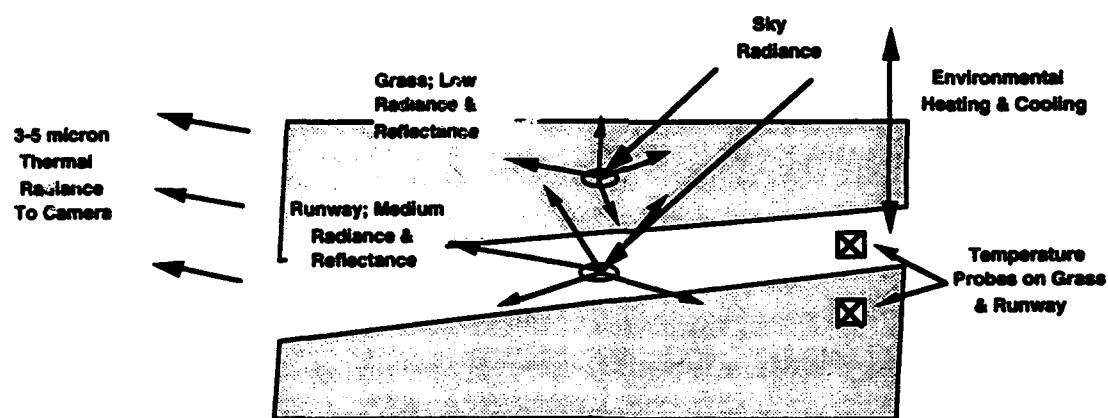
Figure 10. IR detection of a runway.

wavelength range accepted by an IR camera is based on the type of sensitive detector element used. Image contrast is developed by the differences in radiance received from the typically warmer pavement and the typically cooler grass areas within an airport scene. The actual radiance difference is a function of environmental heating and cooling during the daily cycle, grass moisture, and meteorological events.

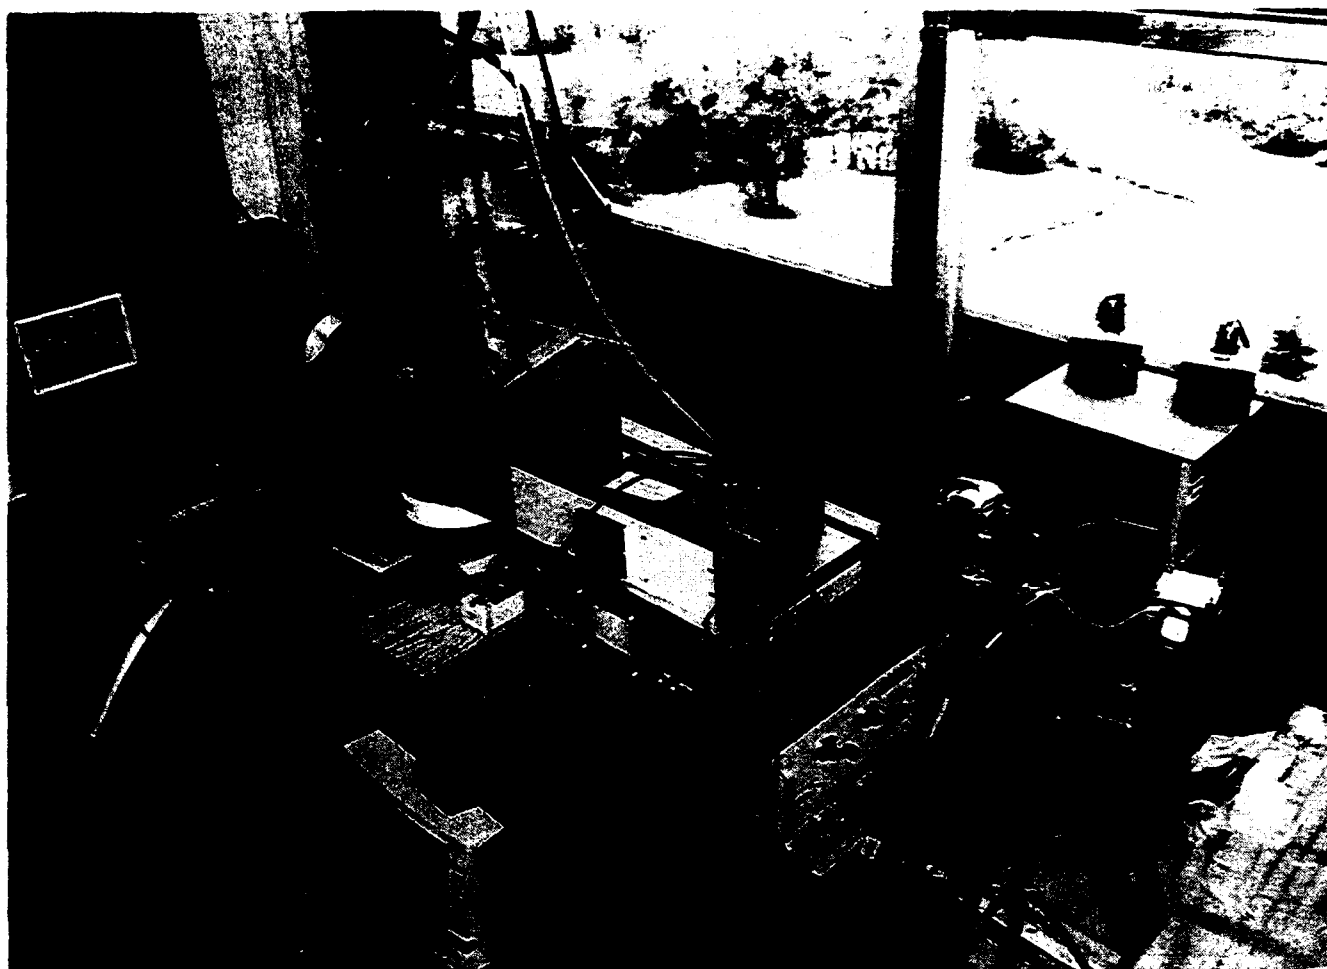
**Figure 11. Kodak 3-5 micron Sensor System Used In Tower Tests**

The IR sensor systems used in the SVTD program to collect data in the 3 to 5 micron infrared band were focal plane array cameras with Stirling-cycle refrigeration for sensor cooling. Most of the infrared image data were collected with the Kodak Model KIR-310 infrared camera system, shown in Figure 11 as it was installed in the tower test facility. Image data were also acquired with a Mitsubishi Electric Corporation model IR-5120C infrared camera. Both of these instruments utilized platinum-silicide (PtSi) focal plane array sensors and provided the image data in an RS-170 video signal format. Important characteristics of the two camera systems are listed in Table 2.

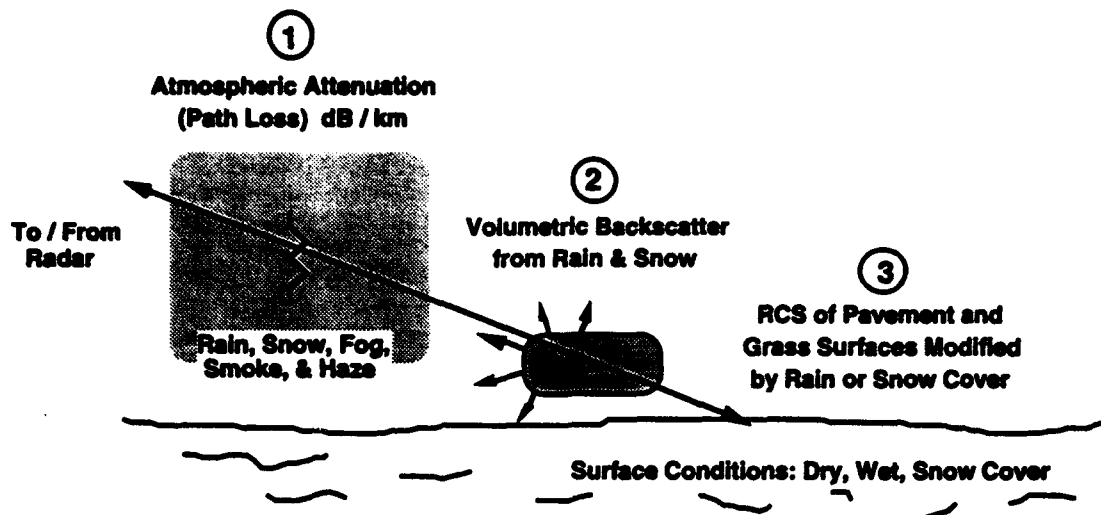
**Figure 12. Meteorological effects on MMW radar sensors.**

Conditions in the intervening atmosphere between a MMW radar and a target can degrade the radar's ability to detect and image that target, as shown in Figure 12. Airborne moisture due to fog and precipitation (rain, sleet, or snow) causes scattering and diffusion of the radar's electromagnetic waves. Atmospheric effects are separated into attenuation and volumetric backscatter.

Attenuation is the loss of apparent target RCS due to the intervening atmosphere. Atmospheric attenuation applies over the entire radar propagation path, from the radar to the target and back to the radar, or twice the target slant range for a monostatic radar (i.e., one with the transmitter and receiver collocated). Attenuation reduces the range at which a radar can resolve runways from bordering grass areas, due to a reduction in apparent grass clutter RCS and runway clutter RCS.

Volumetric reflectivity is the RCS of airborne particles within the radar beam per unit volume. MMW volumetric reflectivity is very low for fog, is relatively low for snow, but can be significant for rain.

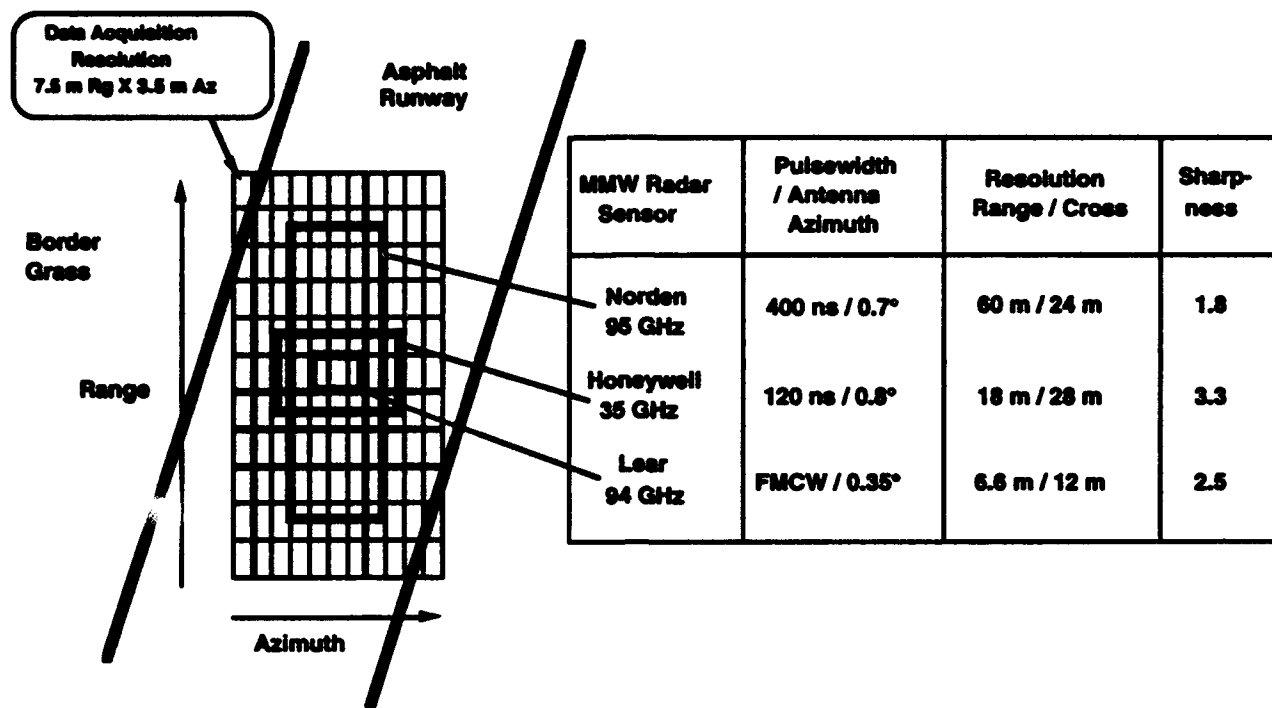
**Figure 14. MMW sensor resolution of runway at 2 km range.**

Analysis of the performance of the MMW sensors in clear weather established a performance baseline against which the effects of weather could be determined. Baseline measurements also allow comparisons of perceived image quality to the operating parameters of these particular radar sensors. Figure 14 shows how the radar resolution cell sizes at 2 km range compare with the width of the runway at the tower test scene. The radar resolution cell dimensions, downrange and cross-range, are defined by the range and azimuth resolution of the radar sensor, respectively. The fine grid overlay represents the sampling resolution of the data acquisition system (DAS), which in every case exceeded the sensor resolution. DAS oversampling gave a constant data set resolution independent of the MMW sensor under test and provided additional sample points for averaging.

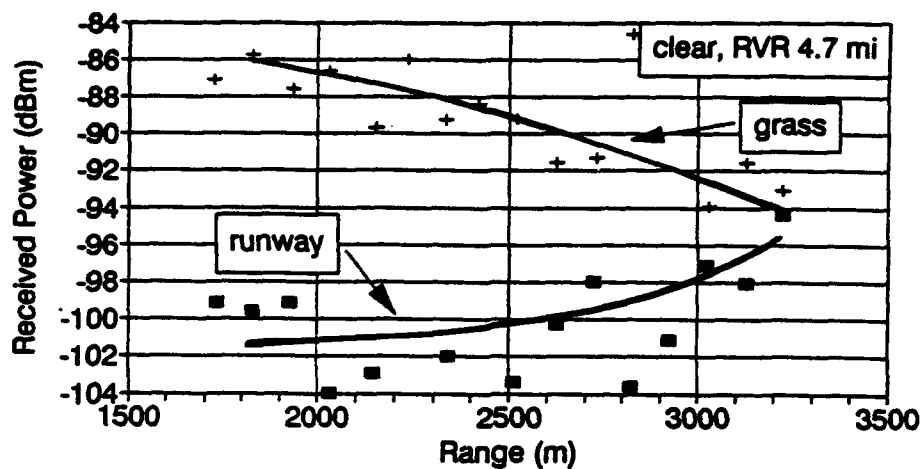
Figure 15a. 35 GHz Downrange Power Profile

Downrange profiles of equivalent received power are a good method of rating a MMW radar sensor's ability to discriminate the runway from the bordering grass areas. As described in Volume 2 (Sensor Tower Testing) of this report, a series of patch areas were defined along the runway and grass for data processing purposes. A downrange power profile plot presents the equivalent received power values from the patches spaced along the grass and runway between 1,700 m and 3,300 m range. Figure 15a is a downrange power profile for the 35 GHz radar, and Figure 15b is the same profile for the Norden 95 GHz radar sensor. Figure 16 is a similar profile for the Lear Astronics 94 GHz radar sensor. Curves have been fit to the points from the grass patches (plus signs) and the runway patches (solid squares). The difference in received power between the grass patches and the runway patches provided by the radar sensor is converted by the signal processor into image contrast. This power difference decreases with range and in weather, reducing the resulting image contrast and the detectability of the runway.

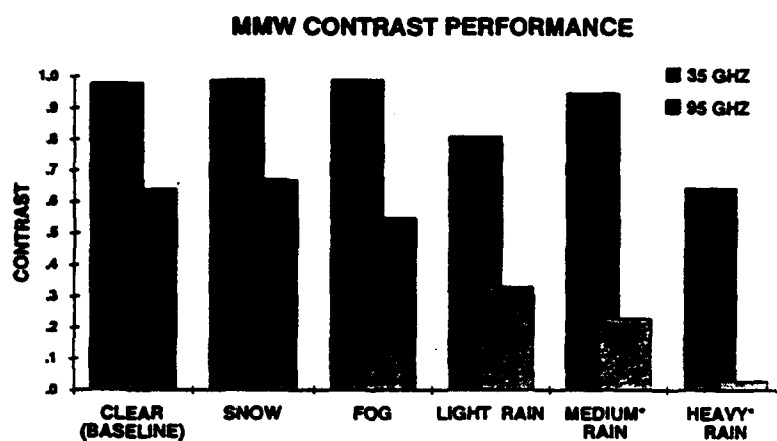
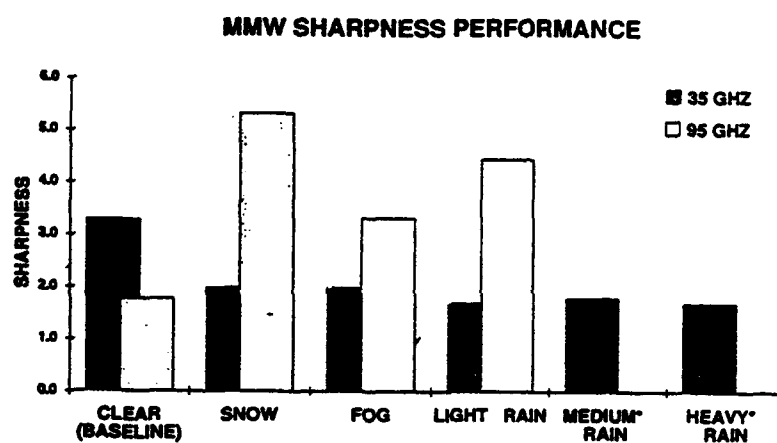
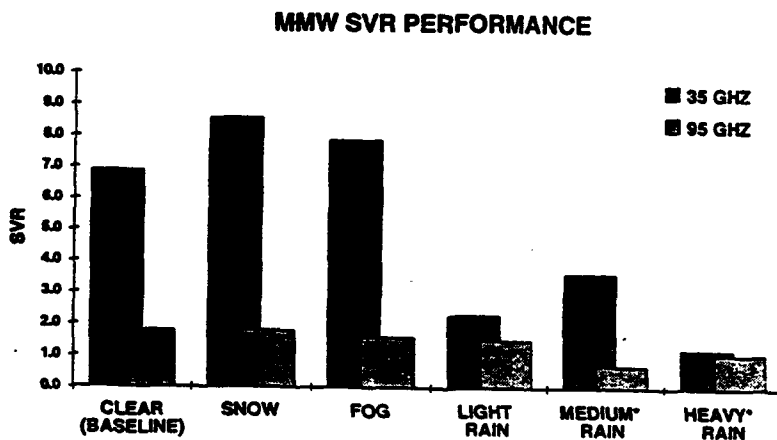
**Figure 17. MMW Sensor Performance at 2 km in Clear Air, Fog, Snow, and Rain**

Results for the Honeywell 35 GHz and Norden 95 GHz radar sensors are summarized in Figure 17 for the three performance categories of contrast, signal-to-variability ratio (SVR), and sharpness. 35 GHz and 95 GHz performance categories are graphed side-by-side for the six weather conditions of clear, medium snow, light fog, very light rain, light rain, and medium rain. These performance values are for runway and grass at 2 km range. The heights of the bars, or relative performance factors, have been normalized to the maximum value measured by these two sensors. No sharpness values could be extracted from the 95 GHz data for the higher rain rates.

The relative performance advantage of this 35 GHz sensor over the 95 GHz sensor in clear weather is due to the design parameters of these particular radars and not due to any fundamental limitations of the 95 GHz frequency band for runway imaging. The degradation in performance with increasing precipitation for each MMW sensor, relative to its own clear weather performance, does reflect the greater impact of precipitation at 95 GHz.

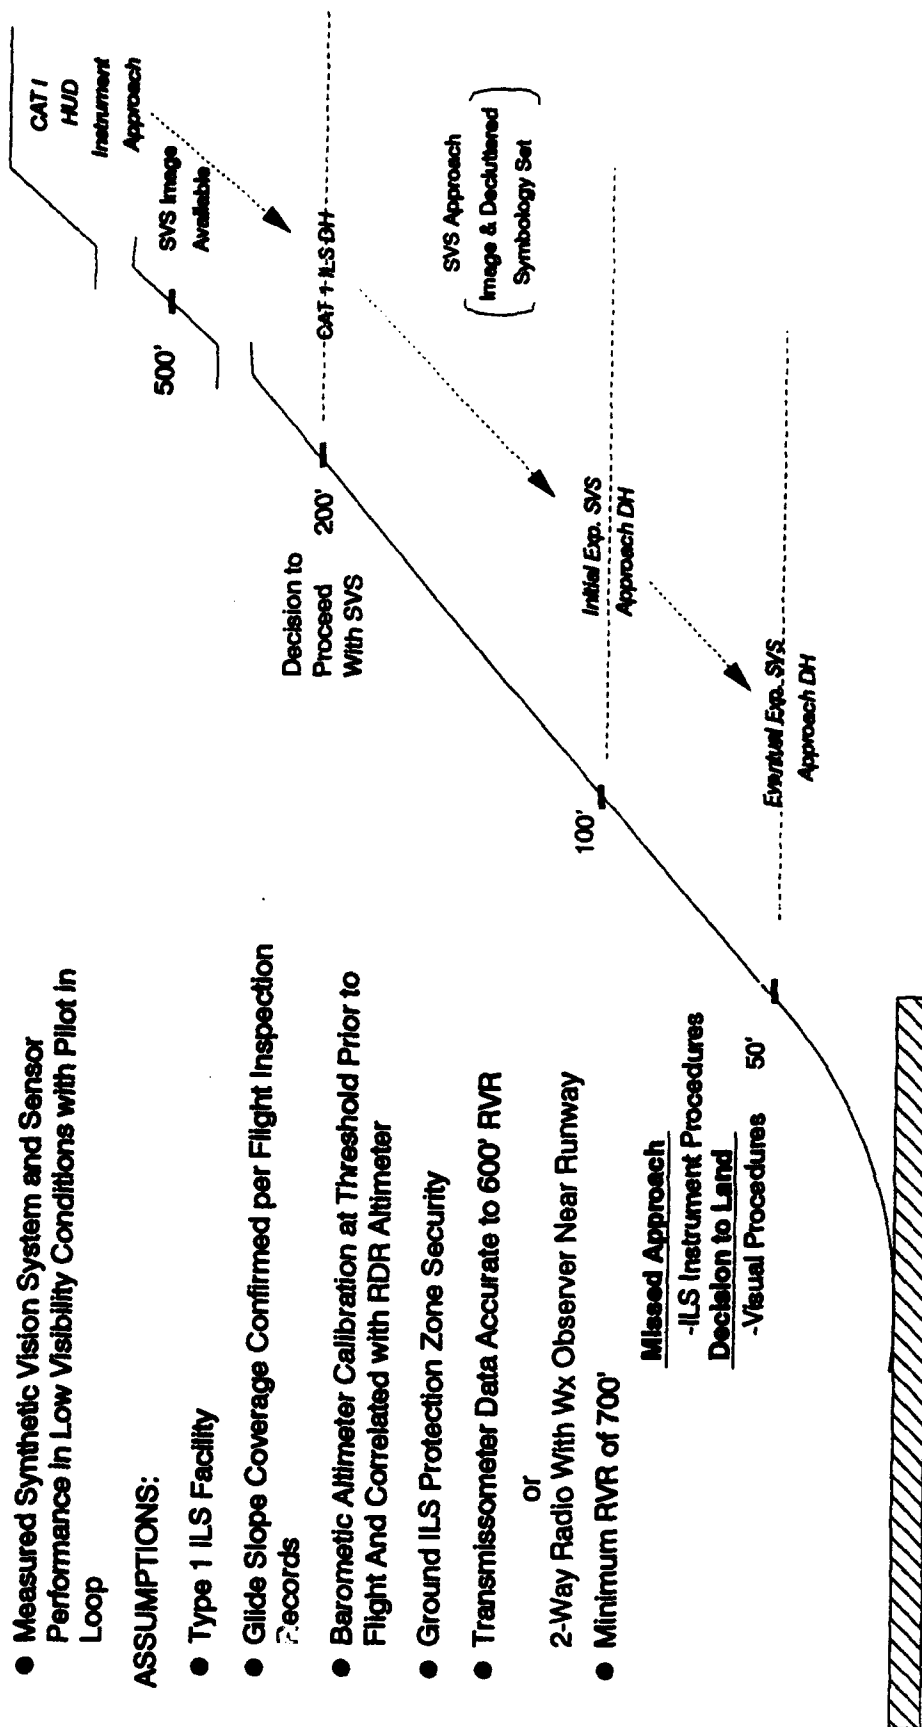
Figure 18. Flight Test Methodology

- ILS Instrument Procedures
- Decision to Land
- Visual Procedures

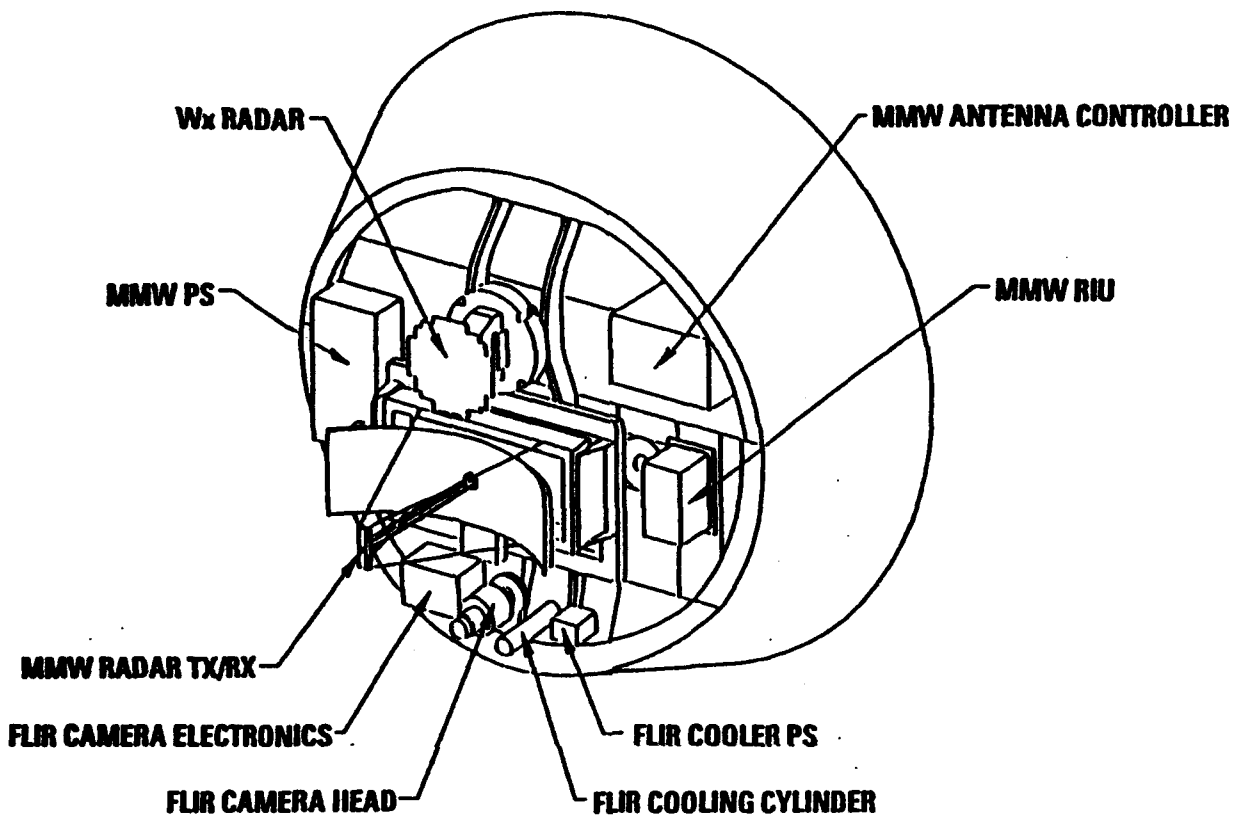
**Figure 20. 94 GHz Sensor Installation in Test Aircraft**

An image processor performed the trigonometric conversion from range-azimuth to elevation-azimuth to produce the conformal image. Conformality was also maintained during platform motion. Platform altitude, pitch, and roll were required by the processor to perform the conversion and stabilization.

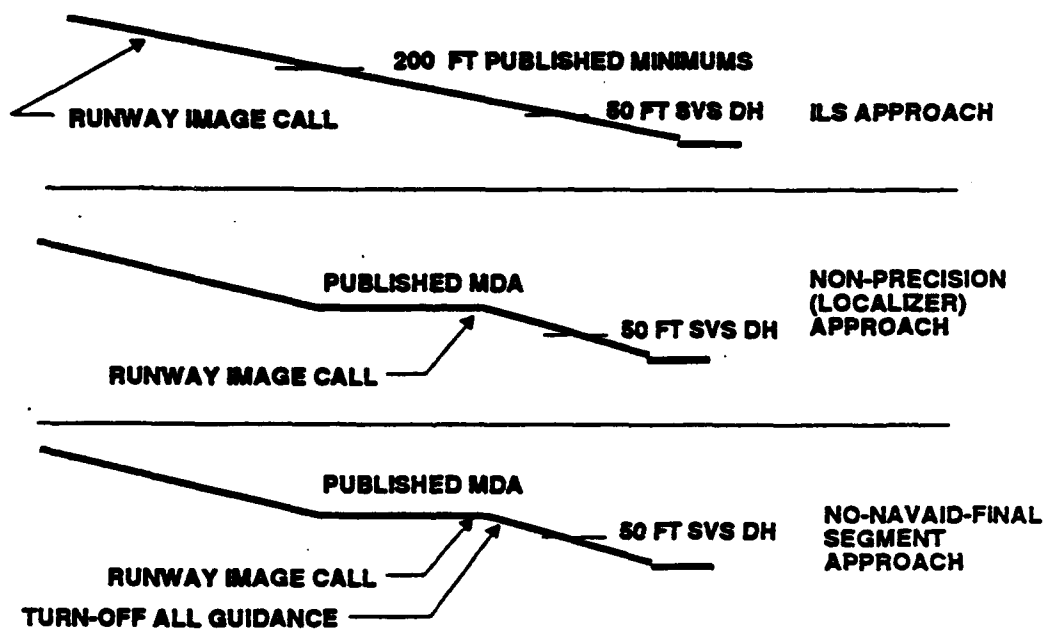
**Figure 25. Approach Procedures Used in Flight Test Program**

vertical speed hold for non-precision approaches, and the raw-data glideslope information was not displayed on the HUD. The no-navaid-final-segment approach was conducted in an identical fashion to the localizer approach except that the test director detuned the ILS localizer frequency after hearing the pilot call "runway image". This required the evaluation pilot to rely only on the HUD image and symbology (without flight director or ILS guidance) for guidance. The safety pilot always had full ILS glideslope and localizer information on his displays. For most simulated IMC approaches the cardboard shield was in place in front of the HUD down to an altitude of 50 feet. A few ILS approaches were conducted to Cat IIIc (0/0) minimums, and a few were conducted to Cat II (100 ft DH) minimums.

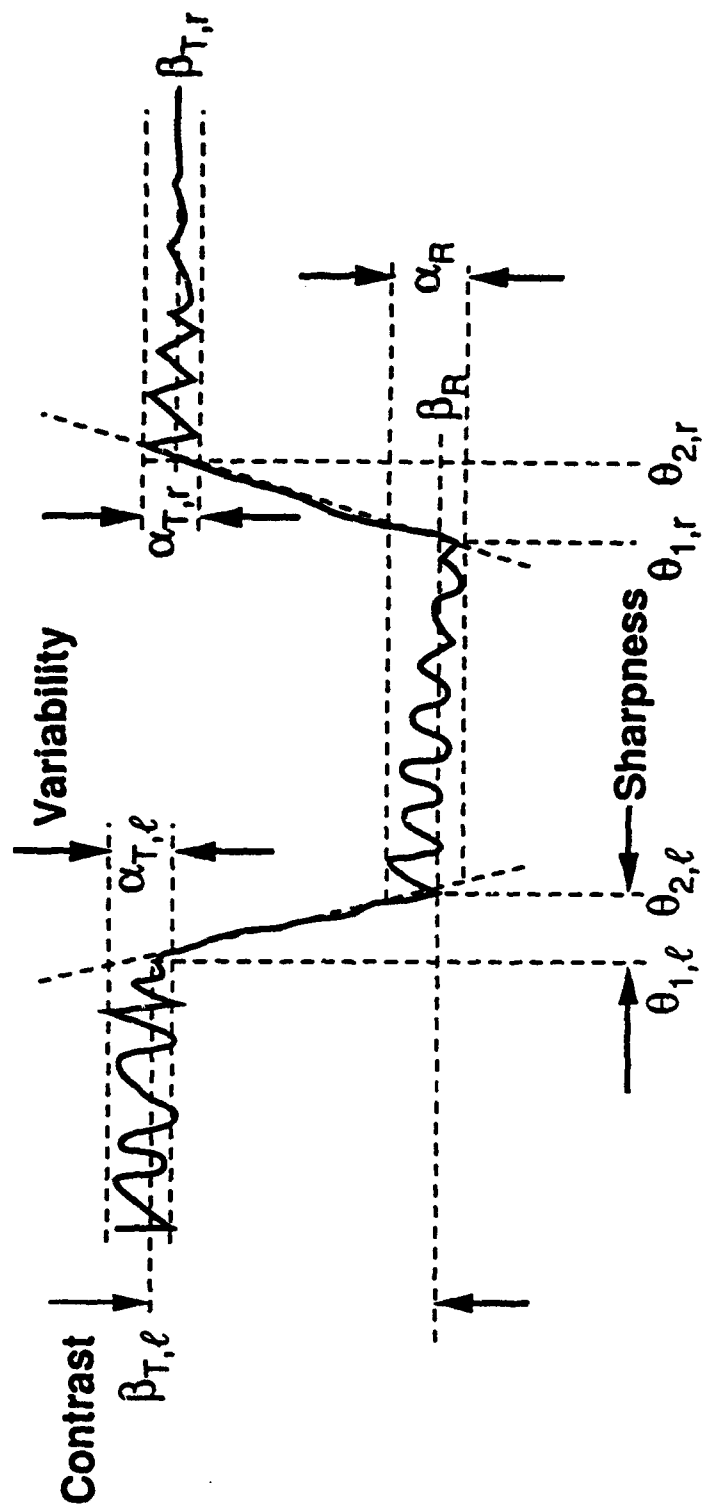
Figure 28. Illustration of Simple Gutter Plot with Basic Image Quality Metrics Indicated

Three parameters can be defined using the gutter plot which it was felt might be useful in characterizing how well the runway can be distinguished from the surrounding terrain. Contrast is a function of the average signal level received from the runway relative to that received from the surrounding terrain.

Intuitively from Figure 28, the contrast improves as the terrain brightness becomes increasingly larger than the runway brightness.

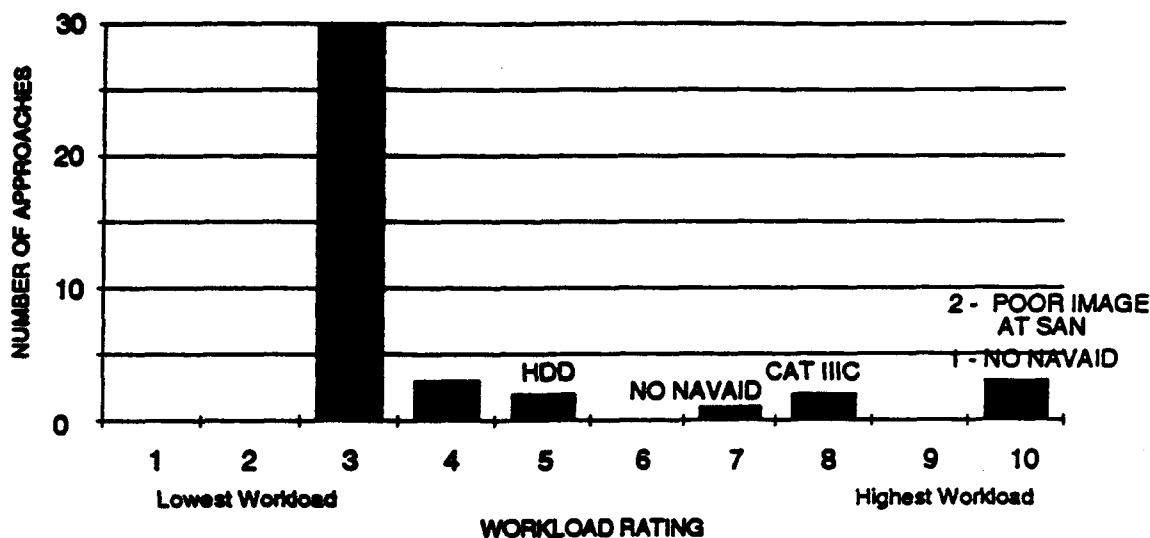
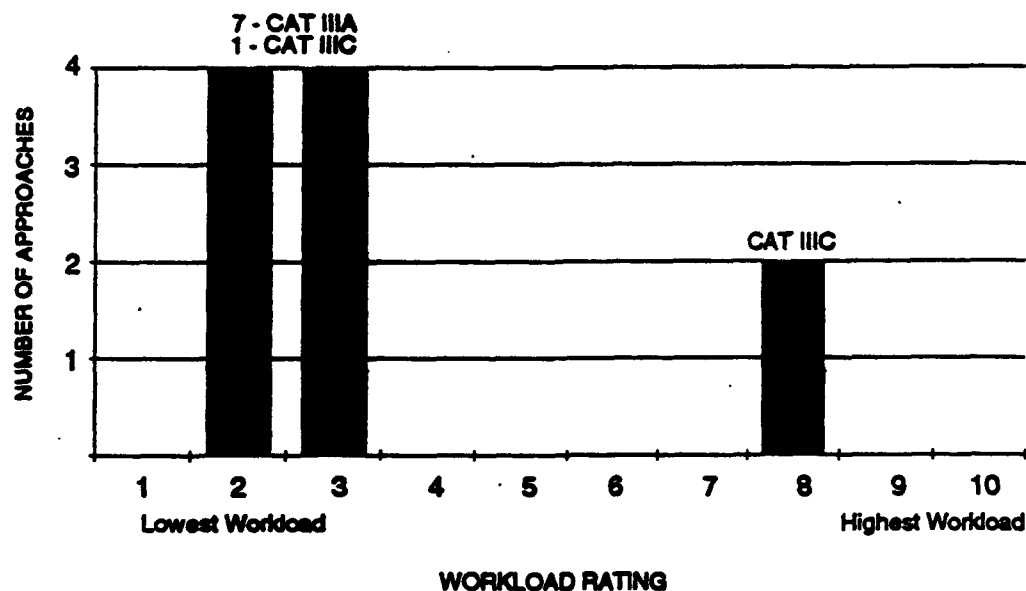
**Figure 35. Frequency Distribution of Pilot Workload Rating Data for Simulated CAT IIIa and CAT IIIC Approaches**

The frequency distributions of the subjective workload ratings for approaches and landing flares to simulated Cat IIIa and Cat IIIc conditions are shown in Figure 35. This data indicates that the majority of the ratings were 3 (ie., satisfactory without improvement). This should not be construed to imply that the experimental SVS was acceptable as a certified system, but rather that it was acceptable for specific approaches under the specified test conditions; in this case simulated IMC. IMC was simulated by placing a cardboard shield in front of the HUD, and removing the shield at the appropriate time, e.g., 50 feet for simulated Cat IIIa. The cases rated as 4 or worse provide valuable insight into potential problems with an operational SVS and were investigated to the extent that resources permitted.

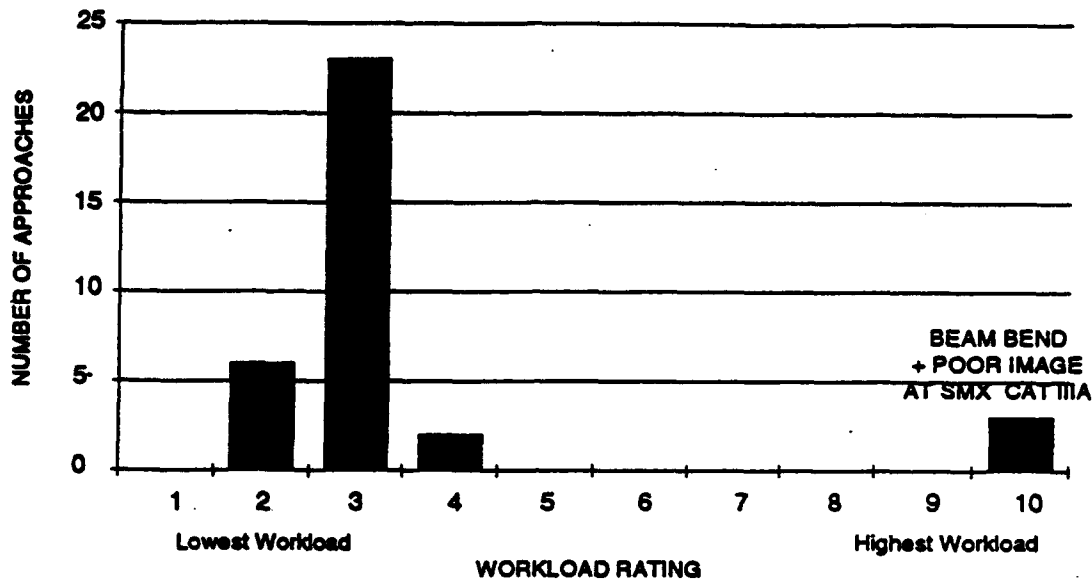
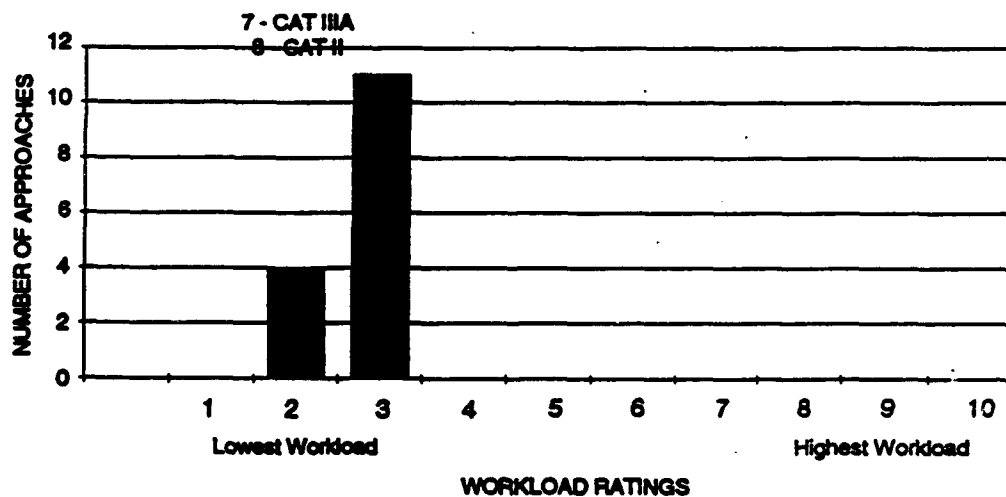
**Figure 36. Frequency Distribution of Pilot Workload Rating Data for Actual Cat II and Cat IIIa Approaches**

A frequency distribution of the pilot subjective workload ratings for approaches and landing flares in conditions below Cat I minimums is shown in Figure 36. Twenty-nine of the approaches received ratings of 2 and 3, two approaches were assigned a 4, and three approaches were rated 10.
