# Metallurgical Examination of M61A1 Breech Bolt Assembly Components

ARL-TR-684

February 1995

The Naval Air Warfare Center (NAWC) requested the Army Research Laboratory (ARL) to perform a metallurgical investigation on 20mm M61A1 Gatling gun system breech bolt assembly components. An unused breech bolt assembly, and an individual locking block (a component of the breech bolt assembly) were both examined. Each part was taken from inventory at NAWCAD, Patuxent River. The Navy had experienced numerous failures of this system in practice gun mount testing and in service. Failures have coincided with the use of a recently developed more potent replacement for the 20mm M50 Series ammunition. This new ammunition is designated as 20mm PGU Series ammunition. The investigation performed by ARL concentrated on determining the conformance of each component to the governing specifications. The examination included high-voltage testing, visual examination, surface finish measurement, dimensional analysis, magnetic particle inspection, metallography, mechanical testing, chemical analysis, and coating measurements. Findings included a nonconforming surface finish upon the individual locking blo

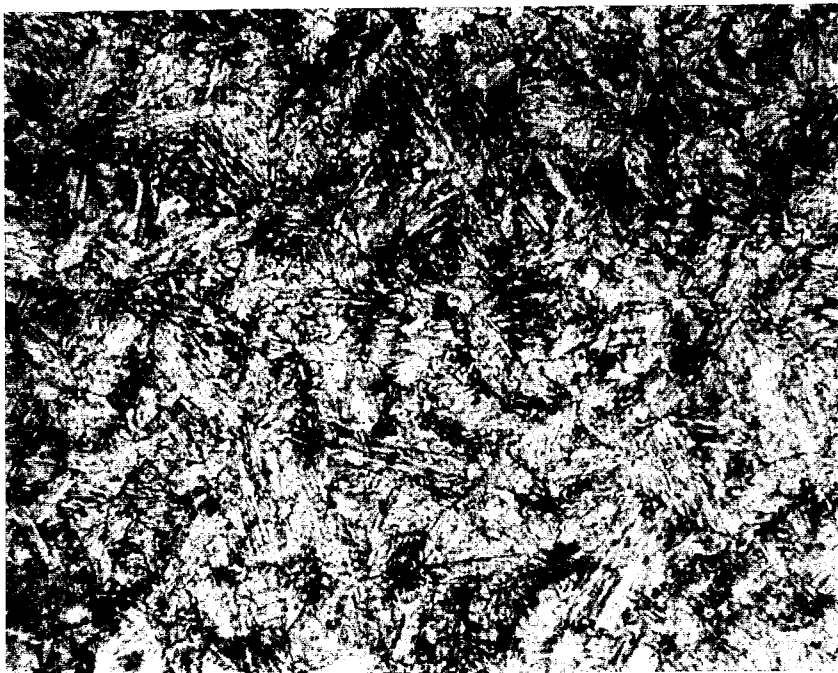
The sectioned and mounted portion of the firing pin was subsequently etched with 4% nital, in order to reveal the microstructure. The structure consisted of aged low-carbon martensite, as shown in Figure 23. This structure was consistent with the prior heat treatment (solution-anneal, age, air cool). Section 3.6.3 of MIL-S-46850 states that for Grade 300, Type III material, *the grain size shall be predominantly six or finer with grains as large as four permissible in accordance with the applicable ASTM E 112 chart.* The 100x micrograph of Figure 24 shows the grain size to be between seven and eight, in conformance to the governing specification. No internal or surface defects were noted within the microstructure.

FIGURE 23 Firing pin microstructure (Maraging, Grade 300) consisting of low carbon martensite, consistent with prior heat treatment. Fry's reagent. Mag. 300x.

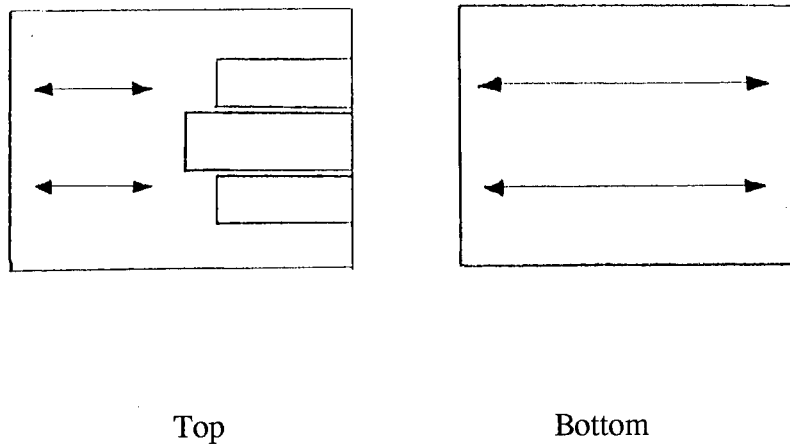
The surface roughness of the locking block was measured with the Mitutoyo Surftest 401 Analyzer. Readings were taken across the top and bottom of the part (see schematic in Figure 32). These were the regions of the component which exhibited machining marks, although not as severe as the machining marks noted on the locking block shipped separately (Figures 33 and 34). The required average surface roughness of the top and bottom of this component was 125  $\mu\text{in}$  RMS (Eng. Dwg. 11691480). The top surface registered an average of 58.4  $\mu\text{in}$

FIGURE 32 A schematic showing directions of surface finish measurement on the locking block.
