**LIFE EXTENSION OF AGING
MACHINERY AND STRUCTURES**

**Proceedings of the 49th Meeting
of the
Society for Machinery Failure Prevention
Technology**

**Virginia Beach, Virginia
April 18-20, 1995**

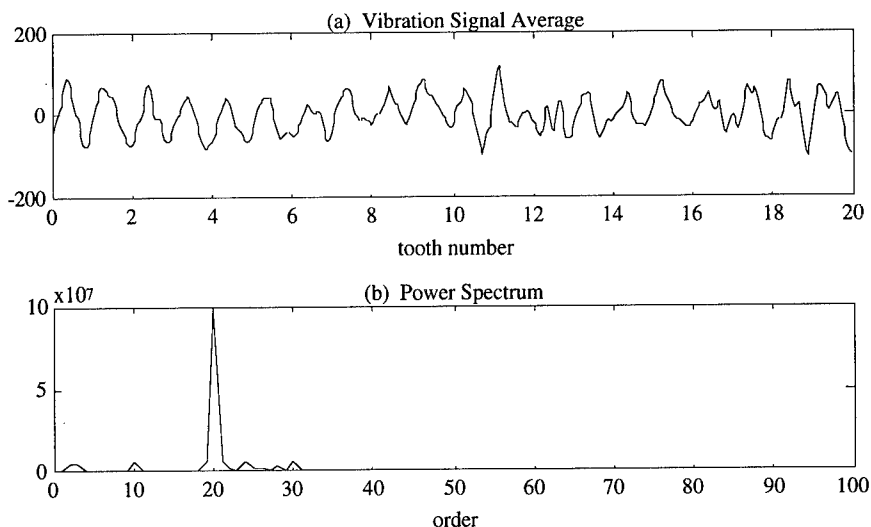
Fig. 1 Vibration signal average and its spectrum

The detection of defects at a very early stage usually requires sophisticated signal detection and processing techniques to enhance the defect information contained in the signal average. Considering the modulation nature of defect related vibration, a number of gear defect detection techniques use amplitude modulation and/or phase modulation as defect signature. In general, methods looking into modulations are most sensitive to gear localized defects. In the following, the modulation phenomenon in gear vibration is examined and modeled. Then, energy operator is introduced to track modulation energy. Its effectiveness in gear localized defect detection is examined and compared to other demodulation schemes, using measured vibration average shown in Fig. 1.

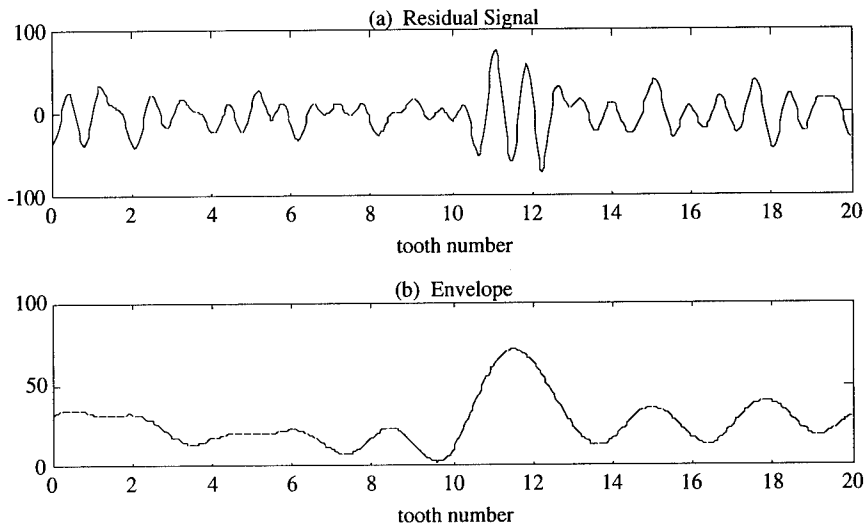
Fig. 4 shows the residual signal and its envelope. The defect on tooth 11 is obviously detectable using either of them, indicated by the singular high level around tooth 11 in the residual signal and its envelope as well. However, it is quite ambiguous whether there is a defect on tooth 18 as both signals appeared at tooth 18 in a similar fashion as at neighboring teeth.

Fig. 4 Residual signal and its envelop

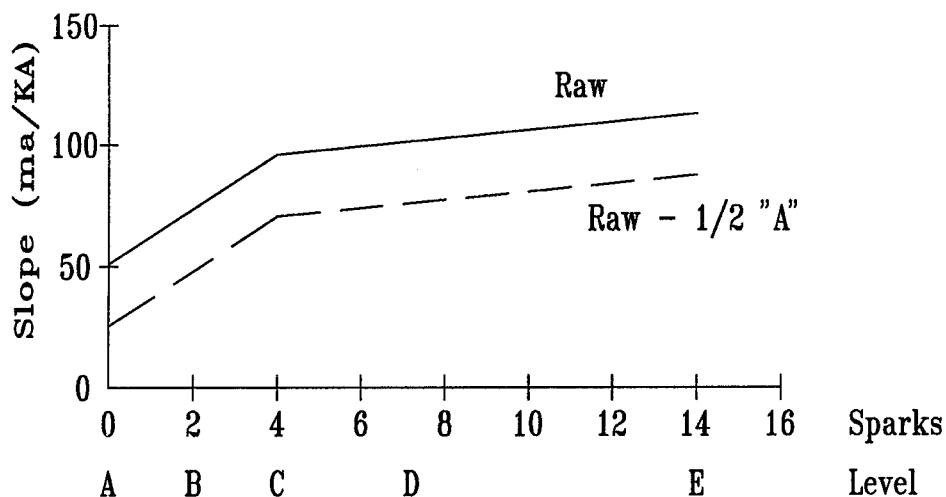
Figure 7. Slope of Bar-passing current vs. Dc current as a function of spark level.

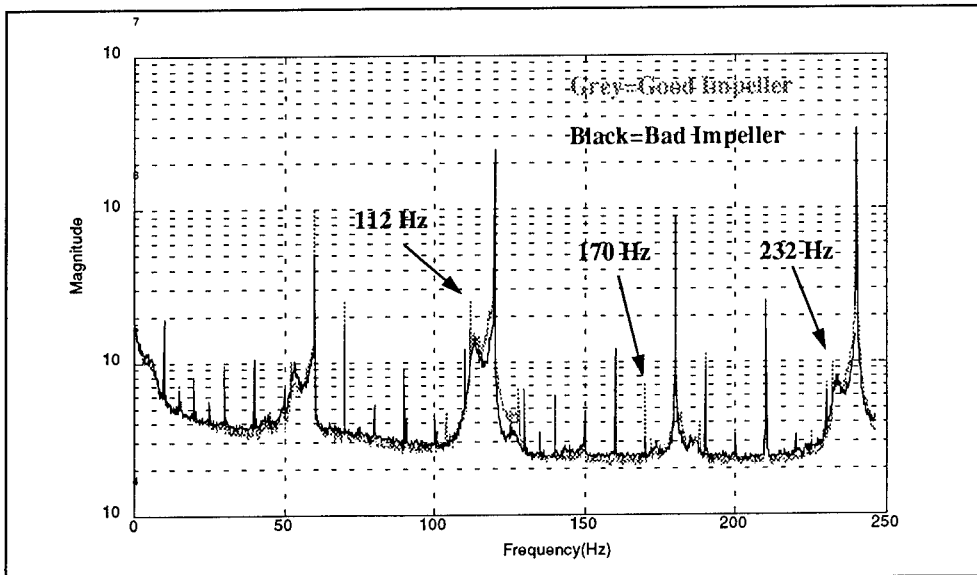
Figure 2- AM demodulated templates from good and bad impeller signals.

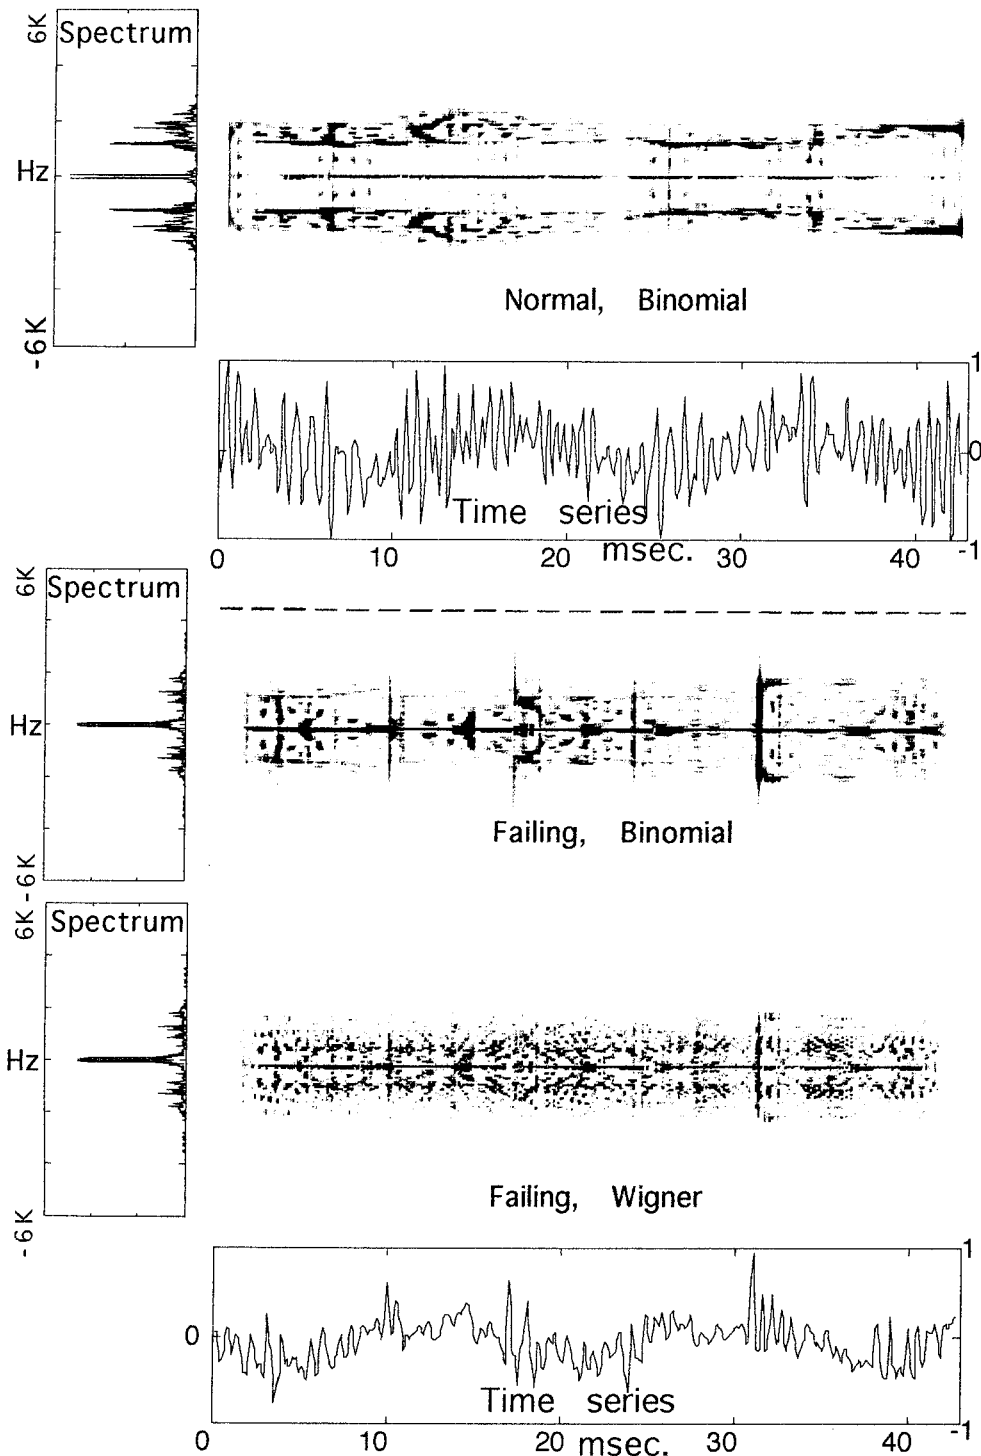
Figure 2. A comparison of a normal bearing and failing bearing using the Binomial and Wigner distributions.

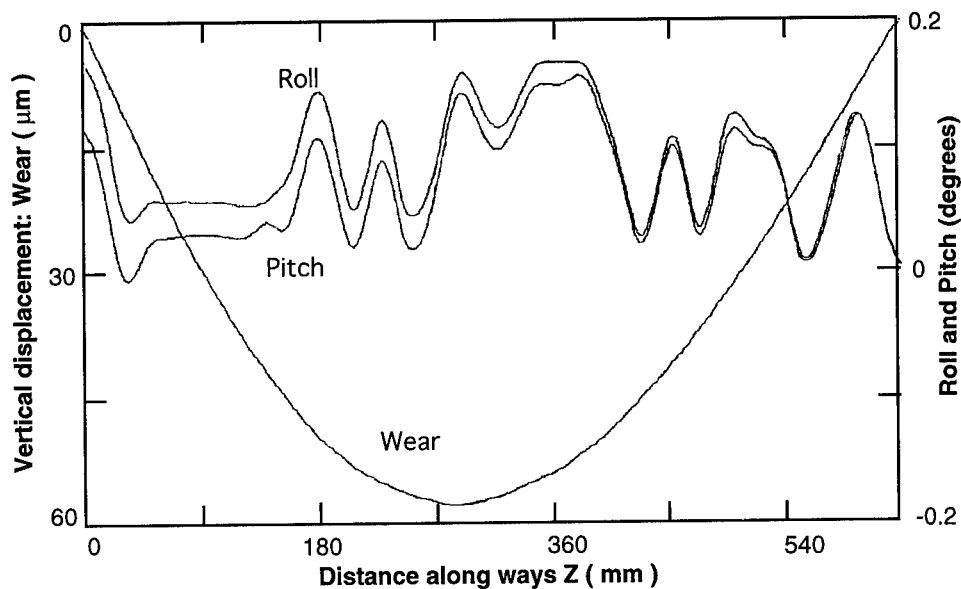
Figure 2: Wear (μm) versus distance z (mm) along the ways of an aged lathe. The concave curve is the worn profile; the two other traces represent tool carriage roll (degrees) and pitch (degrees). The point $z = 0$ is at the headstock.

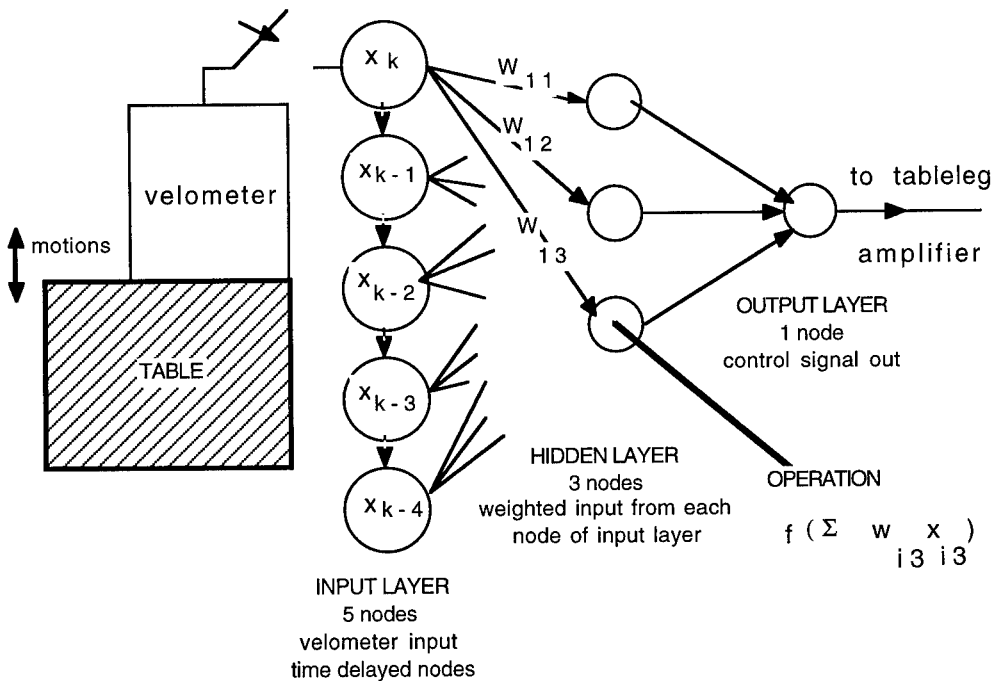
Figure 7: Separate neural controllers, each with five input nodes, three hidden nodes, and a single output node, learn the coupled table and tableleg dynamics and over time constructs control signals that attenuate disturbance vibrations imposed on the table of figure 3.

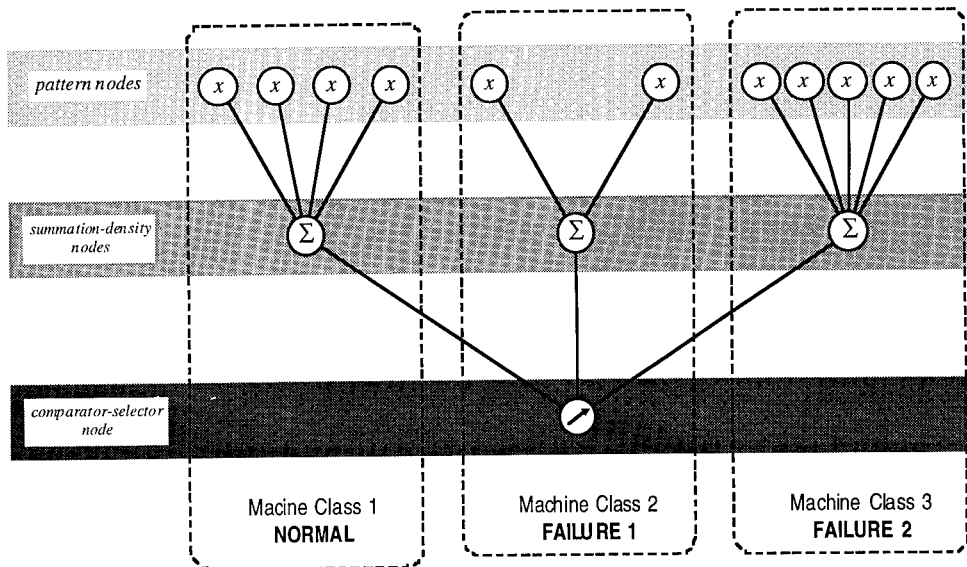
Figure 1
FIRM Network Architecture
