NASA Contractor Report 165677

# Investigation of the Effect of Resin Material on Impact Damage to Graphite/Epoxy Composites

MCDONNELL DOUGLAS CORPORATION  
Douglas Aircraft Company  
Long Beach, California 90846

CONTRACT NAS1-12675 MARCH, 1981

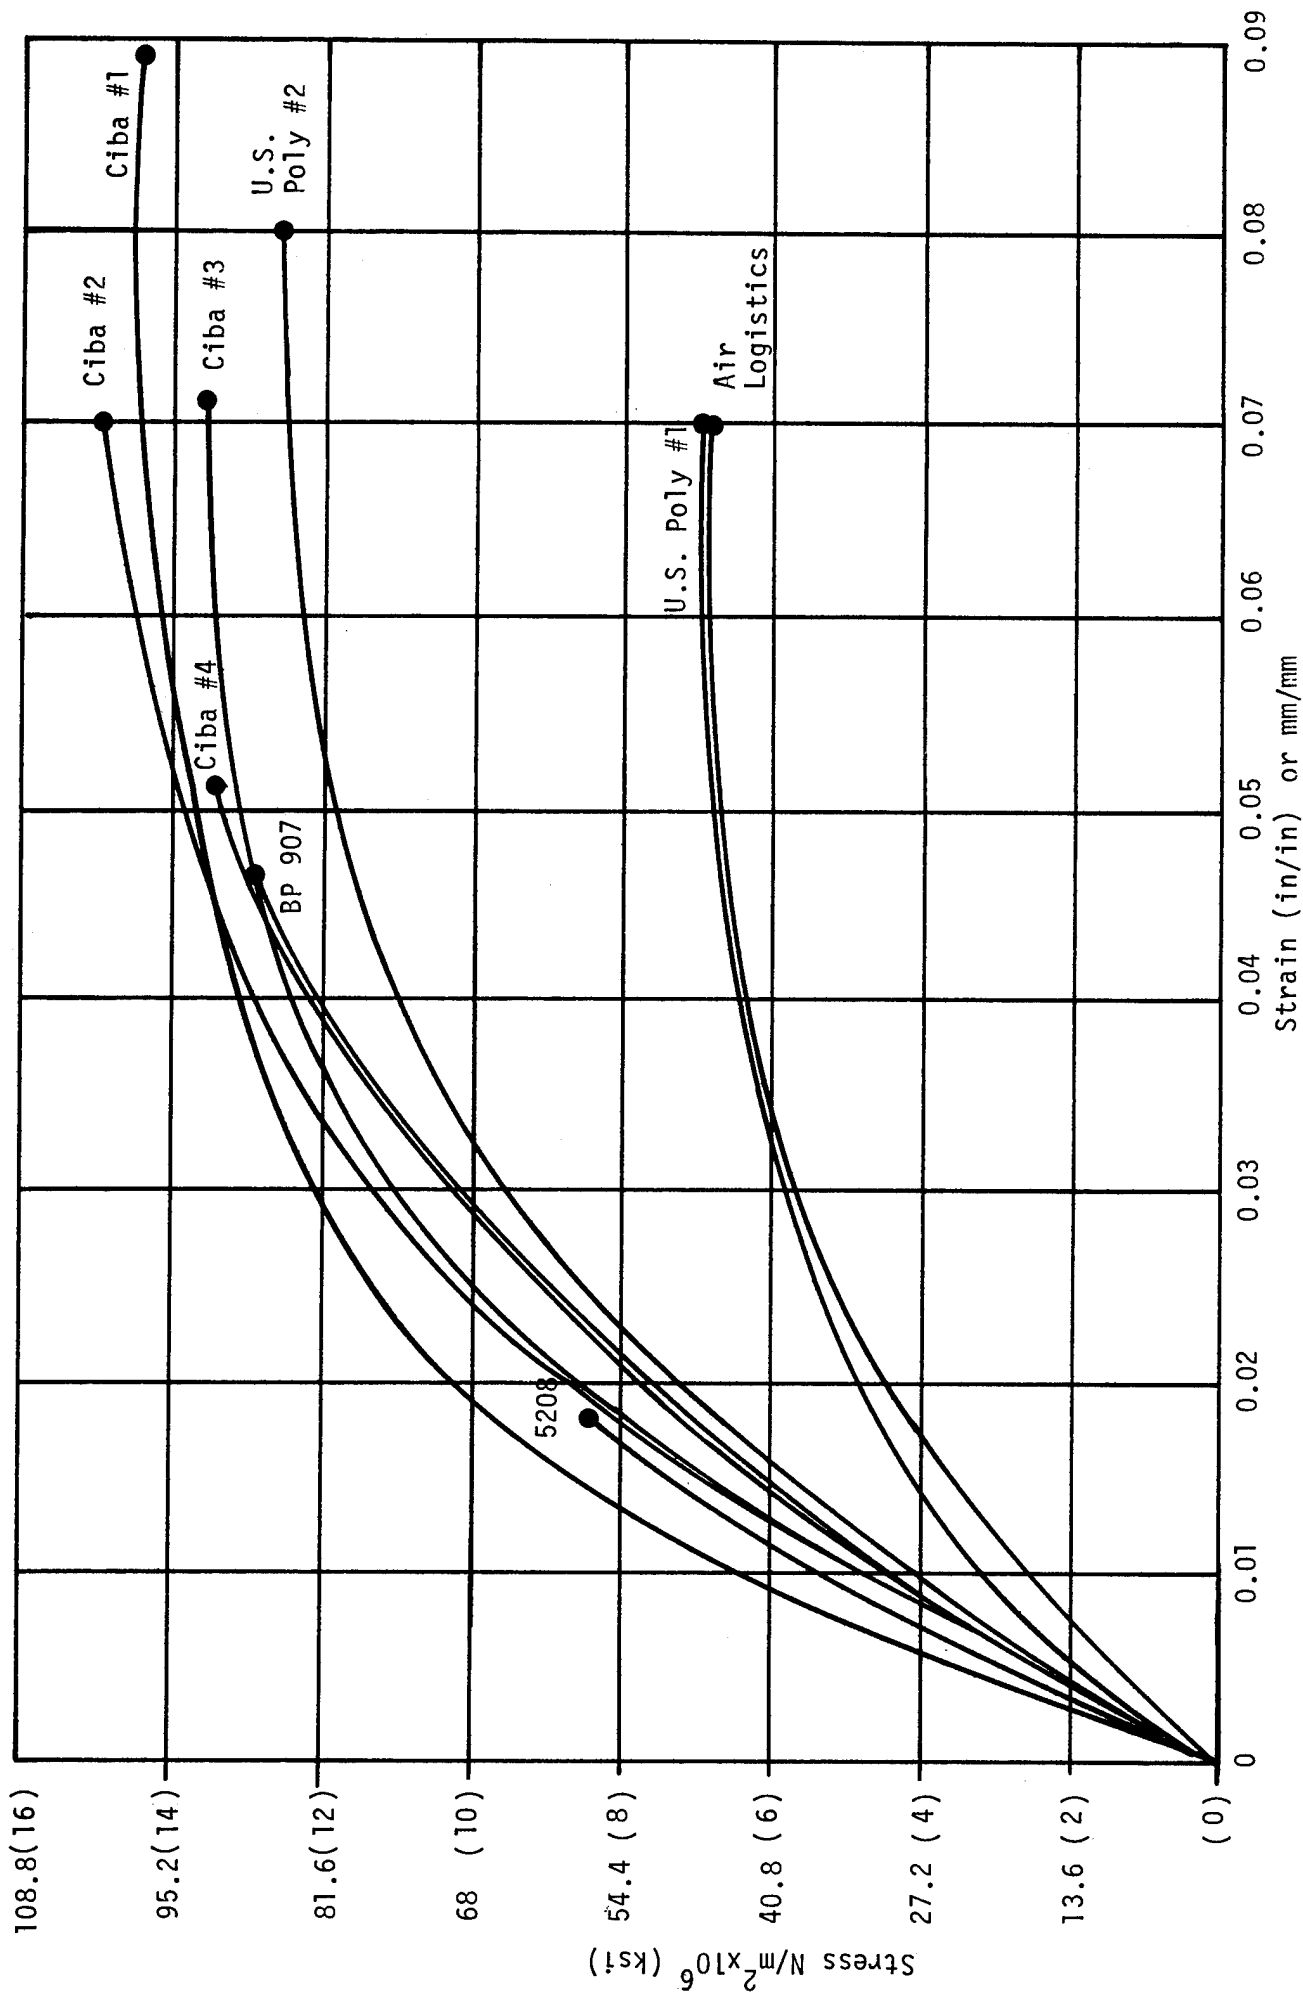
FIGURE 1. TOUGH RESIN STRESS-STRAIN CURVES

NOTE: Curves are averaged results as recorded by various testing agencies and are intended to show general relationships.

All available neat resin stress/strain curves are plotted in Figure 1. All neat resin properties, including stress/strain curves, were supplied by the individual suppliers. The neat resins were cast by most suppliers to the desired thickness and cured by a slow process in an oven to the final curing temperature. Coupons were machined to dog bone specimen configuration and tested for tensile load vs. deflection to failure.

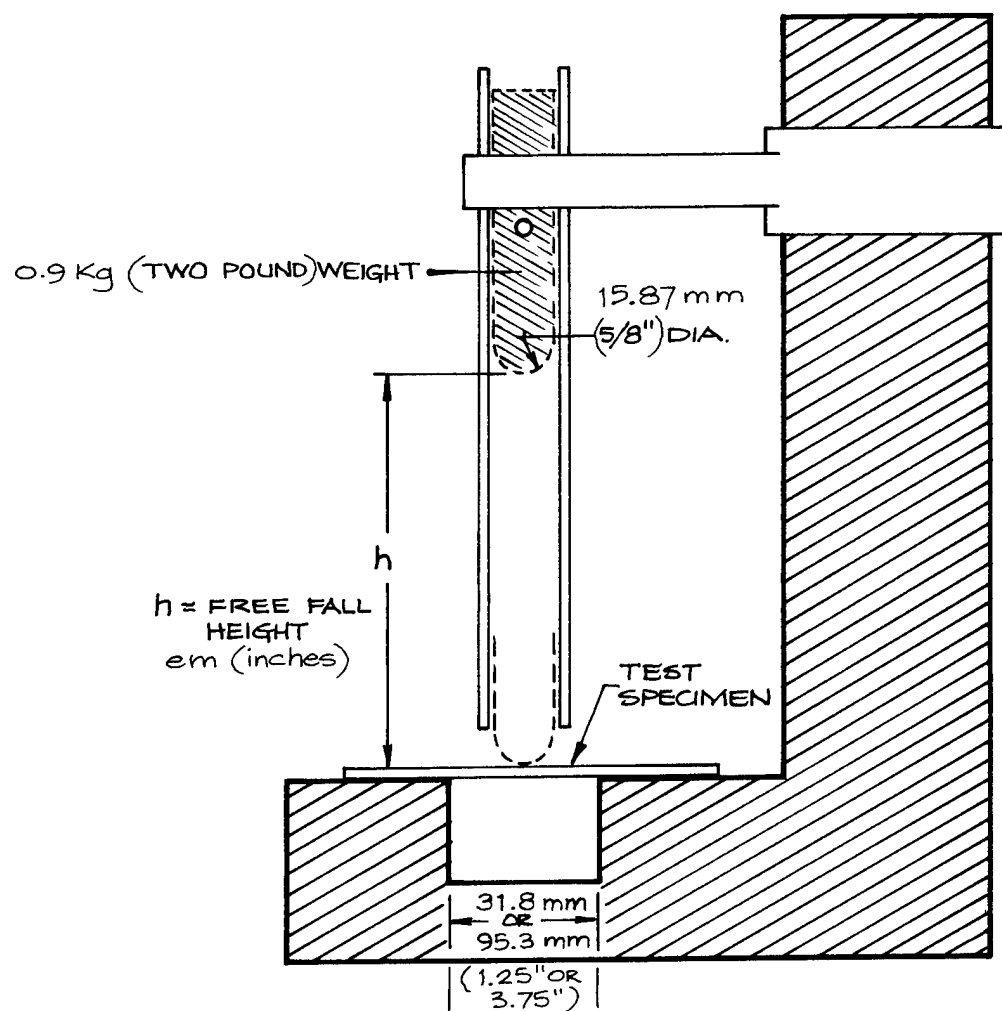
FIGURE 2. GARDNER IMPACT TESTER

The Gardner Impact Tester, see Figure 2, used a free fall, .9 kilograms (two-pounds) weight, in the form of a 15.9 mm (5/8 inch) diameter rod with a rounded 15.9 mm (5/8 inch) diameter impact nose or a flat blunt 15.9 mm (5/8 inch) diameter impact nose. (See Figure 3.) The rod was lifted to a measured height, in Millimeters (inches), and was released for free fall down a guide tube to impact the specimen in a single impact.

All materials were impacted on the Gardner Impact Tester with a 31.8 mm (1.25 inch) diameter simple support, a 15.9 mm (5/8 inch) diameter impact head, and 1.13 (10), 2.26 (20) and 3.39 joules (30 inch pounds) free fall energy. All materials were also impacted on the Gardner Impact Tester with a 95.3 mm (3.75 inch) diameter simple support, a 15.9 mm (5/8 inch) diameter flat impact head, and at various levels between 1.13 joules (10) and 11.3 joules (100 inch pounds) free fall impact energy. (See Figure 2.)

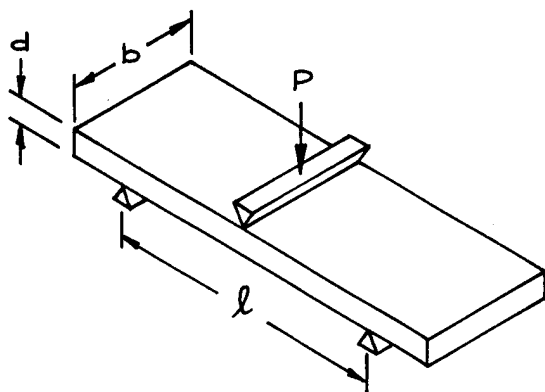
FIGURE 6. FLEXURAL SPECIMEN

Flexural strength and modulus was calculated as the arithmetic mean for a minimum of three specimens.

$$\text{Flexural Strength} = \frac{3PL}{2bd^2}$$

The span to thickness ratio was  $32 \pm 2$  to 1.

Each material received from each of the suppliers was processed into laminate form for both impact and mechanical property tests, as presented in Task 2, during a single curing cycle. All flexural and all short beam shear coupons were cut from 16 ply 0° fiber orientation panels. Flexural coupon size and formula for calculation of maximum stress and modulus of elasticity are shown in Figure 6.

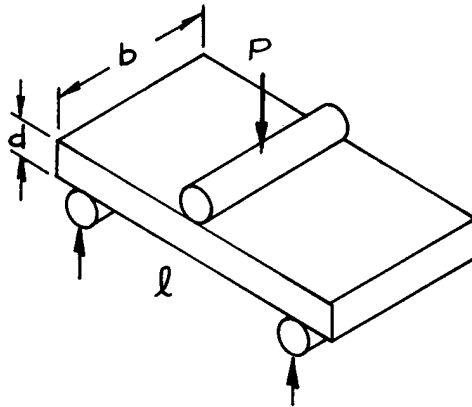
FIGURE 7. SHORT BEAM SHEAR SPECIMEN

Short beam shear strength was calculated as the arithmetic mean of a minimum of three specimens.

$$\text{Horizontal Shear Strength} = \frac{3P}{4bd}$$

The span to thickness ratio was between 3 1/2 and 4 to 1.

Short beam shear coupon size and formula for calculation of shear stress is shown in Figure 7.

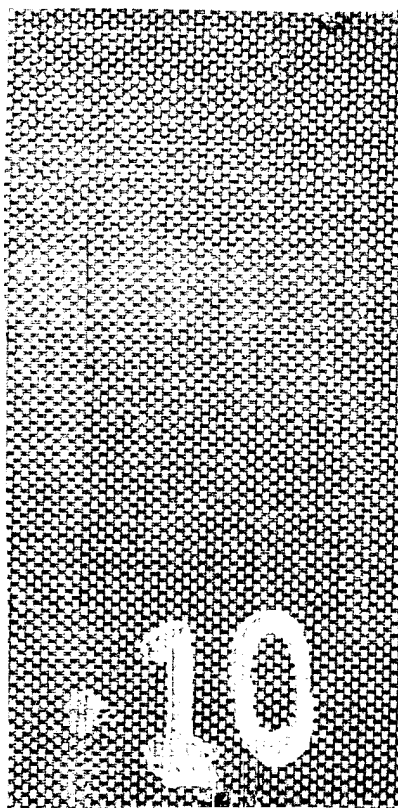
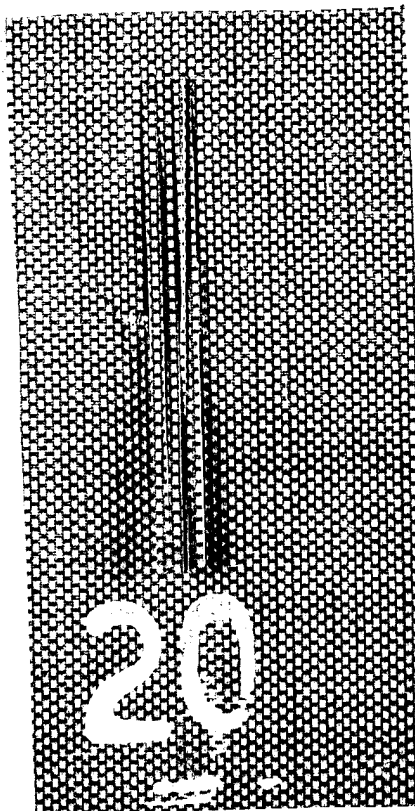
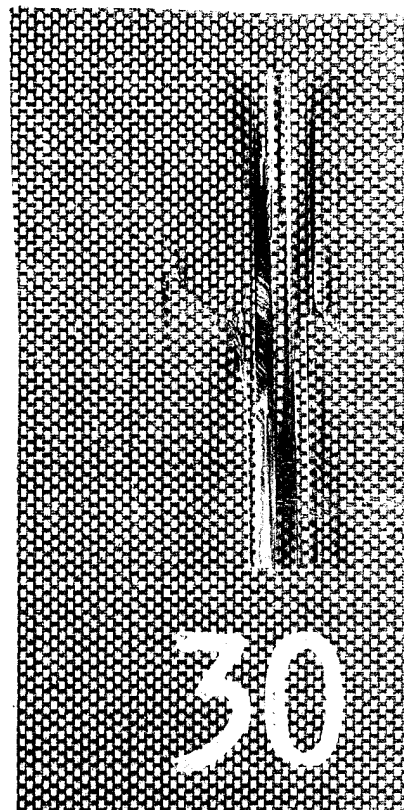
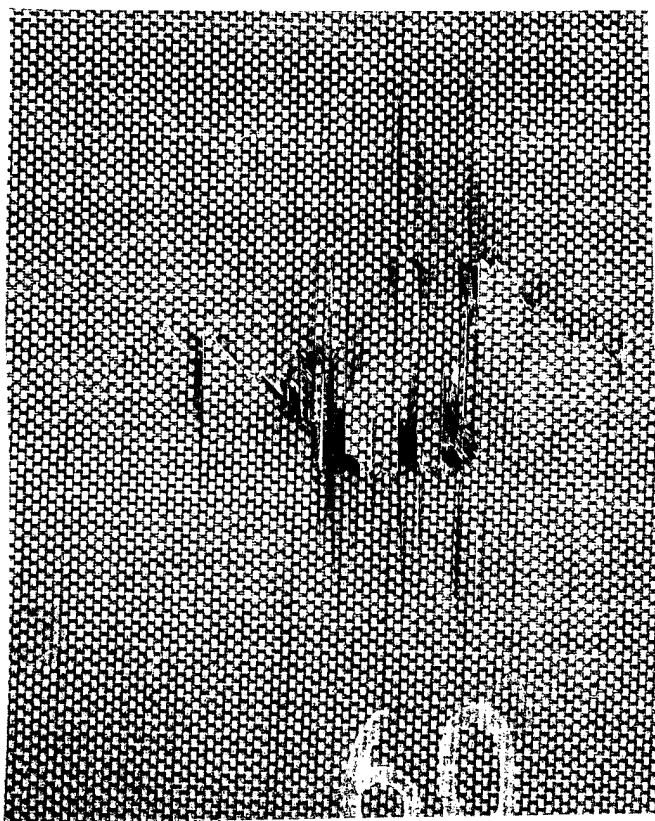
FIGURE 9. VISIBLE IMPACT DAMAGE ON BACK SIDE (0,  $\pm$  45, 90)<sub>s</sub>  
5208 REFERENCE LAMINATE

(10 inch-pounds)  
1.13 Joules

(20 inch-pounds)  
2.26 Joules

(30 inch-pounds)  
3.39 Joules

(60 inch-pounds)  
6.78 Joules

Almost all of the materials evaluated proved to have superior thin laminate impact resistance compared to the baseline Narmco 5208/T-300 material. This was an encouraging result and verified that the material suppliers do have the technical knowledge and capability to improve the toughness of current composite materials. The amount of visible damage from the Gardner Impact Tester is recorded for both the impact side and the back side of each impact panel in Appendix 1. Appendix 1 also includes a record of the C-scan recordings of internal damage and other detail information on resin and laminate properties. Figures 9, 10, 11 12 and 13 show the visual evidence at 2x magnification of damage on the back side of the Narmco 5208/T-300 material and four "toughened" materials. Note that all of the toughened systems exhibit much less visible impact damage. In every case the visible damage is more extensive on the back side than the impact side of the panel as recorded in Appendix 1.

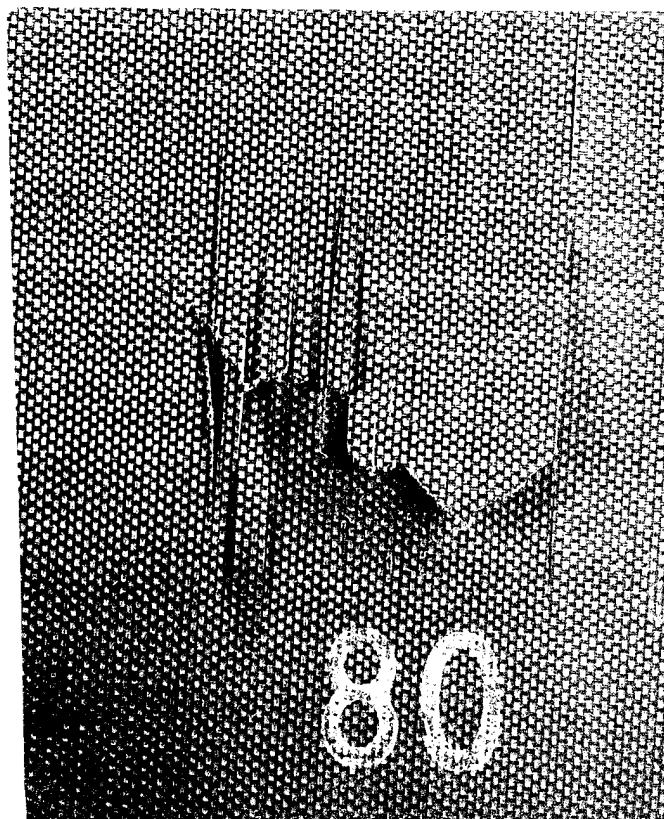
(80 inch-pounds)  
9.04 Joules

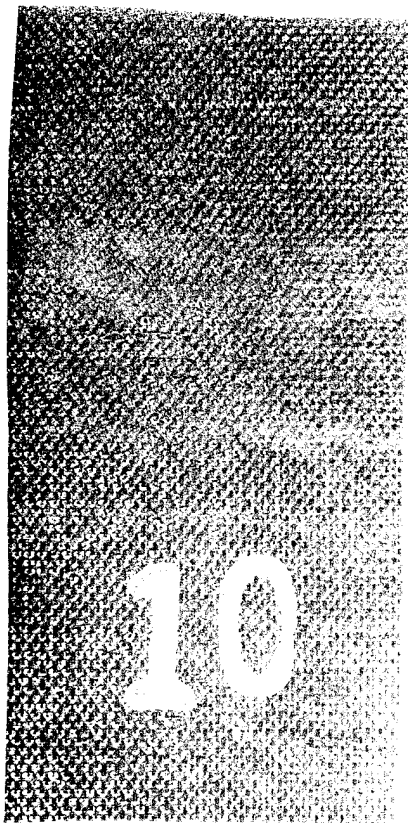
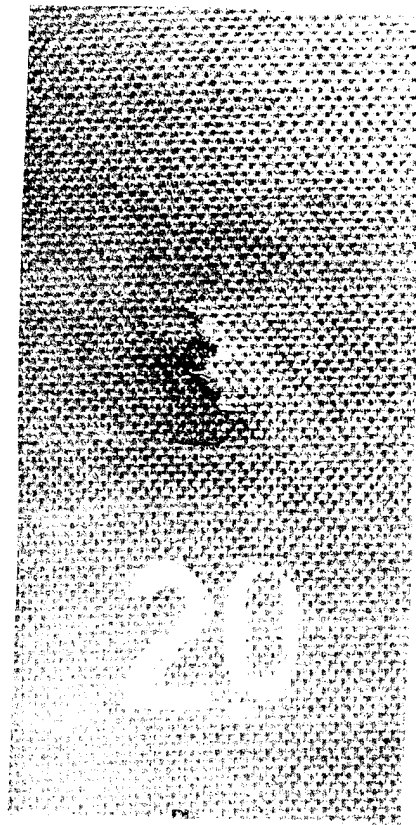
FIGURE 10. VISIBLE IMPACT DAMAGE ON BACK SIDE (0,  $\pm$  45, 90)<sub>s</sub>  
HEXCEL #1 LAMINATE

(10 inch-pounds)  
1.13 Joules

(20 inch-pounds)  
2.26 Joules

(30 inch-pounds)  
3.39 Joules

(60 inch-pounds)  
6.78 Joules

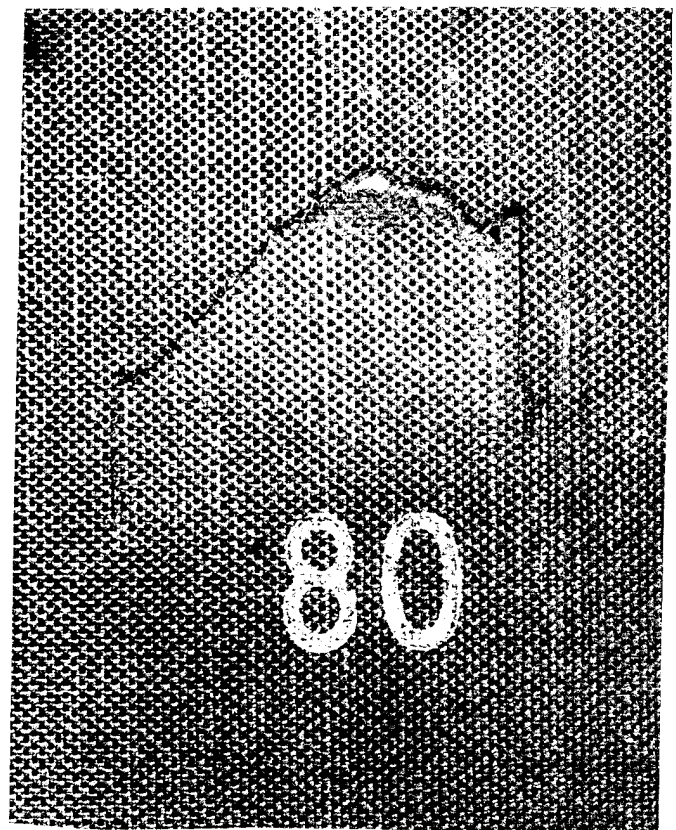
(80 inch-pounds)  
9.04 Joules

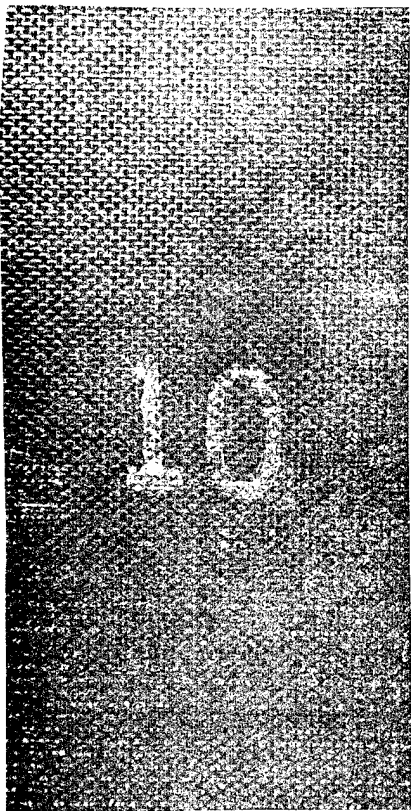
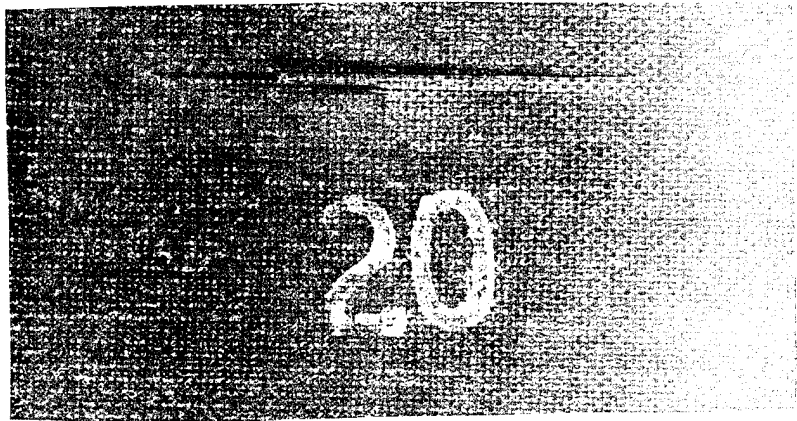
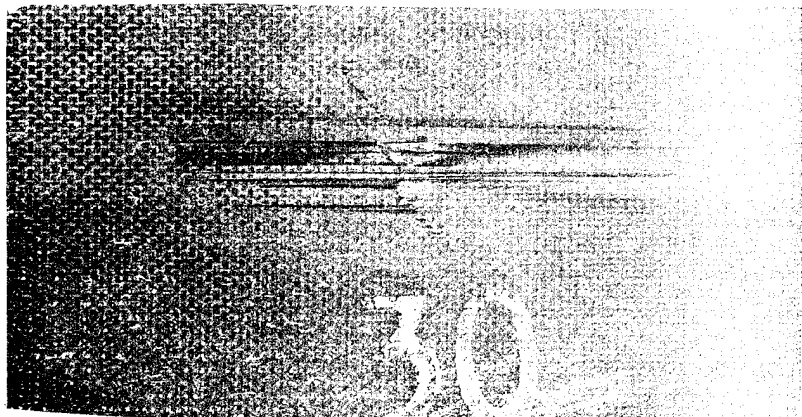
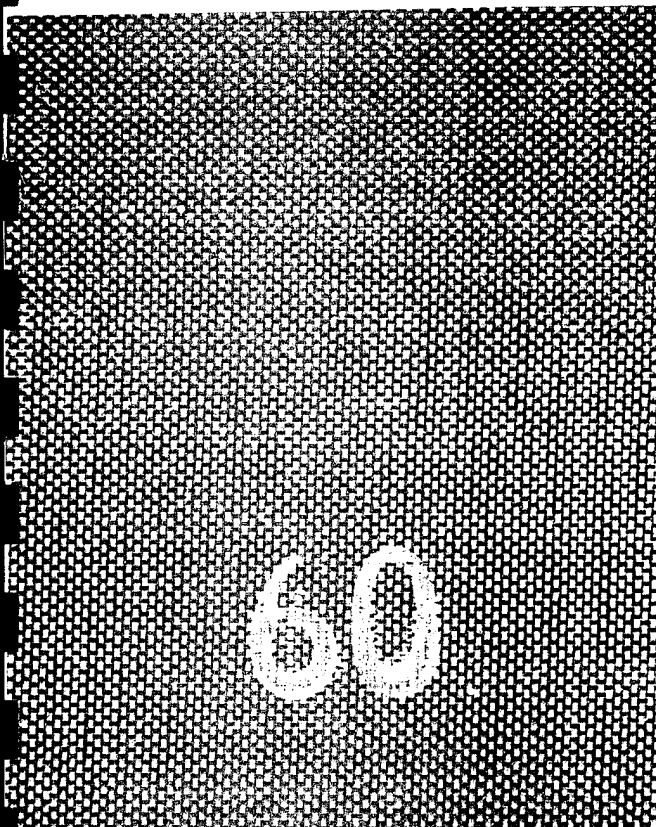
FIGURE 11. VISIBLE IMPACT DAMAGE ON BACK SIDE (0,  $\pm$  45, 90)<sub>s</sub>  
CIBA GEIGY #4 LAMINATE

(10 inch-pounds)  
1.13 Joules

(20 inch-pounds)  
2.26 Joules

(30 inch-pounds)  
3.39 Joules

(60 inch-pounds)  
6.78 Joules

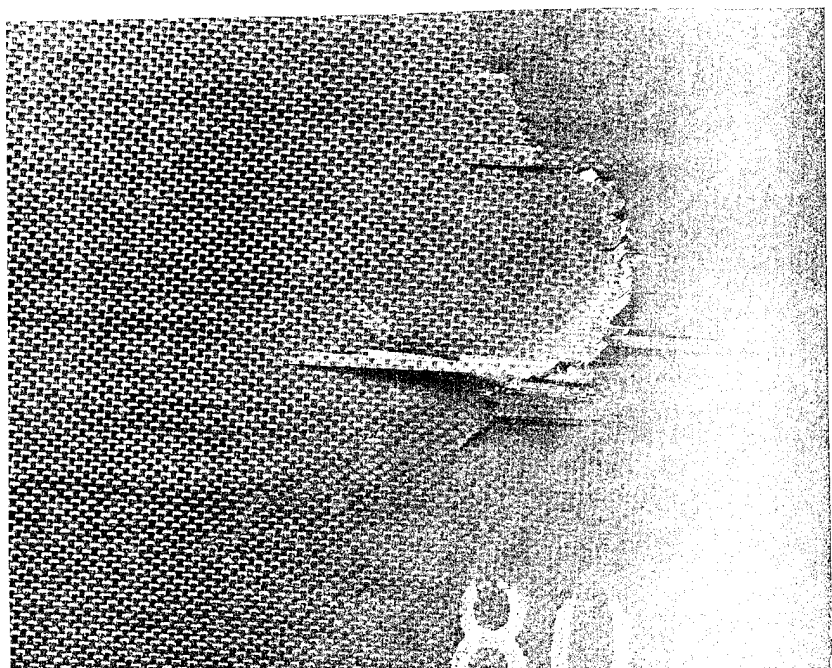
(80 inch-pounds)  
9.04 Joules

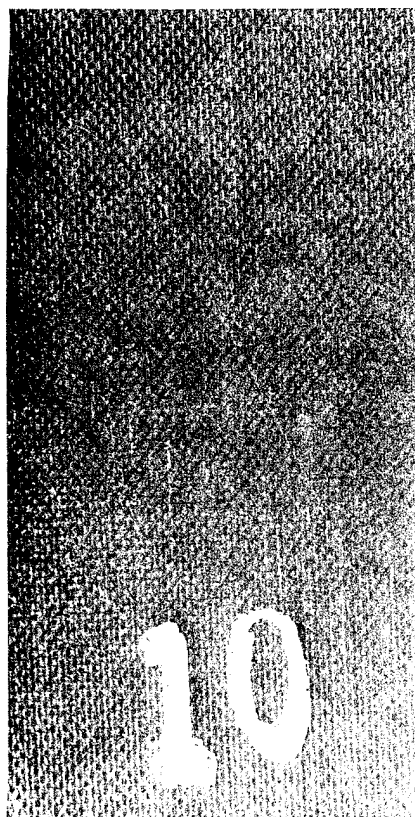
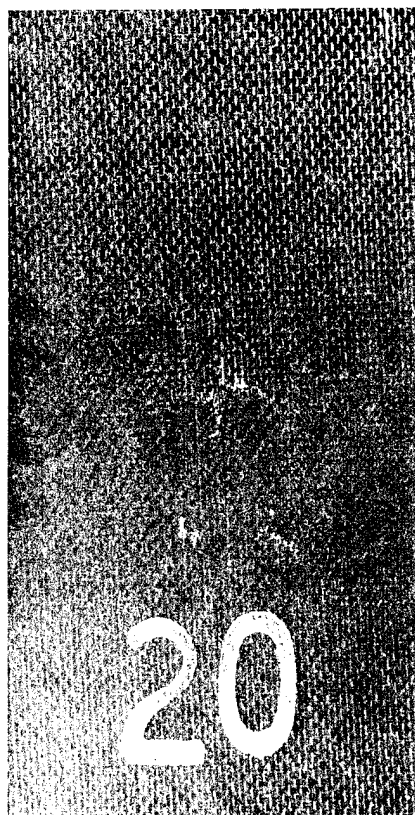
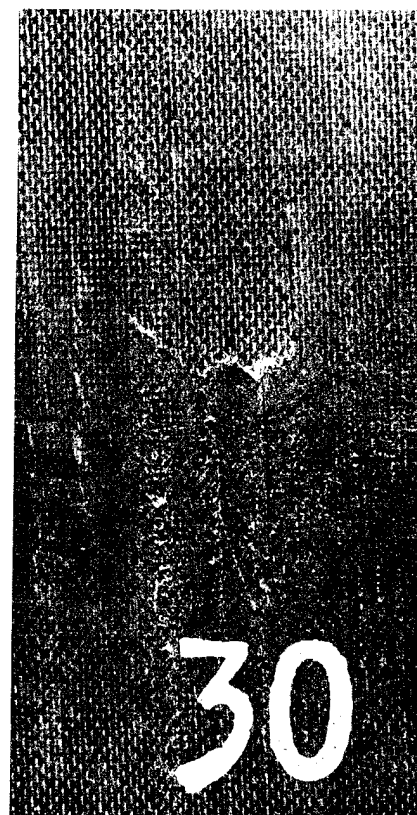
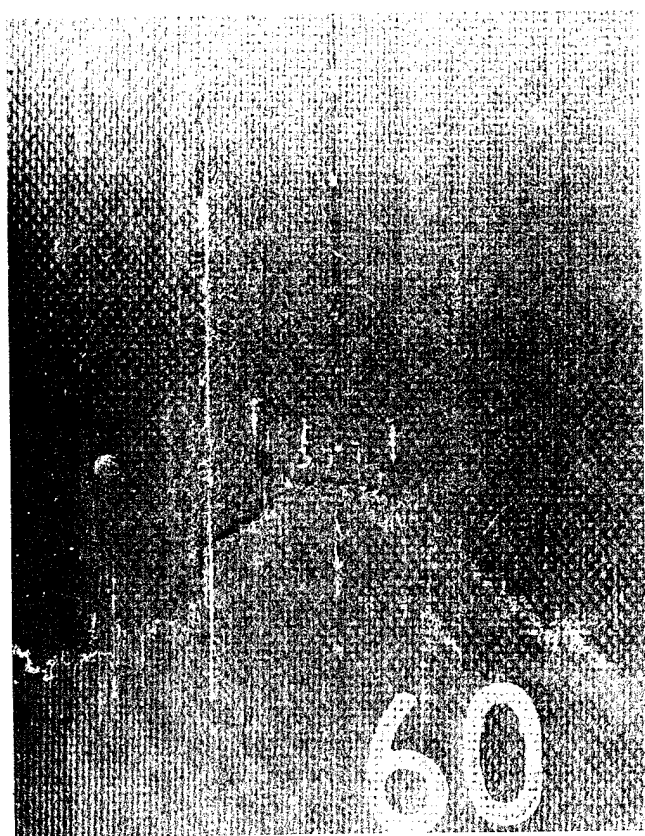
FIGURE 12. VISIBLE IMPACT DAMAGE ON BACK SIDE (0,  $\pm$  45, 90)s  
BP907 LAMINATE

( 10 inch-pounds )  
1.13 Joules

( 20 inch-pounds )  
2.26 Joules

( 30 inch-pounds )  
3.39 Joules

( 60 inch-pounds )  
6.78 Joules

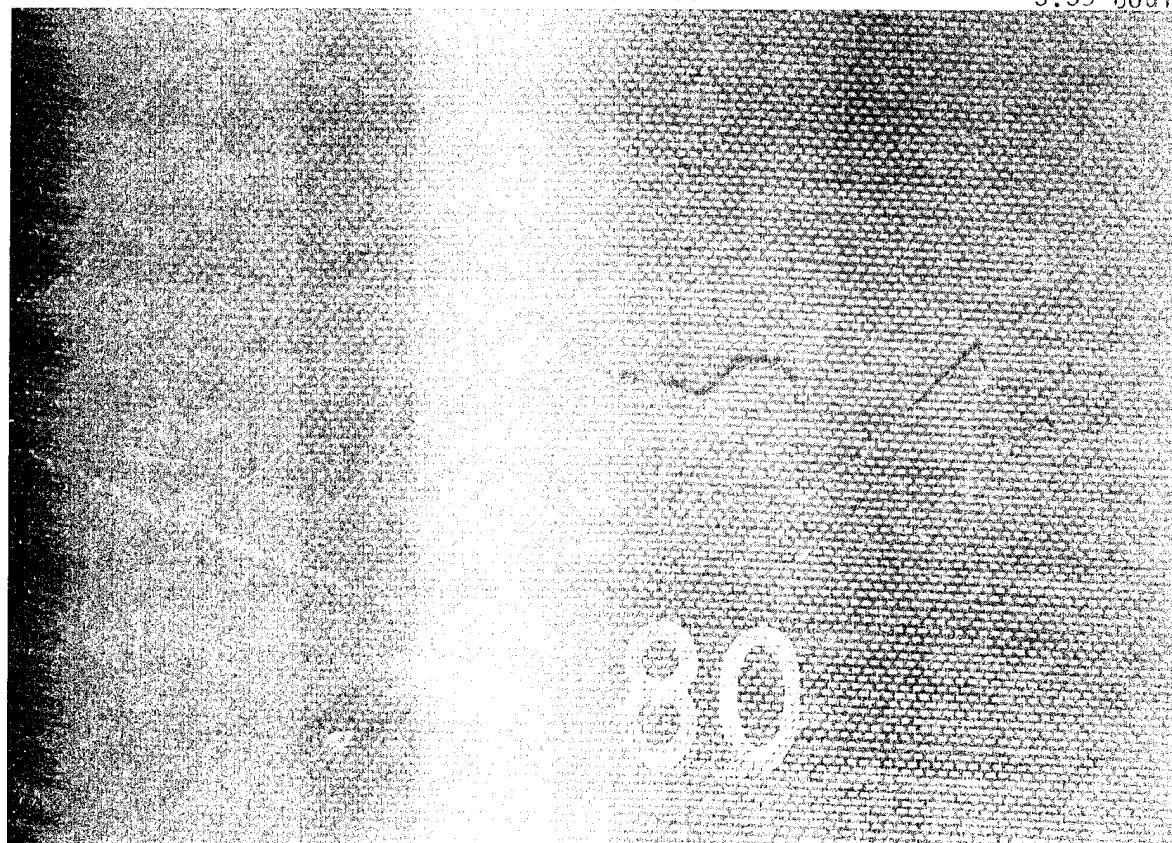
FIGURE 13. VISIBLE IMPACT DAMAGE ON BACK SIDE (0,  $\pm$  45, 90)s  
FIBERDUX 926 LAMINATE

(30 inch-pounds)  
3.39 Joules

(80 inch-pounds)  
9.04 Joules

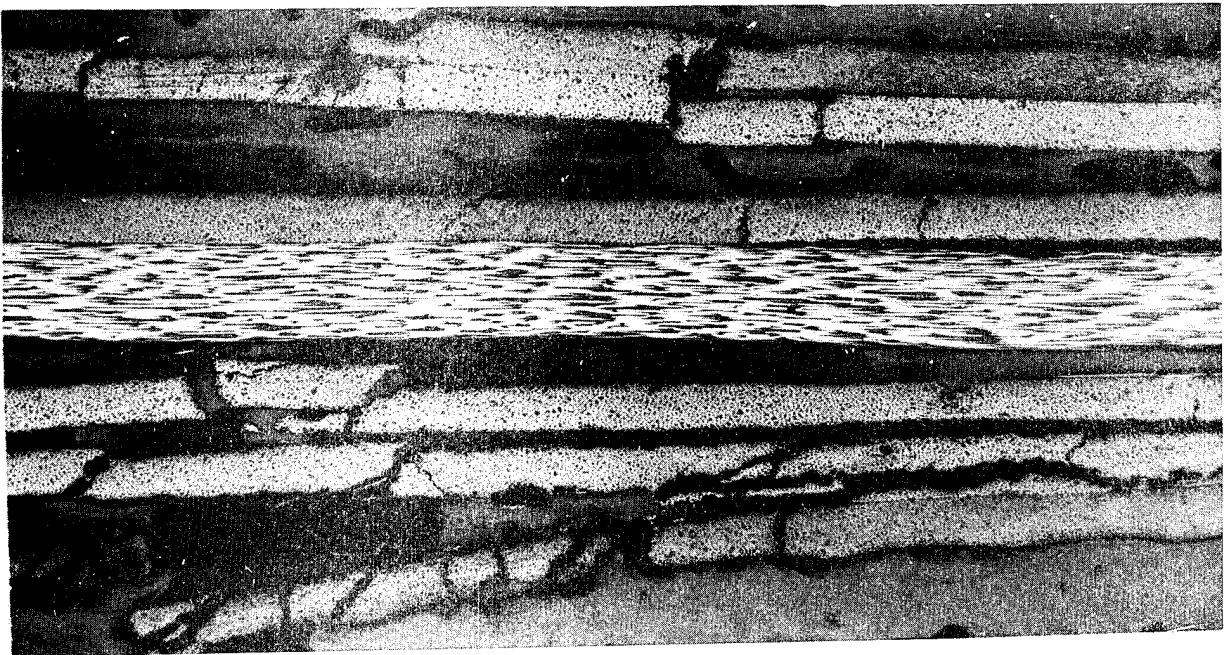
FIGURE 14. NARMCO 5208 3.39 JOULES (30 INCH POUNDS) GARDNER IMPACT

Figures 14, 15, 16, 17, 18 and 19 show cross sectional photographs at varying magnifications of damage caused by impact blows of 3.39 joules (30) and 9.04 joules (80 in pounds) to Narmco 5208, BP-907 and Ciba Geigy #4 eight ply laminates.

The 5208 mode of impact failure, at these load levels of impact, is noticeably different than the "toughened" materials. In the immediate area at impact, photographs No. 14A and 15A, there is considerable splintering and severe delamination between plies of material and thru-the-thickness ply cracking of the resin matrix, best shown in photograph No. 14C. As we move away from the direct impact, photographs 14B and 15B, the failure is mainly delamination in the resin matrix between plies of material. At the periphery of the damaged area, the failure at the tip of the crack appears in the resin interface between plies of laminate, photograph 15C.

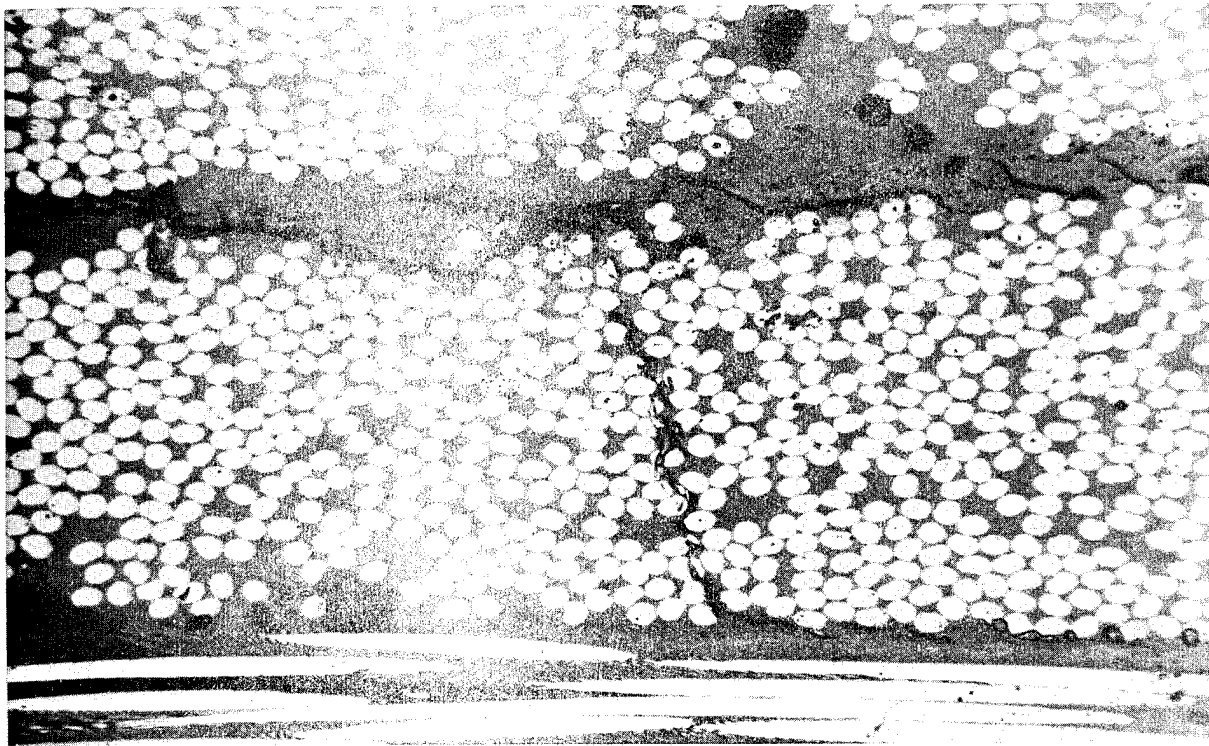
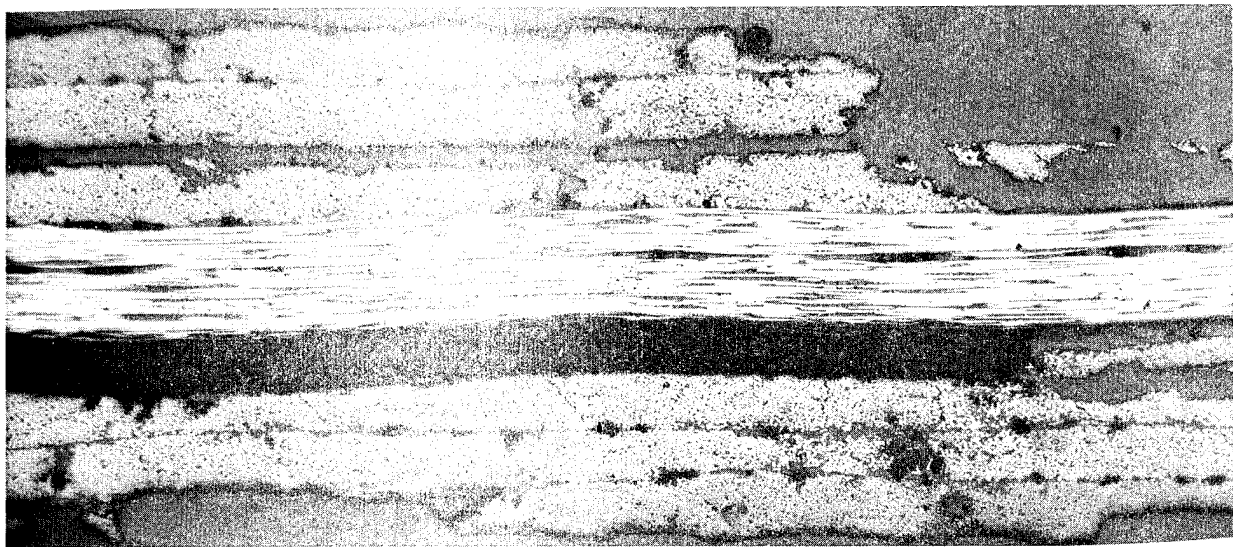
FIGURE 16. BP-907 3.39 JOULES (30 INCH POUNDS) GARDNER IMPACT

The tough resin systems, BP-907 and Ciba Geigy #4, in the immediate area of impact, photographs No. 16A, 17A & B, 18A & B and 19A and B show far less splintering and minimal delamination between plies of material even when relatively close to the impact point. At the periphery of the damaged area, the failure at the tip of the crack appears in the resin matrix within a ply of material, photograph No. 19C.

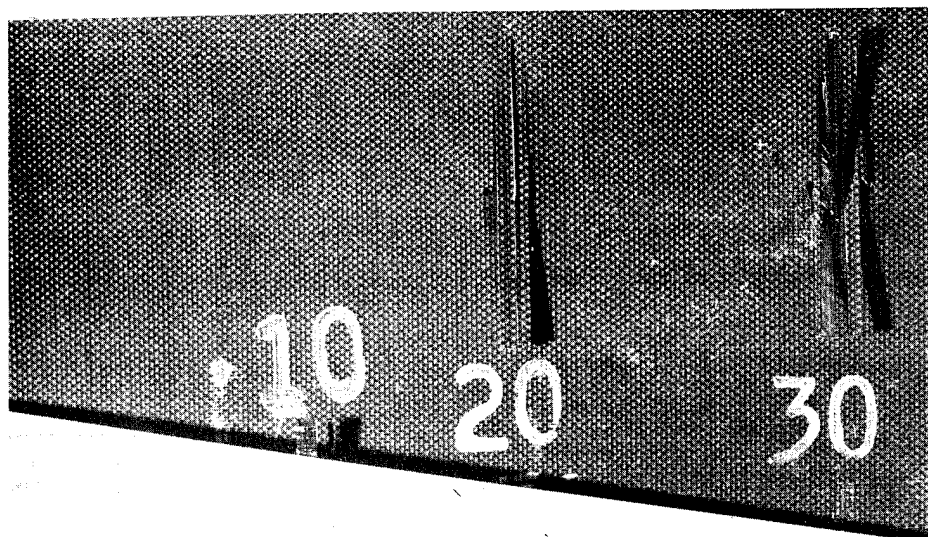
FIGURE 20. COMPARISON OF VISUAL IMPACT DAMAGE VS. NDT INSPECTION FOR NARMCO 5208/T300 FOR 3.17 cm (1.25 INCH) SUPPORT AT a. 1.13 JOULES (10 INCH-POUNDS), b. 2.26 JOULES (20 INCH-POUNDS) AND c. 3.39 JOULES (30 INCH-POUNDS)

Visible  
Damage  
Back side

NARMCO 5208/T300  
REFERENCE

Visible  
Damage  
Front side

3.17 mm  
(1/8 inch) hole +  
broken fibers

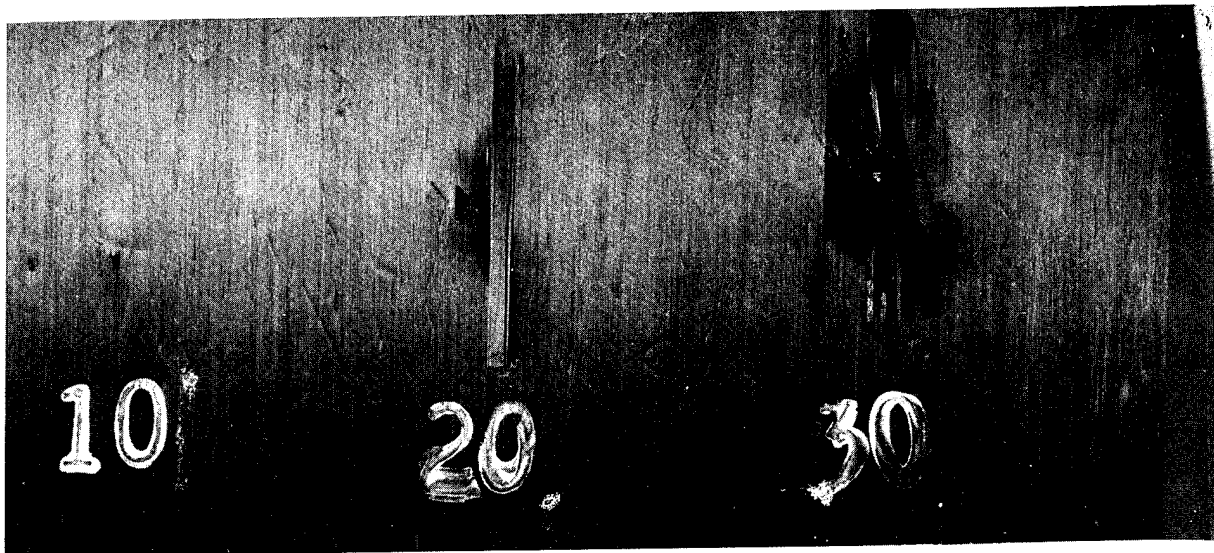
FIGURE 21. COMPARISON OF VISUAL IMPACT DAMAGE VS. NDT INSPECTION FOR NARMCO 95995/T300 FOR 3.17 cm (1.25 INCH) SUPPORT AT a. 1.13 JOULES (10 INCH-POUNDS), b. 2.26 JOULES (20 INCH-POUNDS) AND c. 3.39 JOULES (30 INCH-POUNDS)

Visible  
Damage  
Back side

NARMCO 95995/T300

Visible  
Damage  
Front side

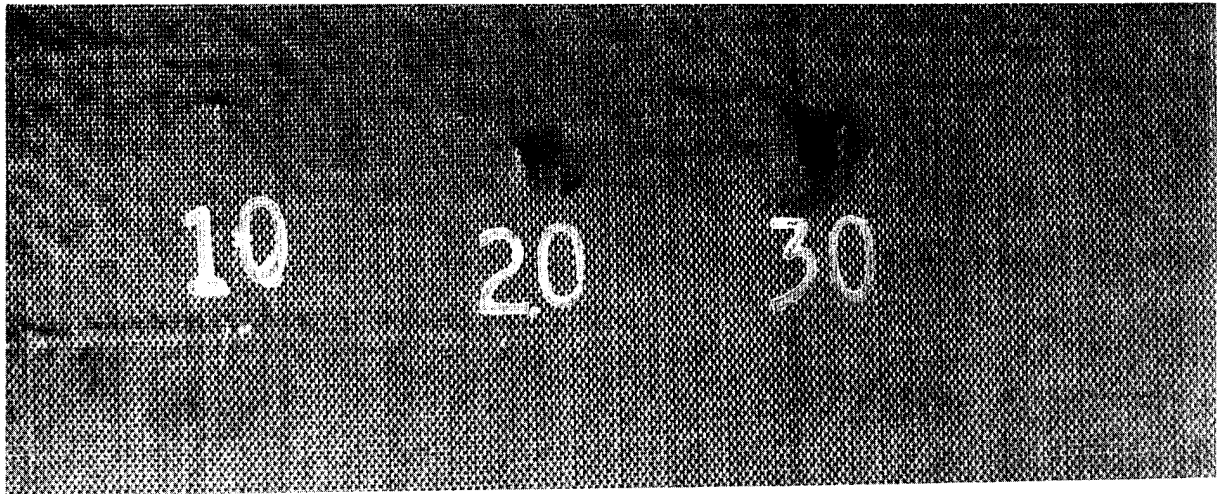
FIGURE 22. COMPARISON OF VISUAL IMPACT DAMAGE VS. NDT INSPECTION FOR U.S. POLYMERIC TOUGH RESIN #1 FOR 3.17 cm (1.25 INCH) SUPPORT AT a. 1.13 JOULES (10 INCH-POUNDS), b. 2.26 JOULES (20 INCH-POUNDS) AND c. 3.39 JOULES (30 INCH-POUNDS)

Visible  
Damage  
Back side

U.S. POLYMERIC TOUGH RESIN #1/T300

Visible  
Damage  
Front side

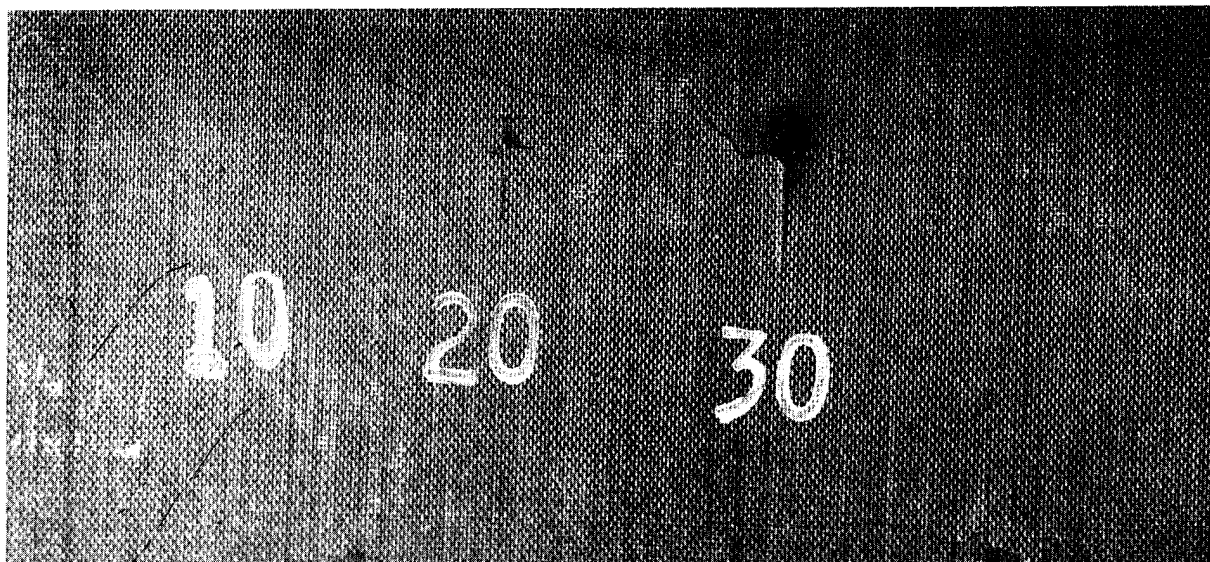
FIGURE 23. COMPARISON OF VISUAL IMPACT DAMAGE VS NDT INSPECTION FOR AMERICAN CYANAMID BP-907 FOR 3.17 cm (1.25 INCH) SUPPORT AT a. 1.13 JOULES (10 INCH-POUNDS), b. 2.26 JOULES (20 INCH-POUNDS) AND c. 3.39 JOULES (30 INCH-POUNDS)

Visible  
Damage  
Back side

AMERICAN CYANAMIDE BP-907/T300

Visible  
Damage  
Front side

6.35 mm  
(1/4 inch) dent +  
broken fibers  
c)

Total Damage  
by C-scan

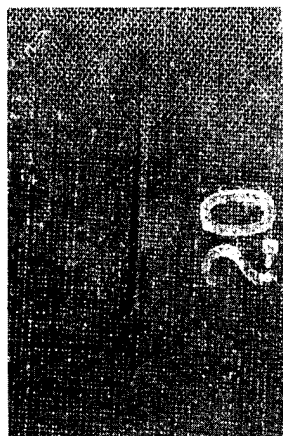
FIGURE 24. COMPARISON OF VISUAL IMPACT DAMAGE VS NDT INSPECTION FOR CIBA GEIGY #4 FOR 3.17 cm (1.25 INCH) SUPPORT AT a. 1.13 JOULES (10 INCH POUNDS), b. 2.26 JOULES (20 INCH POUNDS) AND c. 3.39 JOULES (30 INCH POUNDS)

Visible  
Damage  
Back side

Visible  
Damage  
Front side

None

5.1 mm  
(.2 inch) dent  
some broken  
fibers  
(c)

Total Damage  
by C-scan

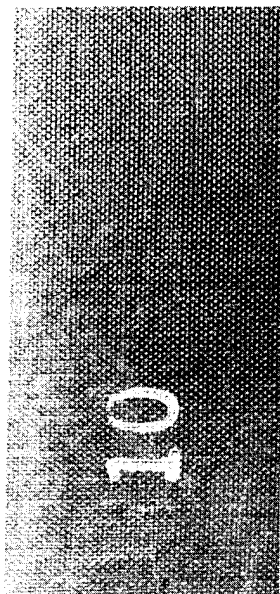
FIGURE 25. COMPARISON OF VISUAL IMPACT DAMAGE VS NDT INSPECTION FOR FIBERDUX 920 FOR 3.17 cm (1.25 INCH) SUPPORT AT a. 1.13 JOULES (10 INCH POUND), b. 2.26 JOULES (20 INCH POUND) AND c. 3.39 JOULES (30 INCH POUND)

Visible  
Damage  
Back side

Visible  
Damage  
Front side

None

Total Damage  
by C-scan

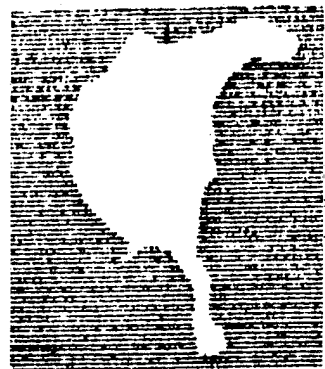
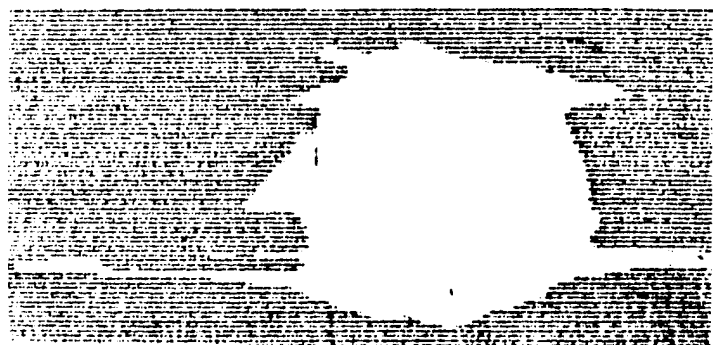
FIGURE 27. BP-907 VS NARMCO 5208 FOR RHEOMETRIC IMPACT AND GARDNER IMPACT AREA OF DAMAGE

Load - 136 kg (300 lbs) Total

5.59 cm<sup>2</sup>

9.04 Joules  
(80 inchpounds)

BP-907

14.43 cm<sup>2</sup>  
Narmco 5208

1.13 Joules  
(10 inch  
pounds)

The Gardner impact data also supports the conclusion that the BP-907 graphite/epoxy laminate has superior damage tolerance or impact resistance than Narmco 5208 laminates. The area of damage, shown by C-scan examination, of Gardner impact damaged panels was less for BP-907 (0.26 cm<sup>2</sup>) than for Narmco 5208 (1.69 cm<sup>2</sup>) material at low 1.13 joules (10 inch pounds) impact. At high load impact of 9.04 joules (80 inch pounds), the BP-907 area of damage, 5.59 cm<sup>2</sup> is much less than the 14.43 cm<sup>2</sup> damage for the Narmco 5208 material.

At total penetration, the Rheometric total "energy absorbed" values for all toughened materials recorded in Table 4 were, as expected from the Gardner Impact Tests, superior to the Narmco 5208. An additional example of this correlation is shown in Figure 28 for Narmco 5208 and Ciba Geigy #4 materials. Note that the higher Rheometric energy absorbed value by Ciba Geigy #4 indicated improved impact resistance. At the same time smaller area damage of the Gardner Impact Test, shown by C-scan also indicates improved impact strength for the Ciba Geigy material.

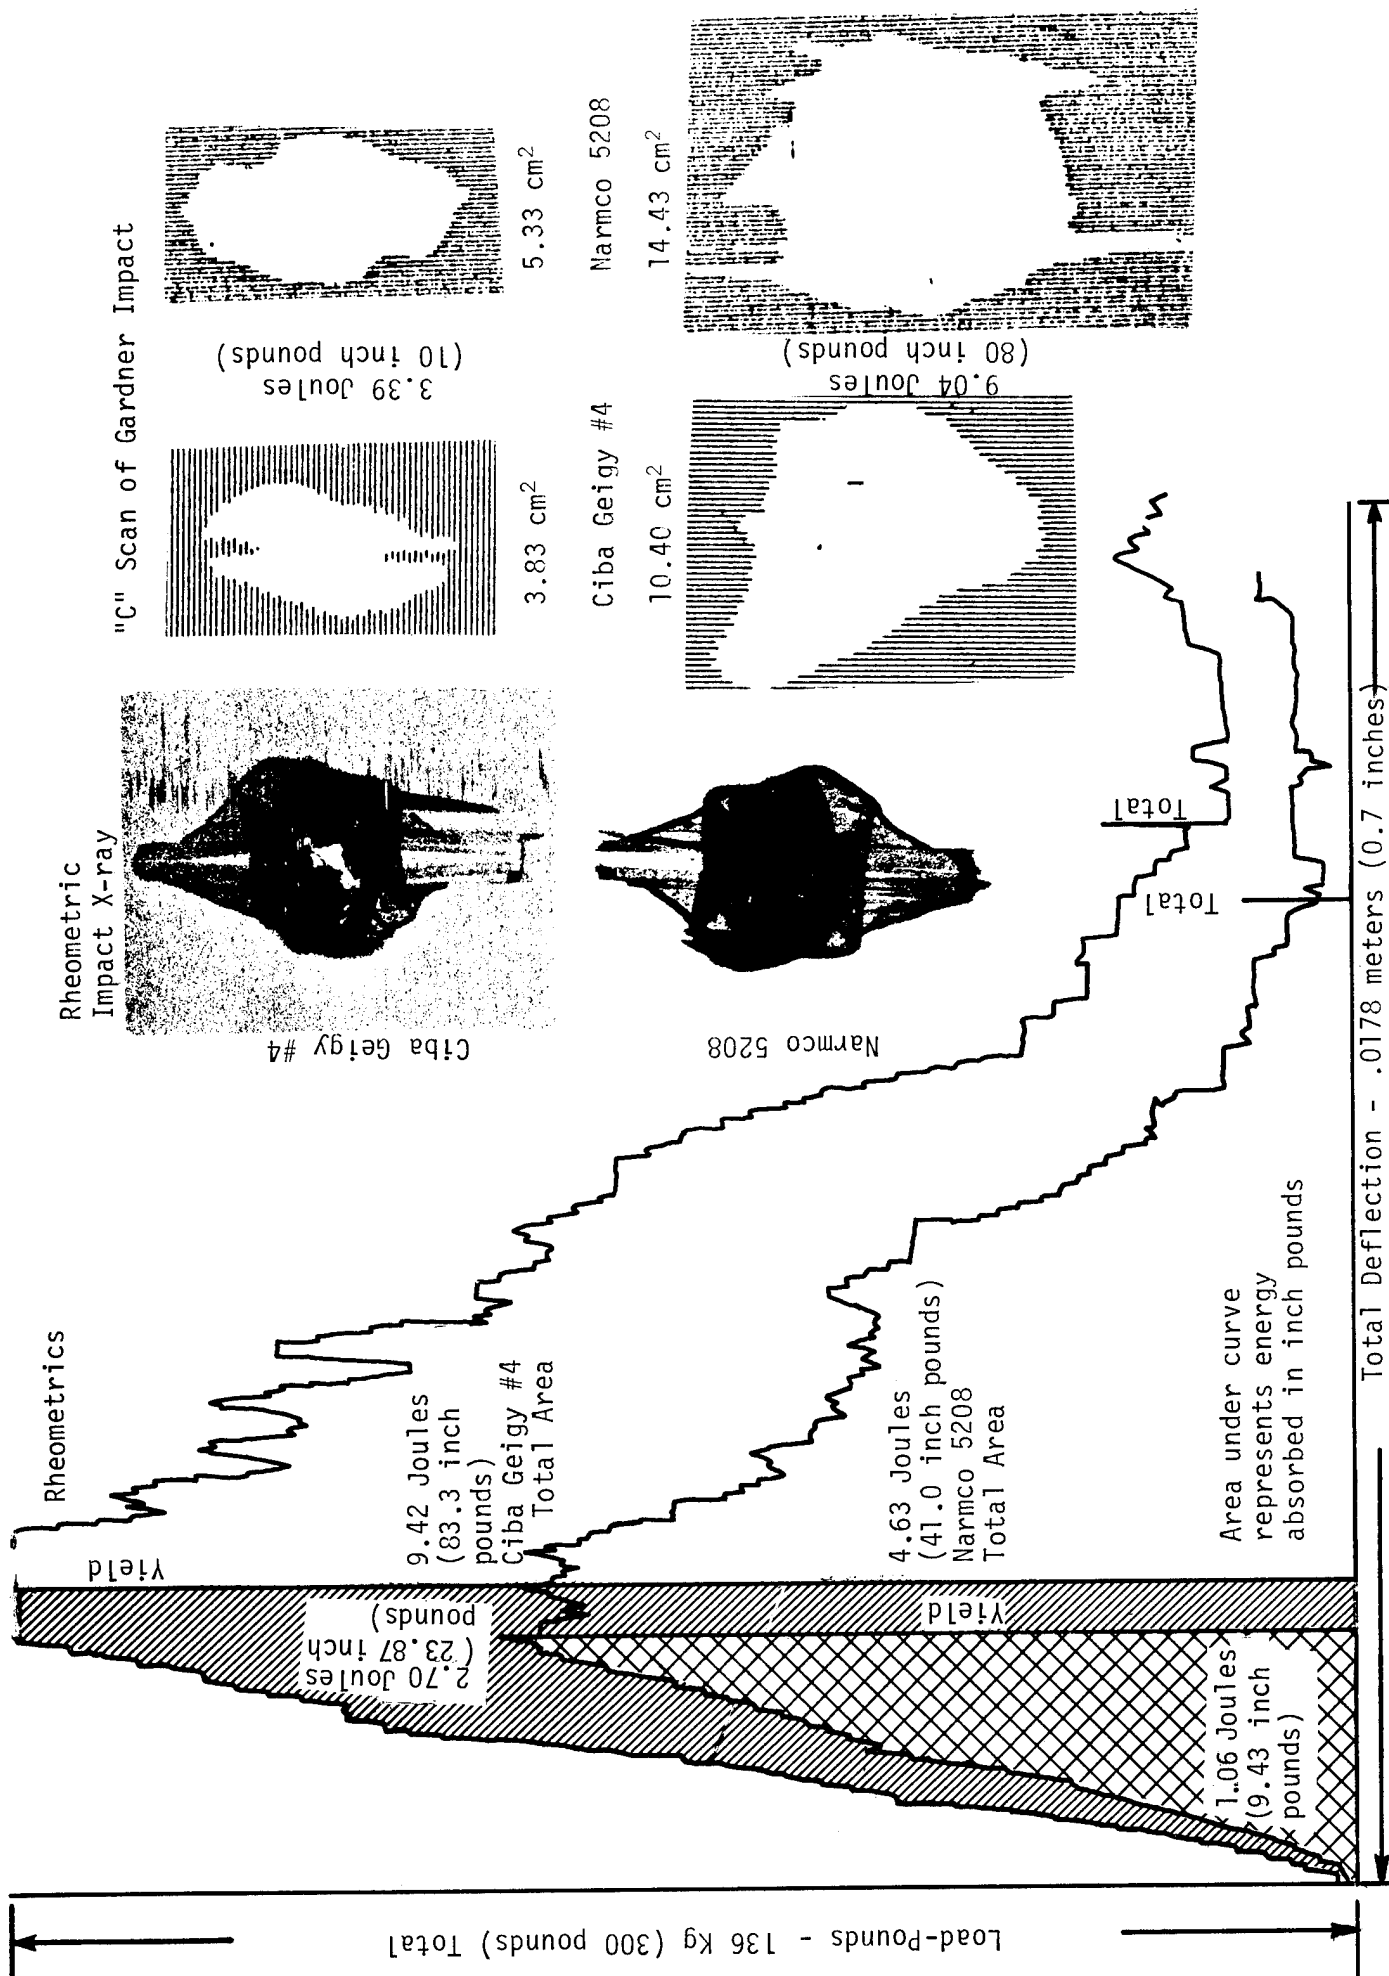
FIGURE 28. CIBA GEIGY #4 VS NARMCO 5208 FOR RHEOMETRIC IMPACT AND GARDNER IMPACT AREA OF DAMAGE

An interesting observation of the Rheometric impact penetration specimens is that the impact penetration hole was closed with broken fibers for the Narmco 5208 specimens but every toughened material contained a visible hole, with broken fiber edges, where the impact plunger penetrated. The X-rays of the impacted specimens in Figure 28 show this characteristic.
