NASA Contractor Report 165677

# Investigation of the Effect of Resin Material on Impact Damage to Graphite/Epoxy Composites

MCDONNELL DOUGLAS CORPORATION  
Douglas Aircraft Company  
Long Beach, California 90846

CONTRACT NAS1-12675 MARCH, 1981

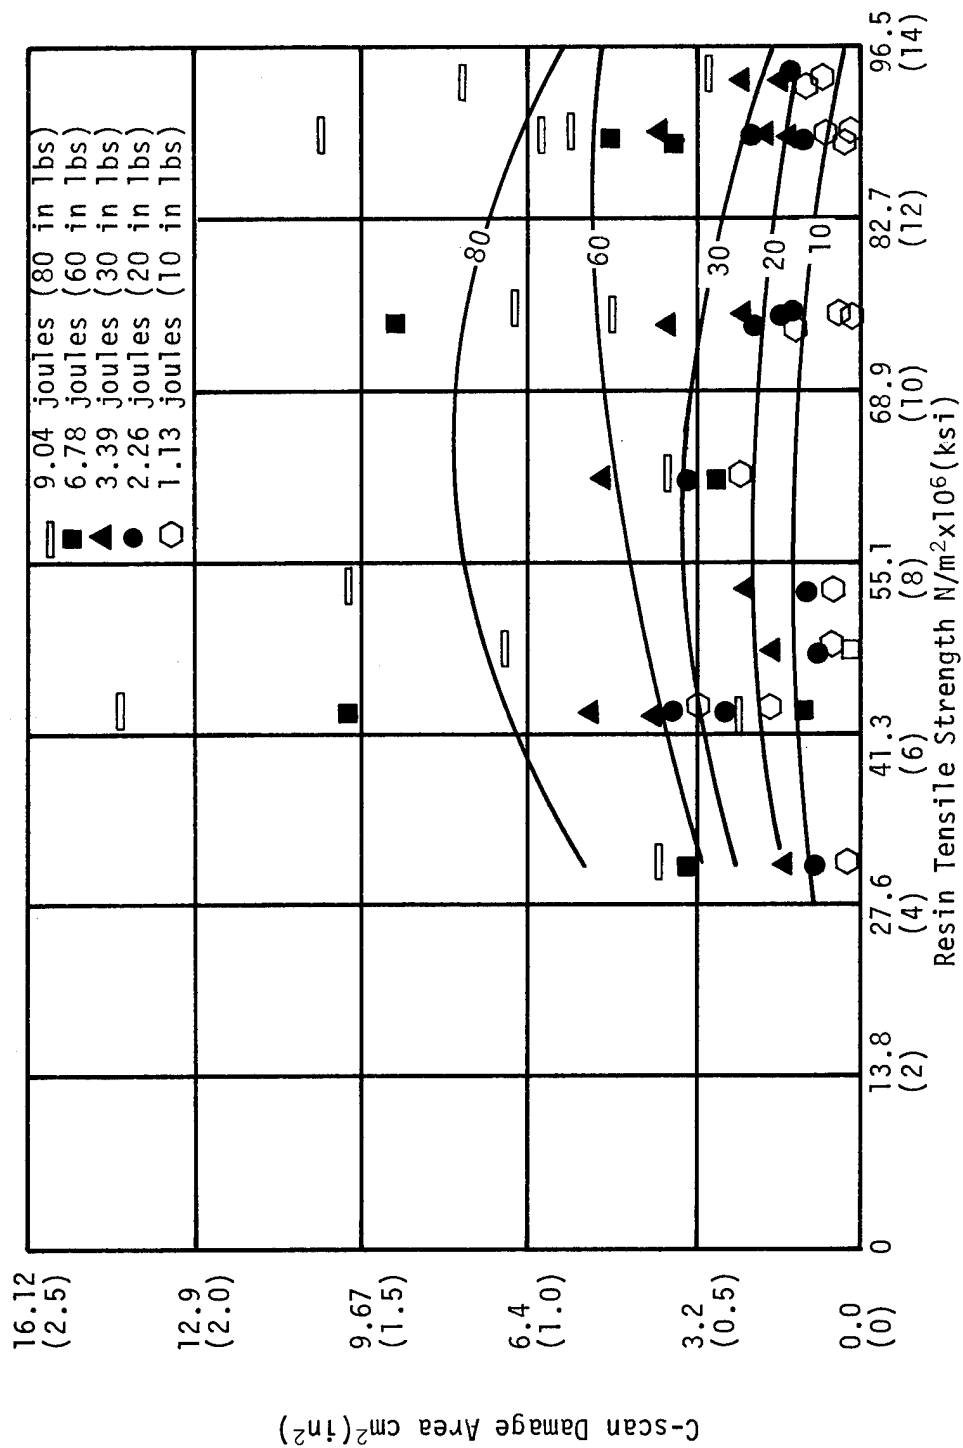
FIGURE 29. NEAT RESIN TENSILE STRENGTH VS IMPACT DAMAGE AREA

The resin tensile strength is not an important resin variable for developing laminate impact resistance as shown in Figure 29. Toughened resins with both higher and lower tensile strength than Narmco 5208 resin produced higher impact resistant laminates.

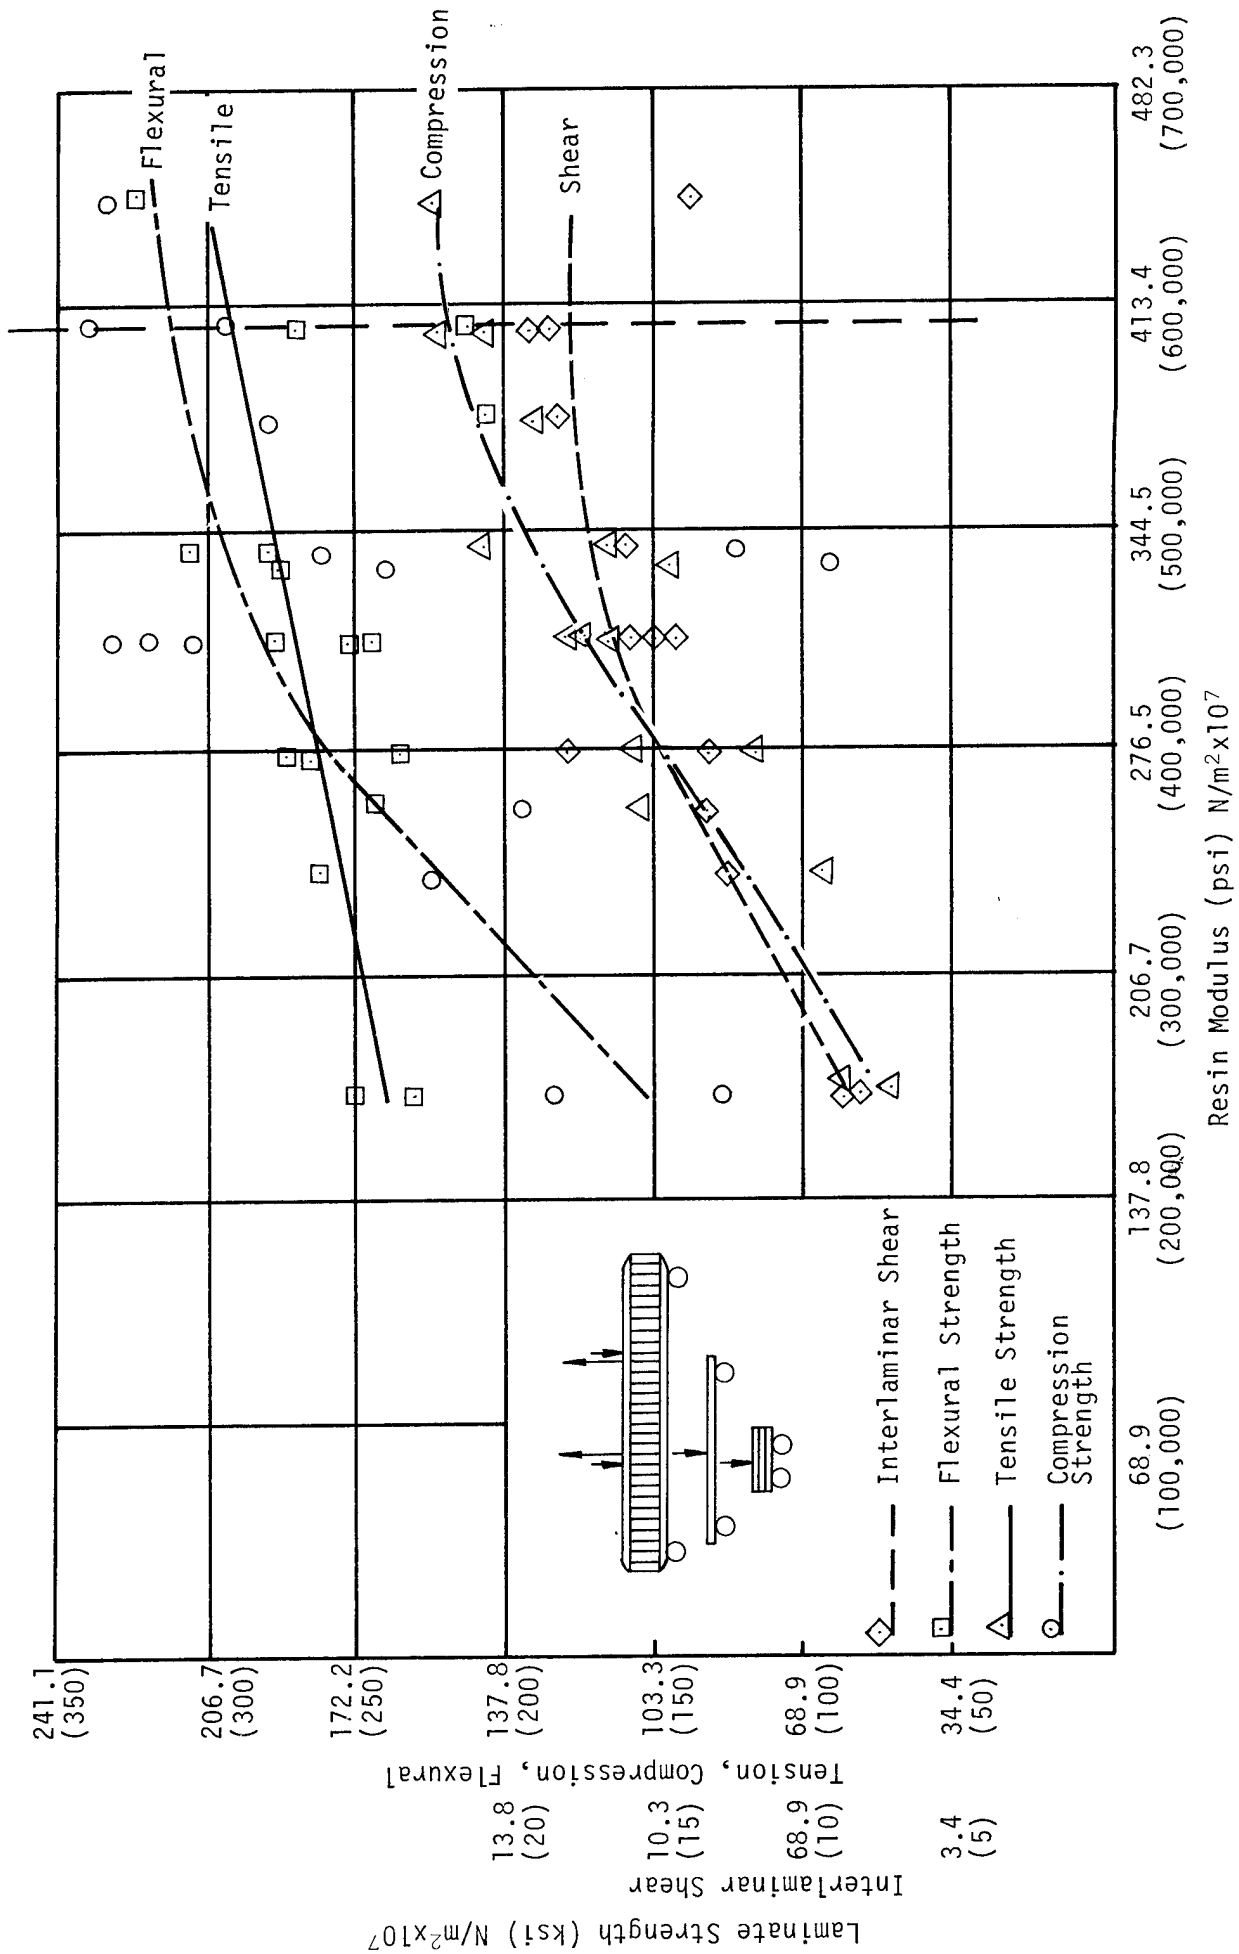
FIGURE 33. RESIN TENSILE MODULUS VS LAMINATE MECHANICAL PROPERTIES

The neat resin tensile modulus appears to be more important than resin tensile strength in controlling laminate mechanical properties. There is a rapid decline in flexural, interlaminar shear and compression strength in laminates when the resin tensile modulus falls much below  $344 \times 10^7 \text{ N/M}^2$  (500,000 psi) as shown in Figure 33. The laminate tensile strength is less affected with change in resin tensile modulus, but does show a gradual reduction in laminate tensile properties as the resin modulus declines.

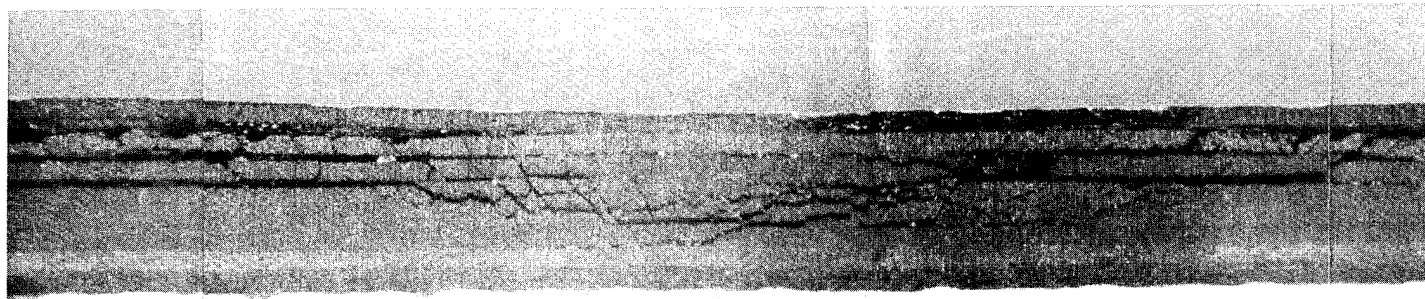
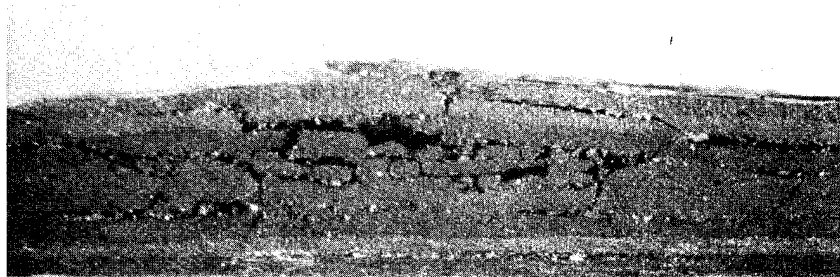
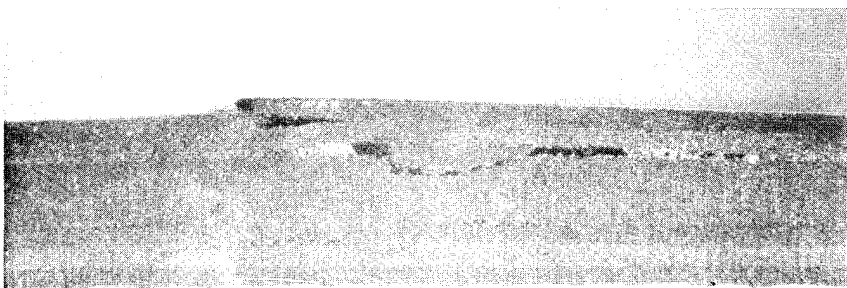
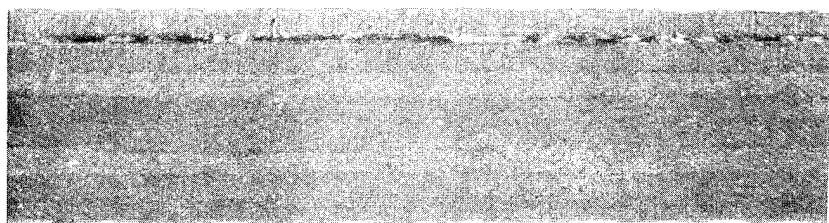
FIGURE 35. PHOTOMACROGRAPHS AT 20x & C-SCAN OF 2.26 JOULES (20 INCH POUNDS) IMPACT

a. Narmco 5208/T-300

b. Fiberdux 920

c. BP 907

d. Ciba Geigy #4

Figures 35, 36 and 37 show cross sectional photomicrographs at 20x magnification for composite plates constructed using Narmco 5208, BP 907, Ciba Geigy #4 and Fiberdux 920 resins and impacted by the Gardner Tester at several levels near the threshold of damage. (The arrow shows the point of impact.) C-scans of the same area are shown. The three toughened systems exhibit significantly less damage at all levels compared to 5208 as previously discussed. The majority of the damage occurred on the side opposite the impact.

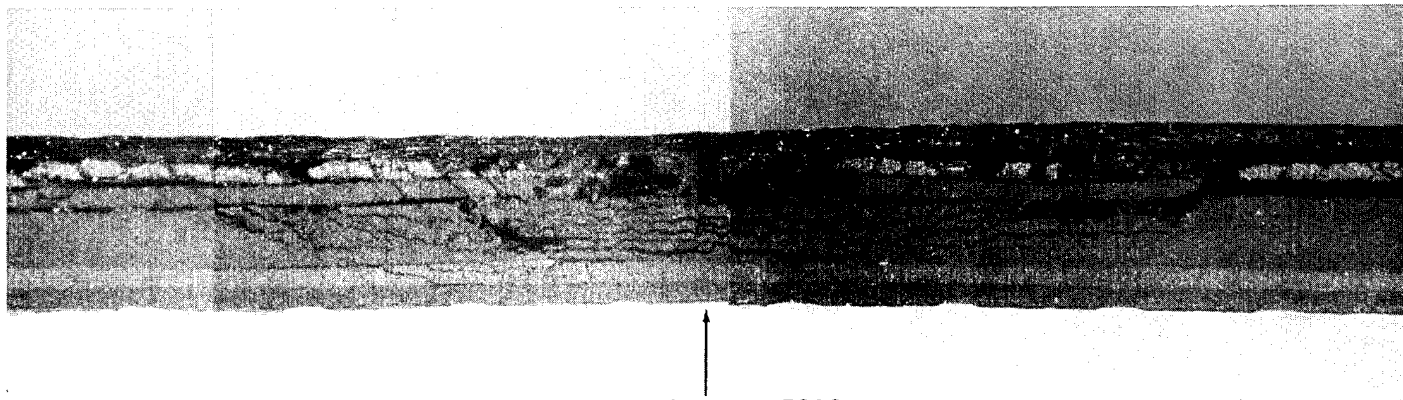
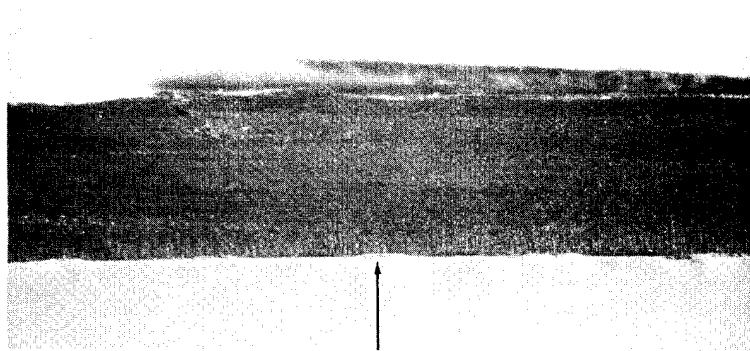
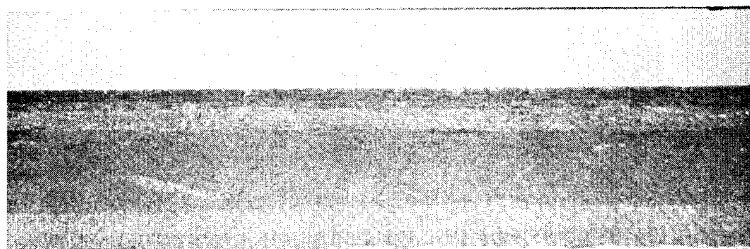
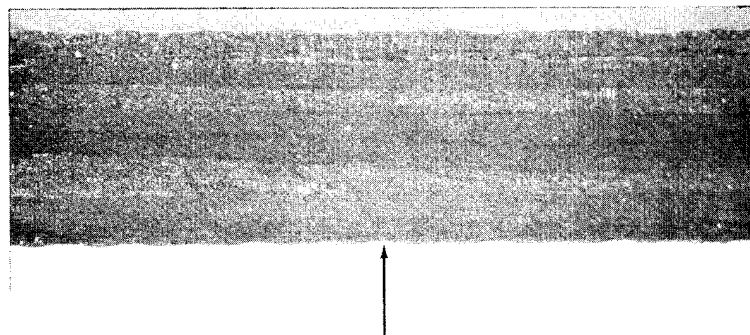
FIGURE 37. PHOTOMACROGRAPHS AT 20x AT IMPACT LEVELS BELOW VISUAL SURFACE DAMAGE

a. Narmco 5208

b. Fiberdux 920

c. BP-907

d. Ciba Geigy #4

The 5208 laminate was damaged at very low impact levels. Cracks and delaminations are present at .45 joules (4 inch pounds) (see Figure 37), well below the damage threshold of approximately 1.13 joules (10 inch pounds) for the other three materials. The 5208 laminate had one interesting failure characteristic; the resin cracks through the plies all point toward the point of impact. Thick laminates exhibit the same type of failure at comparative low impact levels. the toughened materials did not show this type of failure. In general, they failed by delamination with the exception of Fiberdux 920, which randomly shattered at 2.26 joules (20 inch pounds).

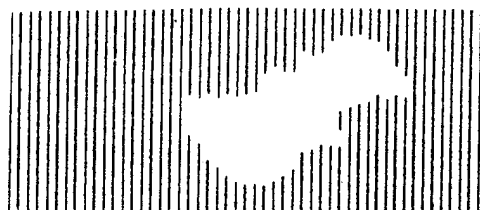
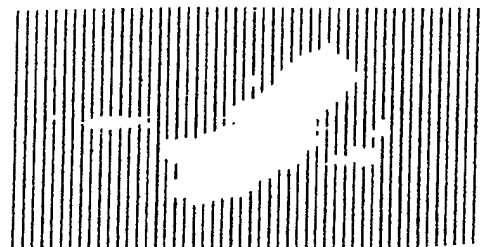
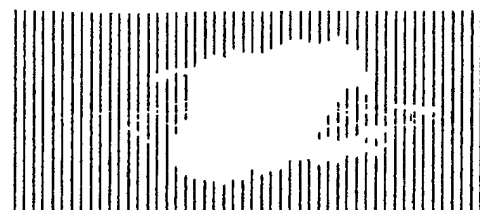
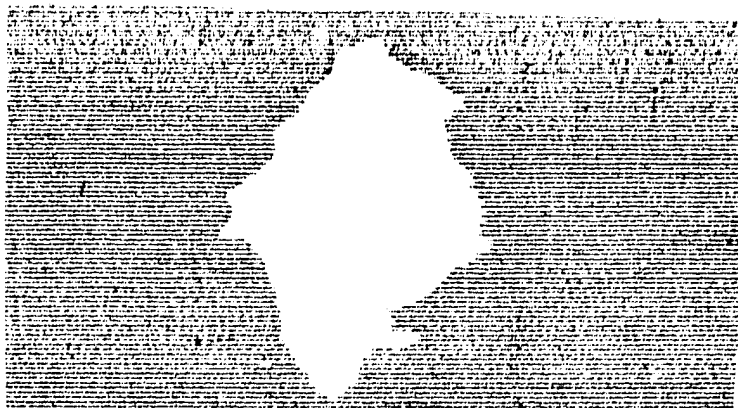
C-SCAN DAMAGE  
 JOULES (IN/LBS)

1.13  
 (10)

2.26  
 (20)

3.39  
 (30)

6.87  
 (60)

9.03  
 (80)

damage to be higher. The impact area of damage at 6.78 (60) and 9.03 joules (80 inch pounds) was actually less than the 3.39 joules (30 inch pound) impact with the round head.

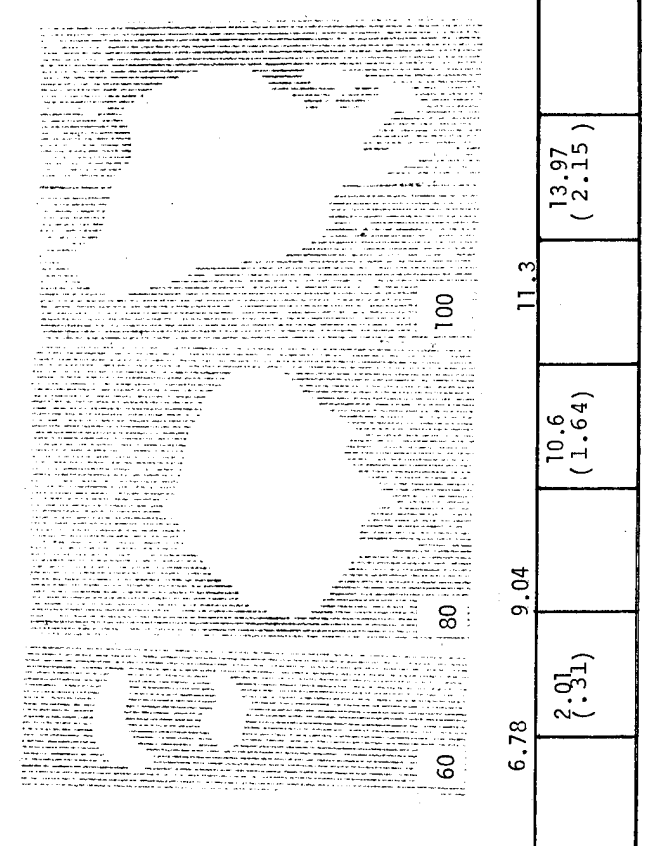
FIGURE A-19 IMPACT DAMAGE DATA FOR (0/+45/90)s LAMINATE USING FIBREDUX 920 RESIN REFERENCE PANEL

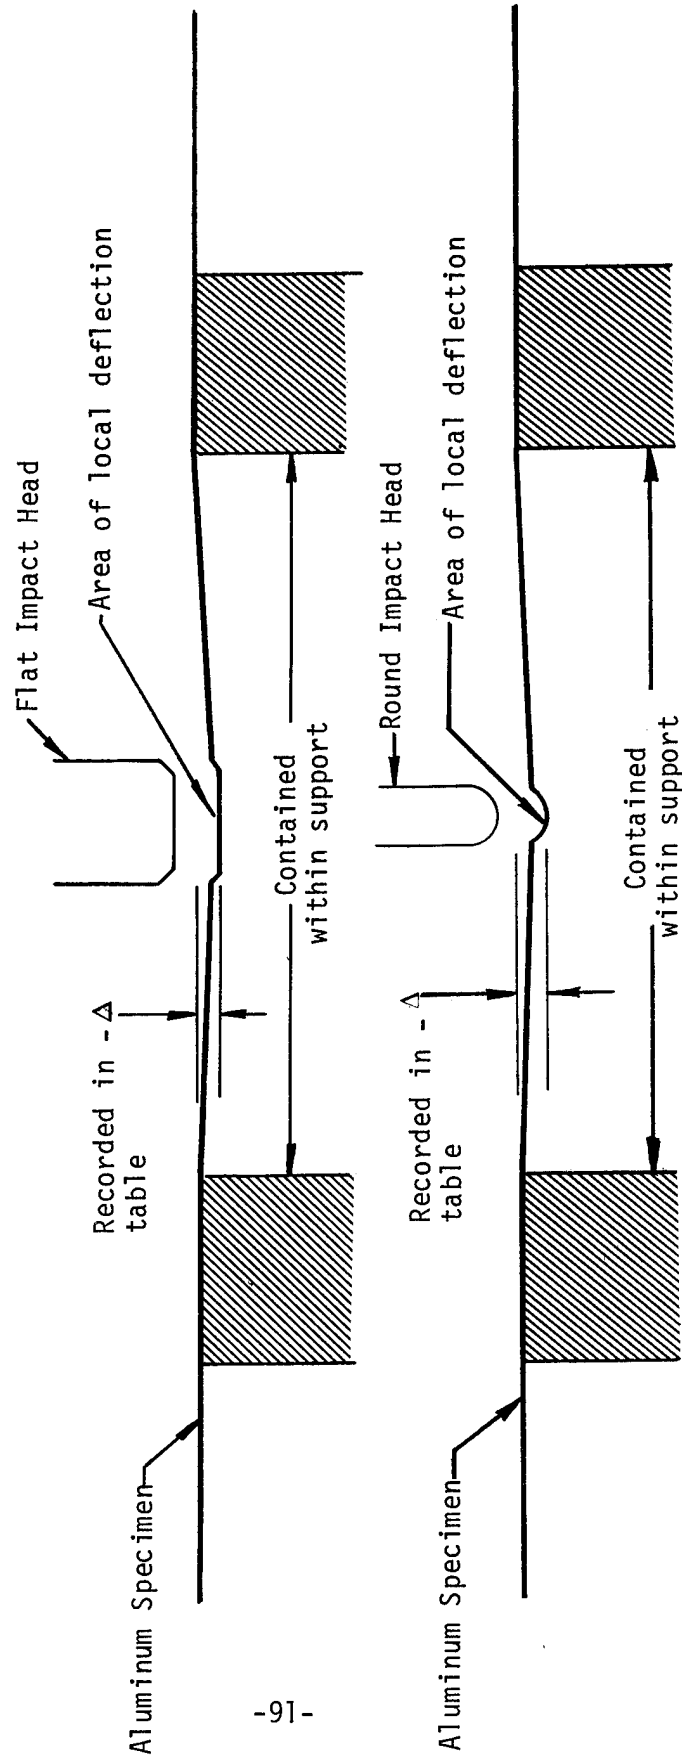
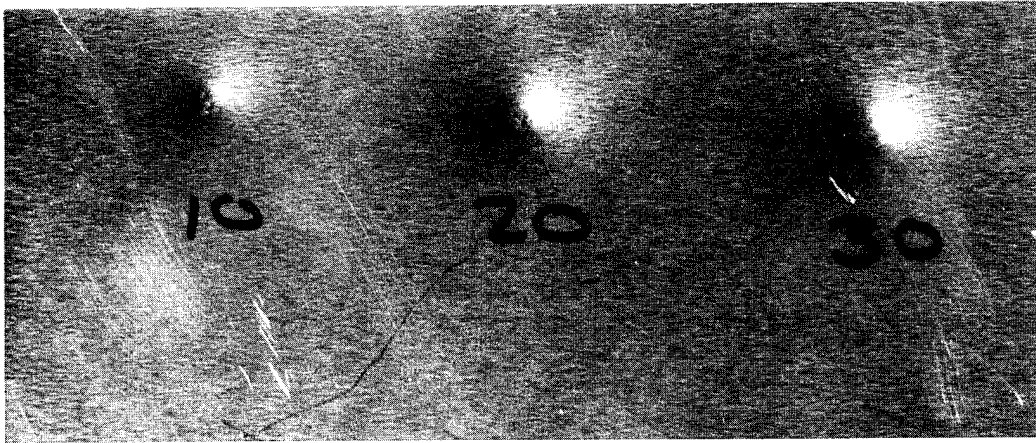
FIGURE B-1 2024-T3 .98 mm (.040") 14.9 mm (5/8") ROUND, 31.7 mm (1.25")  
SUPPORT 1.13 (10), 2.25 (20), 3.39 JOULES (30 INCH POUNDS)

Photographs B-1 through B-12 show the damage to .98 mm and .61 mm thick aluminum alloy 2024-T3 impacted at the same levels as the graphite/epoxy laminates. The .98 mm sheet is approximately the same thickness as the GR/EP panels and the .61 mm sheet is approximately equal weight for a given surface area as the composite panels.

There was no fracturing, however the aluminum yielded significantly in the direction of impact; the area of damage was equal to the area within the back support. As would be expected the maximum deformation took place at the point of impact, this deflection is recorded in Table B-1.

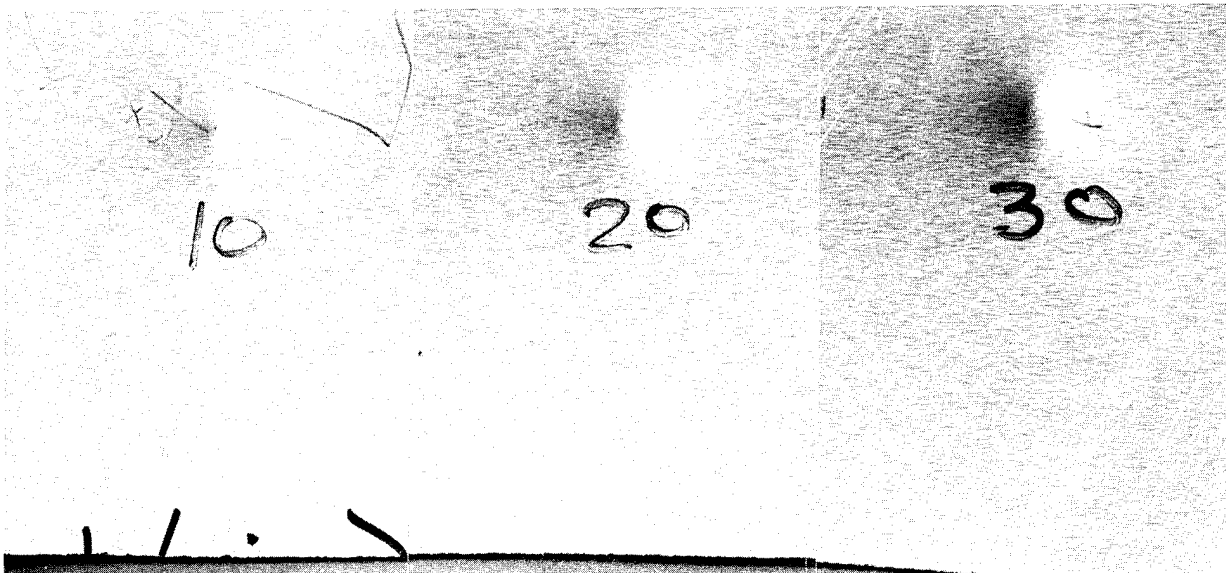
FIGURE B-2 2024-T3 .98 mm (.040") 15.9 mm (5/8") ROUND, 95.3 mm (3.75")  
SUPPORT 1.13 (10), 2.26 (20), 3.39 JOULES (30 INCH POUNDS)

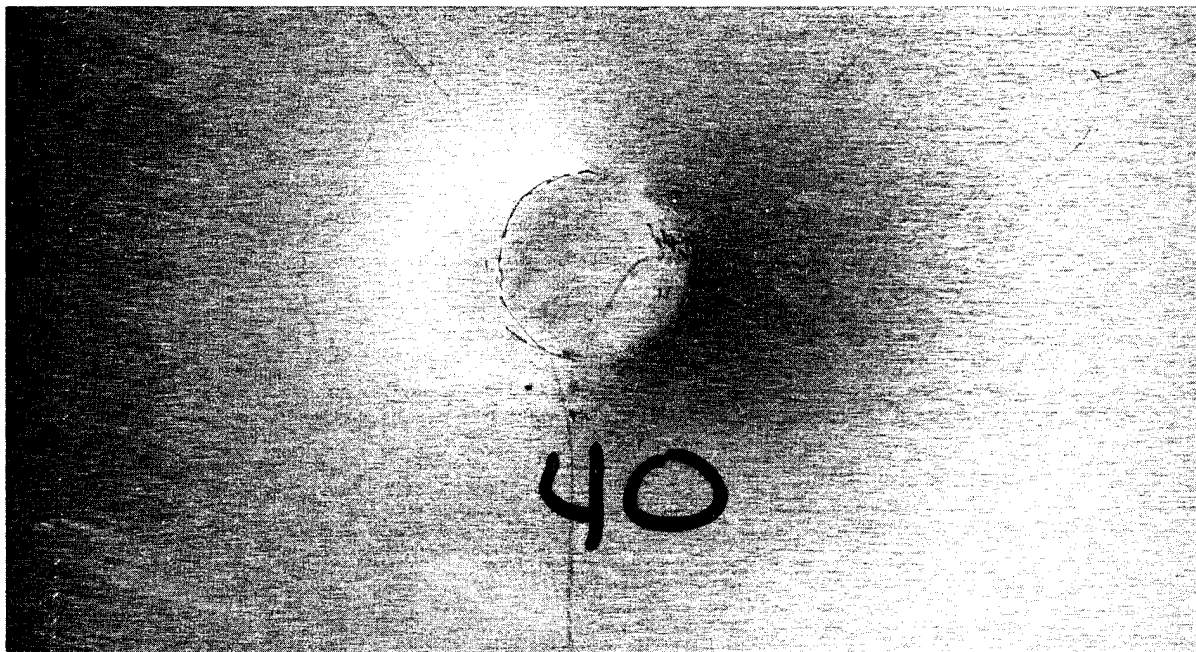
FIGURE B-3 2024-T3 .98 mm (.040") 15.9 mm (5/8") FLAT, 95.3 mm (3.75") SUPPORT  
4.52 JOULES (40 INCH POUNDS)

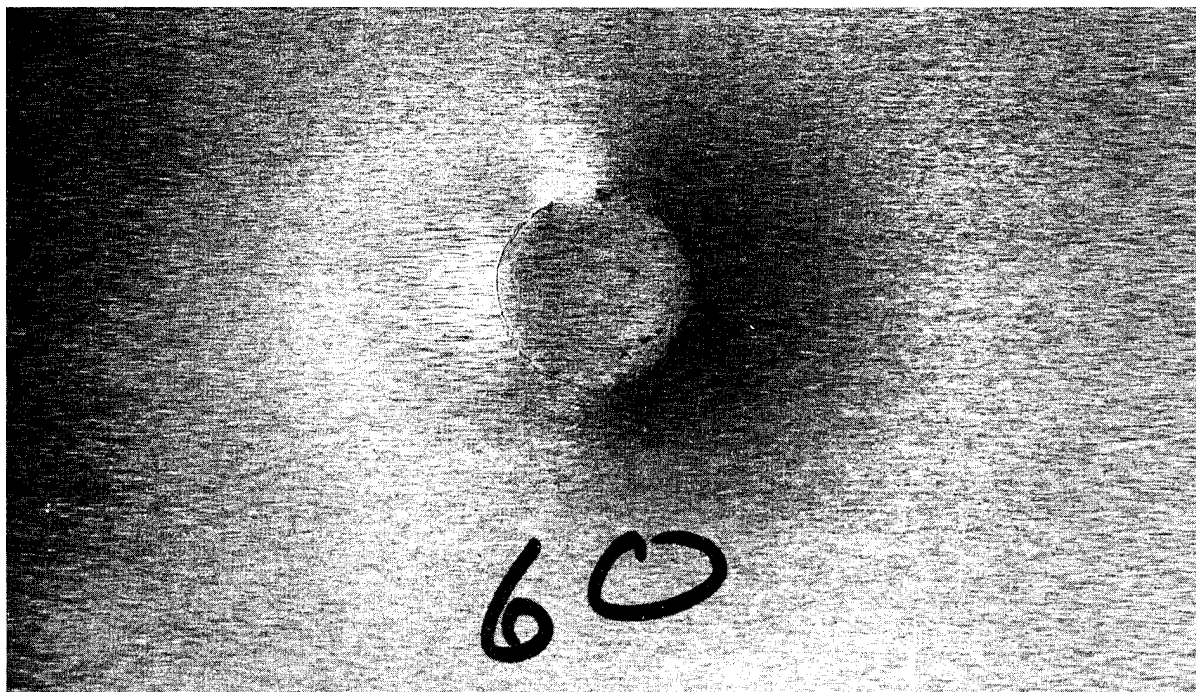
FIGURE B-4 2024-T3 .98 mm (.040") 15.9 mm (5/8") FLAT 95.3 mm (3.75") SUPPORT  
6.78 JOULES (60 INCH POUNDS)

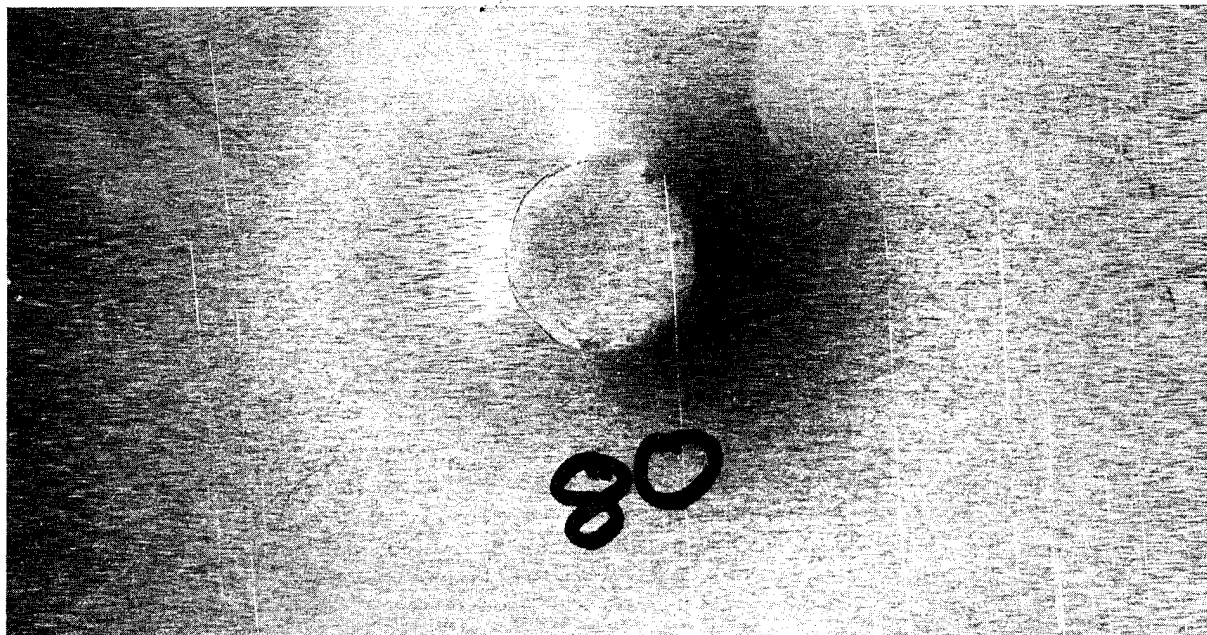
FIGURE B-5 2024-T3 .98 mm (.040") 15.9 mm (5/8") FLAT 95.3 mm (3.75")  
SUPPORT 6.78 JOULES (60 INCH POUNDS)

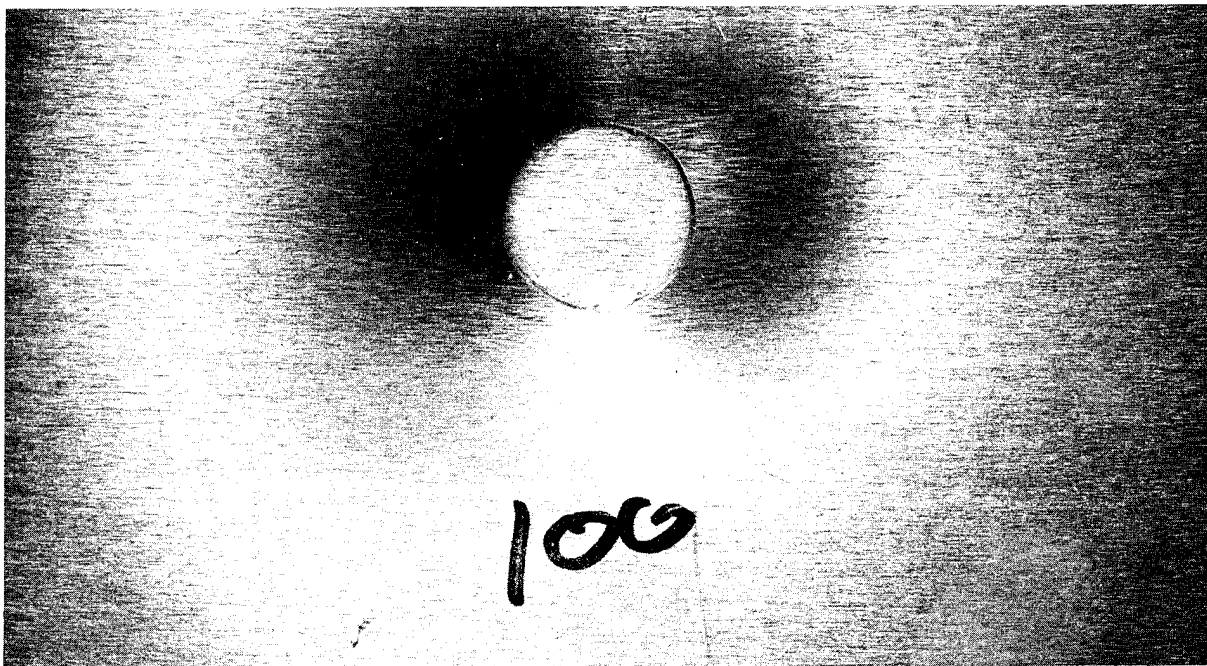
FIGURE B-6 2024-T3 .98 mm (.040") 15.9 mm (5/8") FLAT 95.3 mm (3.75")  
SUPPORT 11.3 JOULES (100 INCH POUNDS)

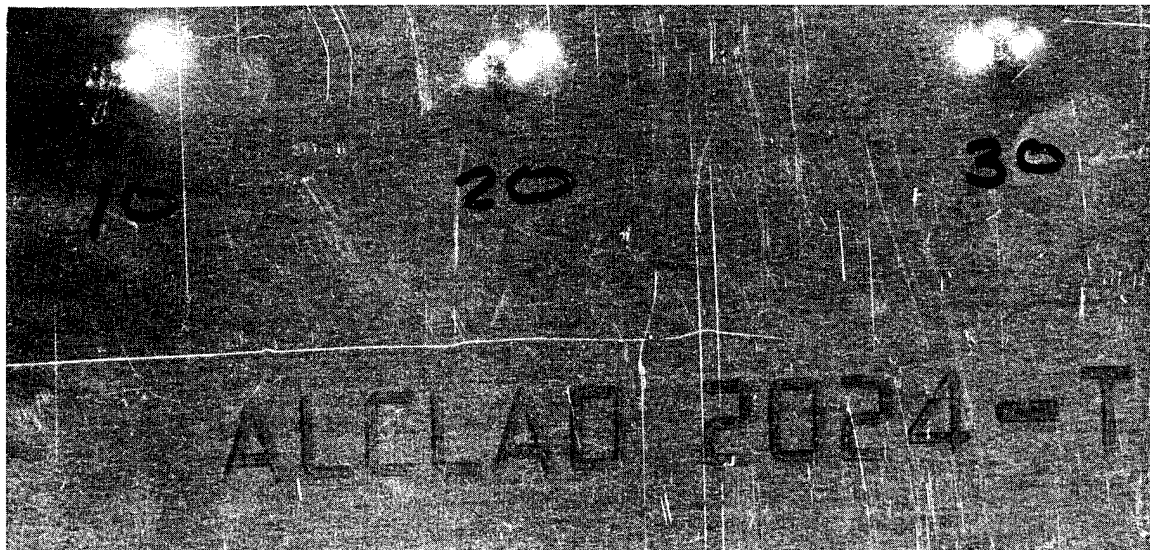
FIGURE B-7 2024-T3 .61 mm (0.25") 15.9 mm (5/8") ROUND, 31.7 mm (1.25")  
SUPPORT 1.13 (10), 2.26 (20), 3.39 JOULES (30 INCH POUNDS)

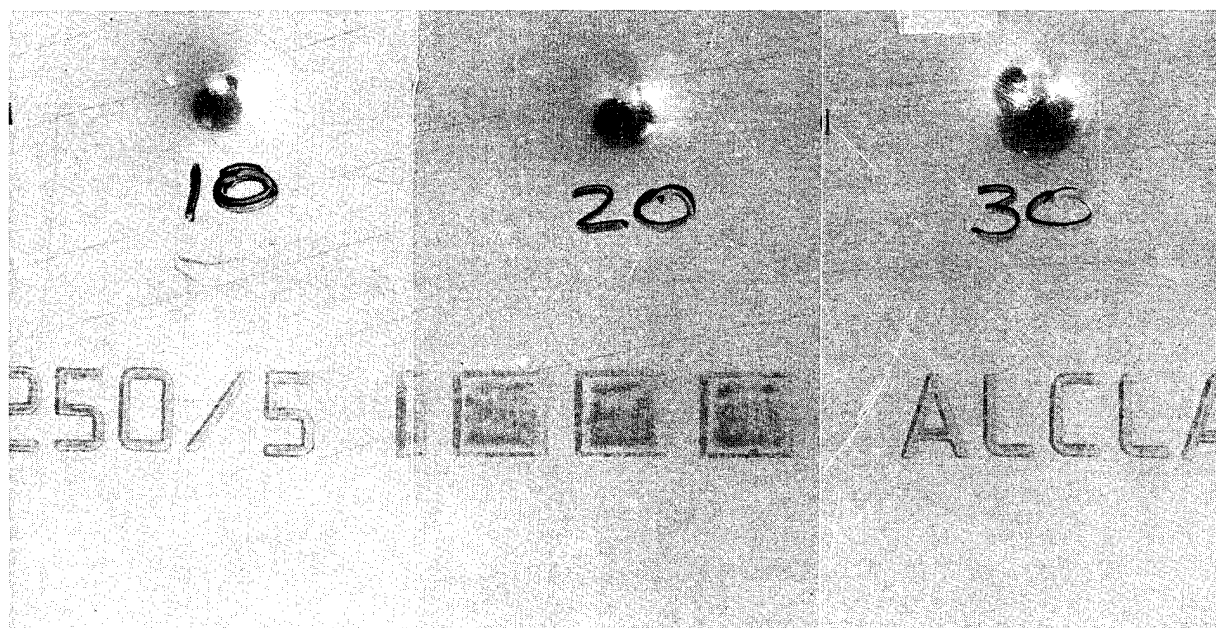
FIGURE B-8 2024-T3 .61 mm (.025") 14.9 mm (5/8") ROUND, 95.3 mm (3.75")  
SUPPORT 1.13 (10), 2.25 (20), 3.39 JOULES (30 INCH POUNDS)

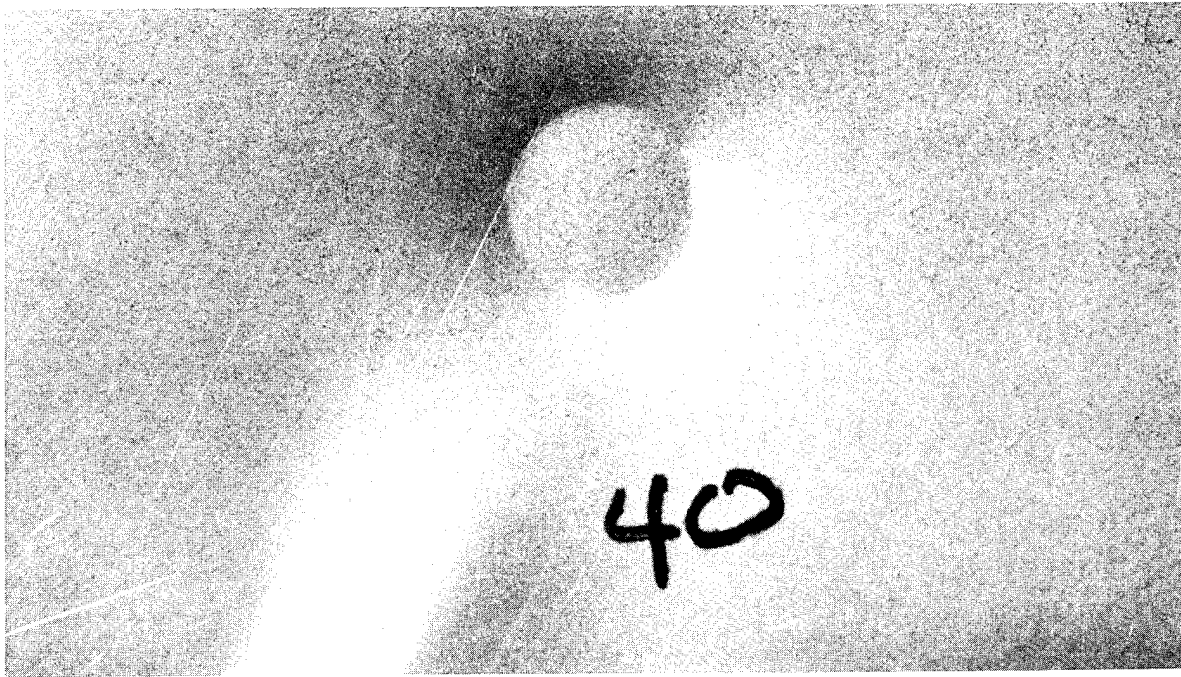
FIGURE B-9 2024-T3 .61 mm (.025") 15.9 mm (5/8") FLAT, 95.3 mm (3.75")  
SUPPORT 4.52 JOULES (40 INCH POUNDS)

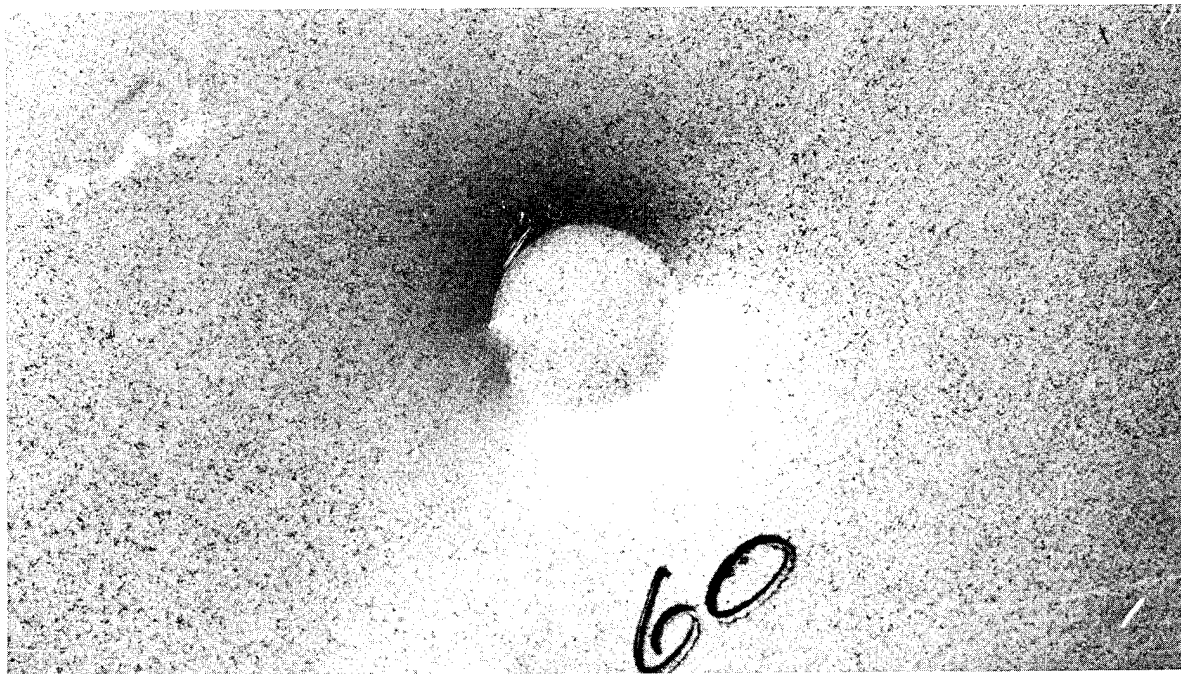
FIGURE B-10 2024-T3 .61 mm (.025") 15.9 mm (5/8") FLAT 95.3 mm (3.75")  
SUPPORT 6.78 JOULES (60 INCH POUNDS)

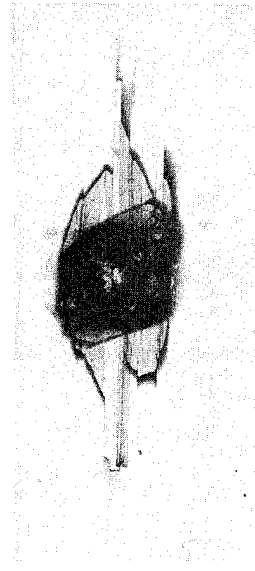
X-ray of damaged area

FIGURE C-10 RHEOMETRIC AND X-RAY DATA FOR U.S. POLYMERIC #2 LAMINATE

The Rheometric Constant Speed Penetrating Impact machine load deflection curves, data reduction for slope of curve and impact energy absorbed and X-ray of the damaged areas are recorded for ten materials in Appendix 3. Diiodobutane (DIB) was used to aid X-ray.
