NASA CR-134555

**THIN-METAL LINED PRD 49-III COMPOSITE
VESSELS**

**THE BOEING AEROSPACE COMPANY
RESEARCH AND ENGINEERING DIVISION
SEATTLE, WASHINGTON**

JANUARY 1974

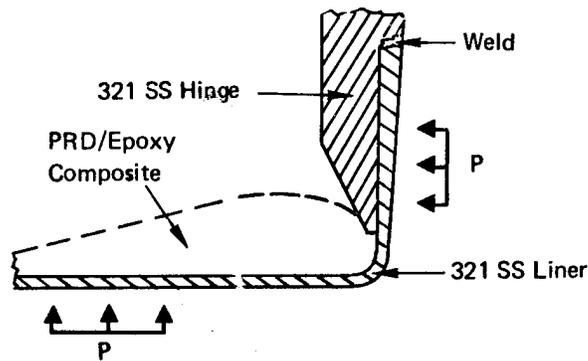
An idealized model of the boss is shown in the following schematic.

Referring to the schematic, pressure is applied over the entire internal surface of the stainless steel liner (including the neck section) forcing the liner to strain with the filament wound composite. Pressure vent holes are provided in the boss body (not shown in schematic) to allow for this action. Computer output indicated the biaxial strain in this region of the membrane induced by the burst pressure was 0.021 in/in (0.021 cm/cm) resulting in a metal membrane stress of 53.5 ksi. ($3.67 \times 10^8 \text{ N/m}^2$).

In the region where the composite "build-up" no longer provides backing for, or strain control of the liner, a structural hinge (short cylinder) is incorporated.

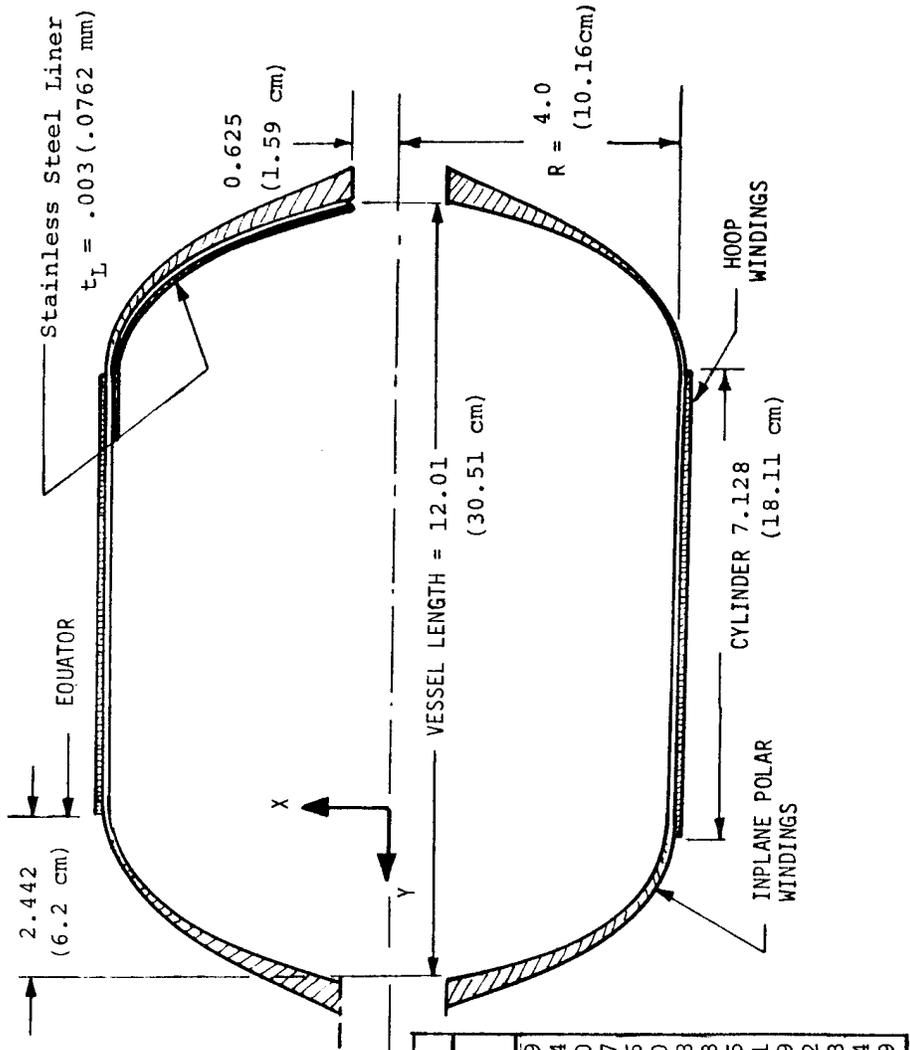
FIGURE 1 SCHEMATIC OF 8 IN. DIAMETER (20.3 cm) PRESSURE VESSEL

DOME CONTOUR				
	Inches		cm	
	Y	X	Y	X
Equator	0.000	3.992	0.000	10.139
	0.159	3.982	0.404	10.114
	0.359	3.961	0.912	10.060
	0.558	3.916	1.417	9.947
	0.757	3.849	1.923	9.776
	0.956	3.760	2.428	9.550
	1.155	3.645	2.934	9.258
	1.354	3.501	3.439	8.893
	1.553	3.321	3.945	8.435
	1.752	3.095	4.450	7.861
	1.950	2.905	4.953	7.379
	2.147	2.414	5.453	6.132
	2.308	1.962	5.862	4.983
	2.325	1.545	5.906	3.924
	2.436	1.153	6.187	2.929
Boss

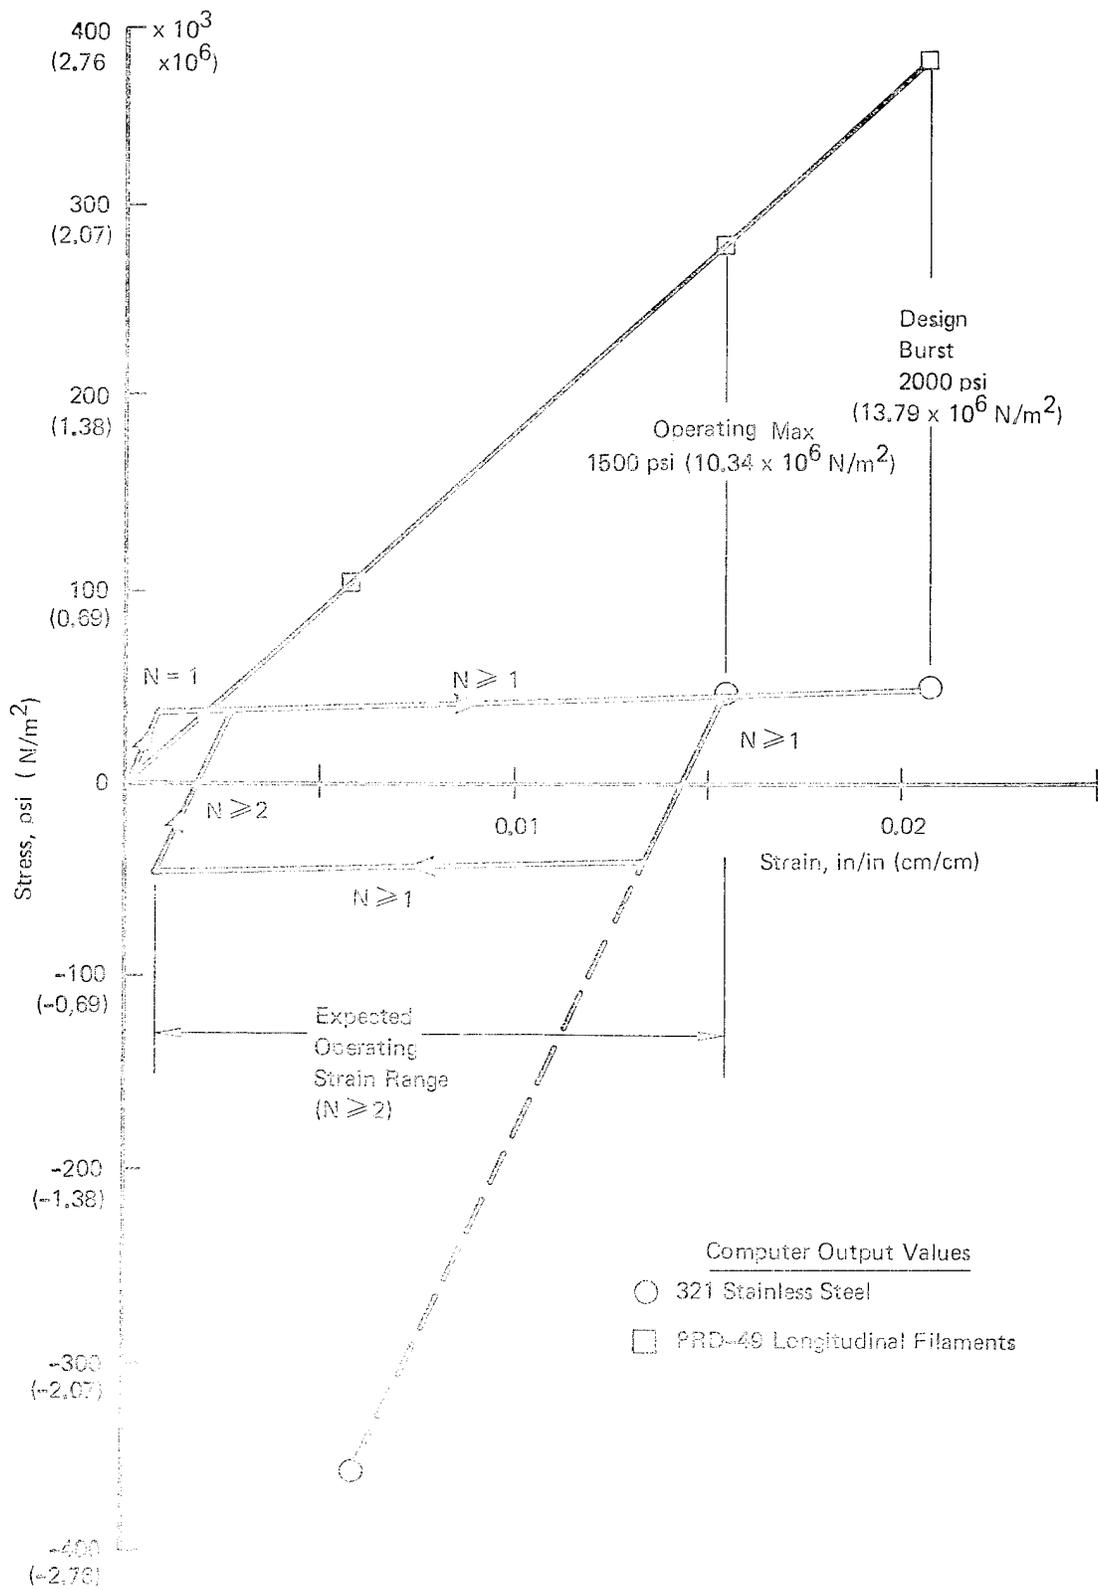
Figure 2: Ambient Stress-Strain Relationships, Longitudinal Direction of Cylinder (N = Cycle No.)

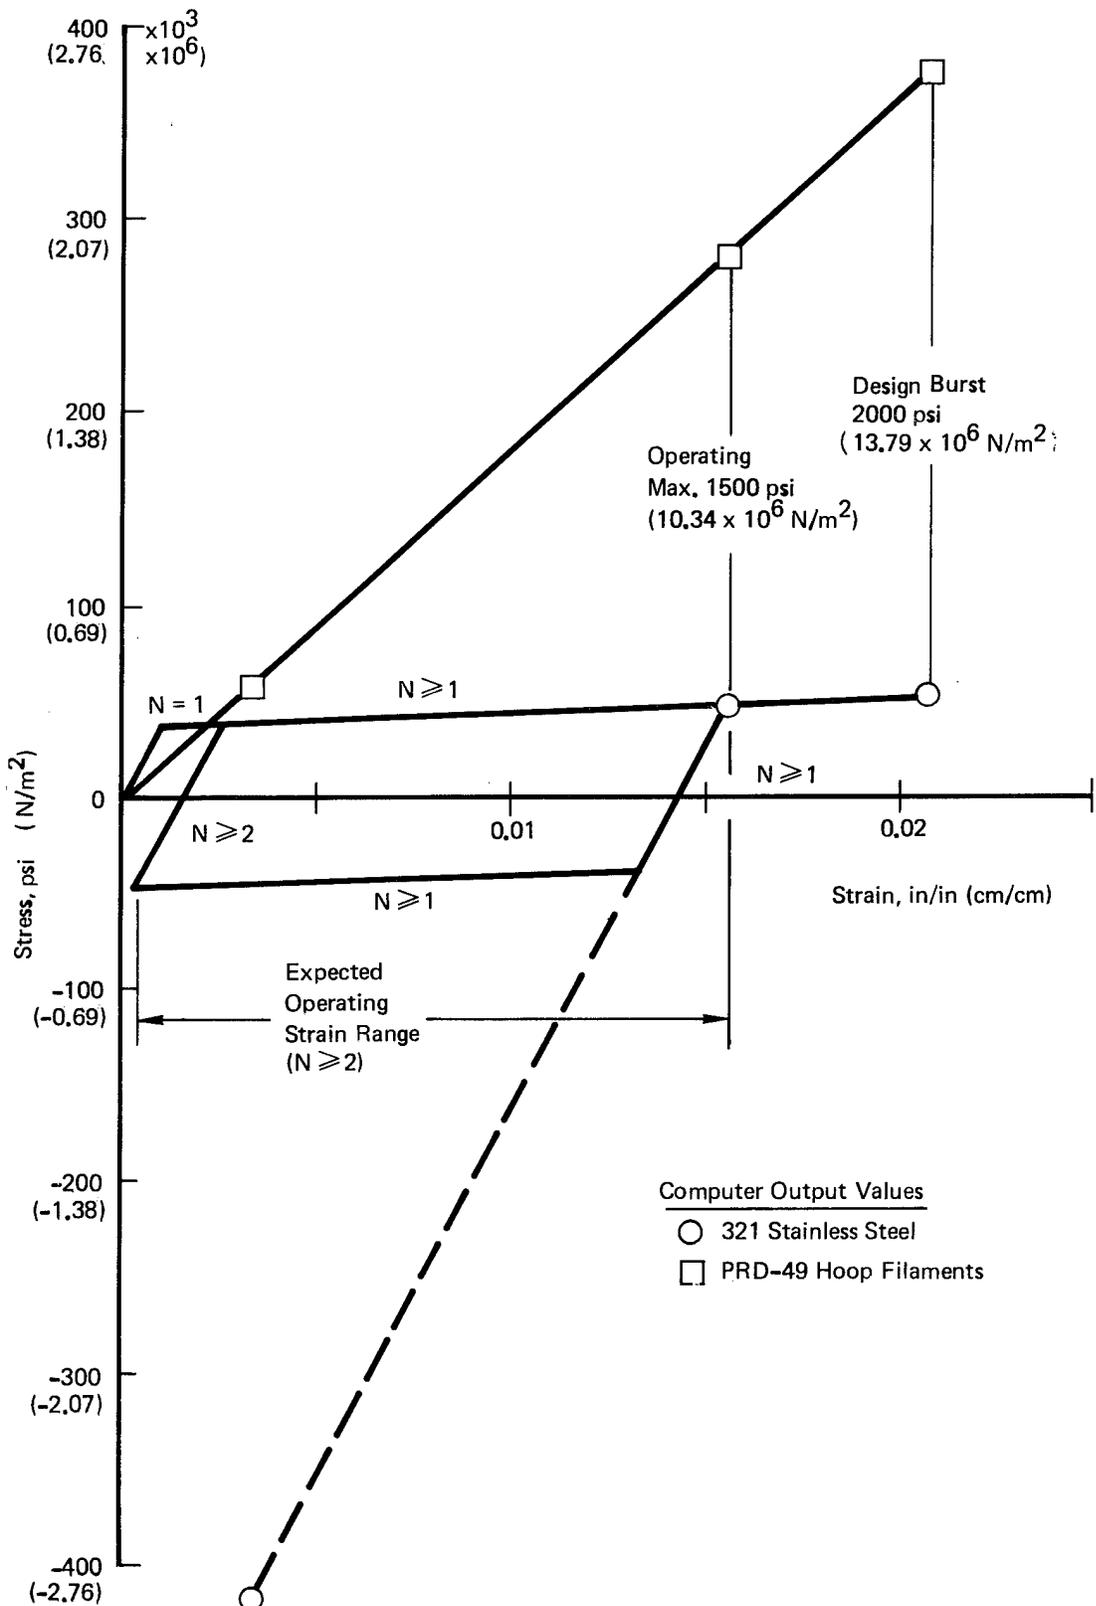
Figure 3 : Ambient Stress-Strain Relationships, Hoop Direction of Cylinder ($N =$ Cycle No.)

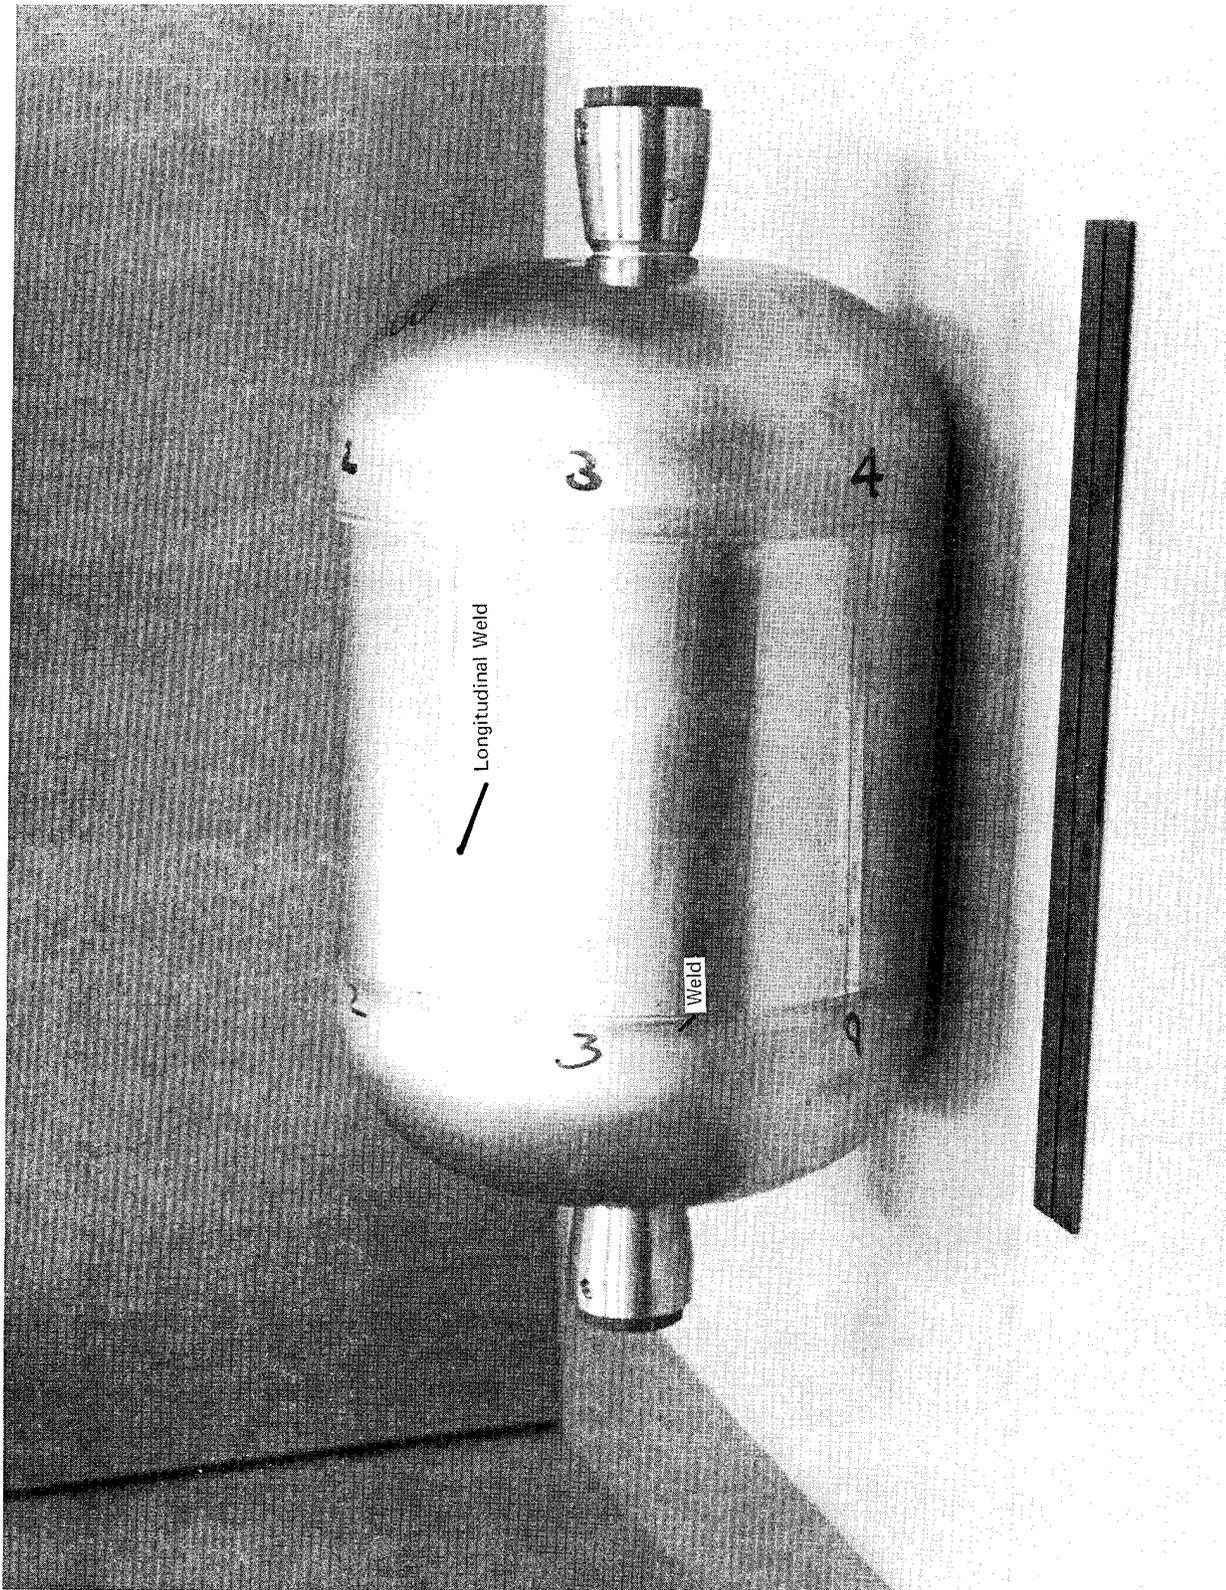
FIGURE 11 — METALLIC LINER—321 STAINLESS STEEL

The liner was subjected to X-ray inspection and helium leak checks and then weighed and labeled. A completed liner is shown in Figure 11.

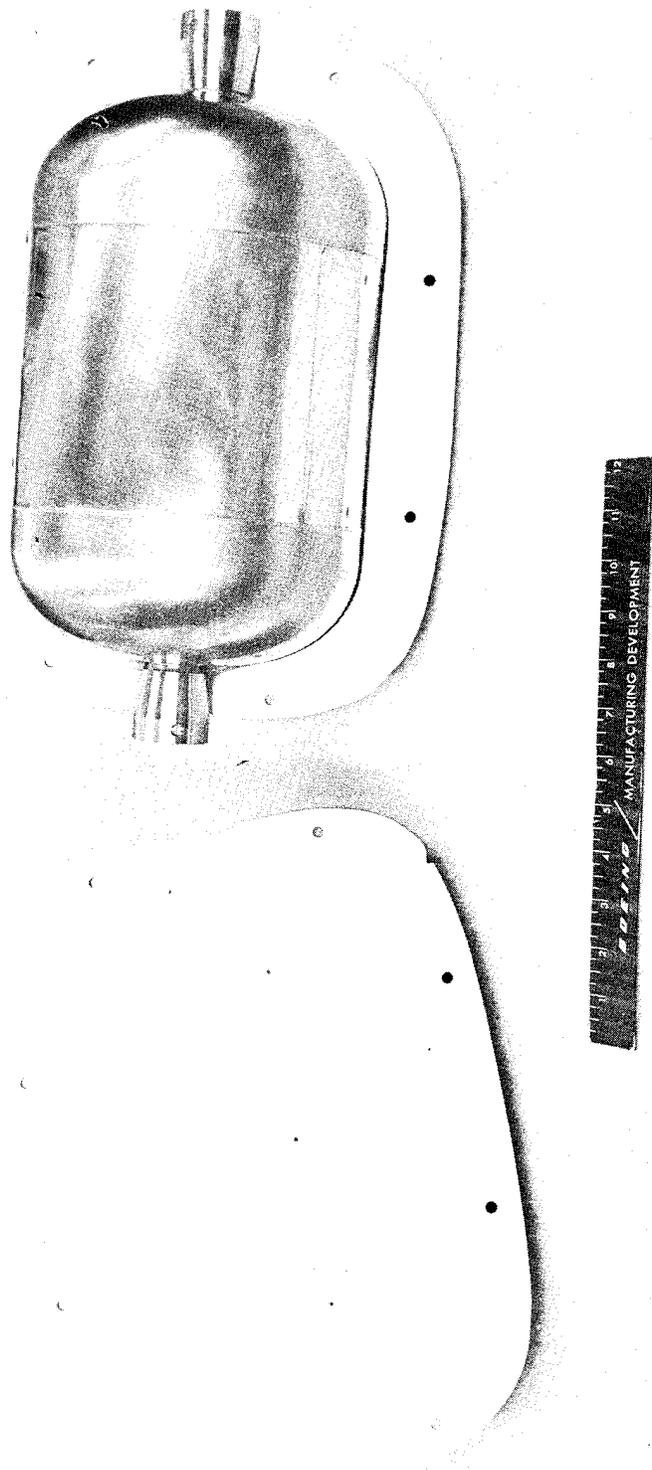
FIGURE 12--LINER STABILIZATION MOLD

In preparation for winding the vessels, the stainless steel mandrel was sized by placing it into a fiberglass mold. This mold, shown in Figure 12, was made to the exact outside contour of the liner. Since the liner was very unstable the sizing mold was used to obtain the correct vessel length and boss alignment. While the liner was in the mold the winding support shaft was installed and secured to the bosses. An internal pressure of 5 psi (3.45×10^4 N/m²) was applied to the liner to insure contact with the mold and then final adjustments were made.

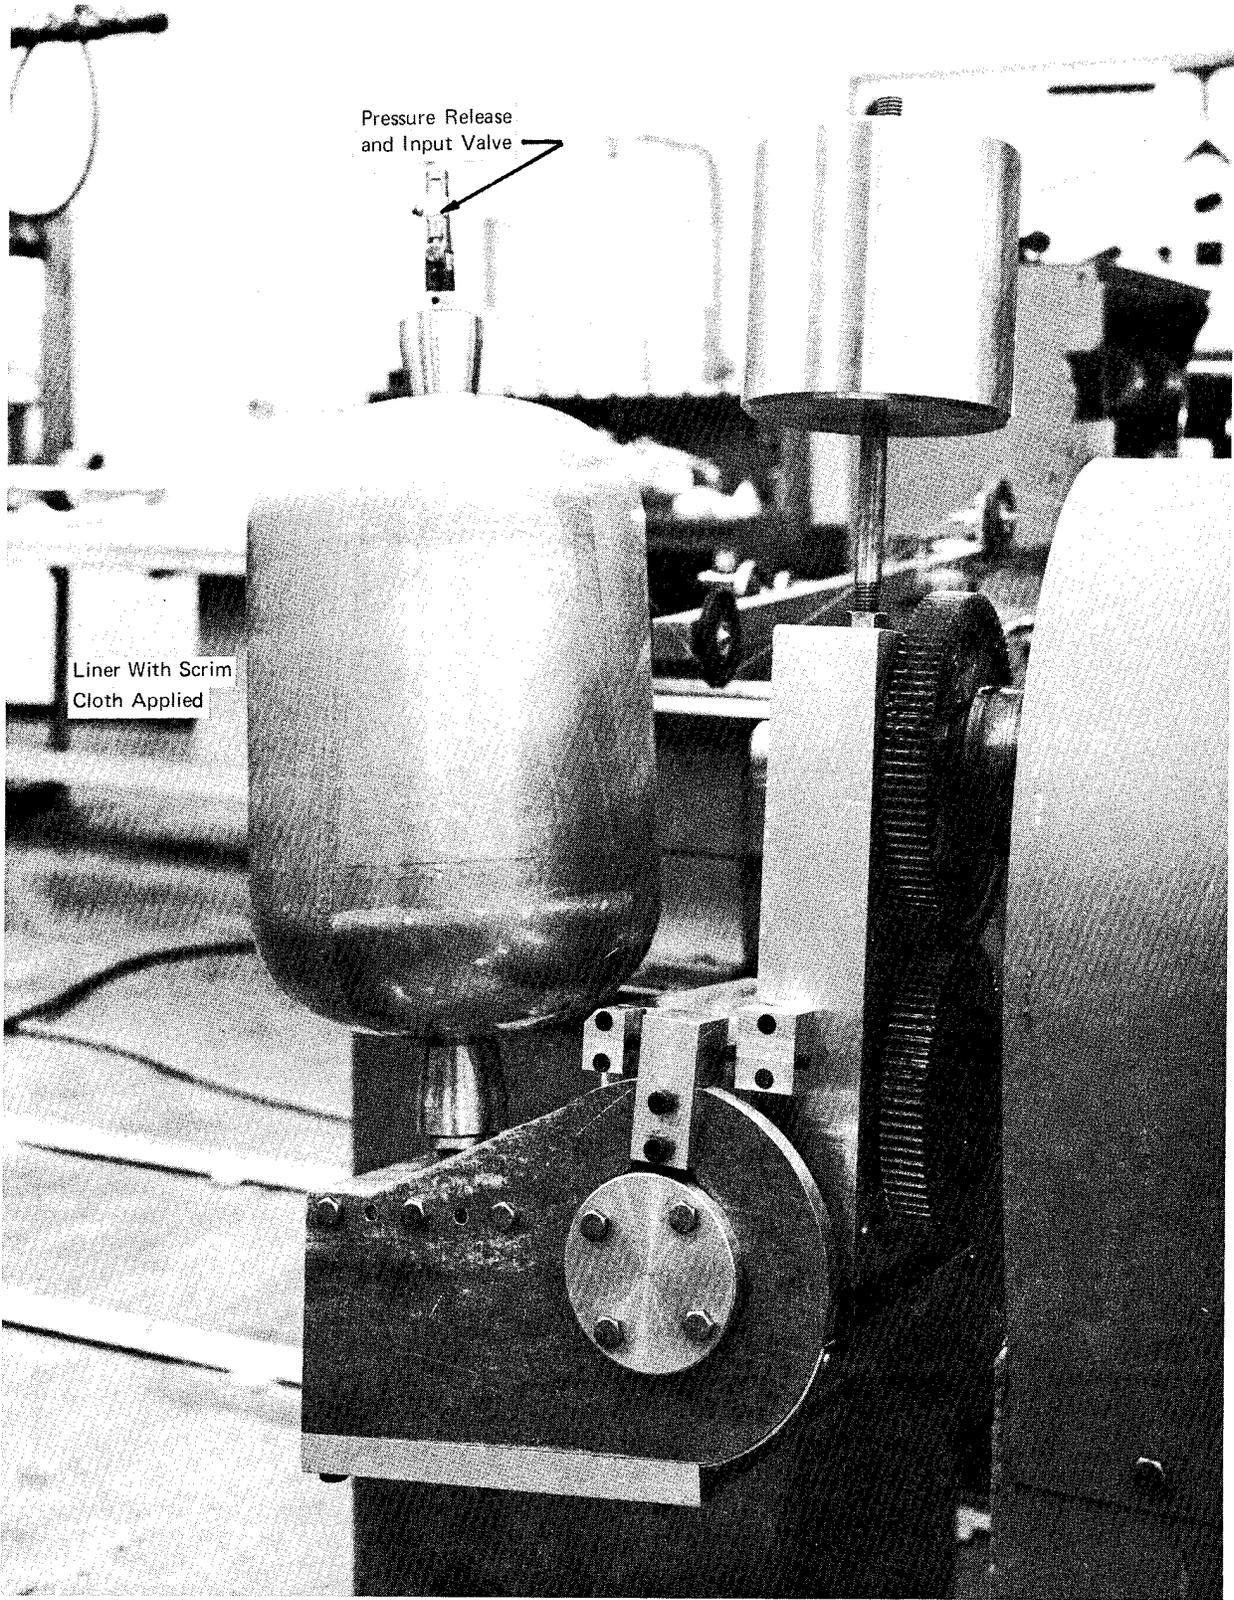
FIGURE 13—FILAMENT WINDING EQUIPMENT

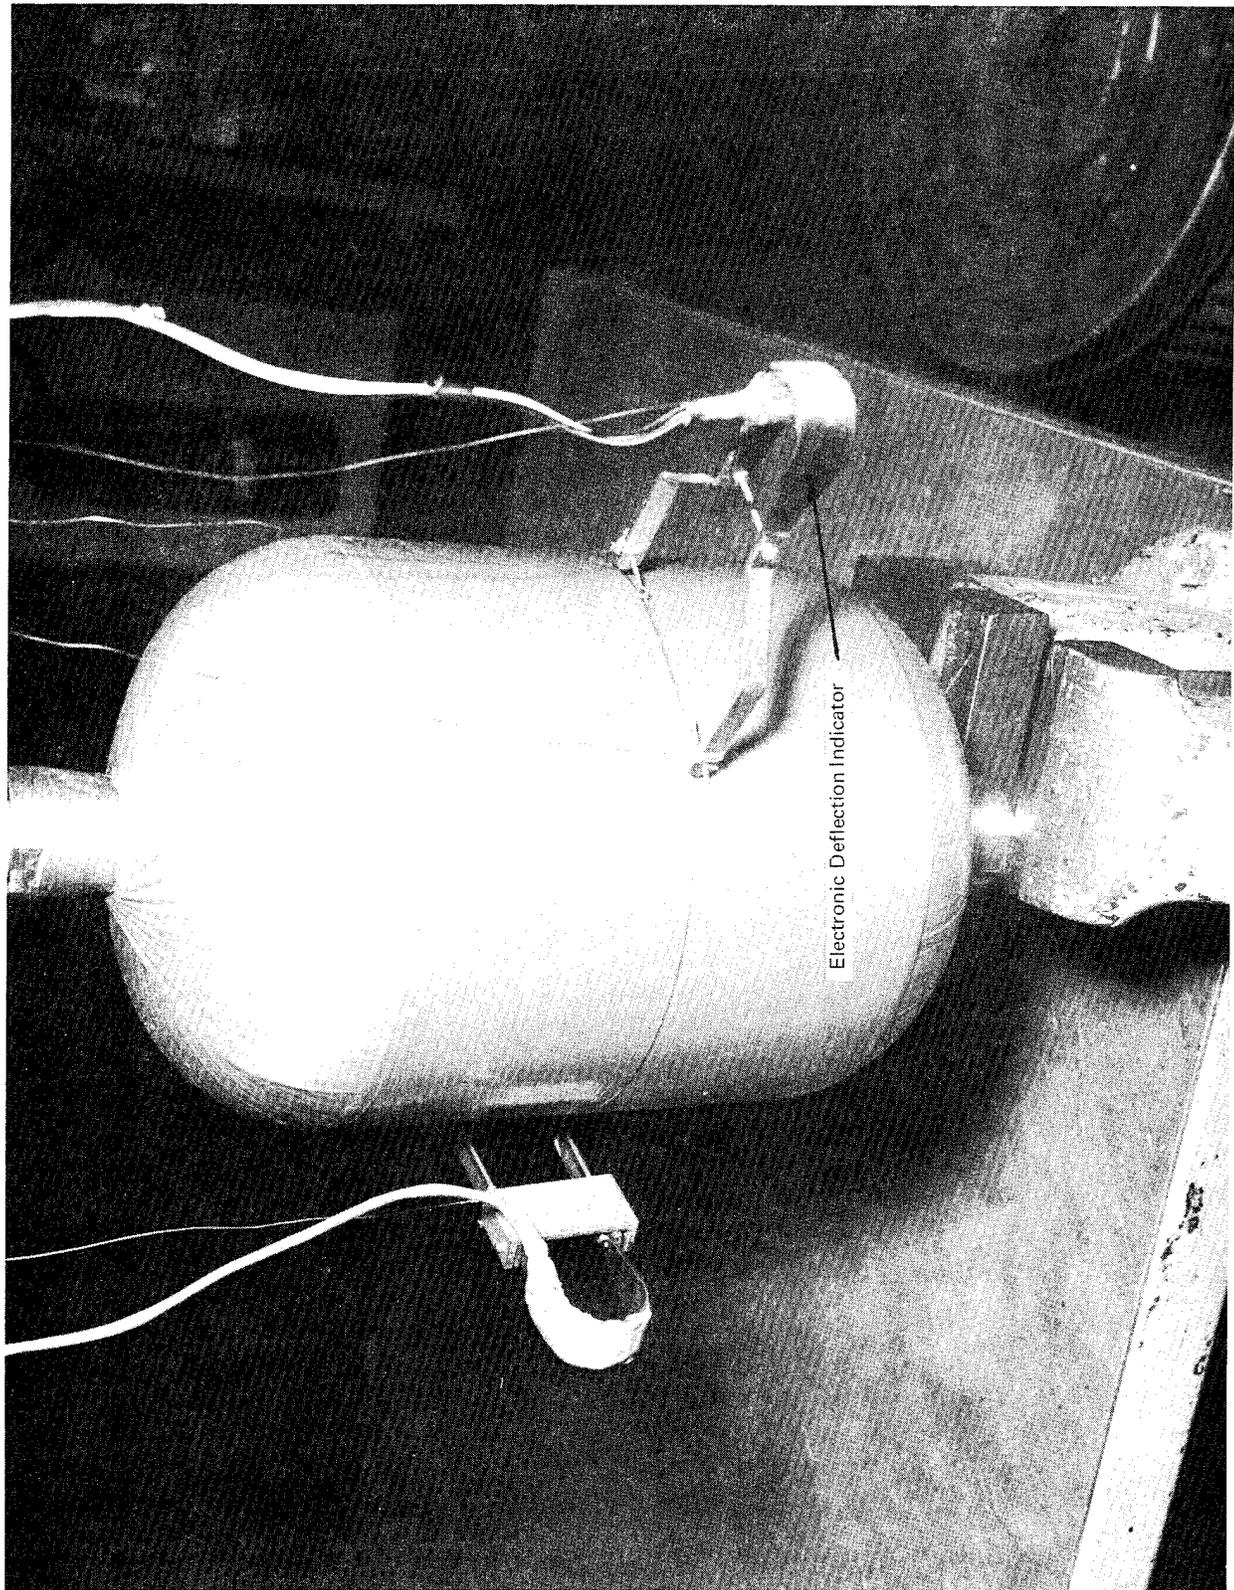
FIGURE 15—INSTRUMENTATION FOR CIRCUMFERENTIAL STRAIN MEASUREMENTS

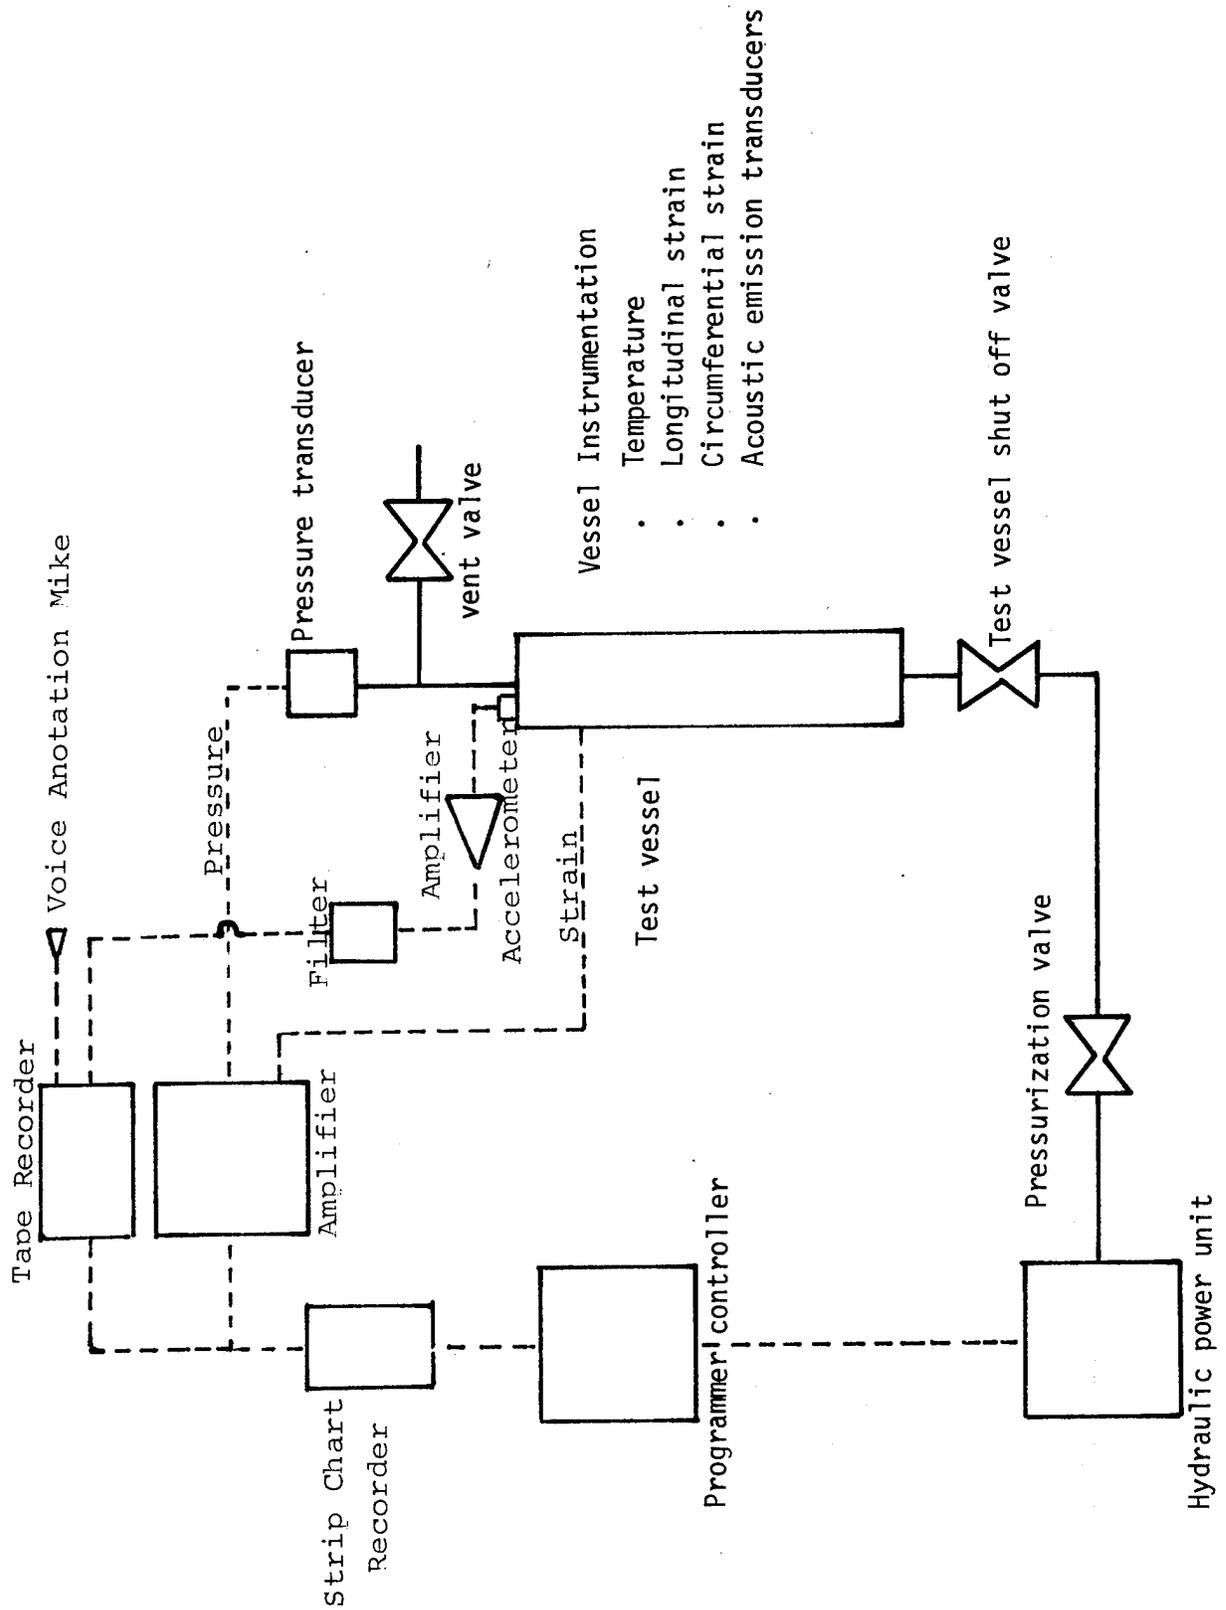
Figure 1.7 TEST SYSTEM (70°F)

Testing was performed with a hydraulic pump unit with a capacity of 55 gpm (208 lpm) at 3000 psig (20.7×10^6 N/m²). Pressure and pressurization rate was controlled through a closed loop servo valve system. A Data-trak programmer provided accurate and controlled pressurization rates and pressure cycle profiles. The test vessels were installed in a heavy steel chamber for safety precautions and to provide temperature control. A forced draft hot air heating system was used to maintain a temperature of 70°F \pm 5°F (21°C \pm 2°C) test temperature condition in the chamber.

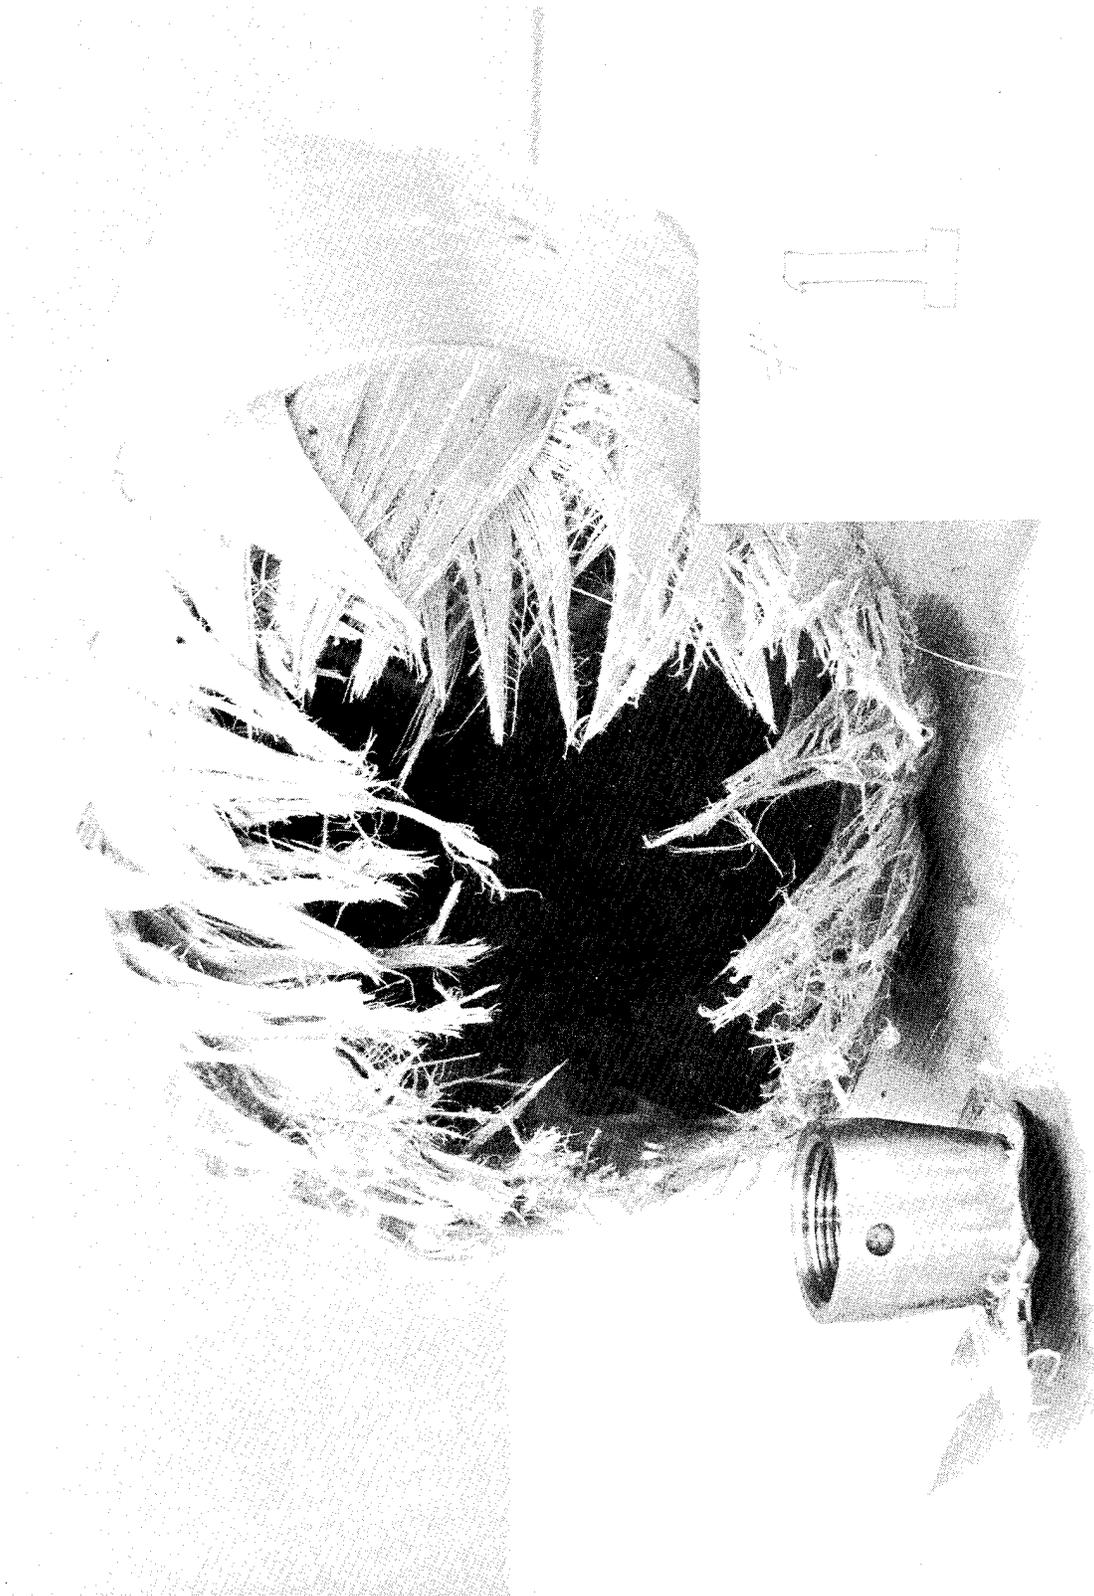
FIGURE 19—VESSEL NO. 1 AFTER BURST TEST

$P_{ult} = 2440 \text{ psig} [16.6 \times 10^6 \text{ N/m}^2]$

Vessel No. 1 burst at a pressure of 2440 psi (16.8×10^6 N/m²) with failure occurring in the dome (See Figure 19). The circumferential strain was significantly lower than the longitudinal strain, as shown in Figure 20 , which is undesirable for maximum fiber efficiency. This poor efficiency was reflected in a low performance factor for the vessel. To force the burst into the cylindrical section of the vessel, the number of circumferential windings were reduced from 800 to 760 yarns/inch (315 to 300 yarns/cm) for Vessel No. 2.

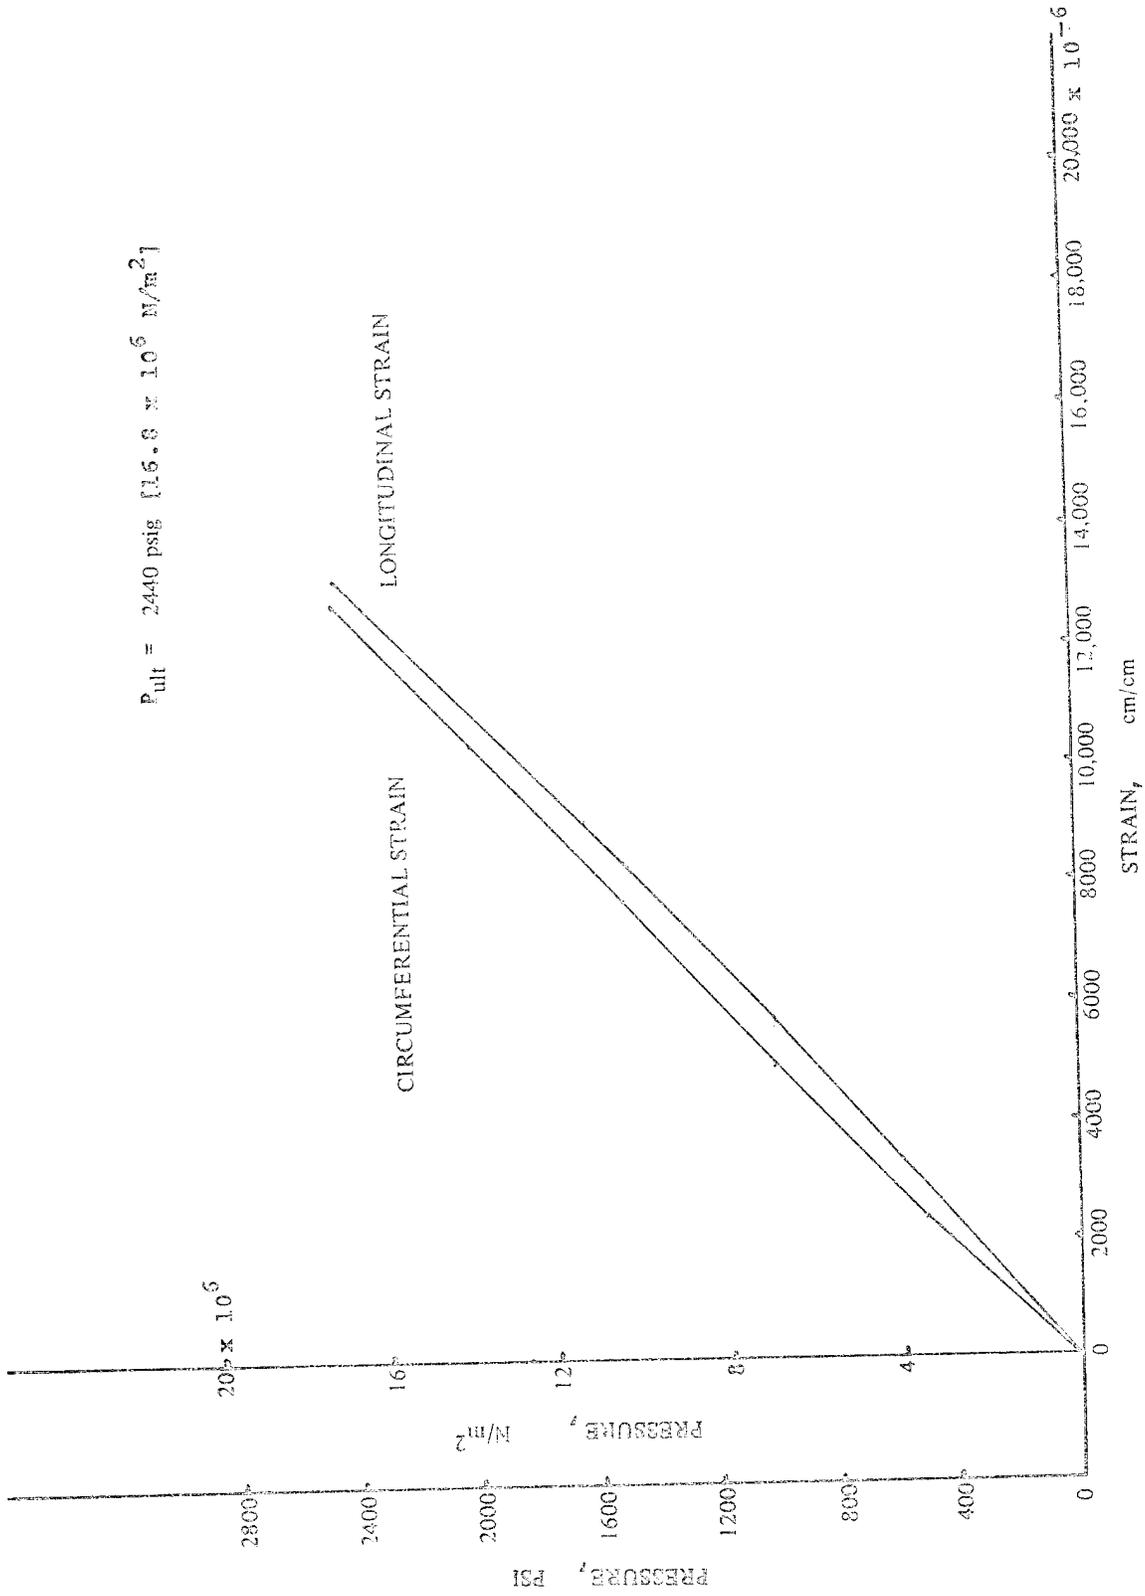
FIGURE 20 PRESSURE VS. STRAIN RELATIONSHIP - VESSEL NO. 1

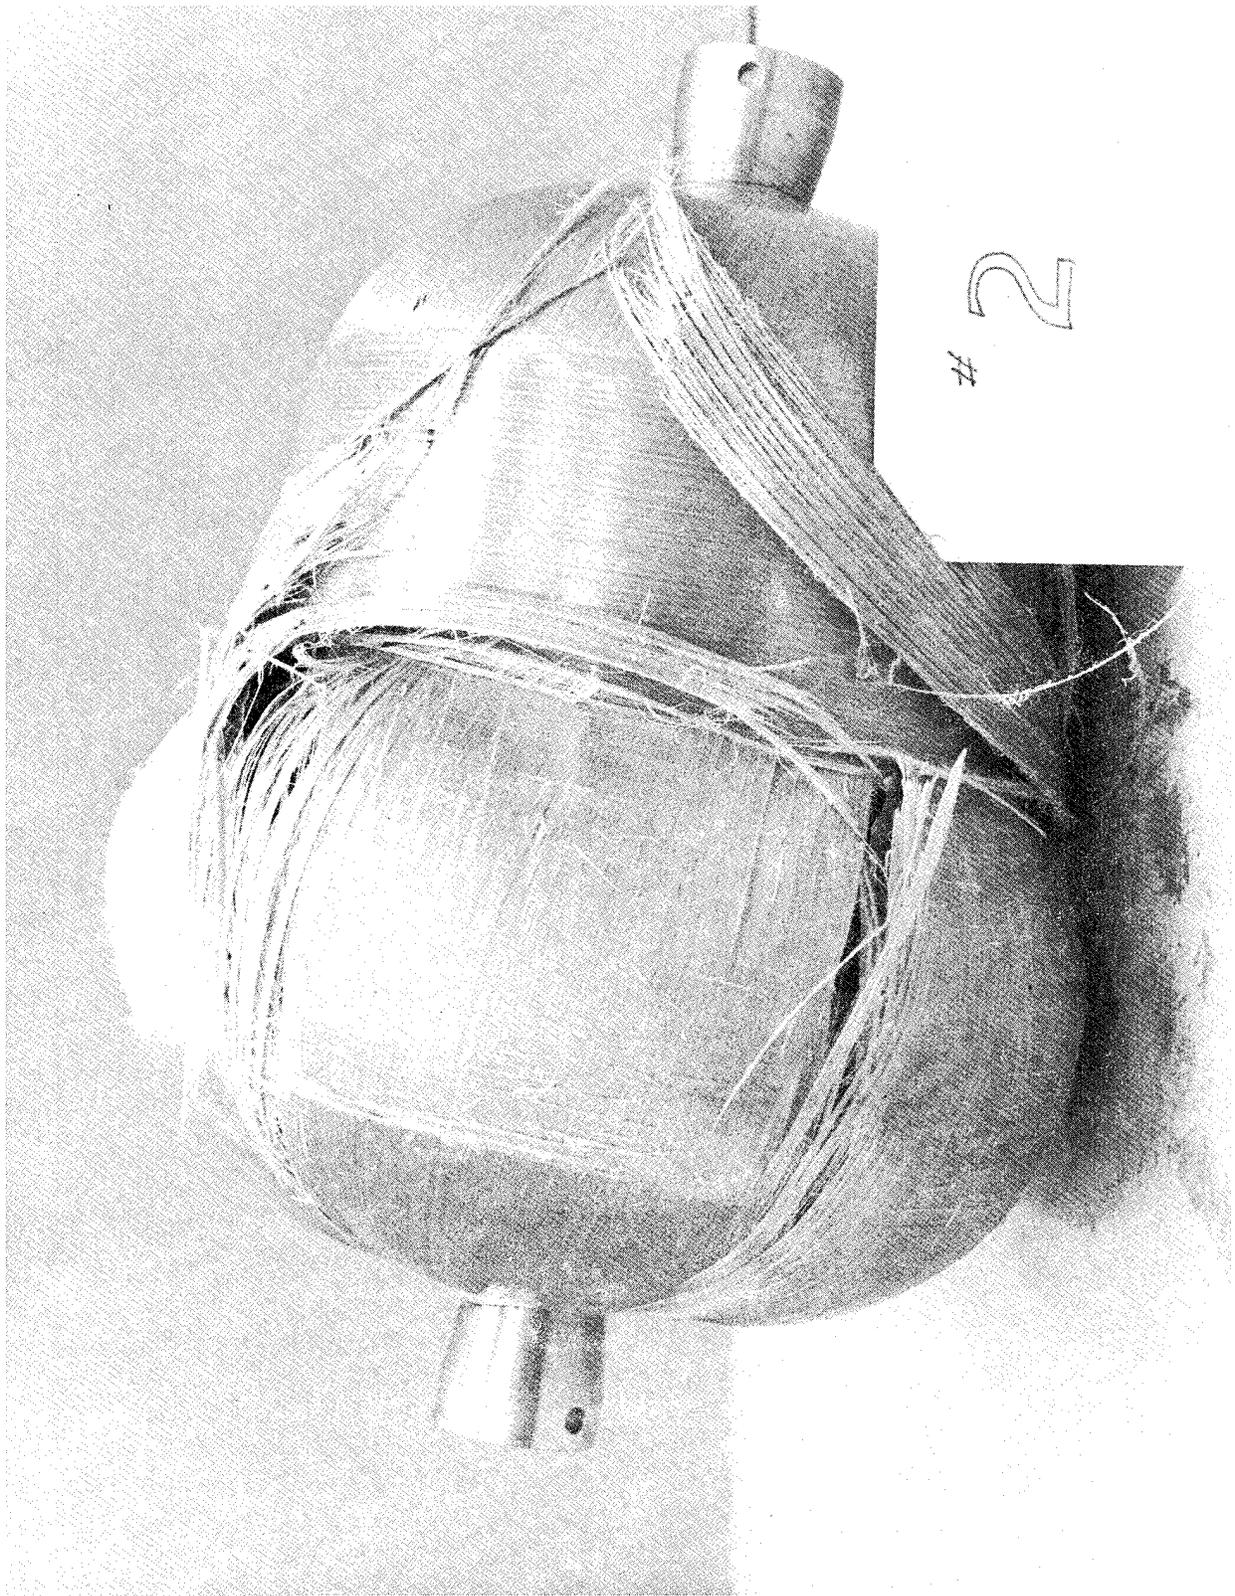
FIGURE 21 - VESSEL NO. 2 AFTER BURST TEST

Vessel No. 2 did fail in the circumferential windings as desired (Figure 21) at a pressure of 2750 psi ($19.0 \times 10^6 \text{ N/m}^2$). This provided a very good performance gain; however, after reviewing the stress-strain behavior of the tank (Figure 22) it was evident that further optimization could be obtained by lowering the burst pressure. In Vessel No. 3, to lower the burst pressure, the longitudinal fiber count was reduced from 402 to 321 yarns/inch (158 to 126 yarns/cm) and the circumferential count reduced from 760 to 608 yarns/inch (299 to 239 yarns/cm).

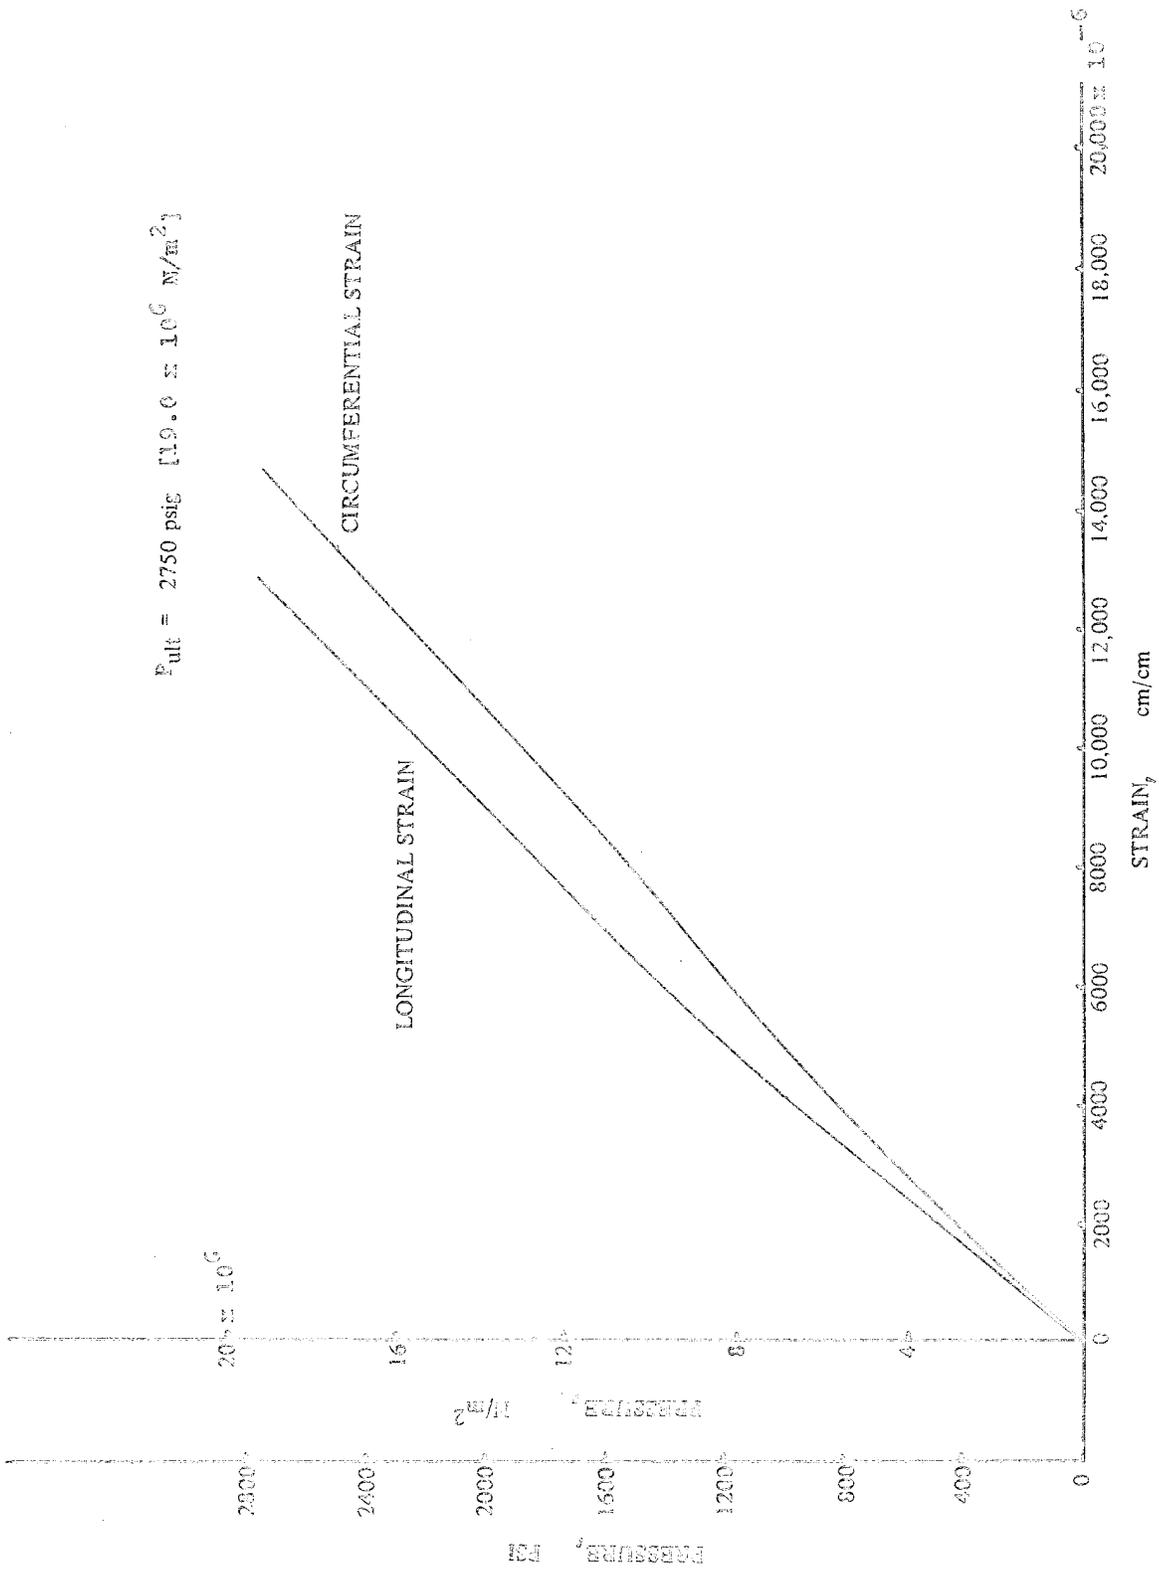
FIGURE 22 PRESSURE VS. STRAIN RELATIONSHIP - VESSEL NO. 2
