NASA CR-134555

**THIN-METAL LINED PRD 49-III COMPOSITE
VESSELS**

**THE BOEING AEROSPACE COMPANY
RESEARCH AND ENGINEERING DIVISION
SEATTLE, WASHINGTON**

JANUARY 1974

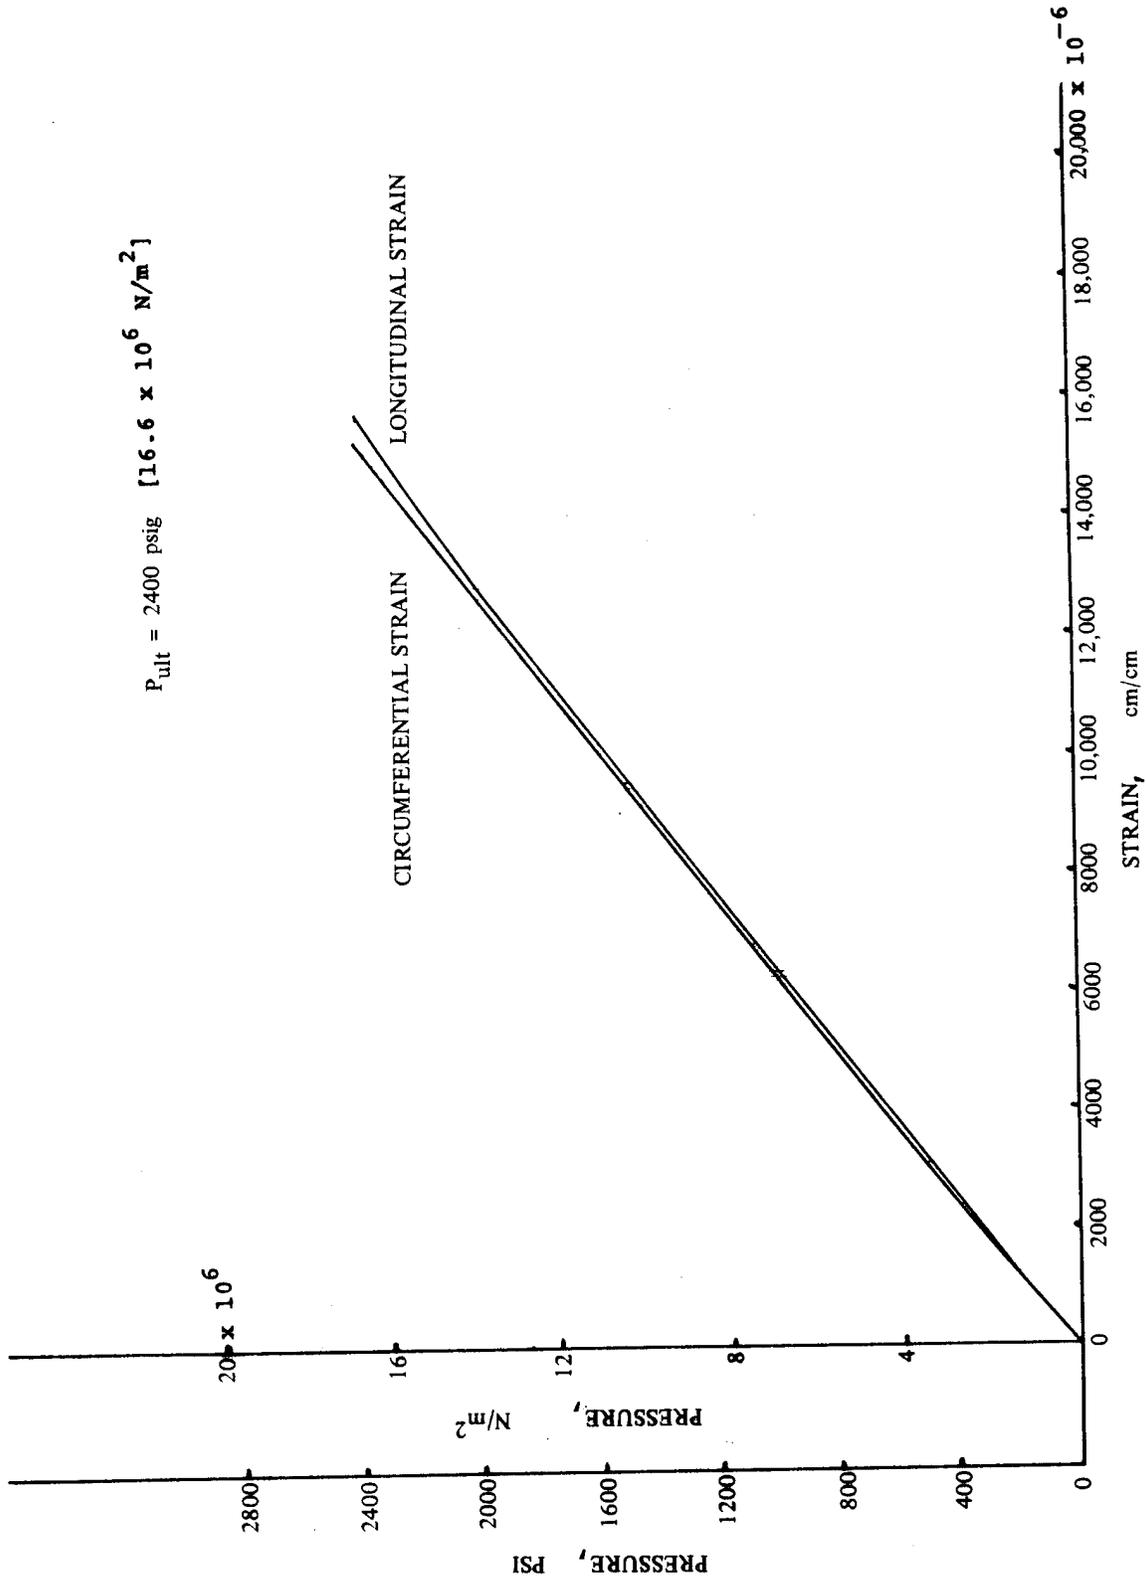
FIGURE 23 PRESSURE VS. STRAIN RELATIONSHIP - VESSEL NO. 3

Vessel No. 3 failed at a burst pressure of 2400 psi ($16.6 \times 10^6 \text{ N/m}^2$) with a performance factor of 1.73×10^6 inches ($4.39 \times 10^6 \text{ cm}$). The pressure vs strain relationships are shown in Figure 23 . The vessel gave the desired strain behavior and it was decided to use the design of this particular vessel for the remaining tanks and concentrate efforts towards solving the liner buckling problem that was occurring during fabrication (see Section 3.2.2). Vessel (No.3) is shown in Figure 24.

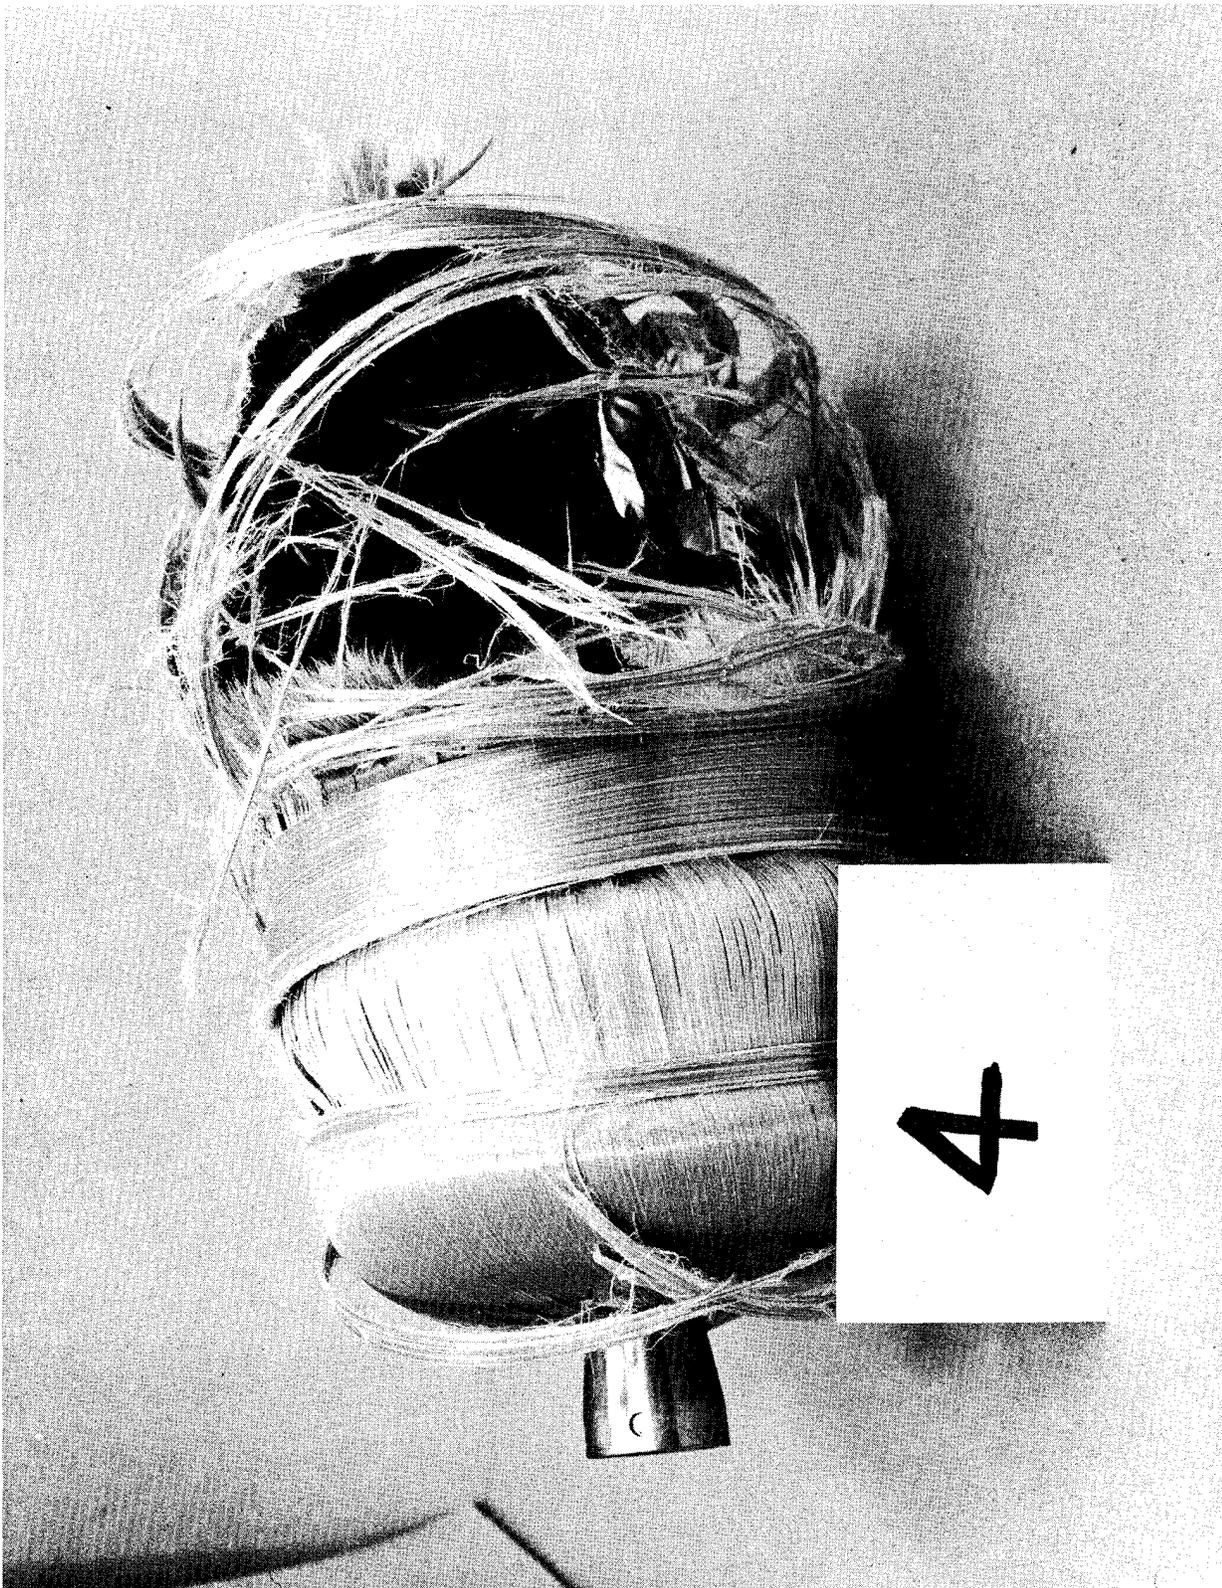
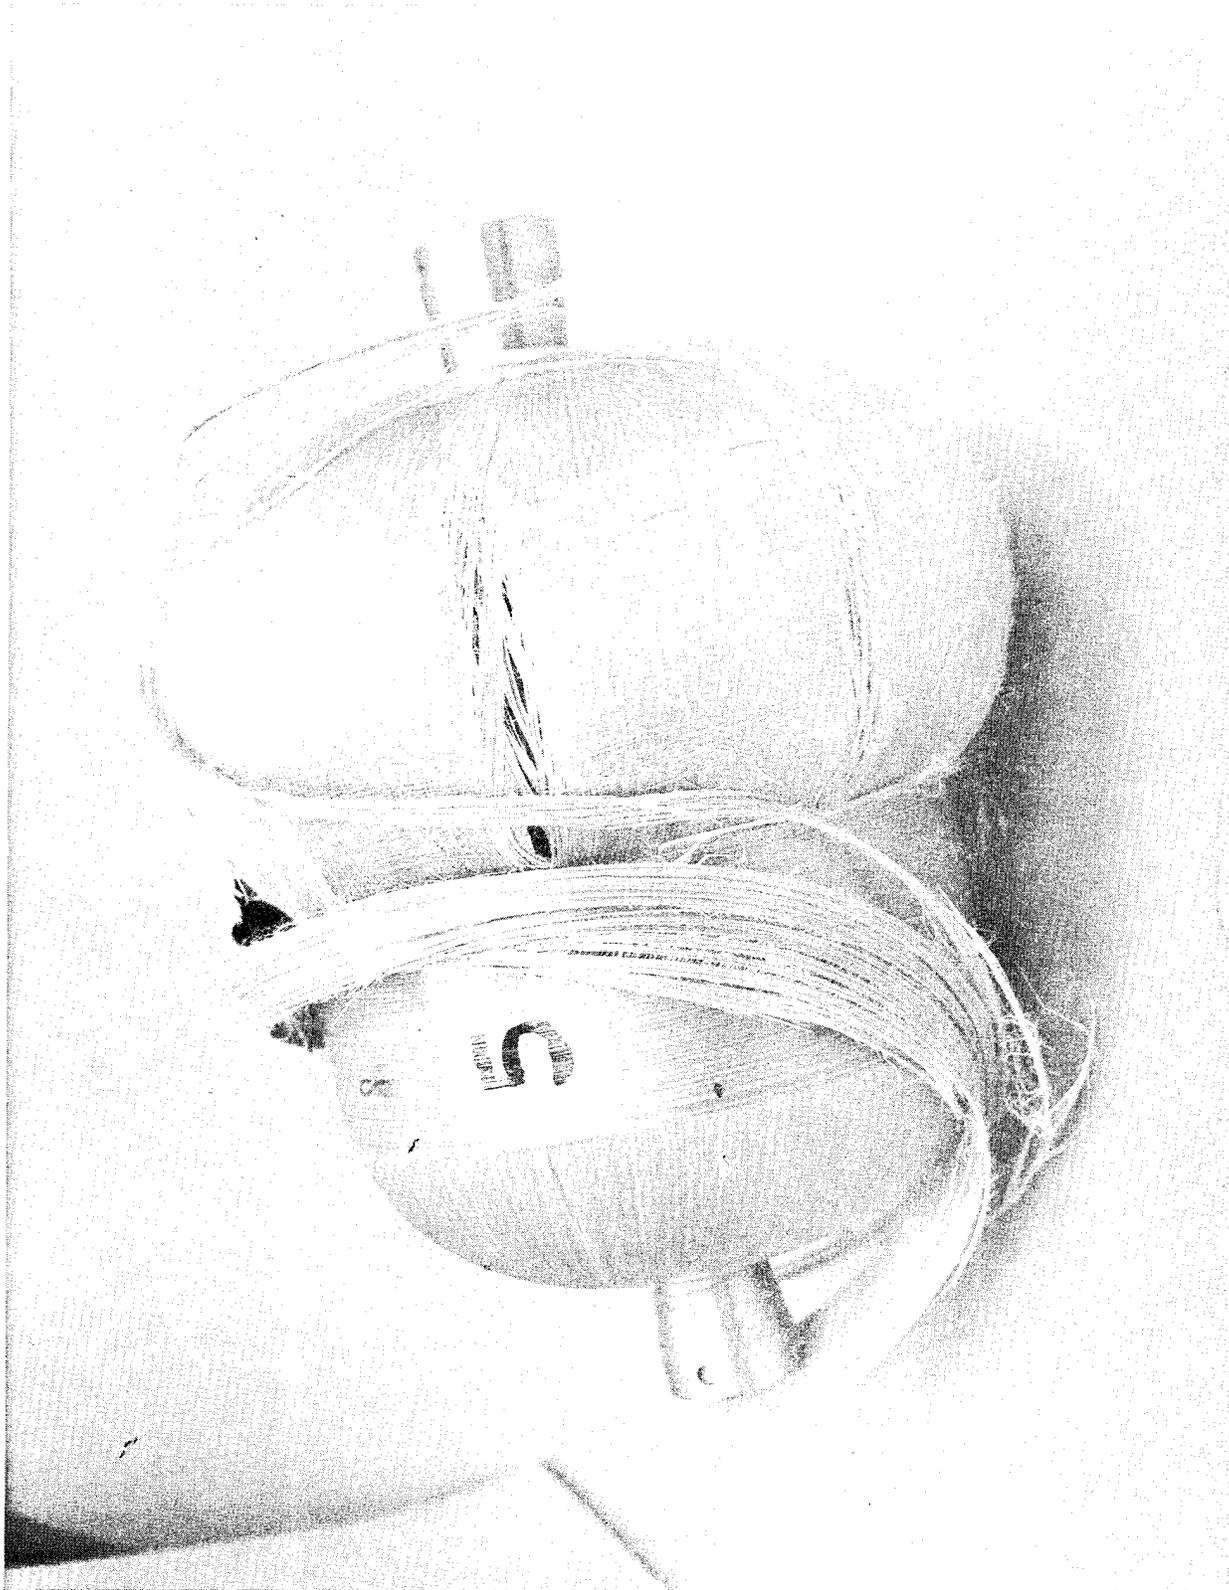
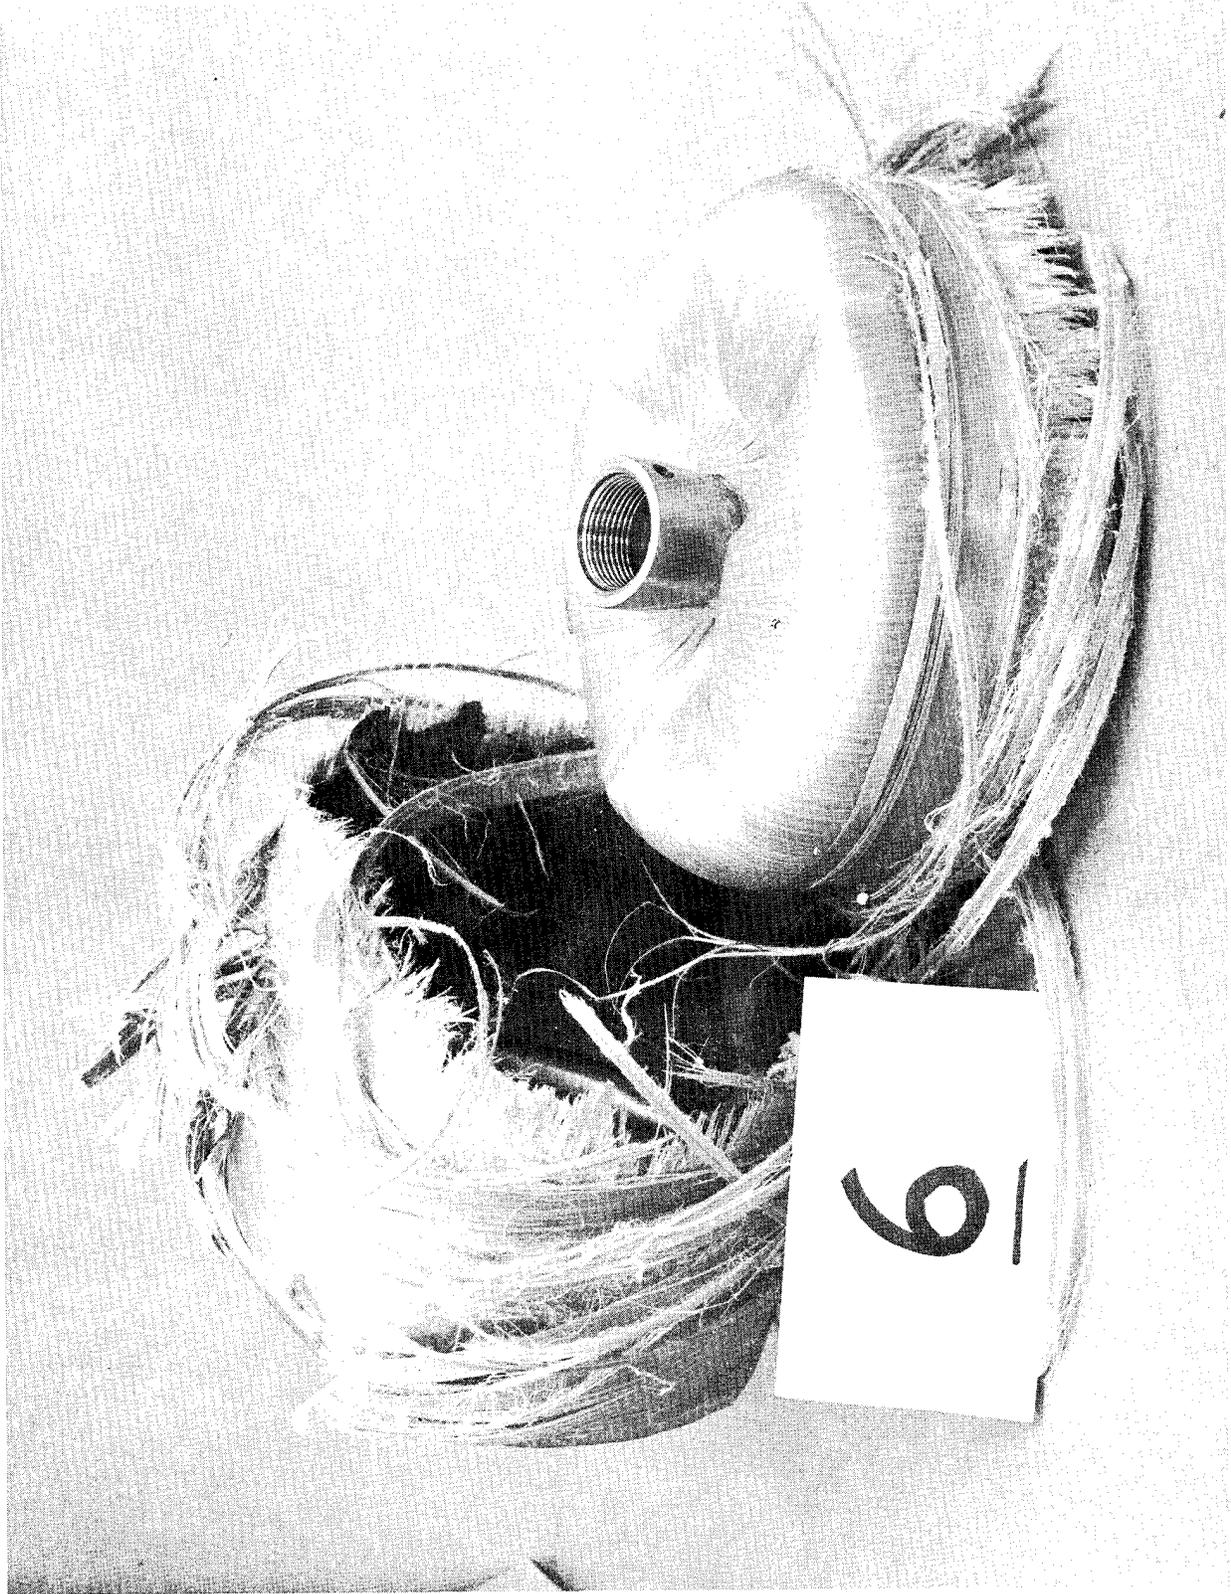
FIGURE 25 - VESSEL NO. 4 AFTER BURST TEST

FIGURE 26—VESSEL NO. 5 AFTER BURST TEST

FIGURE 27--VESSEL NO. 6 AFTER BURST TEST

Vessels No. 4, 5 and 6 failed at values of 2640 psi ($18.2 \times 10^6 \text{ N/m}^2$), 2520 psi ($17.4 \times 10^6 \text{ N/m}^2$), and 2680 psi ($18.5 \times 10^6 \text{ N/m}^2$) respectively. These vessels are shown in Figures 25 26 and 27 with the corresponding stress strain curves shown in Figures 28 , 29 and 30 . The vessels, although fabricated from different resin systems or exposed to different cures, showed no significant differences in burst strength (Table VII) and gave very good performance factors [$(>1.75 \times 10^6 \text{ in.})$ ($>4.45 \times 10^6 \text{ cm}$)].

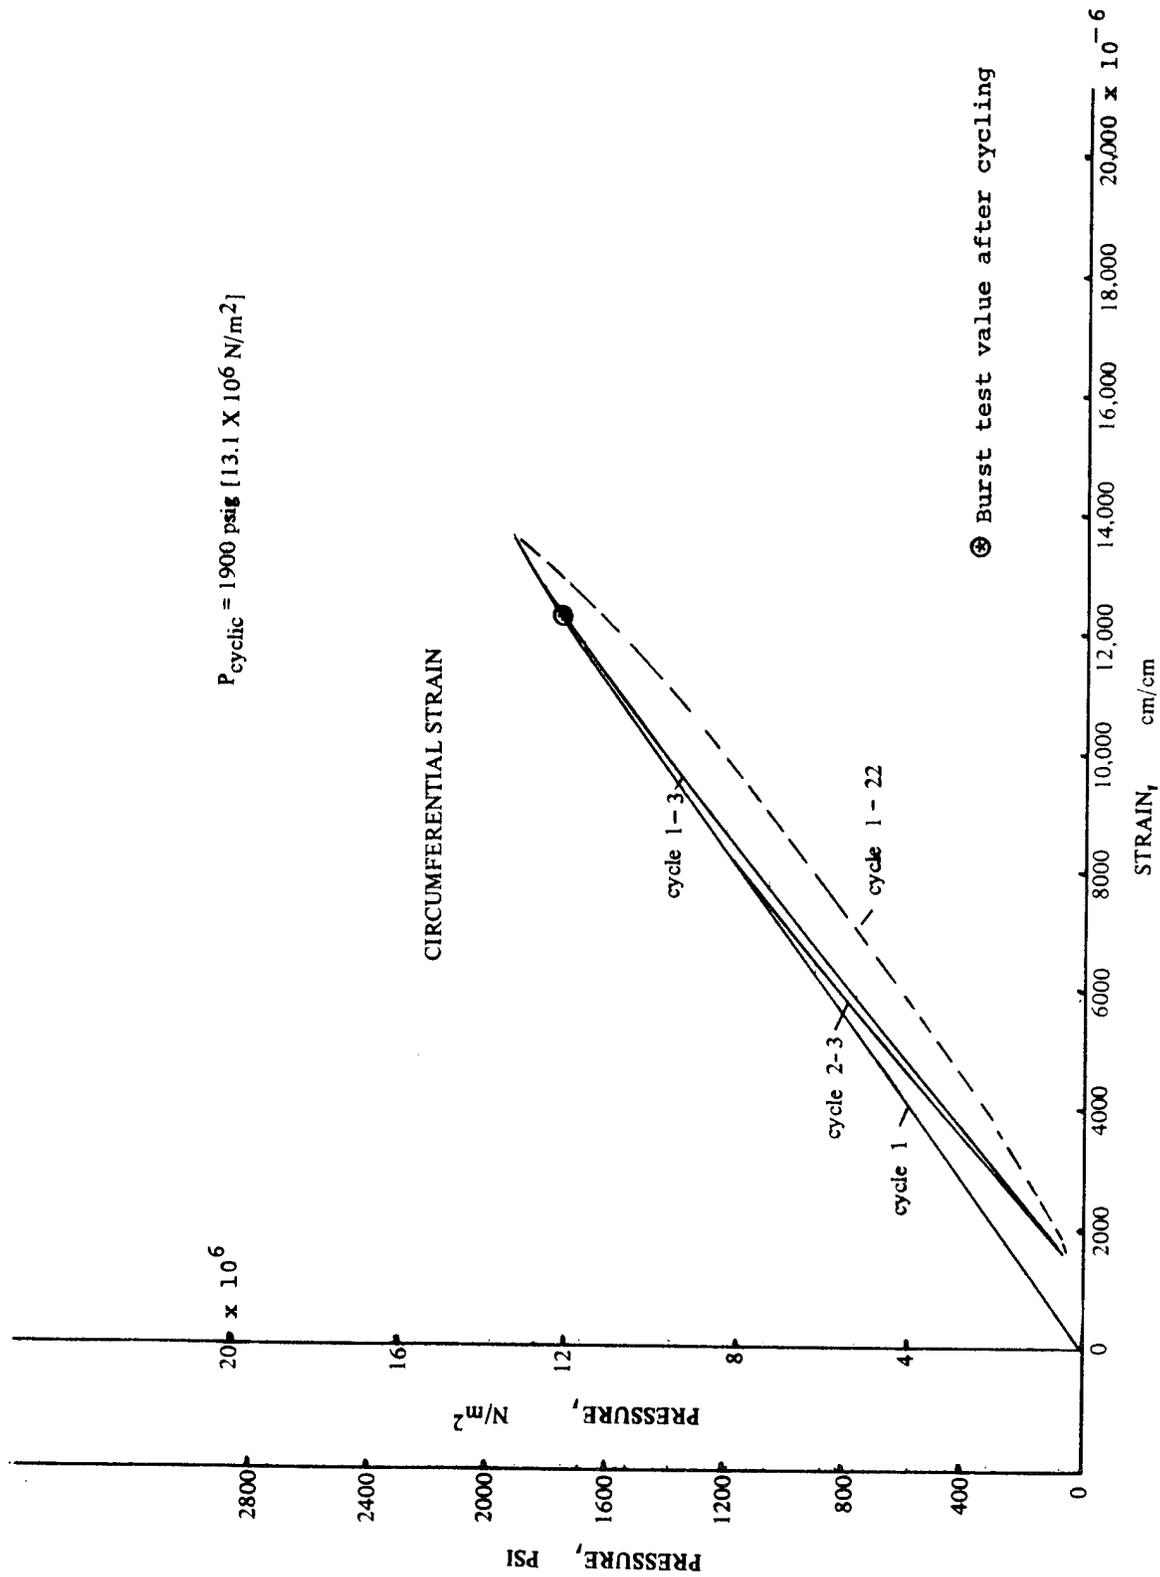
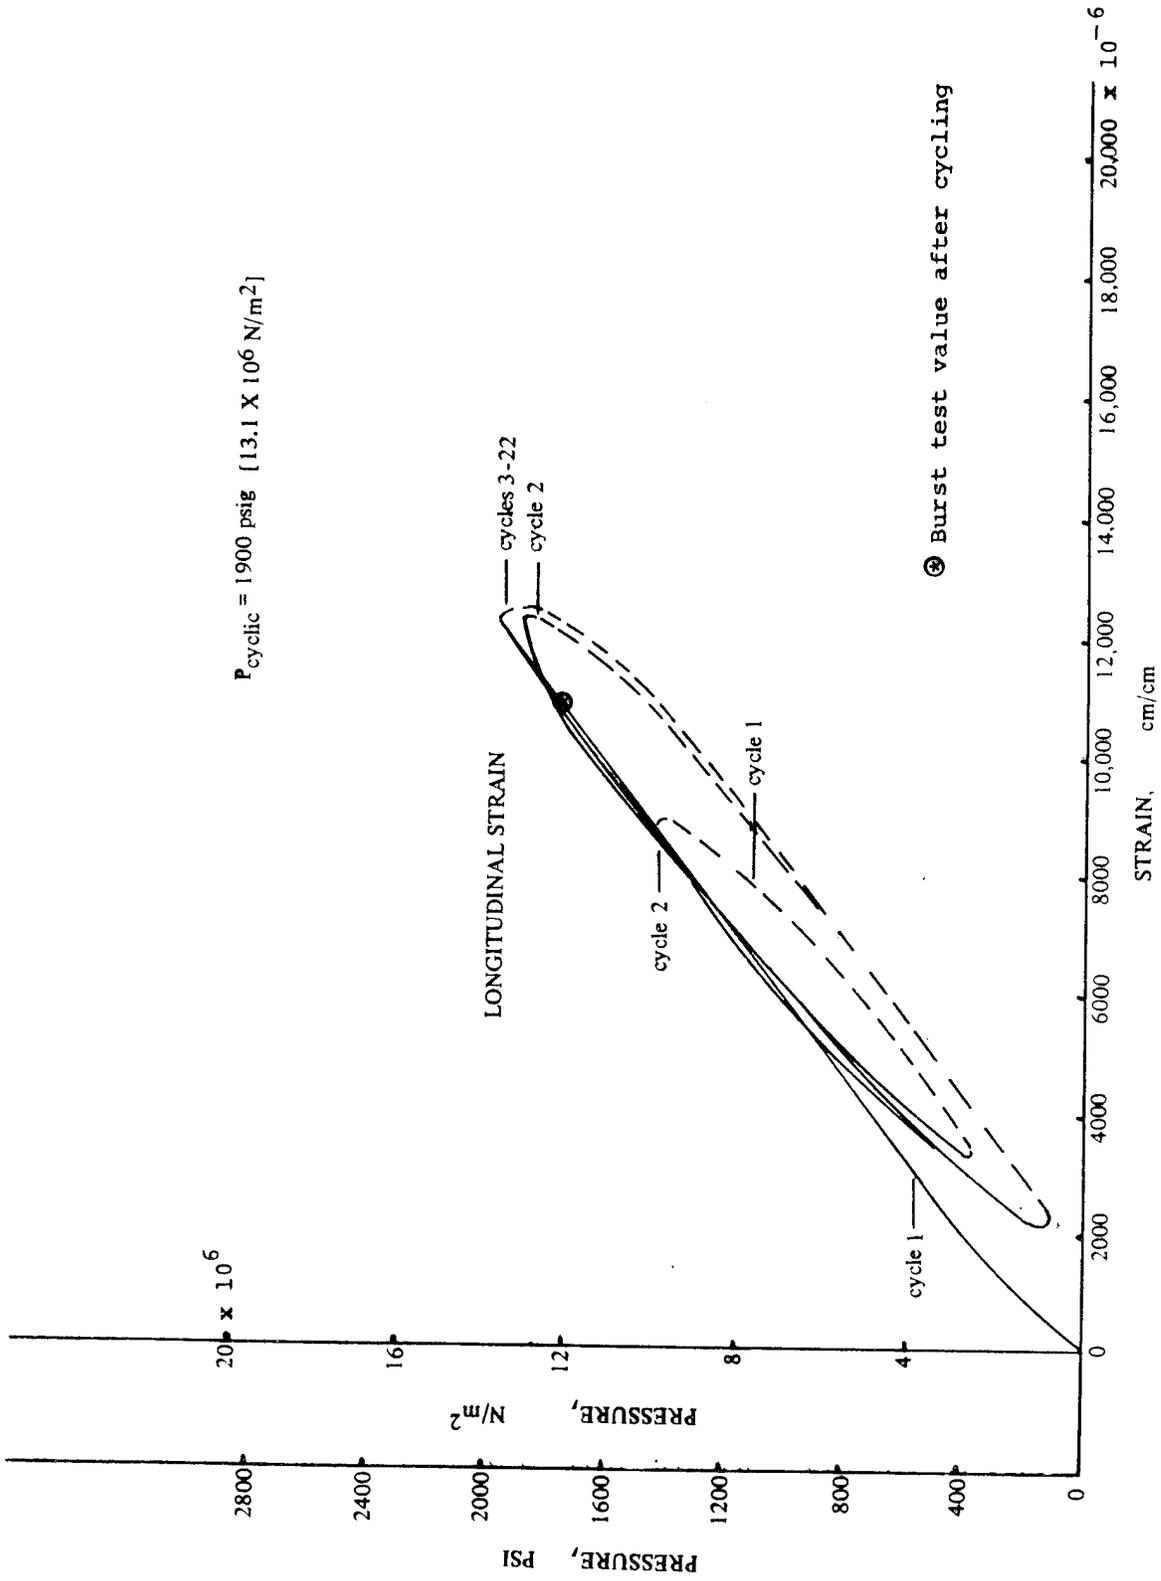
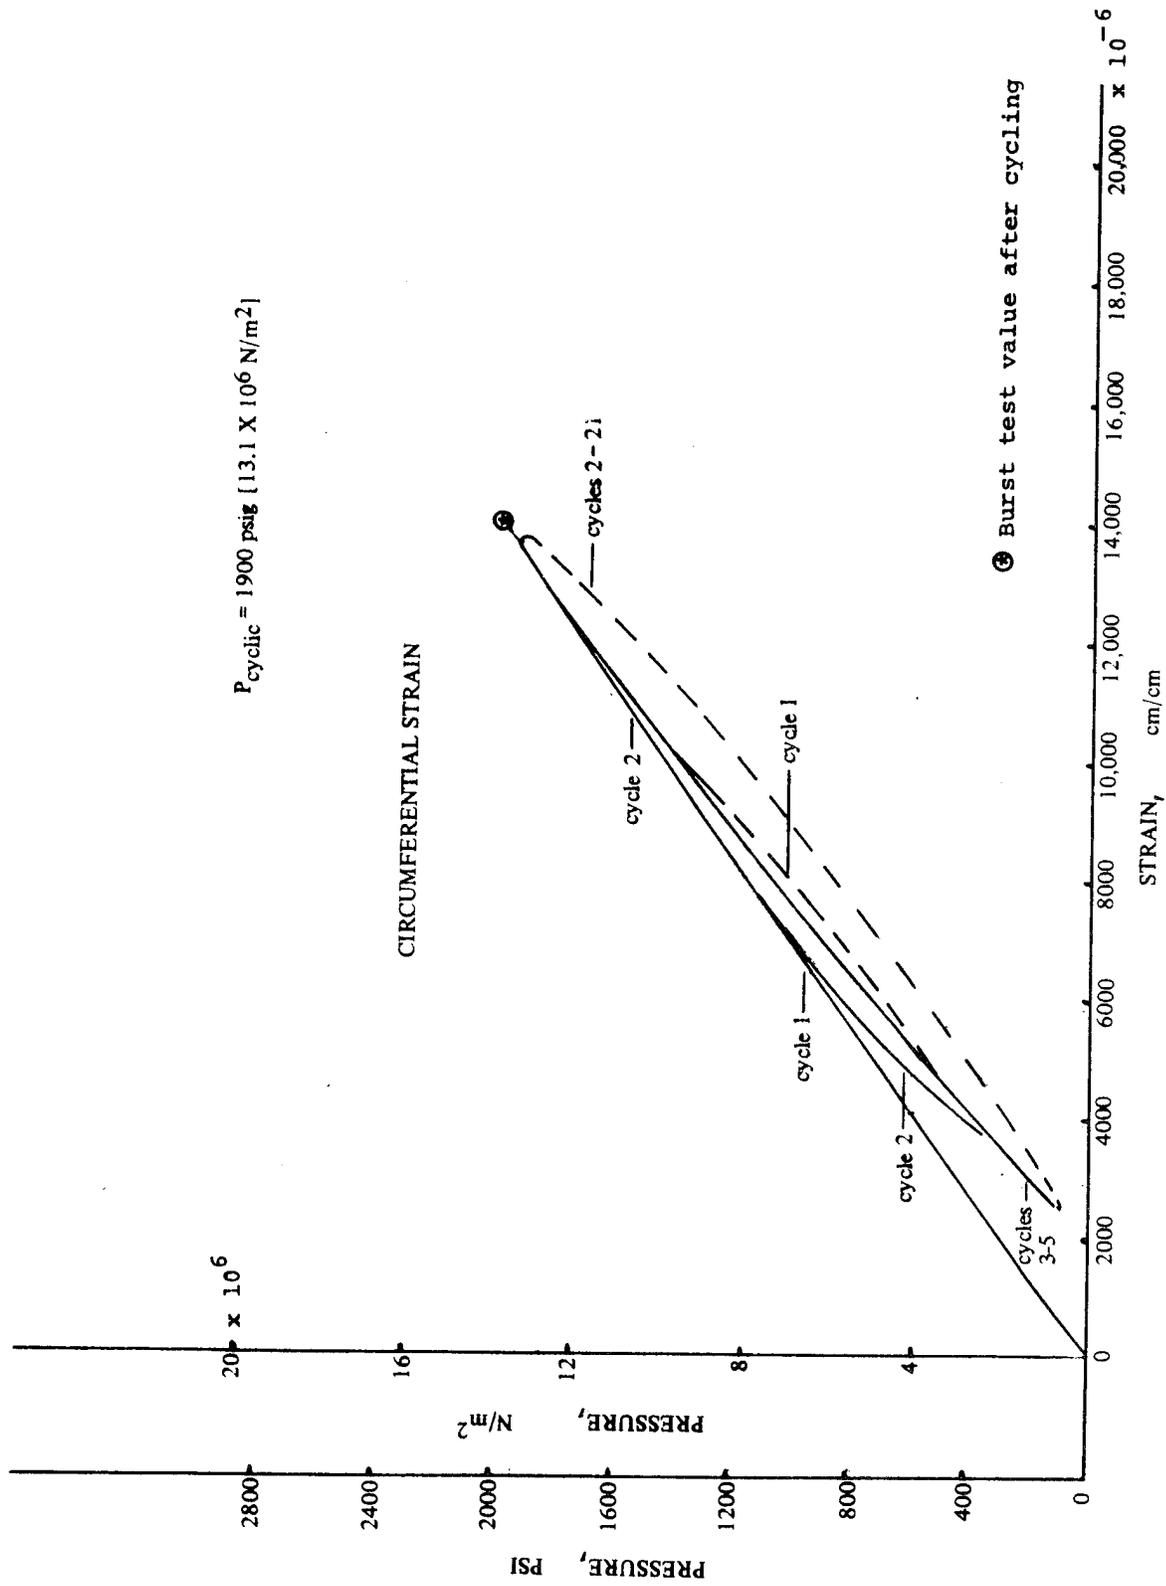
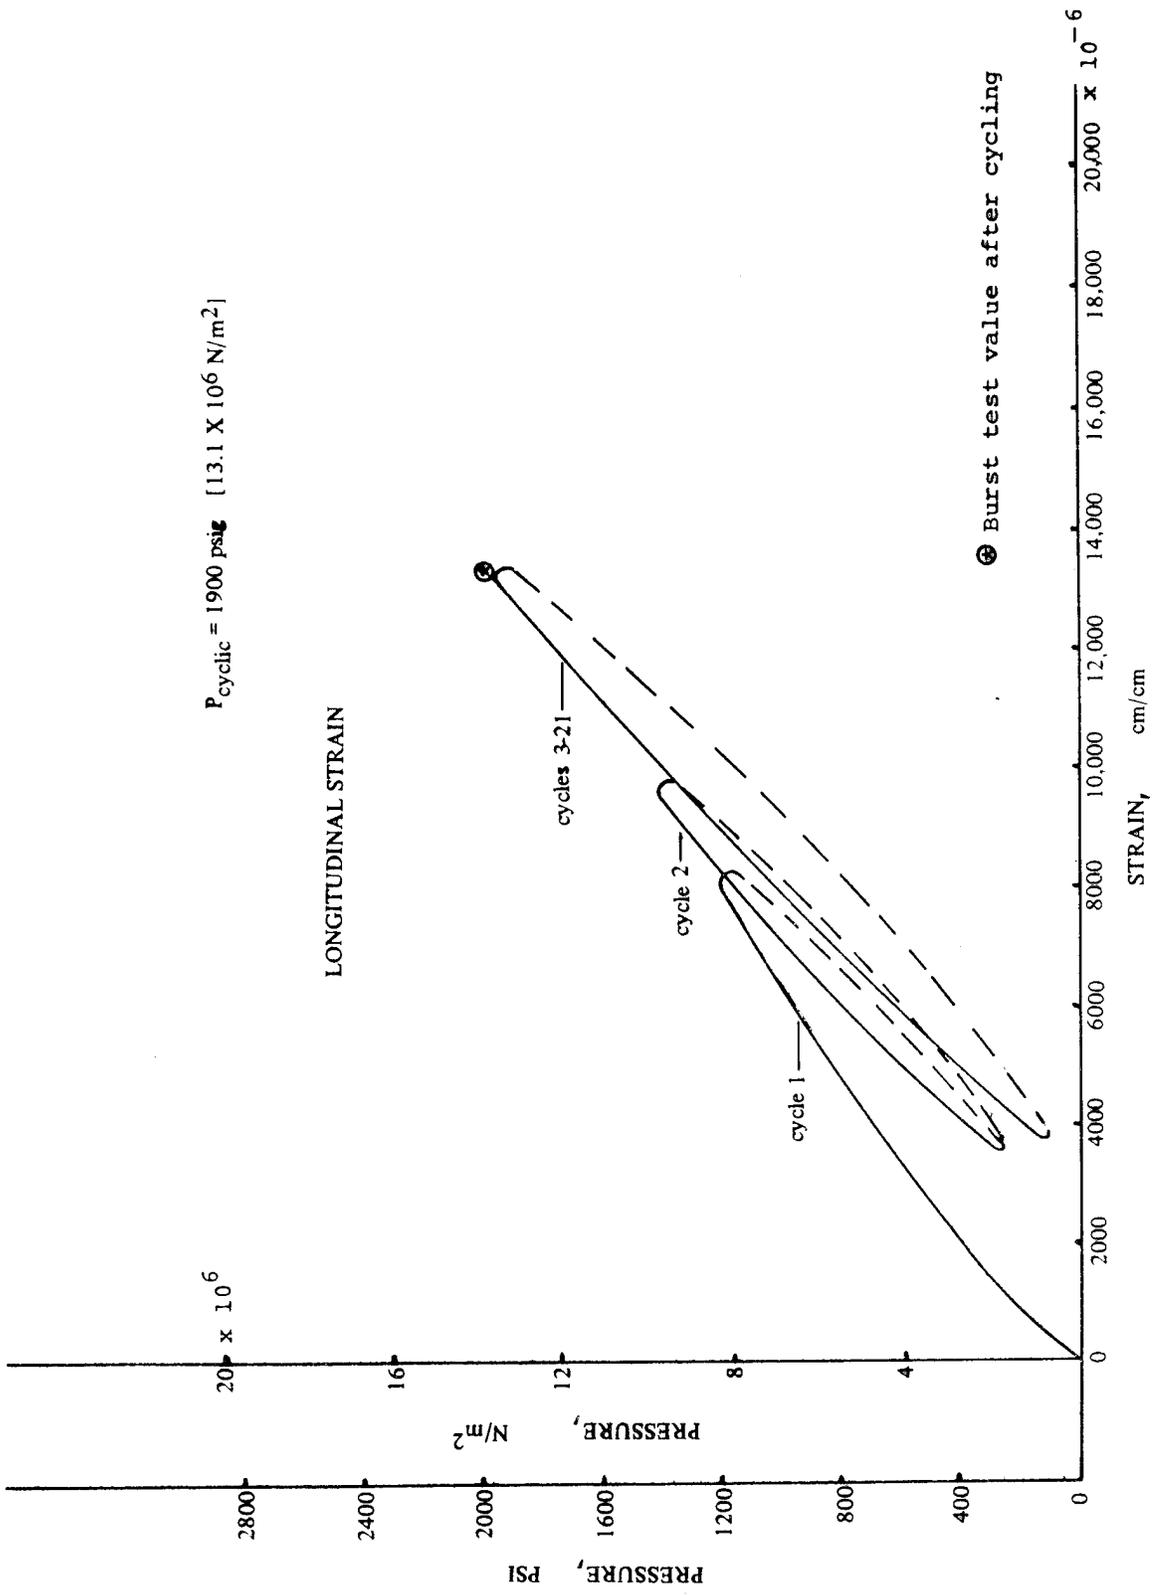
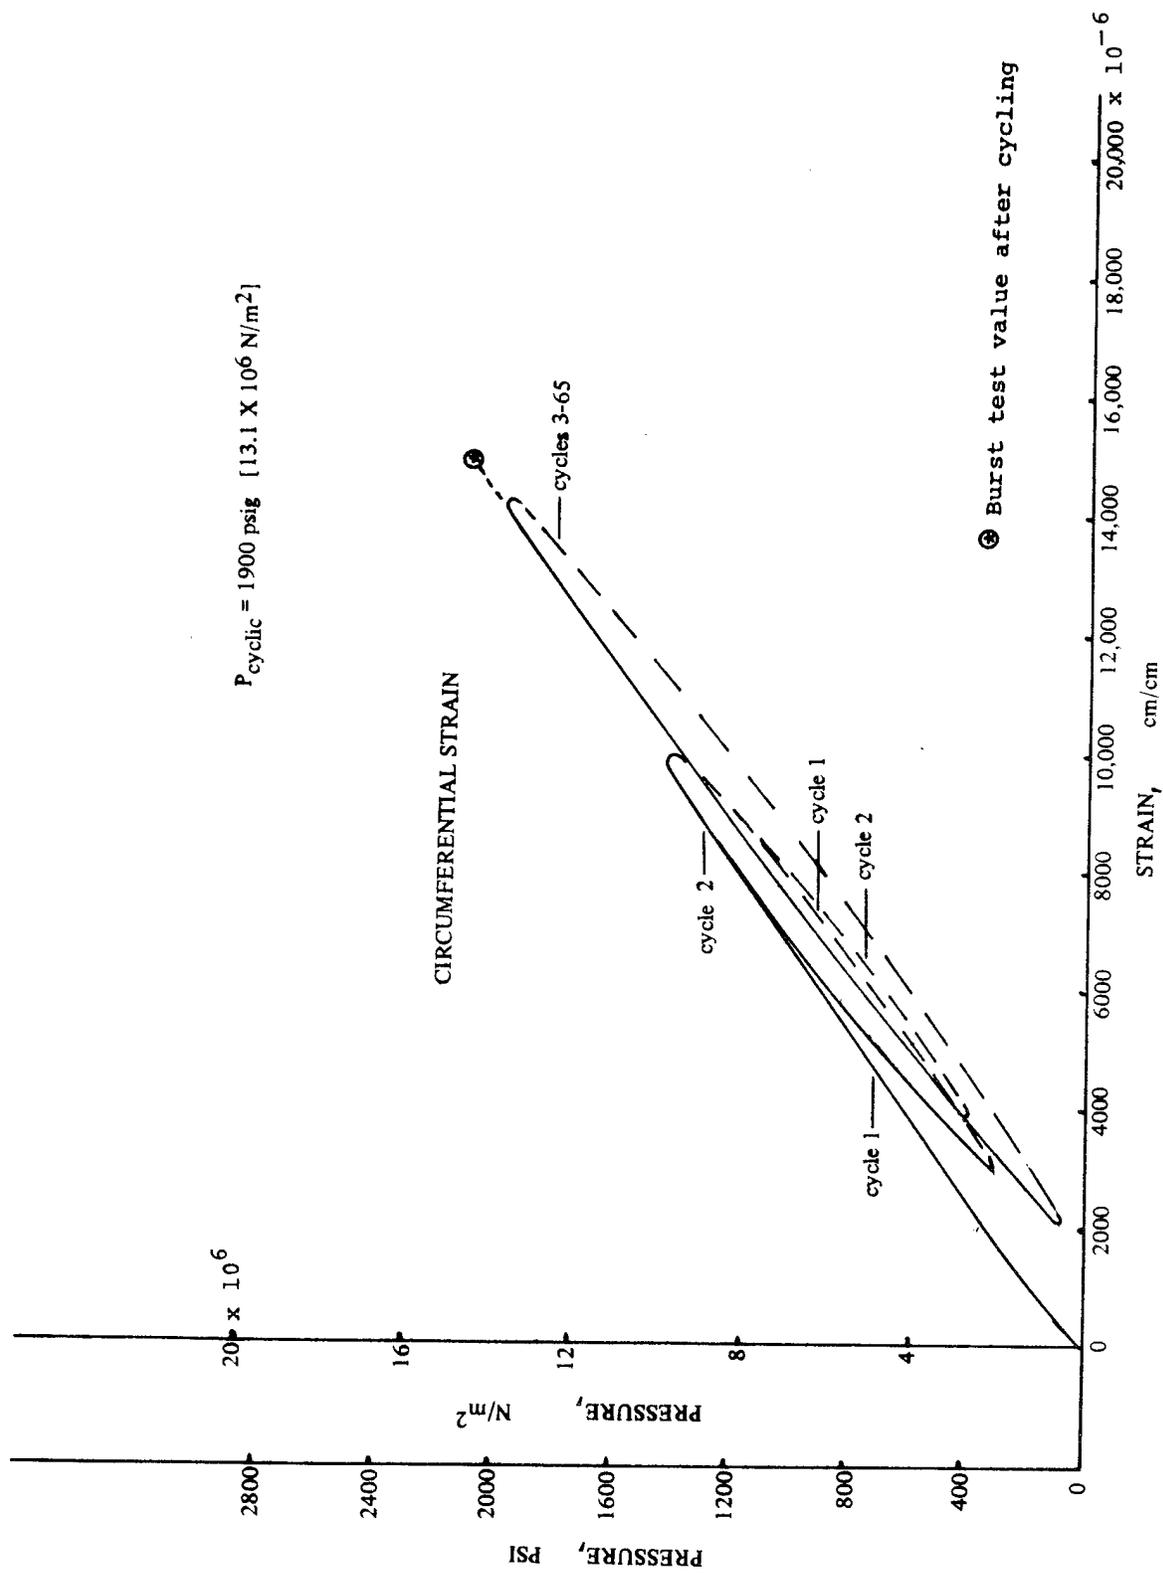
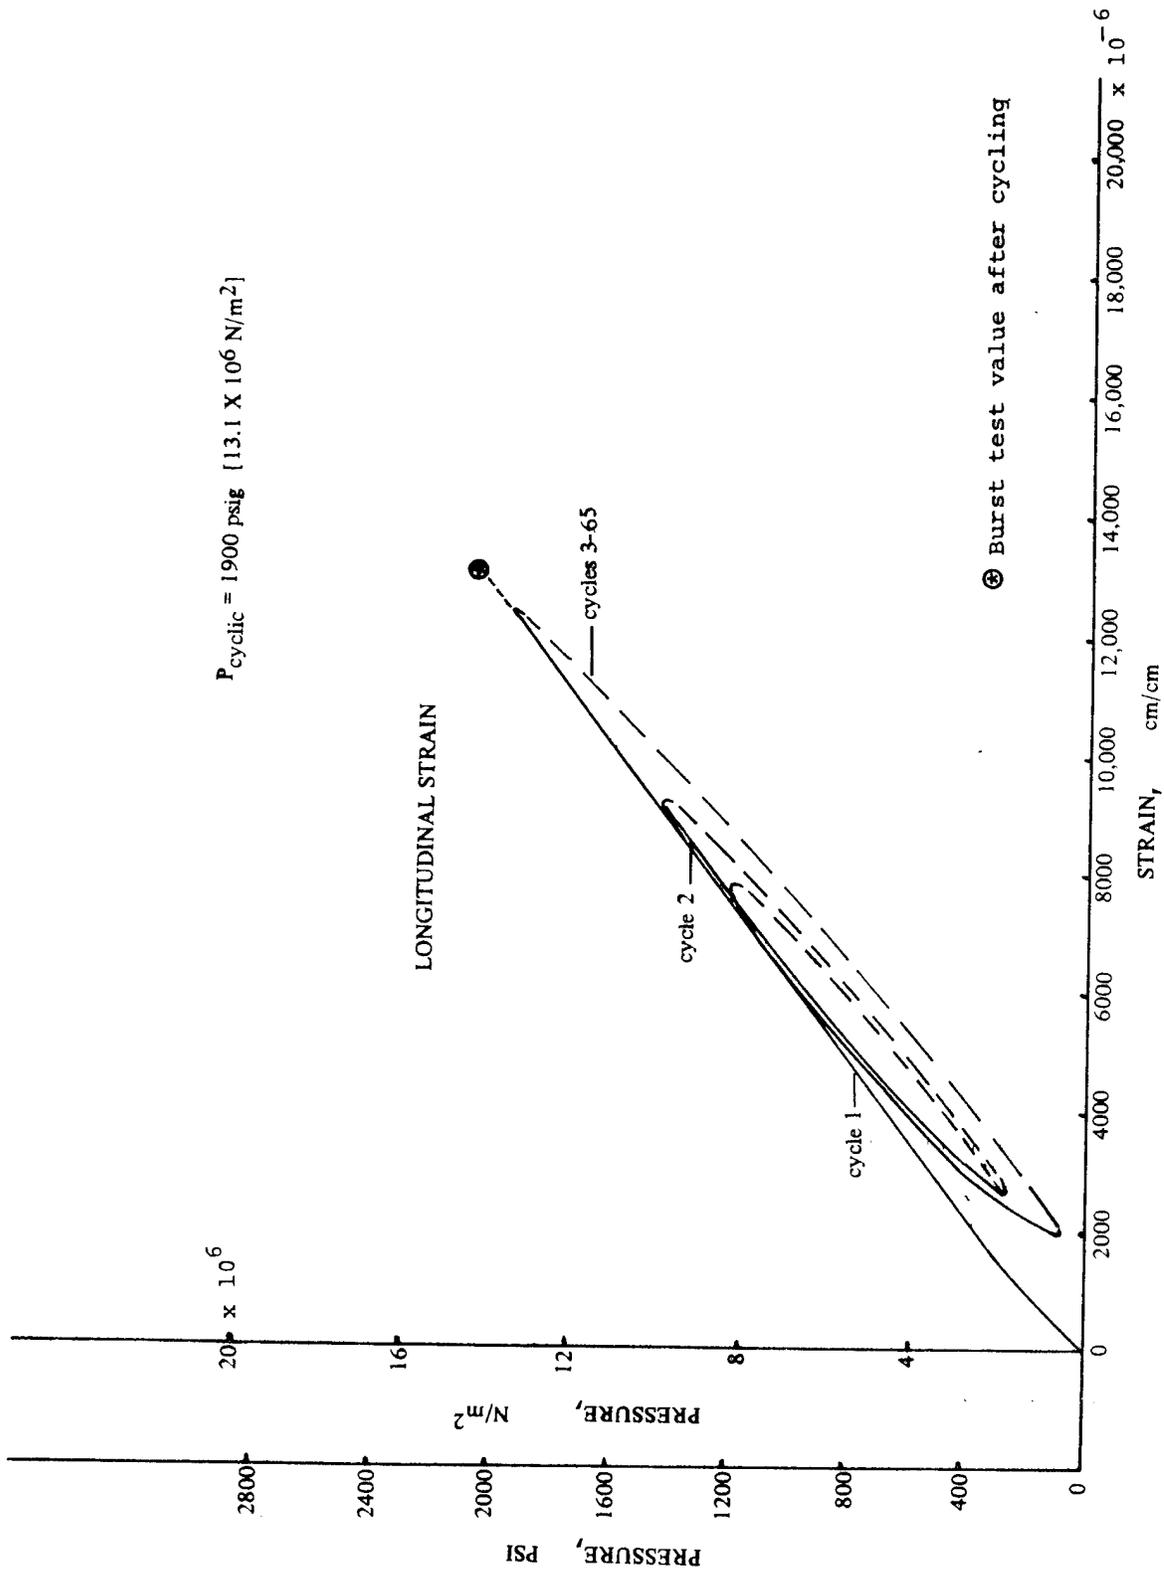
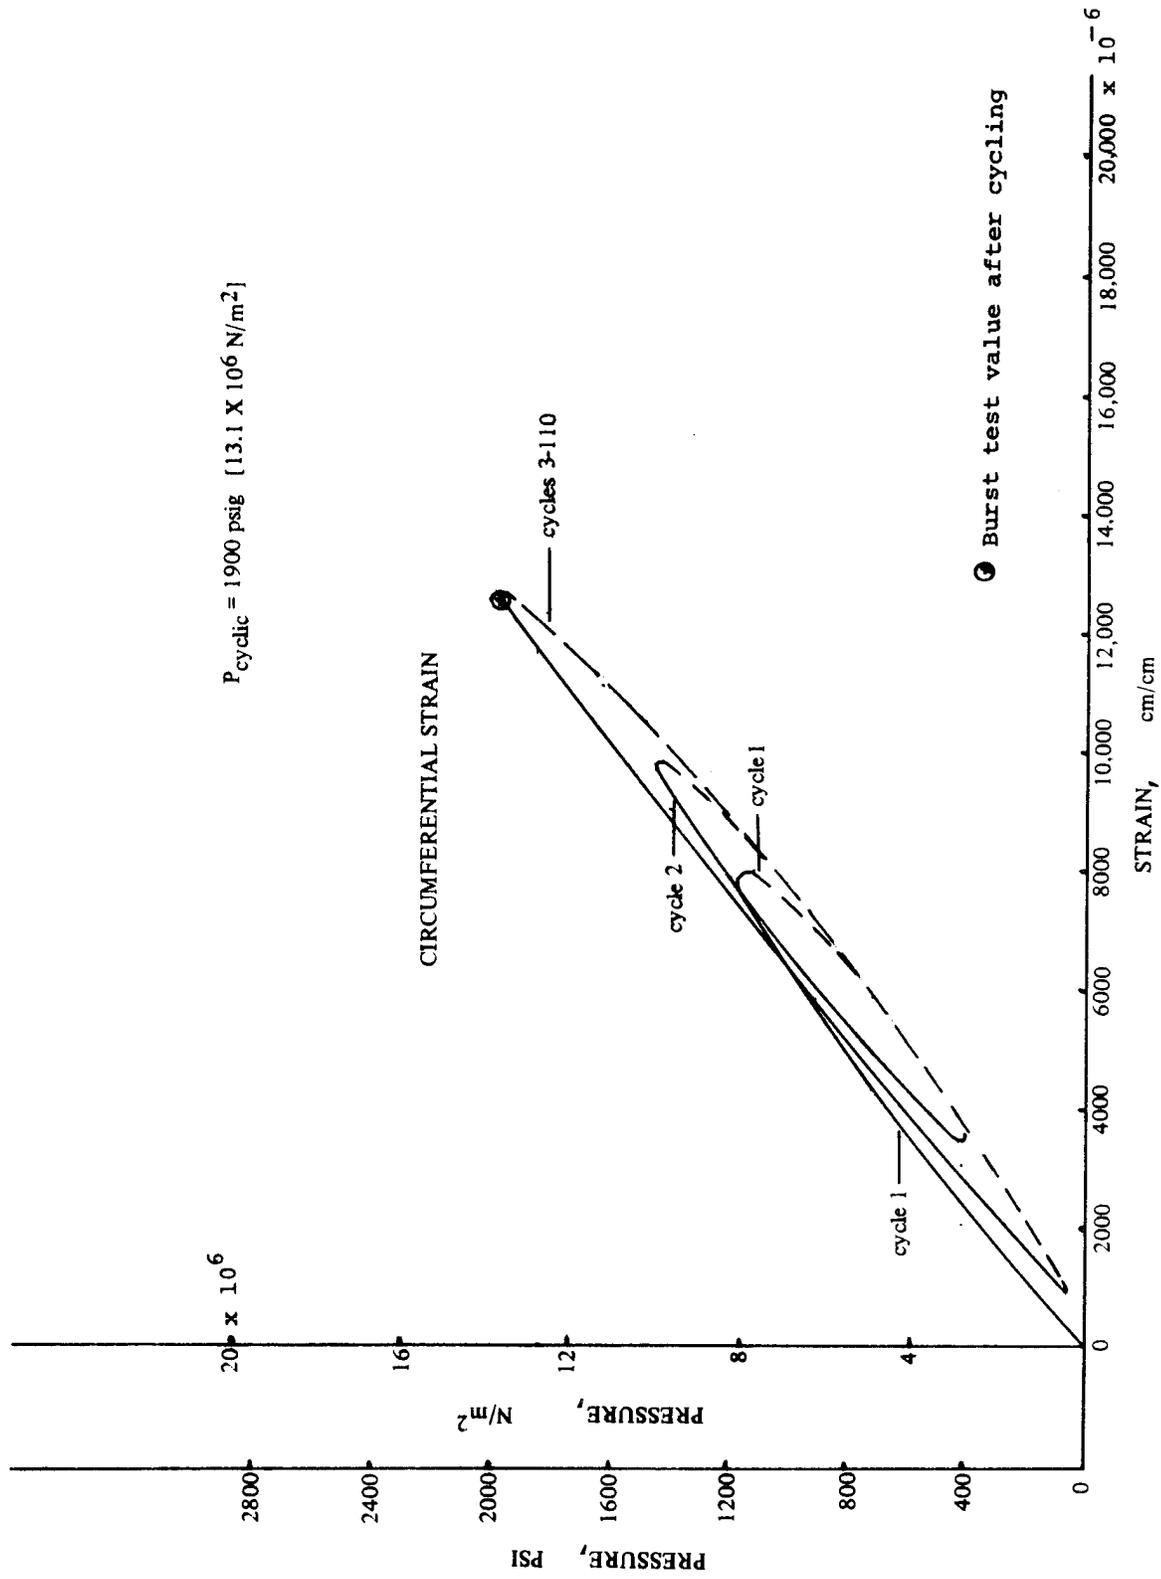
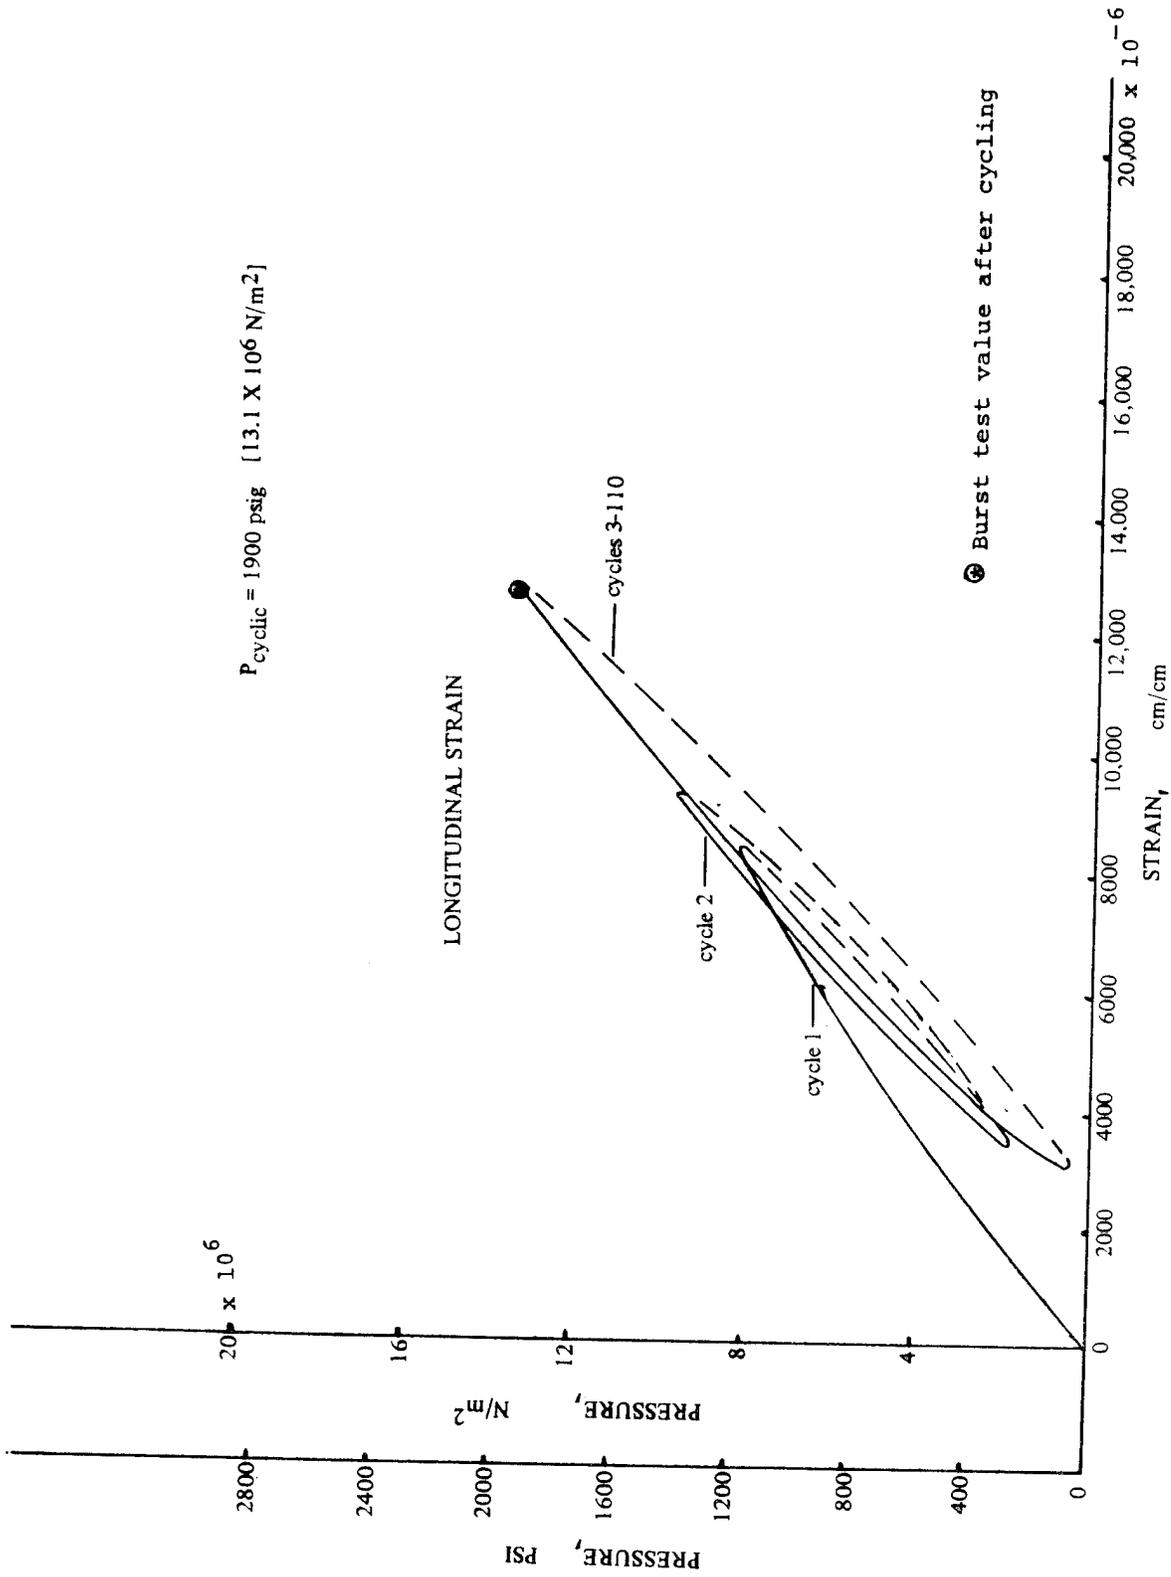
FIGURE 31 PRESSURE VS. STRAIN RELATIONSHIP OF VESSEL NO. 7 IN CYCLIC FATIGUE

FIGURE 32 PRESSURE VS. STRAIN RELATIONSHIP OF VESSEL NO. 7 IN CYCLIC FATIGUE

FIGURE 33 PRESSURE VS. STRAIN RELATIONSHIP OF VESSEL NO. 8 IN CYCLIC FATIGUE

FIGURE 34 PRESSURE VS. STRAIN RELATIONSHIP OF VESSEL NO. 8 IN CYCLIC FATIGUE

FIGURE 35 PRESSURE VS. STRAIN RELATIONSHIP OF VESSEL NO.9 IN CYCLIC FATIGUE

FIGURE 36 PRESSURE VS. STRAIN RELATIONSHIP OF VESSEL NO. 9 IN CYCLIC FATIGUE

FIGURE 37 PRESSURE VS. STRAIN RELATIONSHIP OF VESSEL NO.10 IN CYCLIC FATIGUE

FIGURE 38 PRESSURE VS. STRAIN RELATIONSHIP OF VESSEL NO.10 IN CYCLIC FATIGUE

Figures 31 through 62 show the stress-strain curves for each vessel in both the longitudinal and circumferential directions. In reviewing the curves, it should be noted that the first cycle and in some cases the second cycle were not pressurized to the peak cyclic pressure since the instrumentation used required one or two cycles to obtain an accurate pressure setting.

All the vessels, whether cycled at 50% or 75% of ultimate, reached a state of equilibrium after about the third pressure cycle. Thereafter, very little change occurred in either the vessel modulus or the hysteresis loop. However, the stress-strain curve of the metal-lined composite vessel in this equilibrium condition was not as linear as an uncycled vessel. This is evident by comparing the stress-strain curves of vessels 7-18 to those of vessels 1-6. On the other hand the modulus of the vessels did increase by a value of $\approx 1-2 \times 10^6$ psi ($0.7 - 1.4 \times 10^{10} \text{ N/m}^2$) as a result of cycling.
