NASA CR-134555

**THIN-METAL LINED PRD 49-III COMPOSITE
VESSELS**

**THE BOEING AEROSPACE COMPANY
RESEARCH AND ENGINEERING DIVISION
SEATTLE, WASHINGTON**

JANUARY 1974

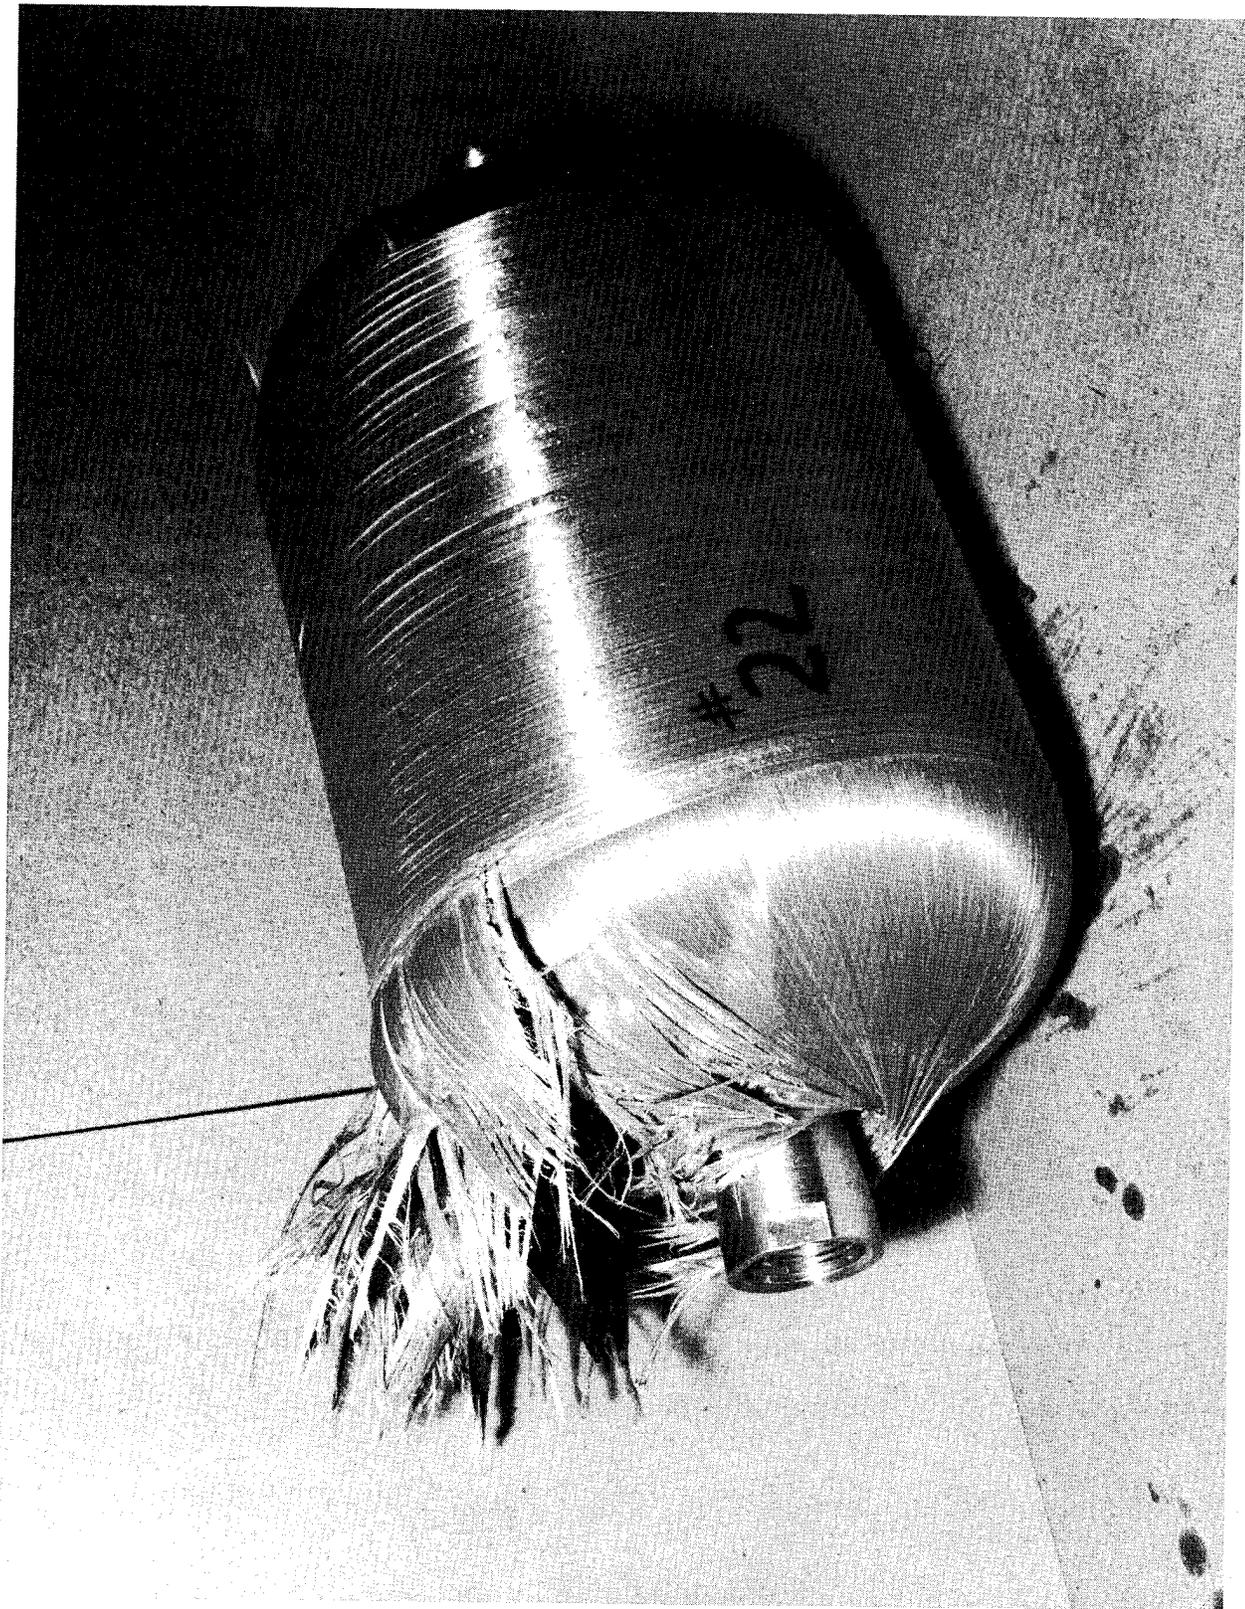
FIGURE 63— VESSEL NO. 22 AFTER CYCLIC TESTING

The total number of pressure cycles which each vessel withstood is given in Table IX. All the vessels with the exception of No. 22, failed in the liner. Vessel No. 22 withstood 2493 cycles and failed in the dome as shown in Figure 63.

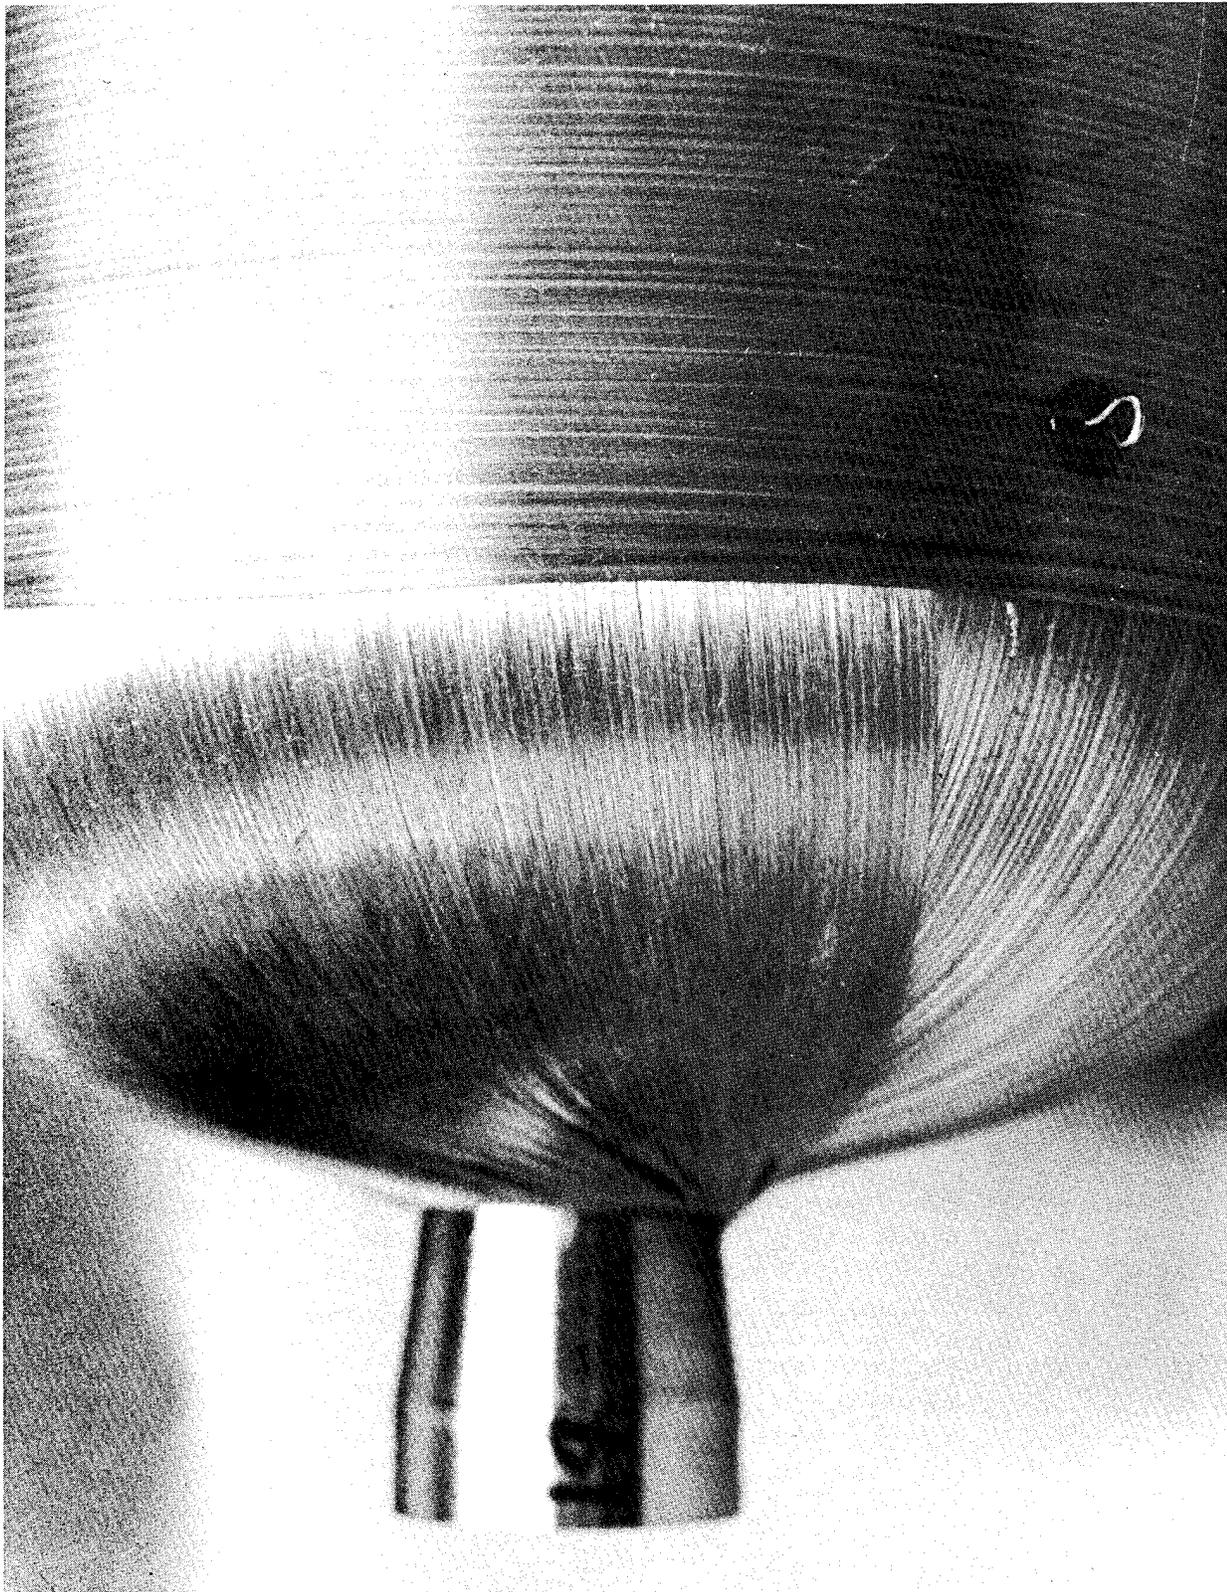
FIGURE 64—VESSEL NO. 14 AFTER CYCLIC TESTING

FIGURE 65 - VESSEL NO. 14 AFTER CYCLIC TESTING

was noted and the mode of failure remained the same. The adhesion to the stainless steel was good but the liner would separate in localized areas and immediately liner failure would occur. With relatively high consistency the initial leakage would occur in the dome-to-body weld area. On vessels 17 and 18 the weld area was reinforced with PRD 49-3 style 120 fabric to reduce the strain. Vessel No. 17 had one layer and vessel No. 18 had two layers of fabric reinforcement in the tangent region. Both vessels used EA934 adhesive with primer. These vessels reached 125 and 230 cycles respectively. The composite portion of all the cycled tanks was in excellent condition after test as evidenced by viewing tank No. 14 in Figures 64 and 65, (except where locally damaged by release of the hydraulic fluid).

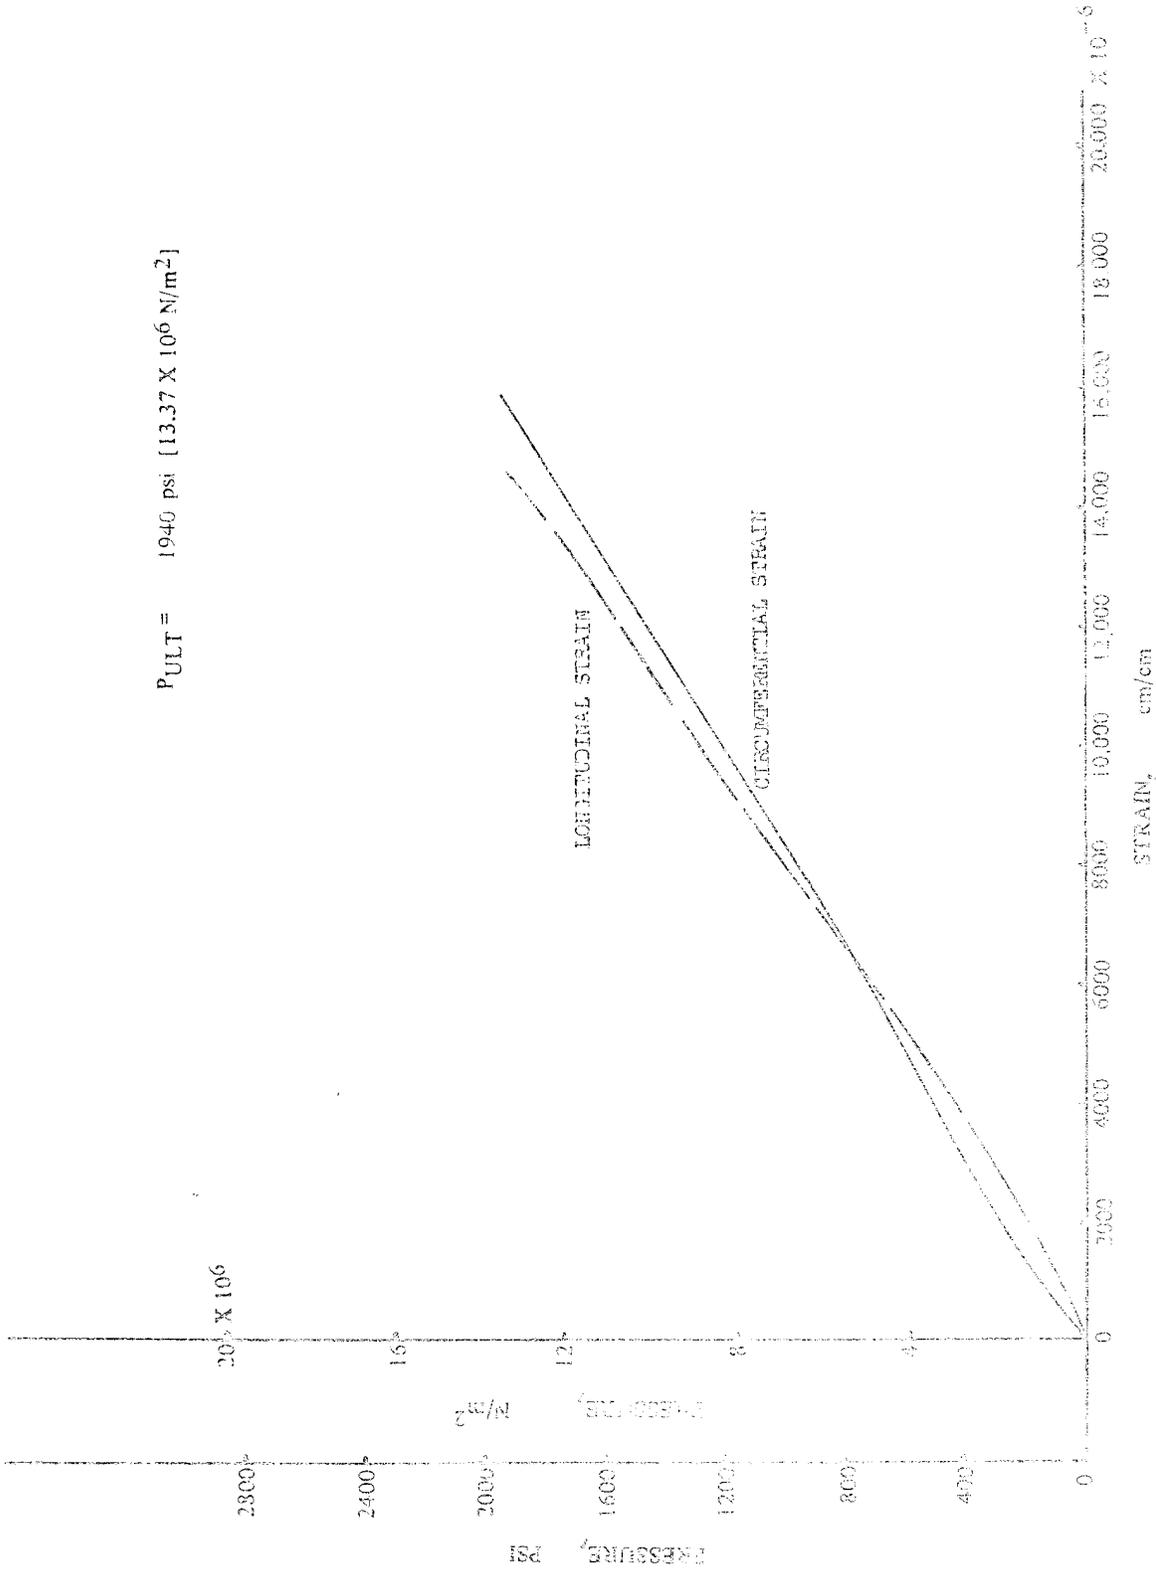
P_{ULT} = 1940 psi [13.37 X 10⁶ N/m²]

FIGURE 66 PRESSURE VS. STRAIN RELATIONSHIP - VESSEL NO. 19

After completing the fatigue tests, vessels No. 7-12 and 19-21 were burst tested to determine the effects of cycling on their ultimate performance. The results of these tests are shown in Table X. All nine tanks had the same basic composite construction and failed at an average pressure of 2,005 psi ($13.8 \times 10^6 \text{ N/M}^2$) with a deviation of ± 250 psi ($\pm 1.72 \times 10^6 \text{ N/M}^2$). The stress-strain curves for each of these vessels are shown in Figures 31-42 and 66-68. The broken tanks are shown in Figures 69 through 77. All nine tanks from the fatigue tests were leaking at the time they were taken to burst and that leakage may have precipitated failure. This is apparently the case in vessels No. 7 and 10 which failed near or below the cyclic pressure. The values shown in Table X may therefore be conservative, although by comparing the ultimate strains they are not unrealistically low. For example, vessels No. 19-21 had ultimate strains of the same magnitude as vessels 3-6 even though the pressures were lower. This seems to indicate that the metallic liners in the latter vessels (No. 3-6) contributed to the vessels performance. There is no evidence that cycling the vessels enhanced the performance of the vessel as was the case with PRD 49-I vessels tested under a previous program (Ref. 1).

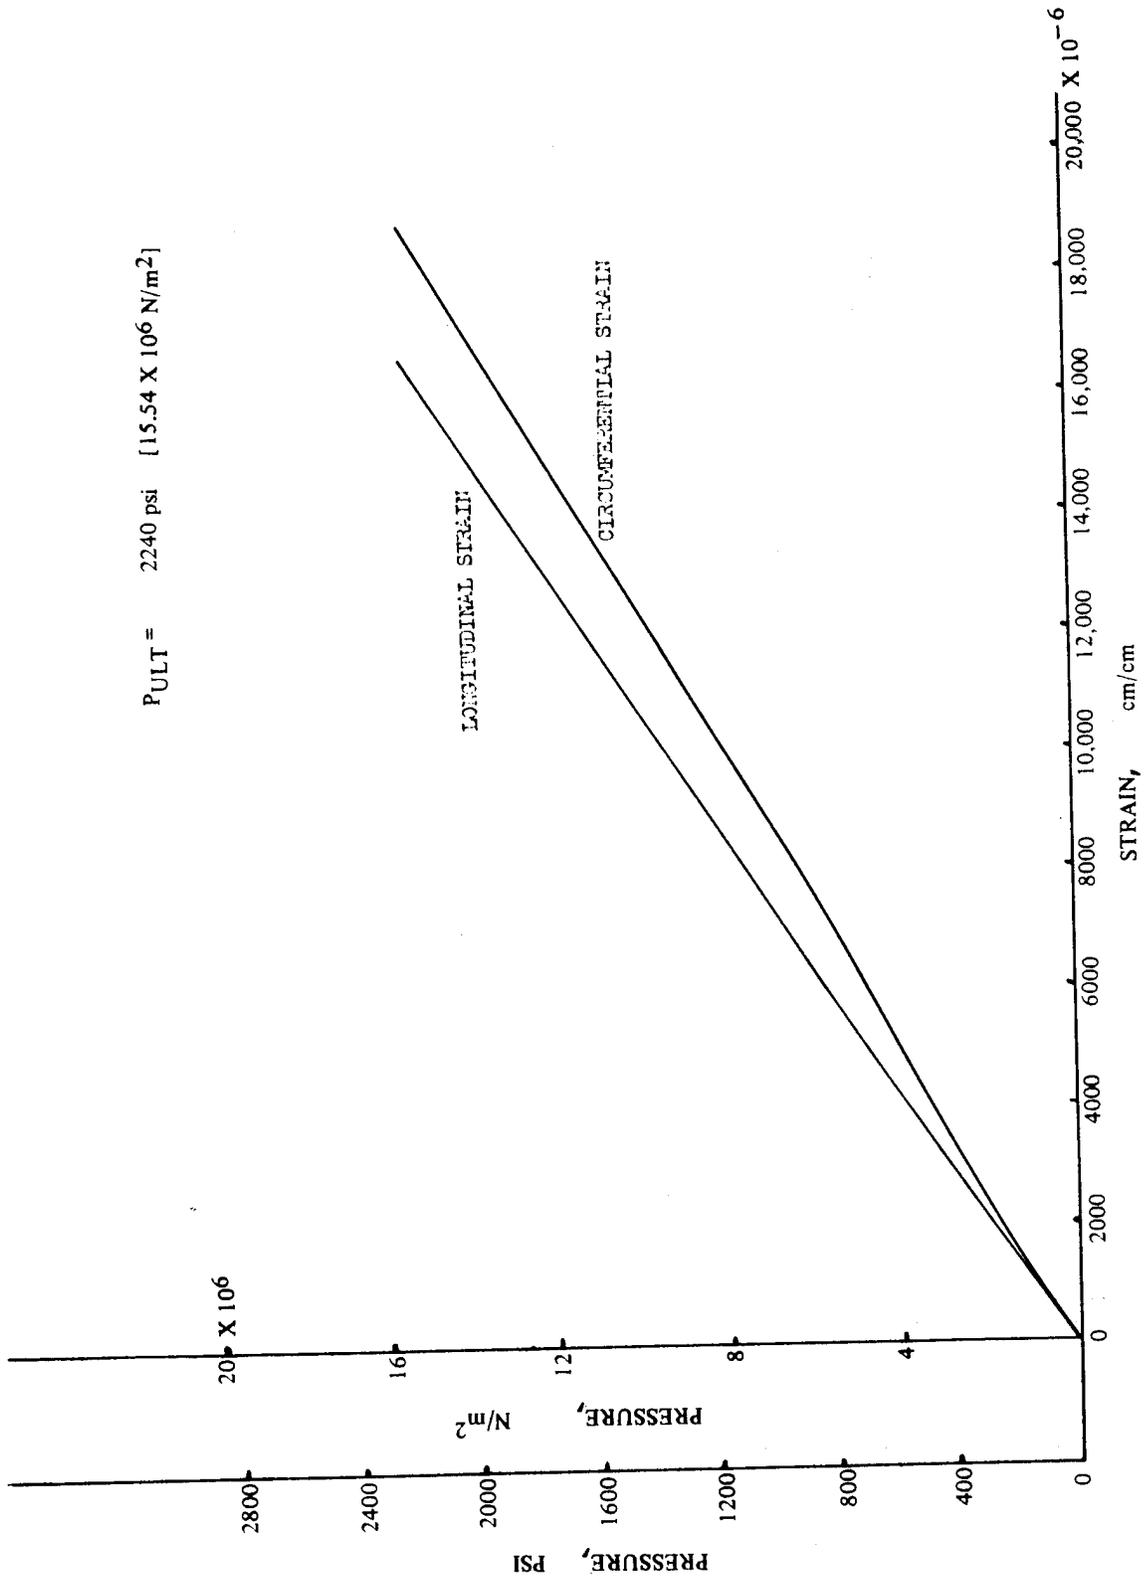
$P_{ULT} = 2240 \text{ psi} \quad [15.54 \times 10^6 \text{ N/m}^2]$

FIGURE 67 PRESSURE VS. STRAIN RELATIONSHIP - VESSEL NO. 20

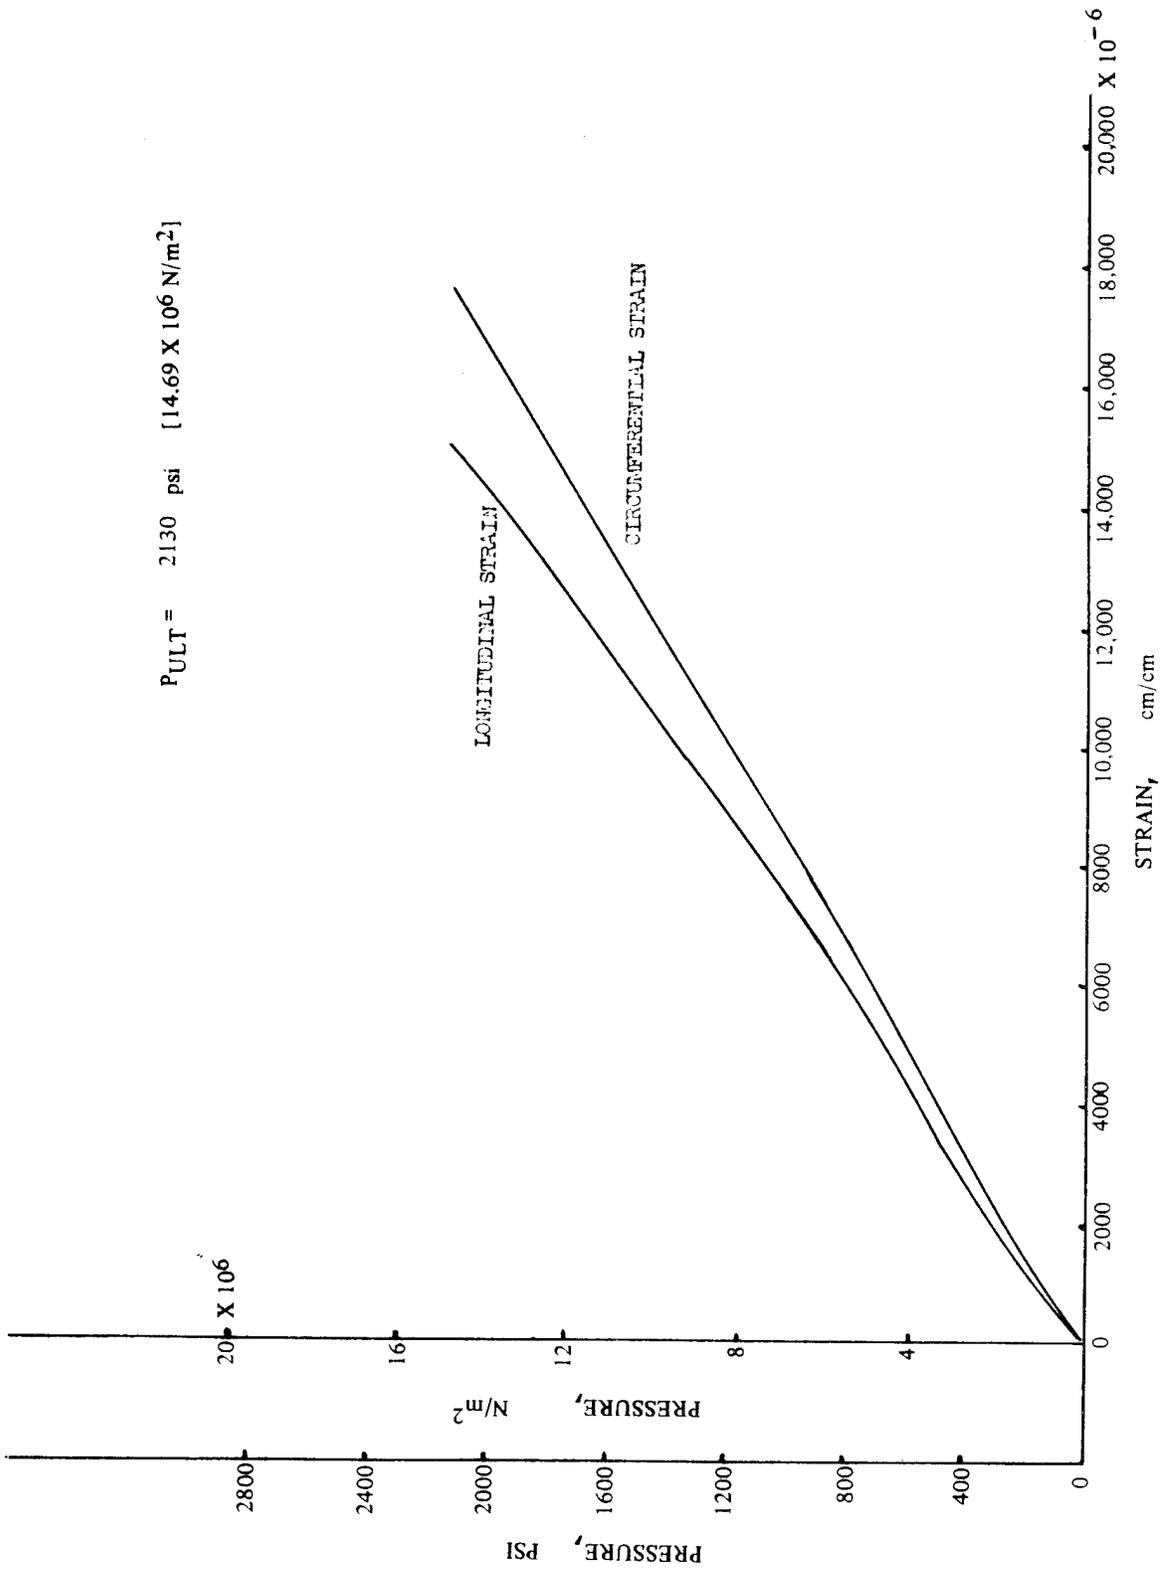
$P_{ULT} = 2130 \text{ psi} \quad [14.69 \times 10^6 \text{ N/m}^2]$

FIGURE 68 PRESSURE VS. STRAIN RELATIONSHIP - VESSEL NO. 21

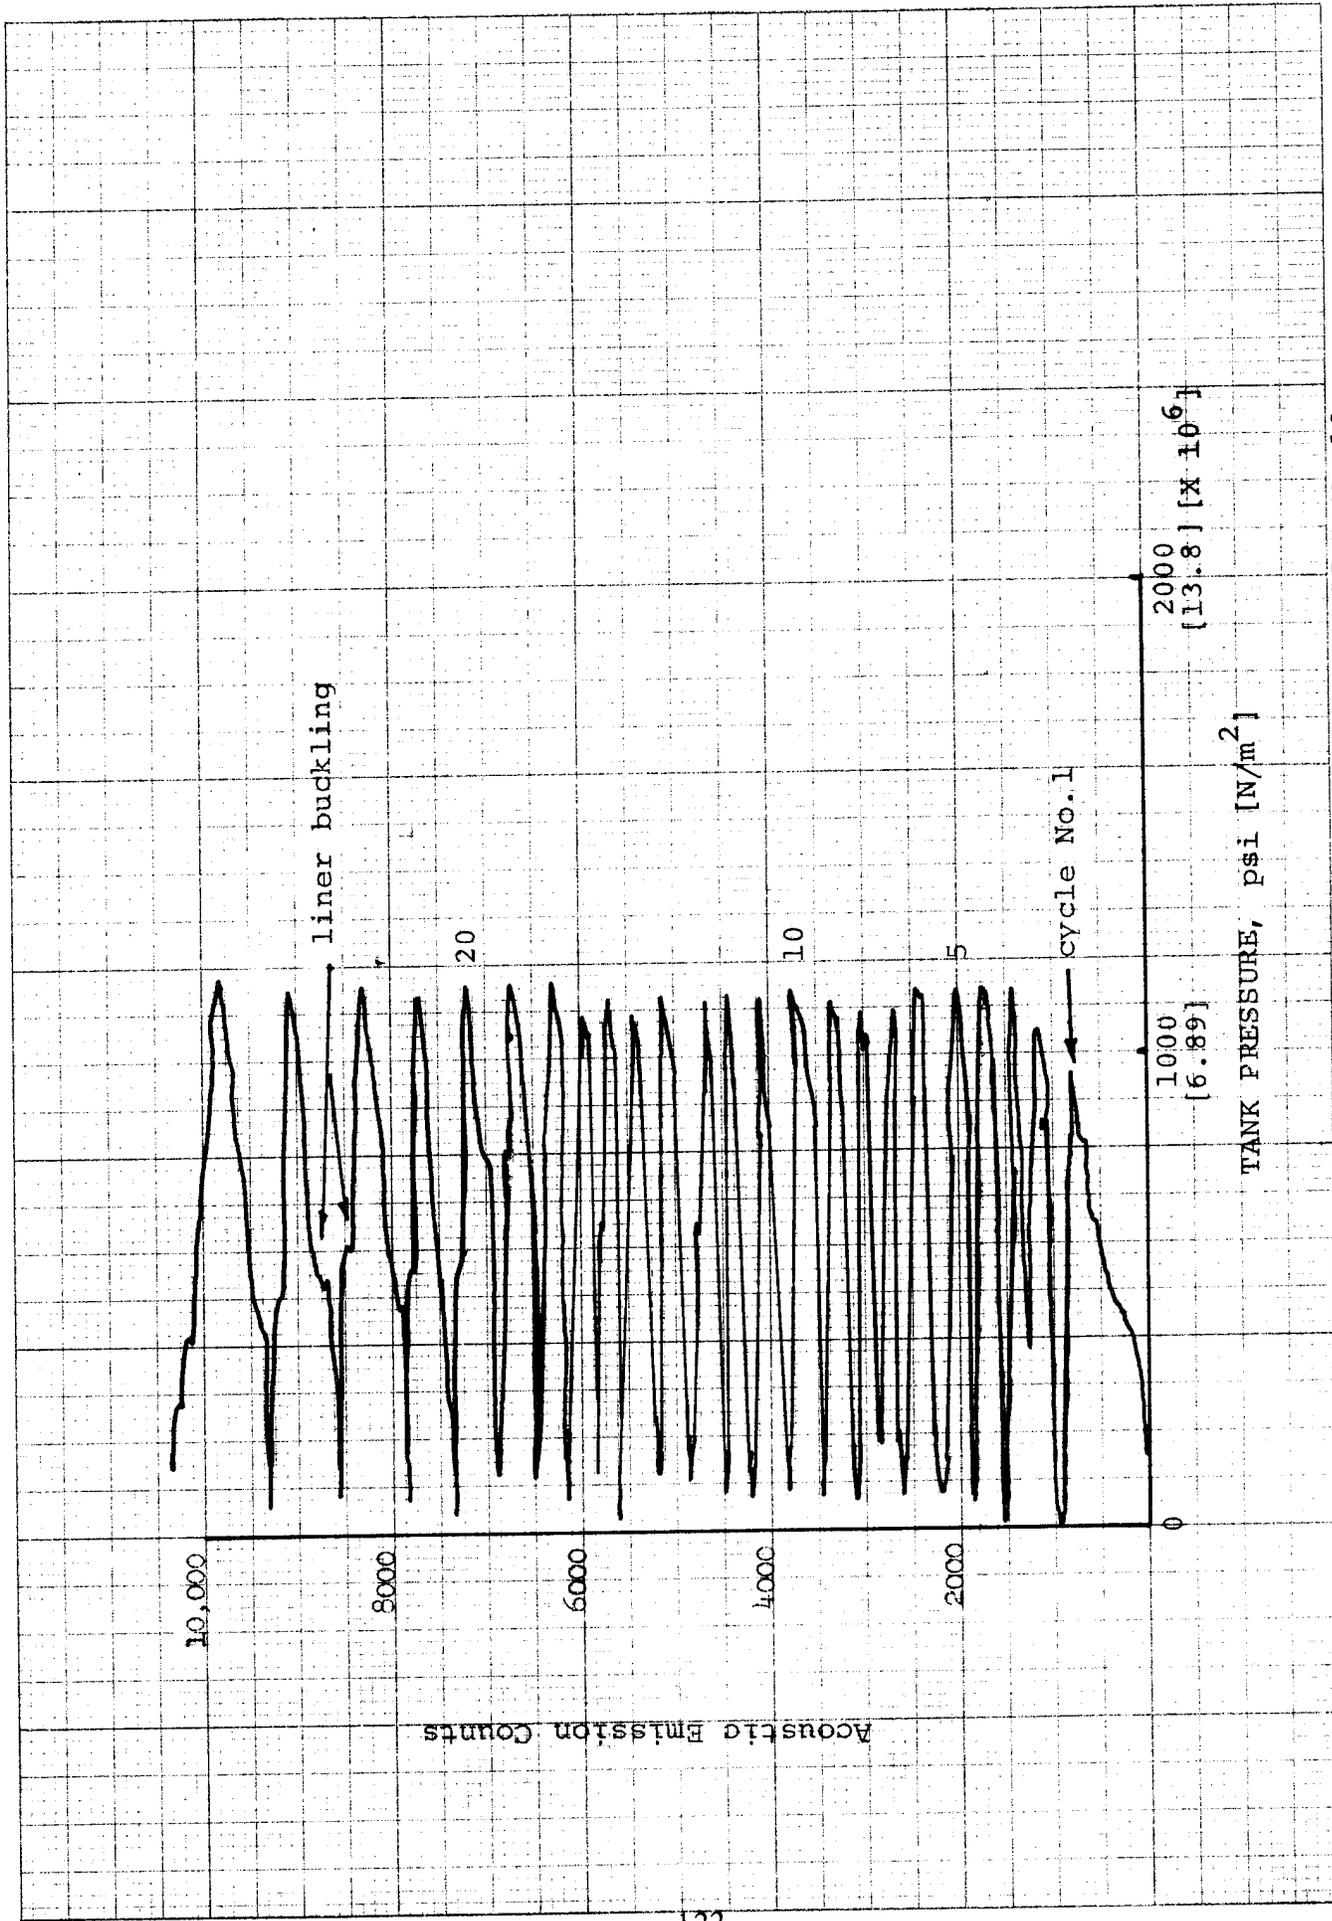
FIGURE 79 ACOUSTIC EMISSION COUNTS DATA FROM VESSEL NO.13

During the fatigue testing of the composite vessels, where the pressure excursions were a fraction of the ultimate burst values the background noise of the liner made it virtually impossible to record the low level acoustic emission signals associated with the fatigue type degradation of the tanks. The metallic liner gave strong emission signals during each pressurization and depressurization cycle and these emissions increased with time. Initially the liner emissions were due merely to elastic and plastic strain. Eventually the liner would debond from the composite wall (a gradual process over several pressure cycles) and these signals were detected. Once debonding occurred liner buckling would occur, followed in a relatively few cycles by liner tearing (metal fatigue) and leakage. All this activity
