1. AGENCY USE ONLY (Leave blank)	2. REPORT DATE 2-26-96	3. REPORT TYPE AND DATES COVERED Final Report, 10-94/2-96		
4. TITLE AND SUBTITLE Automated Silicon Nitride Bearing Ball Inspection Station		5. FUNDING NUMBERS C: DAAH01-94-C -R285

FINAL REPORT

AUTOMATED SILICON NITRIDE BEARING BALL INSPECTION STATION

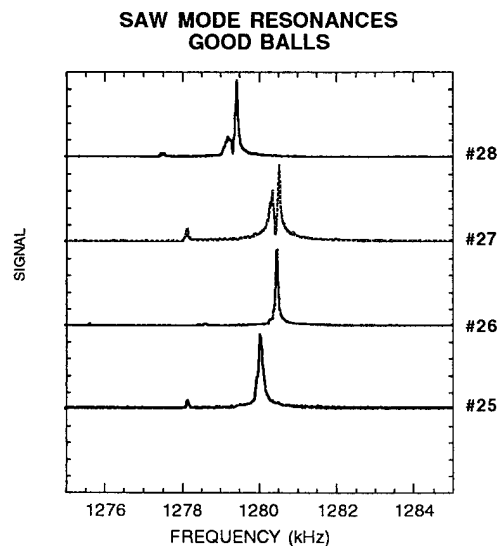
The resonant response of typical bearing balls contain literally thousands of vibrational modes. The 102nd such mode attenuates exponentially with depth from the ball surface, and thus is ideal for detection of surface flaws. The location and nature of this Surface Acoustic Wave (SAW) mode was developed as the result of several analyses performed at Los Alamos National Laboratory. For balls with no surface defects, the SAW mode produces just a few resonant peaks close together, as shown in Figure 6. However, for balls with surface defects, the broken symmetry allows many of the superimposed modes (37-fold degenerate) to manifest themselves as numerous peaks with wide separations, as indicated in Figure 7.

Figure 6. SAW Mode Responses of Selected Good 9/8" Balls

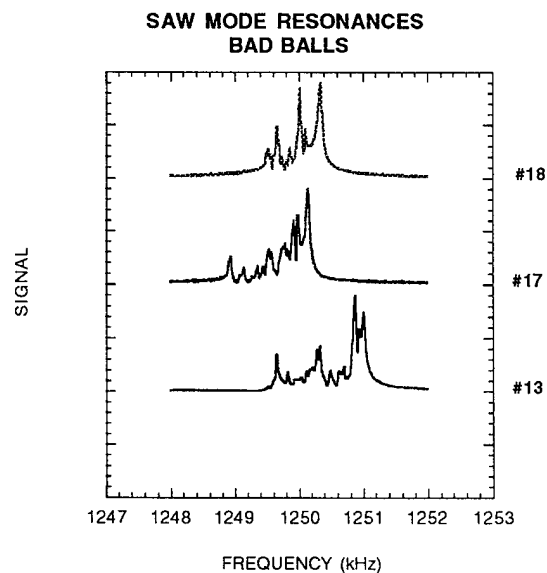
Figure 7. SAW Mode Responses of Selected Bad 9/8" Balls

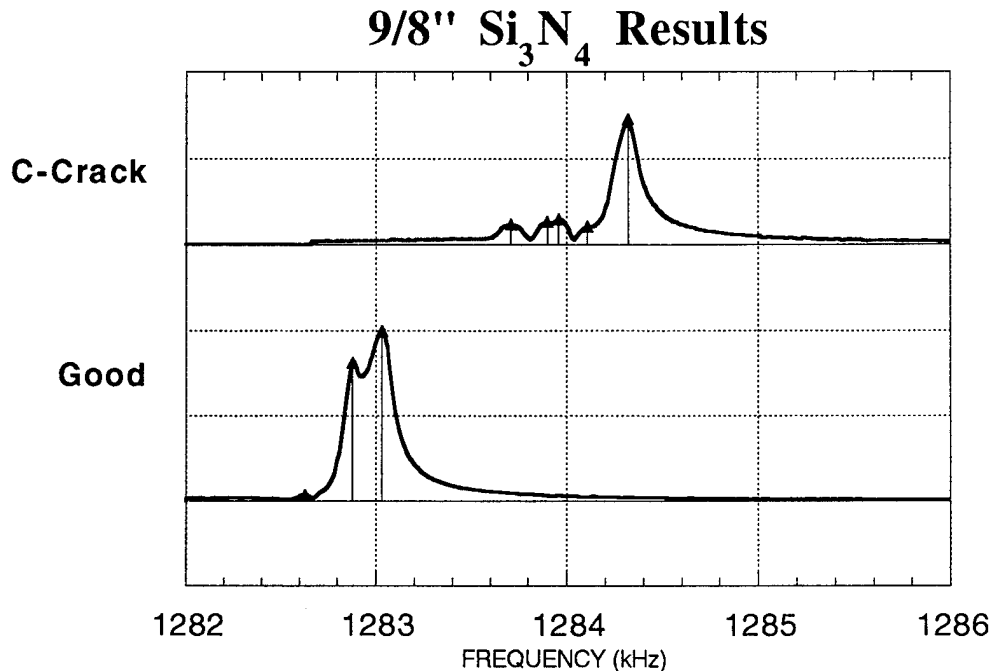
A comparison of Resonant Inspection measurements of two 9/8" diameter silicon nitride balls appears in Figure 8. The good ball (lower trace) has only three resonant peaks (indicated by triangles), with a spread of 401 Hertz (Hz). The other ball (top trace) was in perfect condition, with the exception of a small induced C-crack. For this specimen, there are five peaks, with more than half again as much peak separation (611 Hz).

Figure 8. SAW-Mode Responses of 9/8"-Diameter Si₃N₄ Balls: Good (Lower), C-Crack (Upper)
