LLL: UCRL-52533  
NASA: CR-159512

# HIGH-PERFORMANCE FIBER/ EPOXY COMPOSITE PRESSURE VESSELS

T. T. Chiao, M. A. Hamstad, E. S. Jessop, and R. H. Toland

December 12, 1978

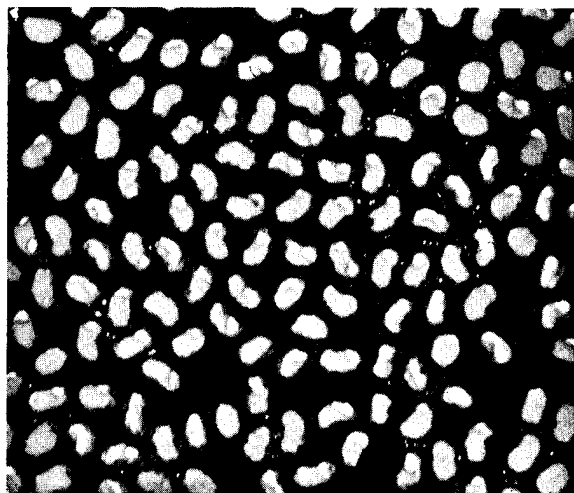
Fig. 3. Photograph of fiber filament shapes.

We used epoxy-impregnated fiber strand specimens to determine the tensile properties of the graphite fiber. Over 5000 composite strands (approximately 180 fiber strands from each spool) were fabricated using a vacuum filament winding process. From a random spool of fiber, we made almost 2000 more composite specimens to study the effect of strain rate and liquid nitrogen temperature on fiber tensile strength. Similar strand specimens also are being used to check the stress-rupture behavior of the fiber composite. The strands were impregnated with the epoxy system described above and cured following the same schedule. We determined the fiber volume content of 10 fiber/epoxy strands selected randomly from each group of 180 specimens. The fiber content of these strands averaged 64.2 vol%, with a CV of 8.7%. The fiber filament shapes are shown in Fig. 3.

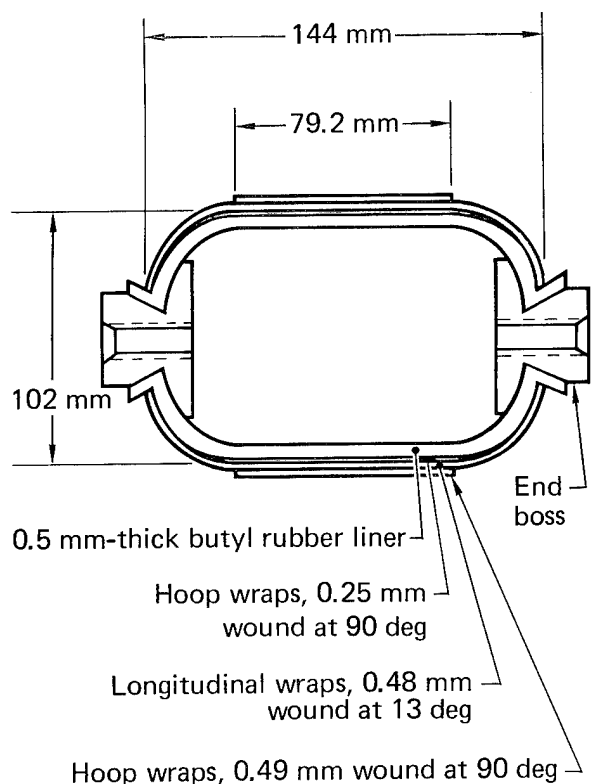
Fig. 7. Typical dimensions of a 10.2-cm-diameter, filament wound pressure vessel (volume =  $950 \pm 8 \text{ cm}^3$ ).

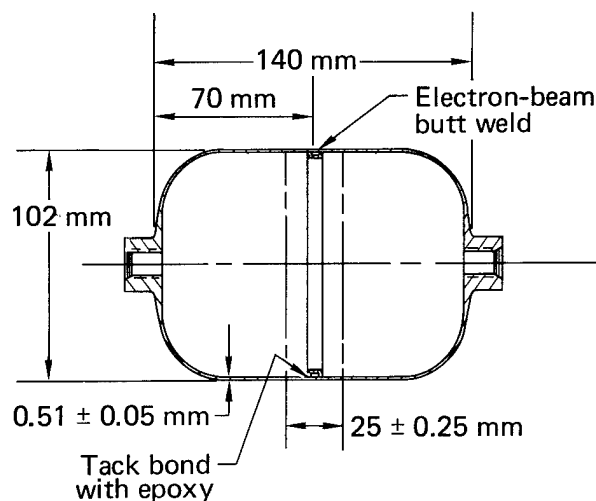
**Fig. 9. Design of the metal mandrel used to wind the 10.2-cm-diameter pressure vessels.**

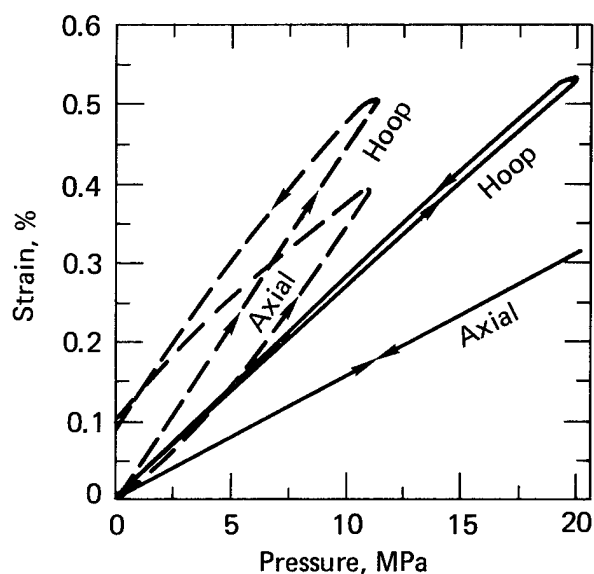
**Fig. 11. Typical pressure vs strain curves during the first load cycle to 50% of the expected failure pressure of titanium-lined and aluminum-lined pressure vessels: solid curves denote titanium-lined vessel results, dashed curves denote aluminum-lined vessel results.**

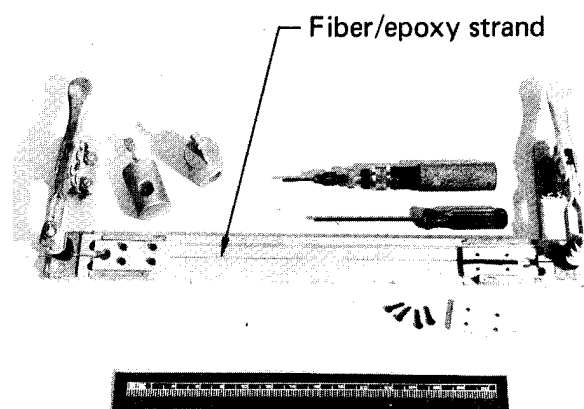
Fig. 21. Clamping arrangement for testing the fiber strengths of epoxy-impregnated strands.

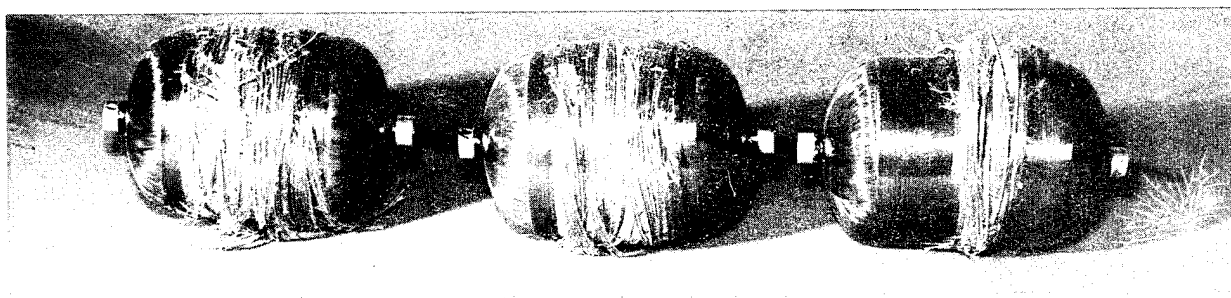
Fig. 23. Typical pressure vessel failures: from left to right, vessels made with epoxy systems 1, 4, and 7.

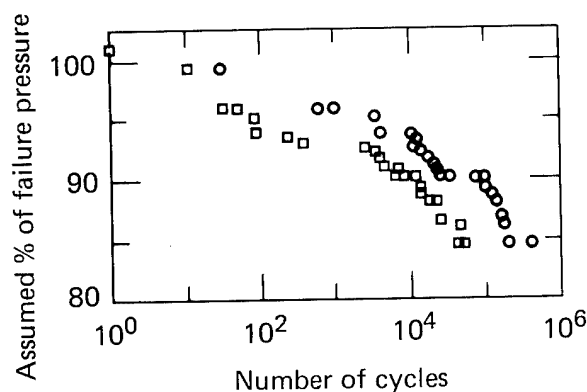
Fig. 34. Fatigue life at assumed peak cyclic stress levels for 10.2-cm-diameter pressure vessels:  $\circ$  denotes failure of vessels under sinusoidal cycling,  $\square$  denotes failure of vessels under rectangular cycling. Vessels that failed at less than one cycle are plotted at one cycle.

Using these expected upper stress levels, we plotted the cyclic lifetimes for both sinusoidal and rectangular pressure cycling (Fig. 34). If the assumptions that led to this figure are correct, extrapolation of the

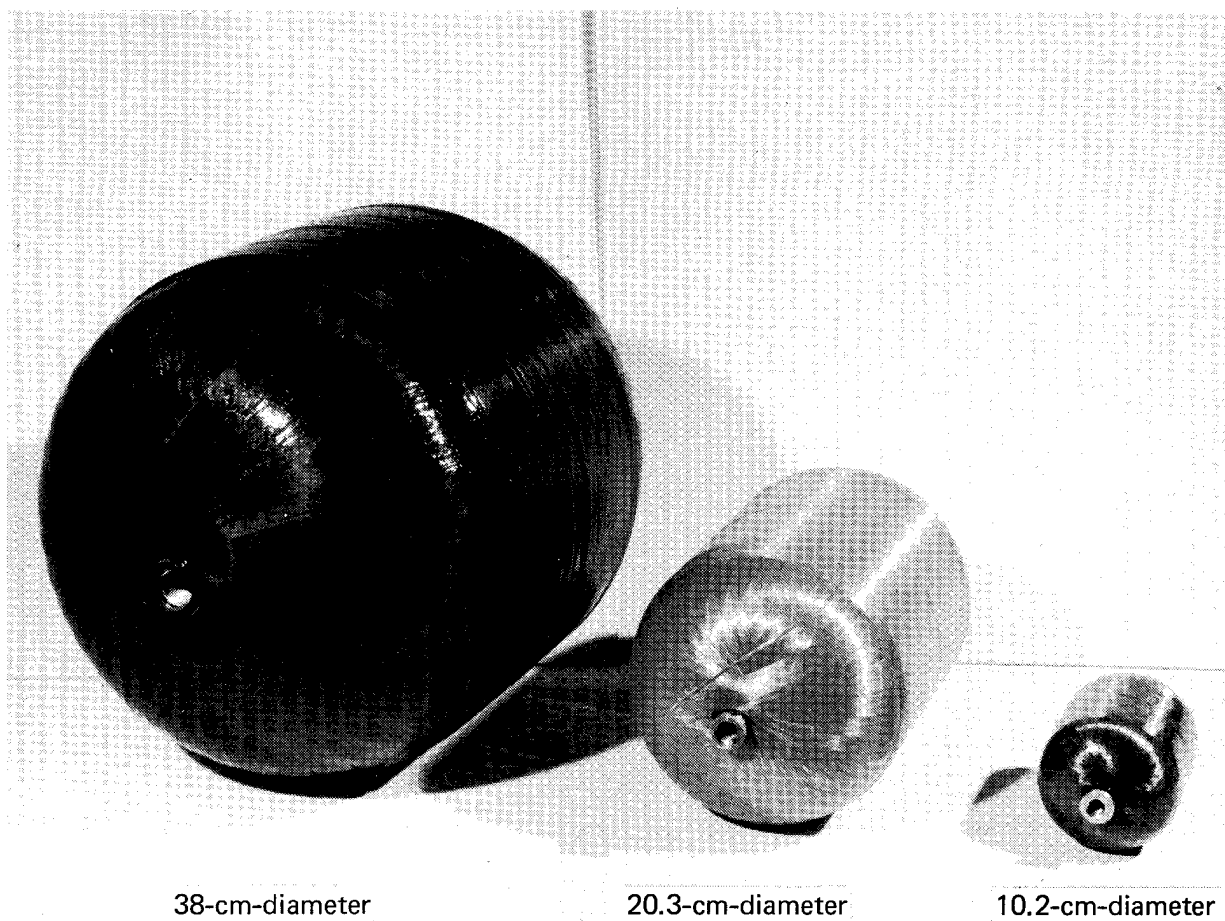
Fig. 36. Photograph of the 10-cm-diameter, 20-cm-diameter, and 38-cm-diameter pressure vessels tested in this study.

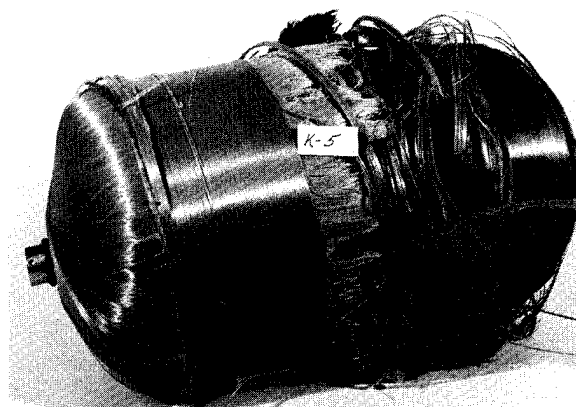
Fig. 38. Photograph of the hoop failure of the K-5, 20.3-cm-diameter pressure vessel.

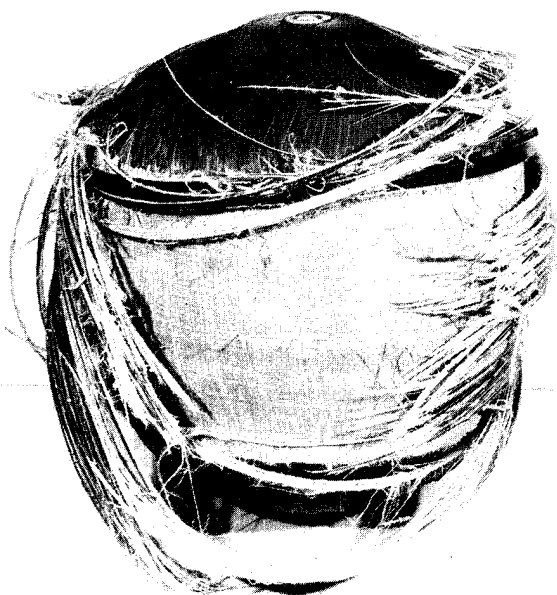
**Fig. 39. Photograph of the hoop failure of a 38-cm-diameter, Kevlar 49/epoxy pressure vessel.**

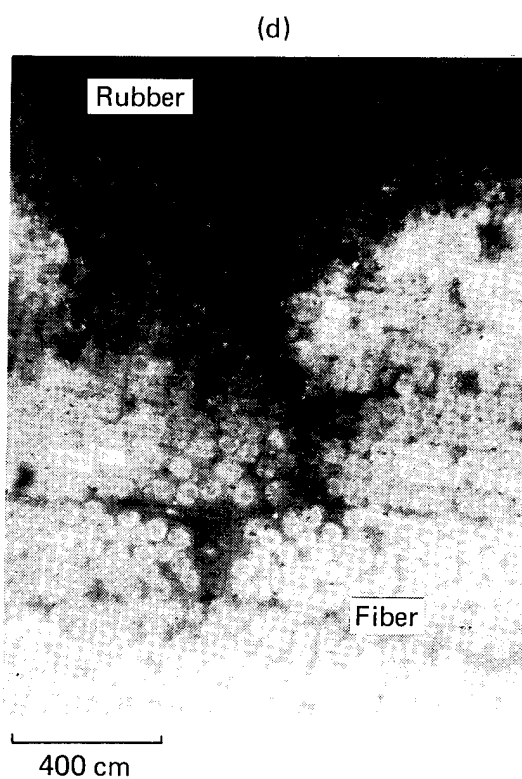
Fig. 43. Photomicrographs of four wall sections illustrating some of the problems with the liners: (a, b) 20.3-cm<sup>3</sup>-diameter vessels with voids, (c, d) 10.2-cm-diameter vessels with rubber migration.

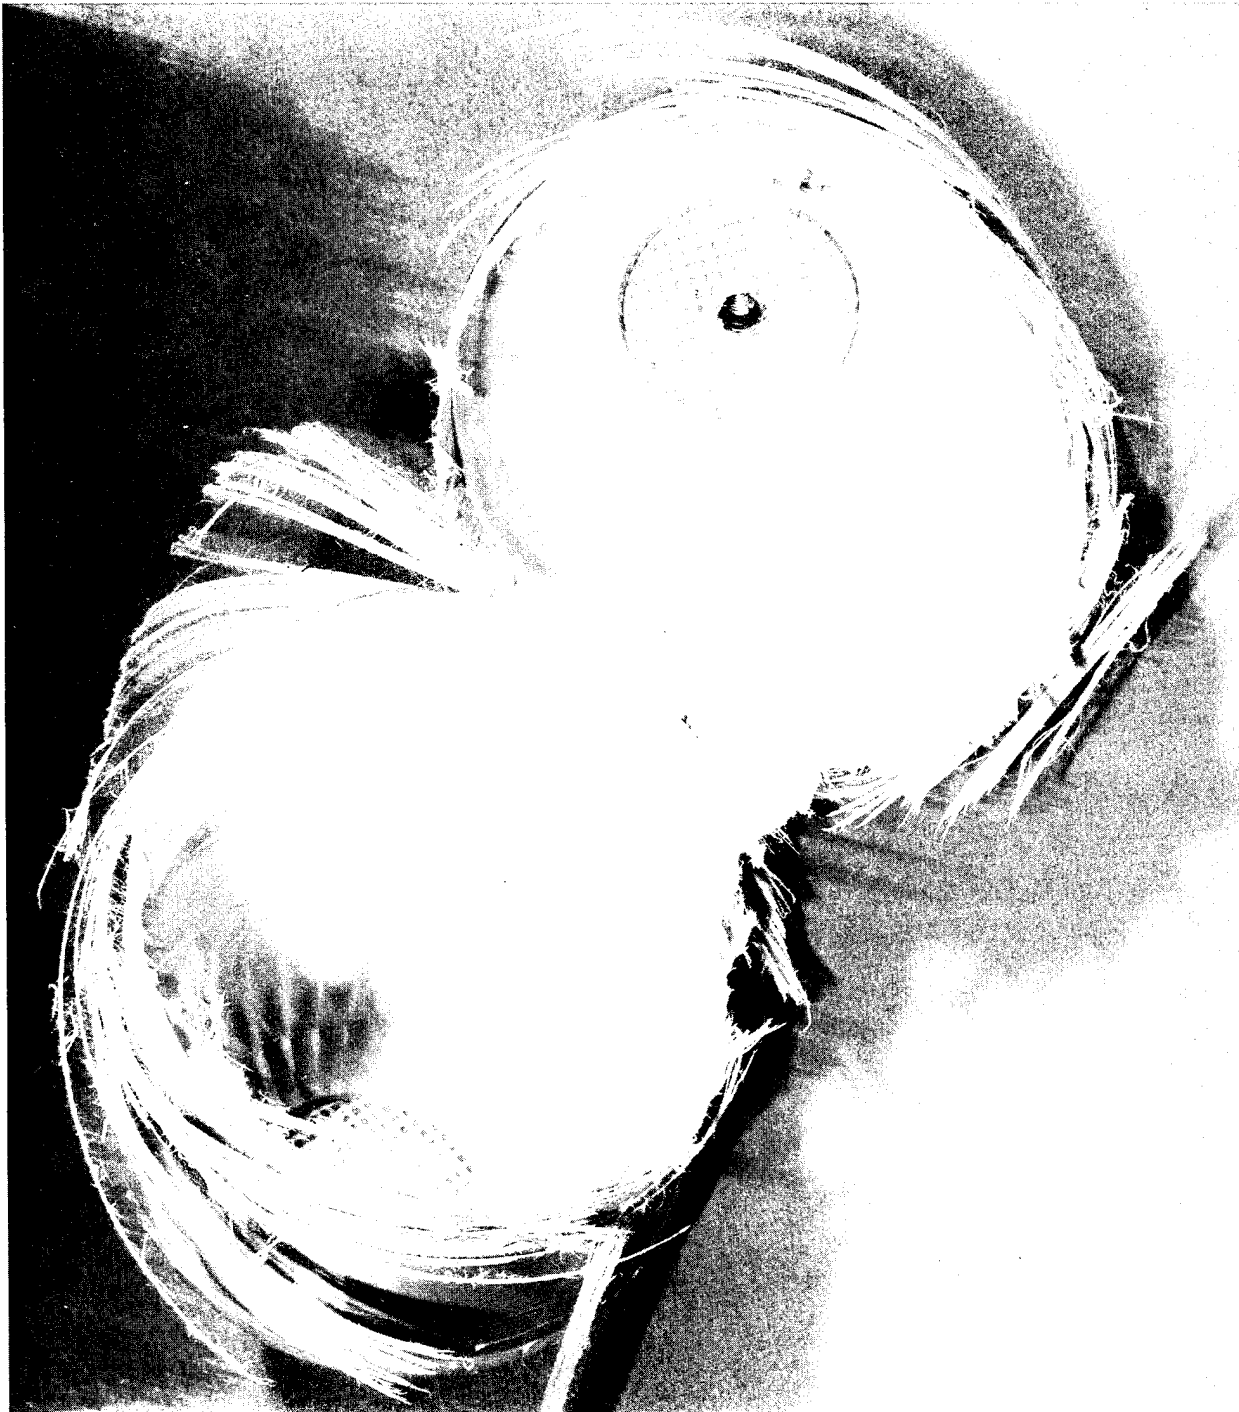
Fig. 44. Photograph of an ABS-lined pressure vessel wound with the double pattern overwind showing the hoop mode of failure (vessel failed at 36.8 MPa).
