# Evaluation of a Vibration Diagnostic System for the Detection of Spiral Bevel Gear Pitting Failures

Dennis P. Townsend and James J. Zakrajsek  
*Lewis Research Center*  
*Cleveland, Ohio*

Prepared for the  
Seventh International Power Transmission and Gearing Conference  
sponsored by the American Society of Mechanical Engineers  
San Diego, California, October 6-9, 1996

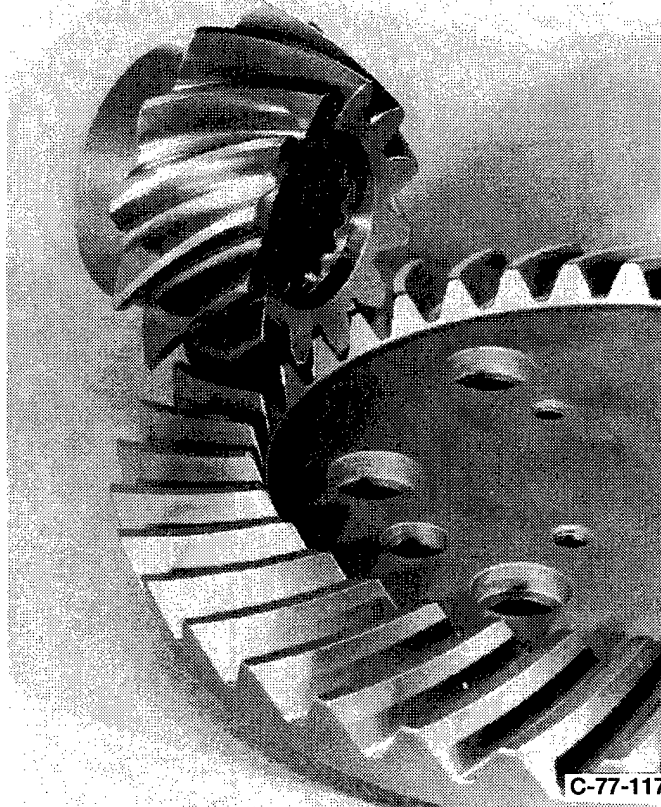
Figure 3.—Spiral bevel test gears.

As shown in Fig. 2 two sets of spiral bevel gears are tested simultaneously. The slave (right) side operates in a speed increaser mode, where the gear drives the pinion. The test (left) side operates in the intended fashion as a speed reducer. The gear ratio for the test rig is three to one with 12 teeth on the pinion and 36 teeth on the gear. A photograph of the test gears is shown in Fig. 3. The test hardware basic design parameters are given in Table I.

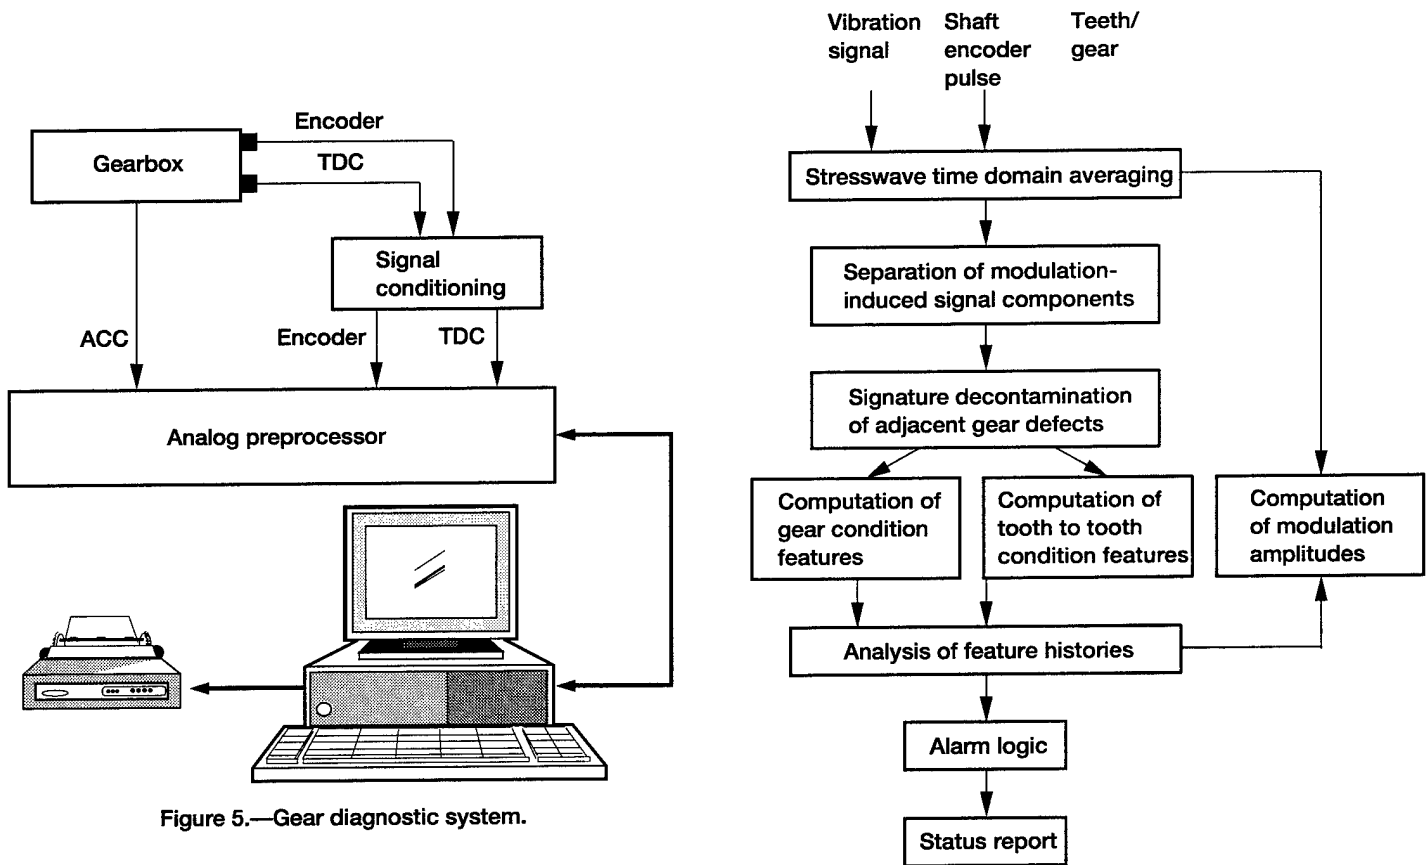
Figure 5.—Gear diagnostic system.

Figure 6.—Gear diagnostic system flow chart.

The diagnostic system used in this research program is a commercial gear diagnostic system. The system consists of a personal computer with an analog to digital board installed, a signal conditioning system, and a software package. A schematic of the system is shown in Fig. 5. The signal conditioning system includes a computer controlled tracking filter, computer controlled analog signal conditioning, a pulse rate multiplier/divider, and interfacing electronics. The software automatically sets and monitors the analog signal conditioning circuitry, performs the analysis and provides monitor displays of individual gear tooth vibration images. Gear condition status and alarms are issued when appropriate. The software can display current and past data in a variety of different formats. A flow chart of the system is shown in Fig. 6.

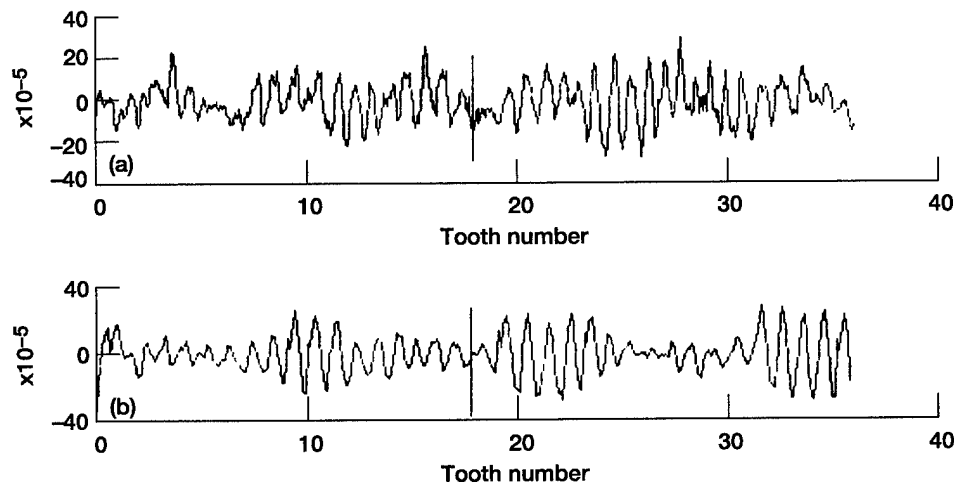
Figure 8.—Time synchronous average plots of gear for test run A. (a) Gear raw baseband plot. (b) Gear baseband envelope.

Figure 8(a) shows a plot of the gear pair raw baseband and Fig. 8(b) shows a plot of the gear pair base band envelope from the test A with the loose pinion hold down nut which ran a total of 122 hr. These plots were taken near the end of the test. The horizontal scale covers one revolution of the gear and shows the condition of each of the 36 teeth on the gear, while the vertical scale is the amplitude of the signal and indicates the intensity of the tooth load. Figure 8(a) shows an increase and decrease in amplitude at three locations during one revolution of the gear which indicates the eccentric condition of the pinion which is running at three times the speed of the gear. The 36 teeth on the gear can be seen in these plots.

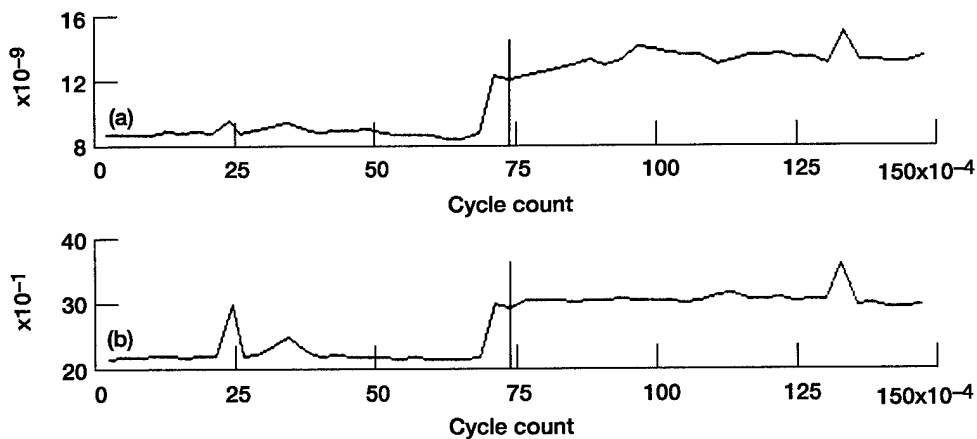
Figure 9.—Features plots of gear for test run A. (a) Total energy gear baseband envelope. (b) Kurtosis of gear baseband envelope.

Figures 9(a) and (b) shows some of the feature plots, produced by the diagnostic system for the test A with the loose nut. These plots show the various parameters from the start until the end of testing and are generated from the data shown in Figs. 8(a) and (b). These plots show the total energy of the gear base band envelope (Fig. 9(a)) and kurtosis of the gear raw baseband (Fig. 9(b)). From these figures it appears that something happened approximately half way through the test, however there were no indications of a failure in the time averaged vibration plots at this time. Near the end of the test these feature plots still indicate that something has happened. The time averaged vibration plots show a three cycle wave giving a change in amplitude with each revolution of the pinion. This condition was caused by a loose pinion nut that allowed the pinion to run in an eccentric condition thereby producing the three cycle amplitude variation per gear revolution.

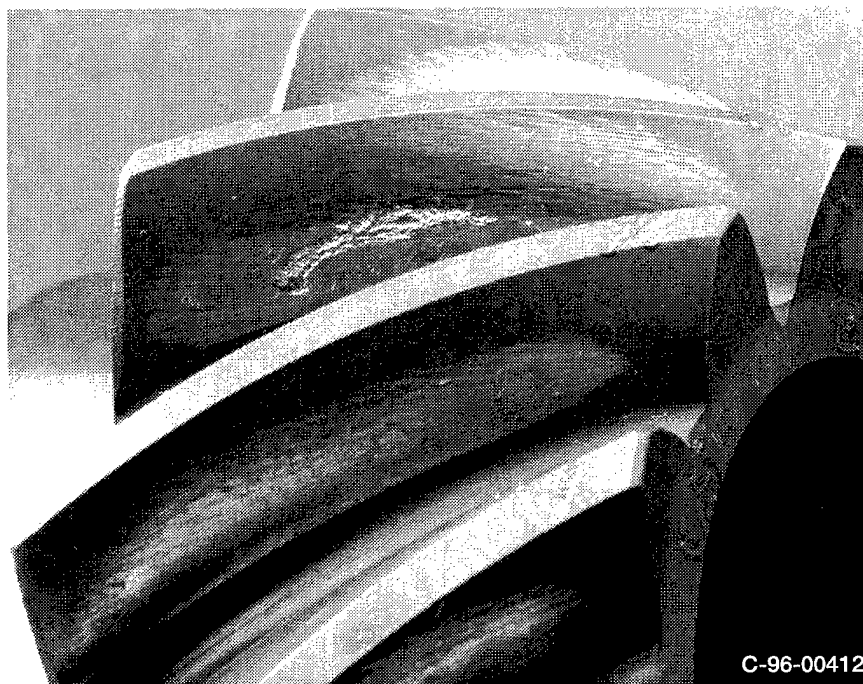
Figure 12.—Pinion tooth fatigue spall test run B.

Figures 11 (a) to (c) are the time averaged plots of the gear stresswave, gear baseband envelope, and hunting tooth baseband envelope for test B. Each of these curves shows the gear teeth at locations 8, 20, and 32 to have a very high amplitude compared to the other teeth on the gear. These are exactly 12 teeth apart which is the number of teeth on the pinion. This increased amplitude of the three teeth on the gear is a result of the surface fatigue damage of one tooth on the pinion shown in Fig. 12.

Figure 13 shows six of the 14 feature plots, for test B. These plots were generated from the data shown in Figs. 10 and 11. Figures 13(a) to (c) are the (a) peak residual ratio, (b) kurtosis and (c) total energy of the pinion stresswave. Figures 13(d) to (f) are (d) the peak residual and (e) total energy of the gear baseband envelope and (f) the kurtosis of the gear stresswave. From these figures it is clear that not much damage occurred until the last 15 percent of total test time. After about 85 percent of total test time all of the above indicators began a steady and continuing increase in amplitude until the test was stopped. The pinion time averaged plots, Figs. 10(c) and (d) show that one tooth (tooth number 8) on the pinion was producing a higher dynamic load than the other teeth. This tooth was found to have fairly sizable fatigue spall as shown in Fig. 12.

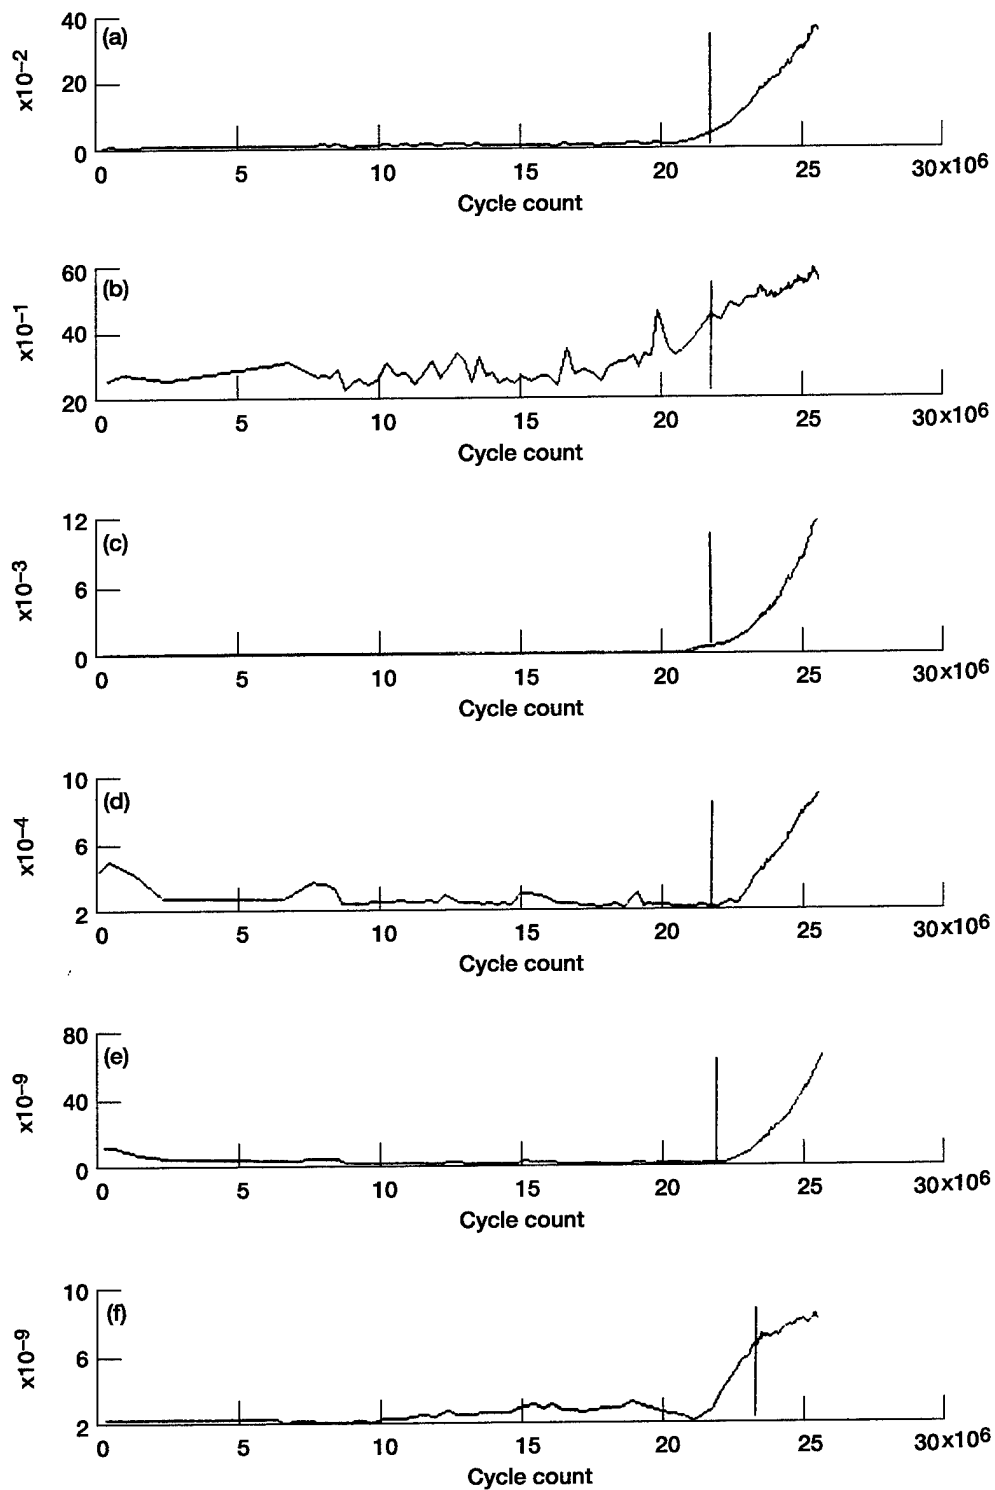
Figure 13.—Features plots for test run B. (a) Peak residual pinion stresswave. (b) Kurtosis pinion stresswave. (c) Total energy pinion stresswave. (d) Peak residual gear baseband stresswave. (e) Total energy gear baseband envelope. (f) Kurtosis gear stresswave.

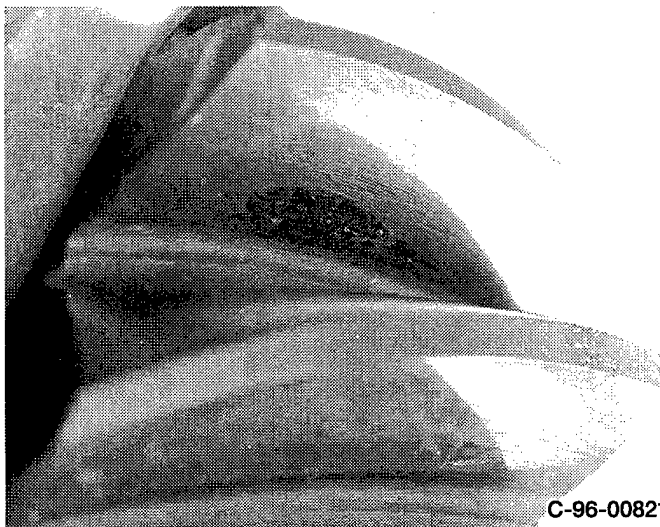
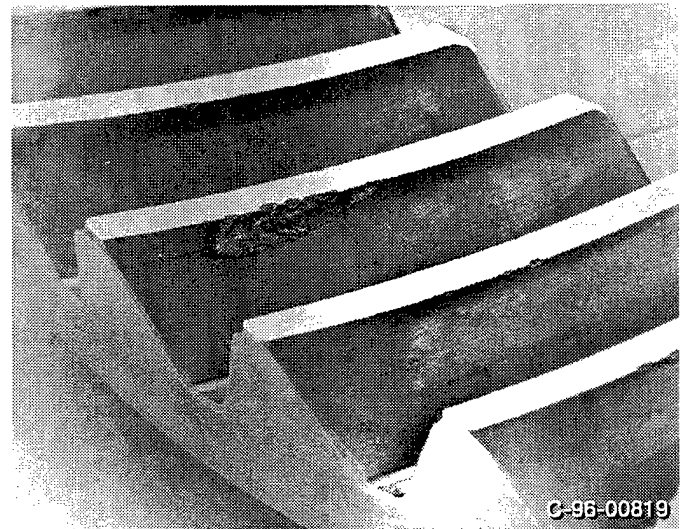
Figure 15.—Gear and pinion fatigue spall for test run C.

Another gear test run C completed a total of 527 hr and had some fatigue damage on one tooth. The plots for the time averaged pinion stresswave, gear stresswave and hunting tooth baseband envelope are shown in Figs. 14(a) to (c) respectively. A signal from each individual tooth cannot be seen on these figures, however these figures show an increase in amplitude for one area of the pinion near tooth number 3 and for three areas of the gear. This indicates that one location on the pinion is contributing to an increase in dynamic load. Figure 15 shows the fatigue spalls on the pinion and gear for test C.
