Technical Report GL-97-4  
April 1997

# Contingency Airfield and Road Construction Using Geosynthetic Fiber Stabilization of Sands

Final report

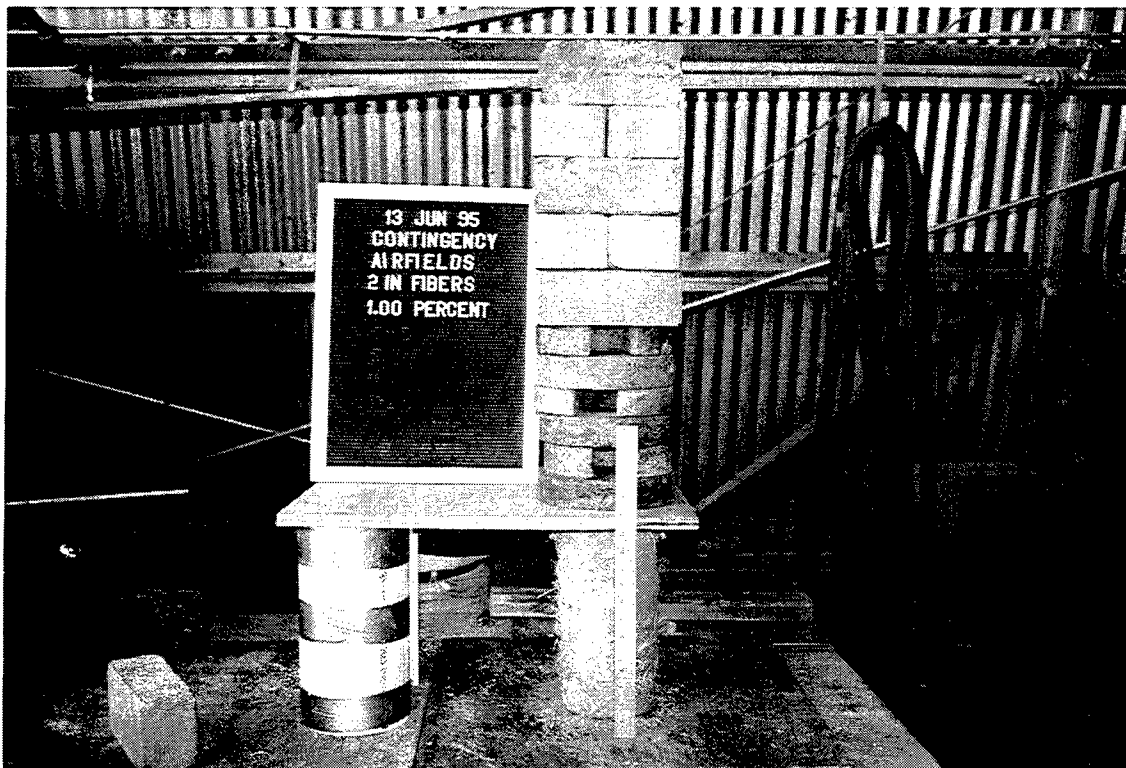
Figure 2. Sand-fiber sample with 201-lb loading

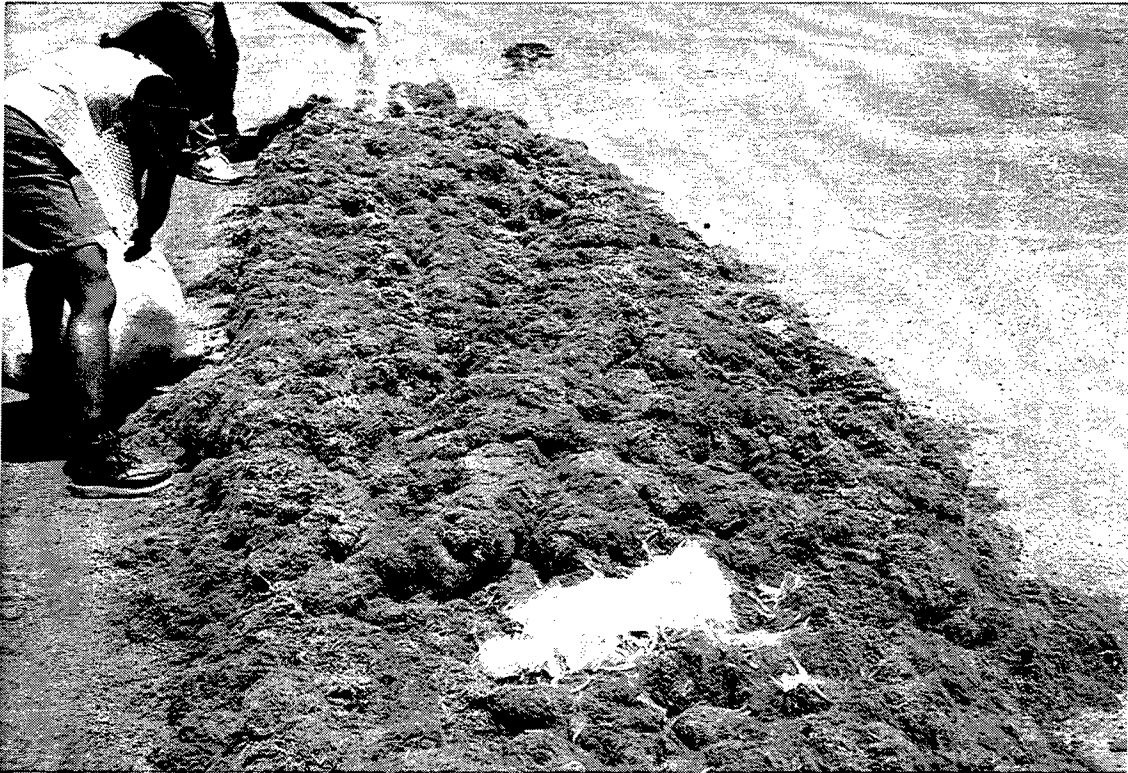
Figure 5. Fiber mixed in sand after four passes

The field mix of sand and fibers consisted of 3,600 lb of moist concrete sand (SP). The sand had an average moisture content of 6 percent. The amount of fiber used was 80 lb which was 2.4 percent (based on dry weight of the sand) of fiber in the mix. A total of 80 lb of fiber (2.4 percent based on dry weight of the sand) was mixed into the sand. First, 0.2 percent of the fiber was mixed into the sand using four passes of the mixer. The fiber content was then increased to 0.5, 1, and finally 2.4 percent. In all the cases, the fibers in the field mixed material looked very uniformly distributed after four passes of the mixer.

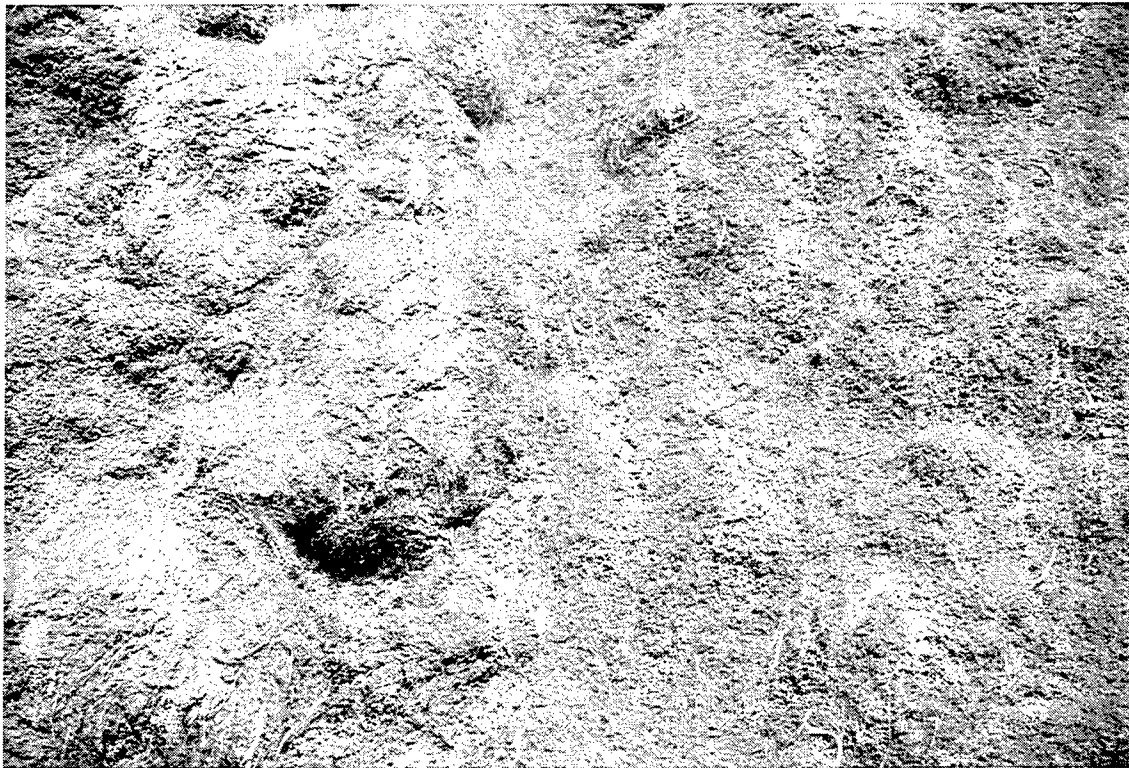
Figure 6. Close-up of sand-fiber mix

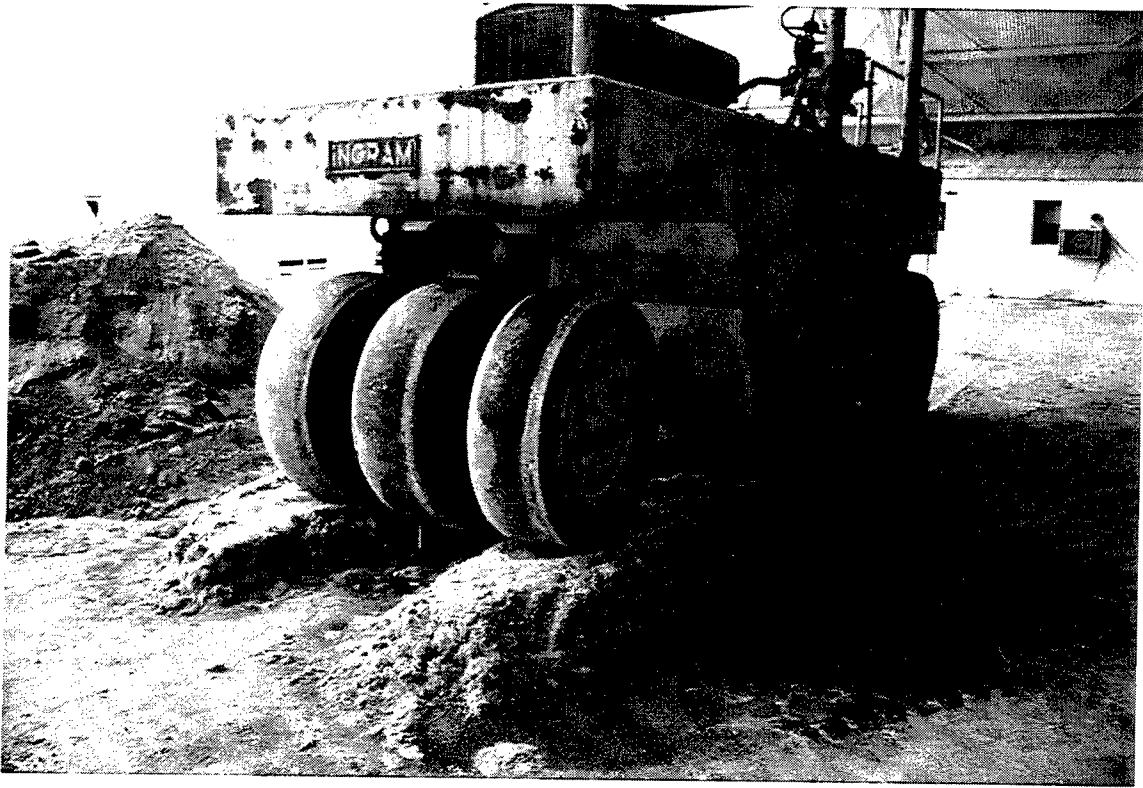
Figure 7. Sand-fiber ramps with 50,000-lb compactor

The self-propelled rotary mixer produced a uniform distribution of the sand-fiber mix during the field mixing evaluation. Sand-fiber mixing can be easily accomplished using existing military construction equipment. A 50,000-lb compactor was positioned over two sand-fiber ramps to evaluate the field sample load-carrying capacity of the field mixed material (Figure 7). The sand-fiber ramps supported the heavy weight without significant deformation.

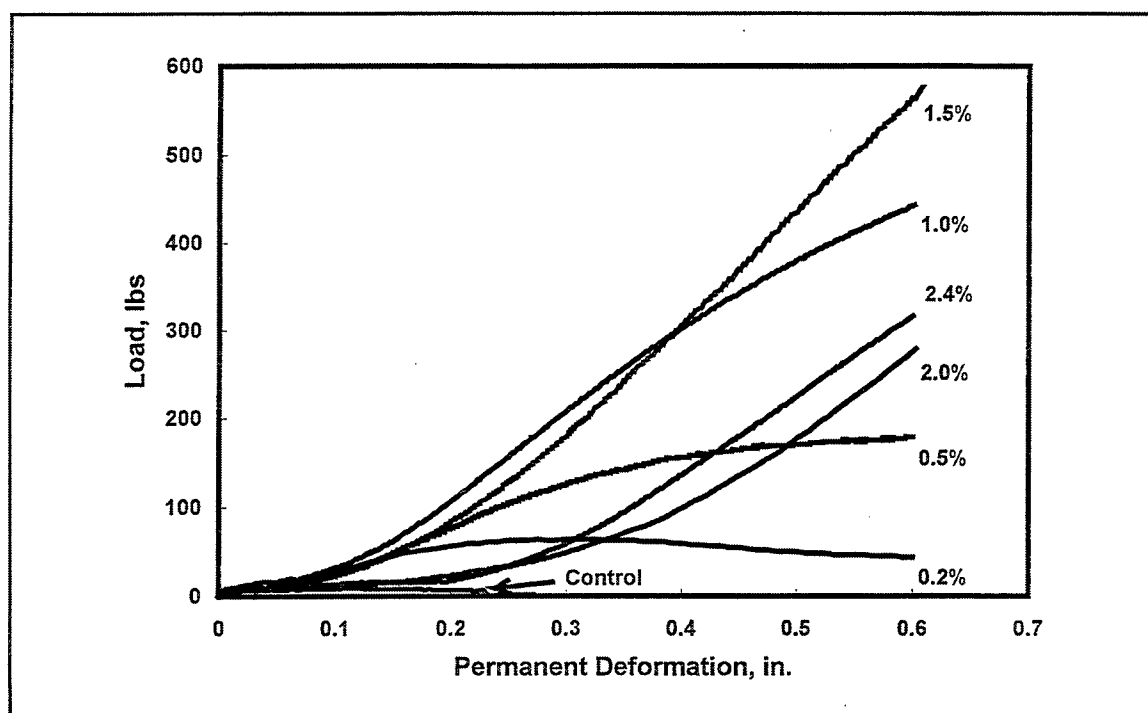
Figure 14. Relationship between percent of fiber and permanent deformation

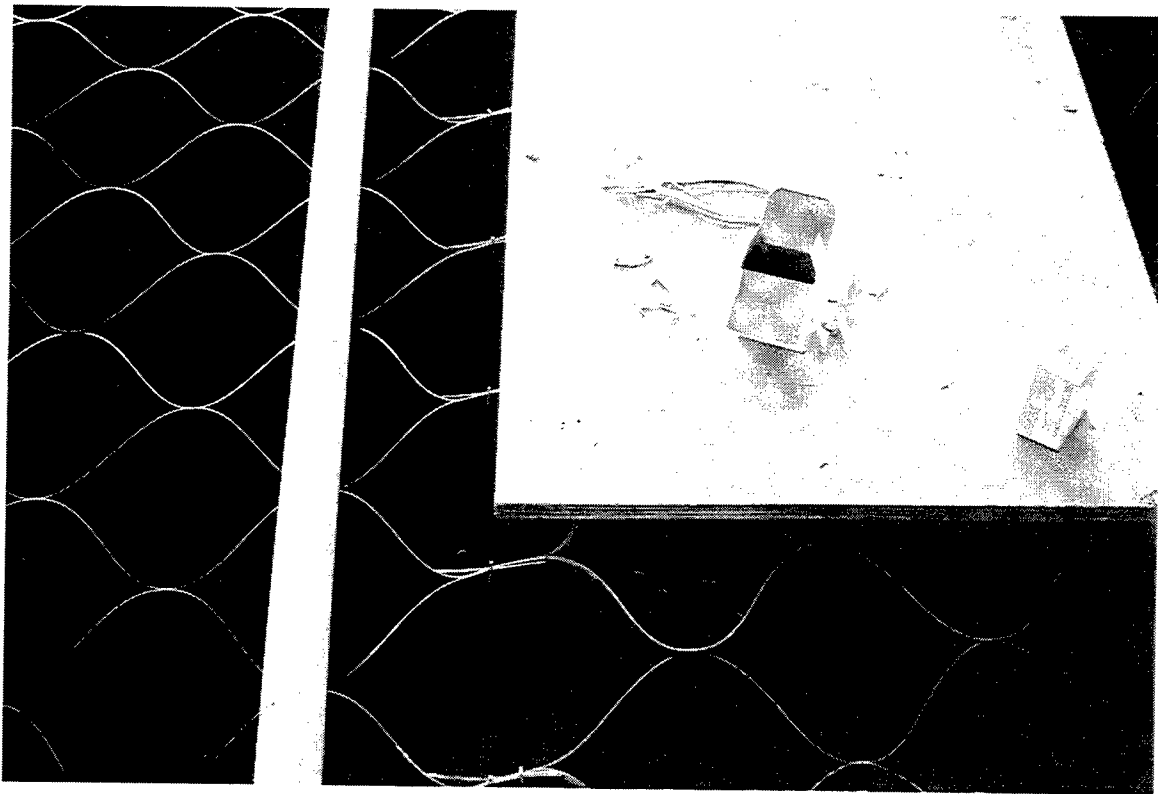
Figure 22. Close-up of hog ring connections

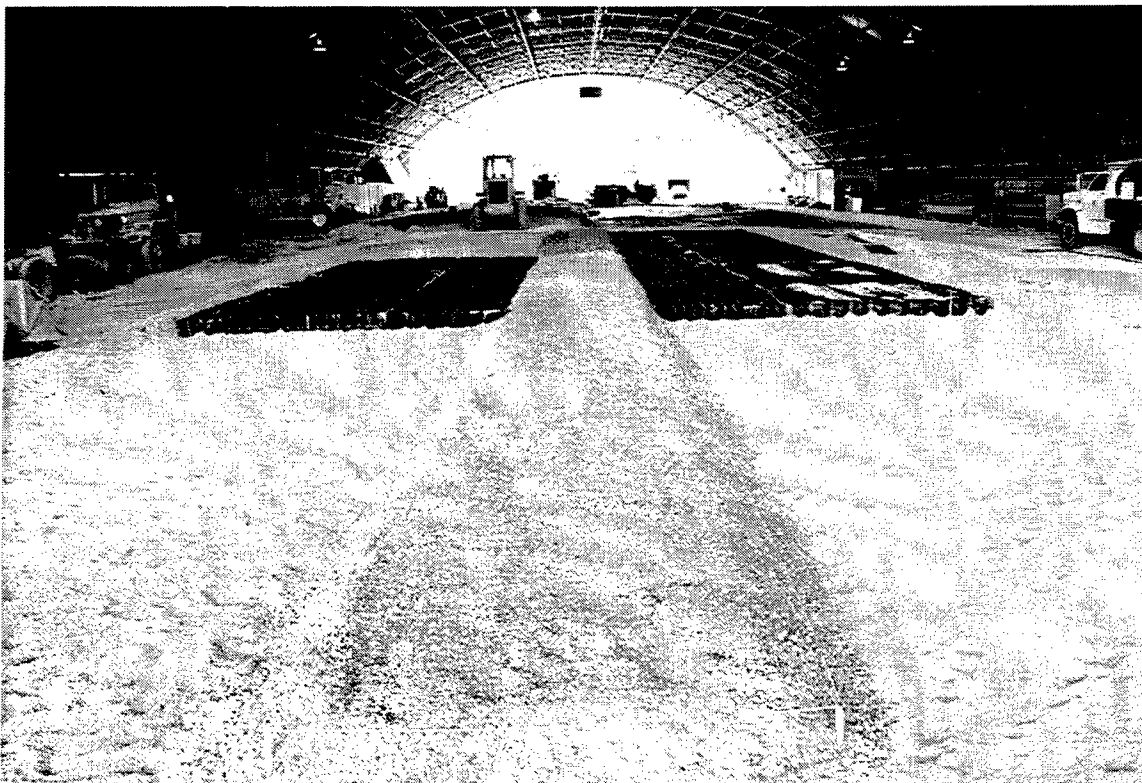
Figure 23. Completed sand grid installation

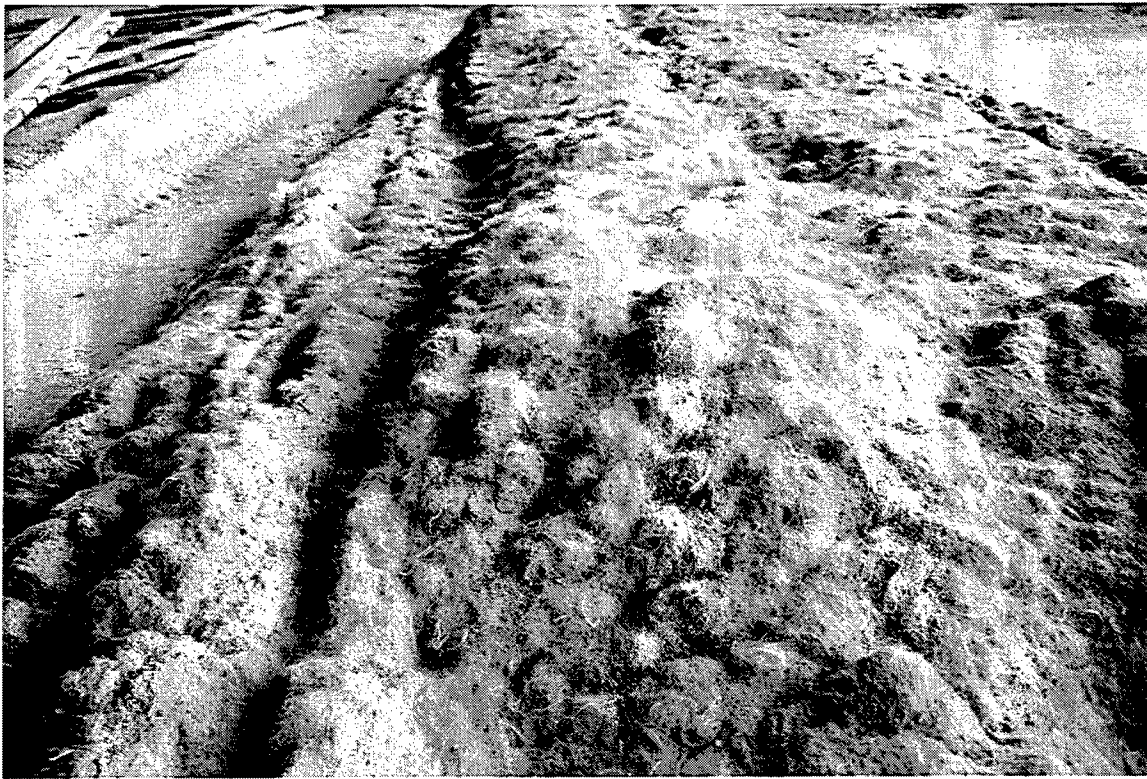
Figure 28. Sand-fiber mixture after four passes with mixer

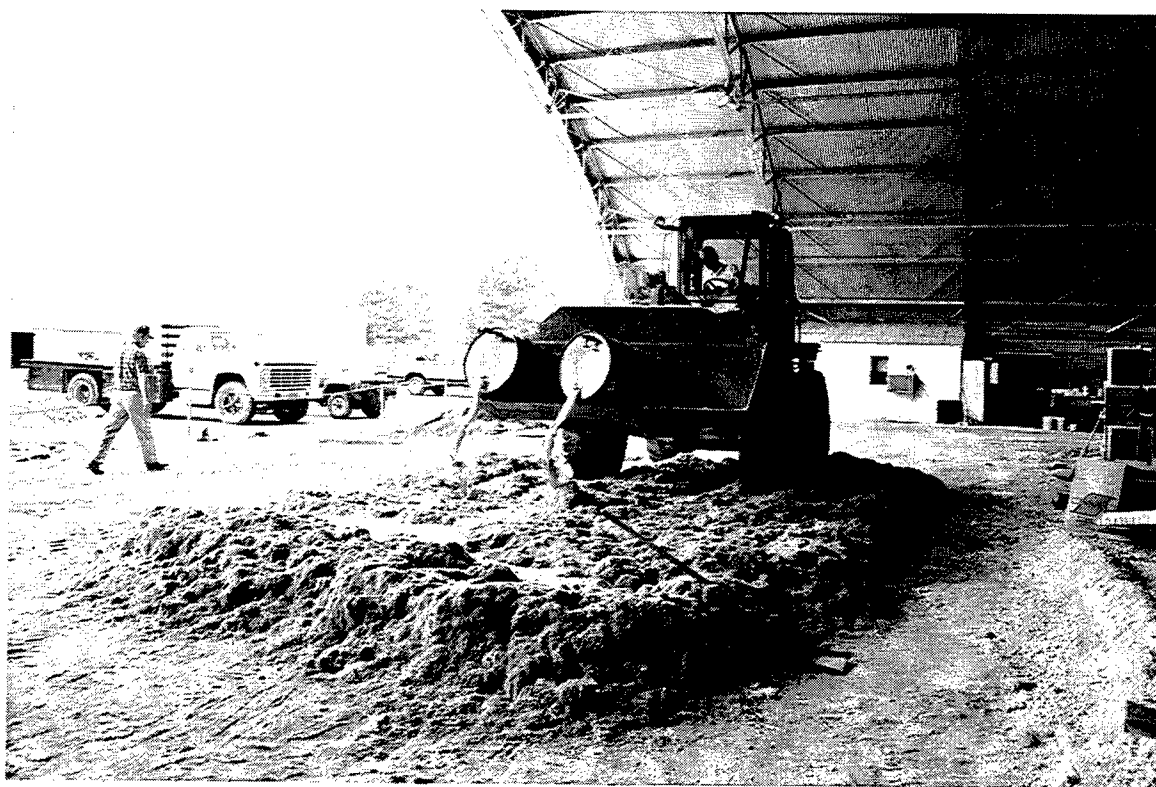
Figure 34. Adding Road Oyl on sand-fiber layer
