An Innovative Method For Rapid Detection of Microbiologically Influenced Corrosion

Mr. George J. Licina*
Structural Integrity Associates
3150 Almaden Expressway, Suite 145
San Jose, CA 95118-1217

Mr. George Nekoksa
Corrosion Failure Analysis and Control
209 Gaucho Court
San Ramon, CA 94583

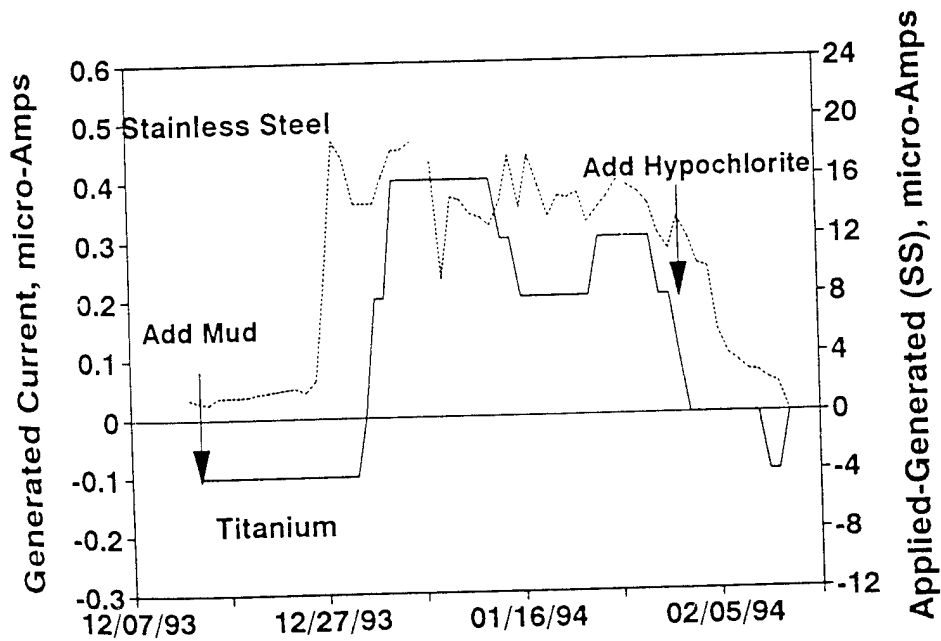
Figure 2. Results from Static Seawater Test
(Titanium at 400mV; Stainless Steel at 100mV)

Figure 2 summarizes the results from the static tests. The applied and generated currents for the stainless steel probe remained stable following the inoculation of the cell, but both currents changed rapidly ten days later. Interestingly, the generated current shifted in the negative direction several days after the inoculation and was of a sufficient magnitude so that the applied current was also negative. The **difference** between the applied current and generated current provided the most useful parameter for plotting. The addition of sodium hypochlorite caused the current difference to return to near its original value.

The applied and generated currents from the titanium probe were much smaller, however, the response characteristic was very similar to that of the stainless steel probe. The applied current exhibited a distinct increase eleven days after inoculation. The generated current was essentially zero initially, but exhibited a very definite increase fourteen days after inoculation. The response of the probe to the destruction of the biofilm by hypochlorite is also readily apparent.

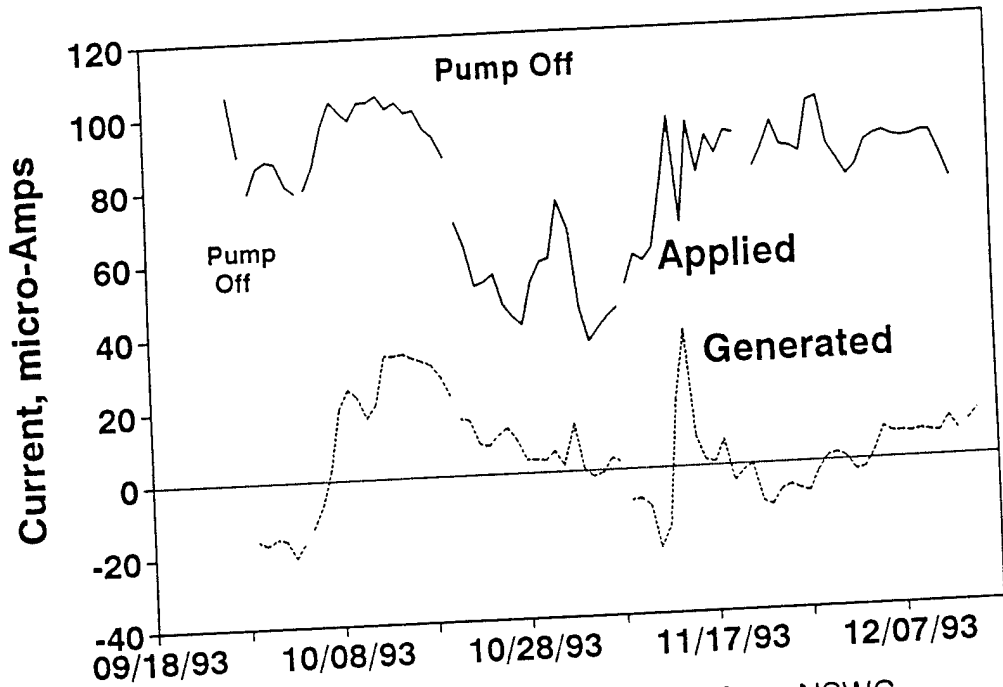
Figure 3. BlOGEORGE Probe Results from NSWC (Stainless Steel, 200 mV, Test #1)

In the first month of exposure, the applied and generated current traces from the stainless steel probe were very similar to those from the static tests. Applied currents stabilized after a few days, then both applied and generated currents increased steadily for the next three days. The applied current reached a maximum of $\sim 100 \mu\text{A}$ and the generated current increased from $-20 \mu\text{A}$ to nearly $33 \mu\text{A}$, both currents remained at those levels until a problem with the system pump caused an eighteen day interruption to system flow. During the time that the flow was interrupted, applied current decreased and became more unstable while the generated current decreased to near zero. When the pump was restarted, the applied current quickly returned to a value near $100 \mu\text{A}$. The generated current responded more slowly but reached a value of about $10 \mu\text{A}$ that persisted through the end of the test. The generated current appeared to provide the more sensitive indicator of biofilm activity (Figure 3).

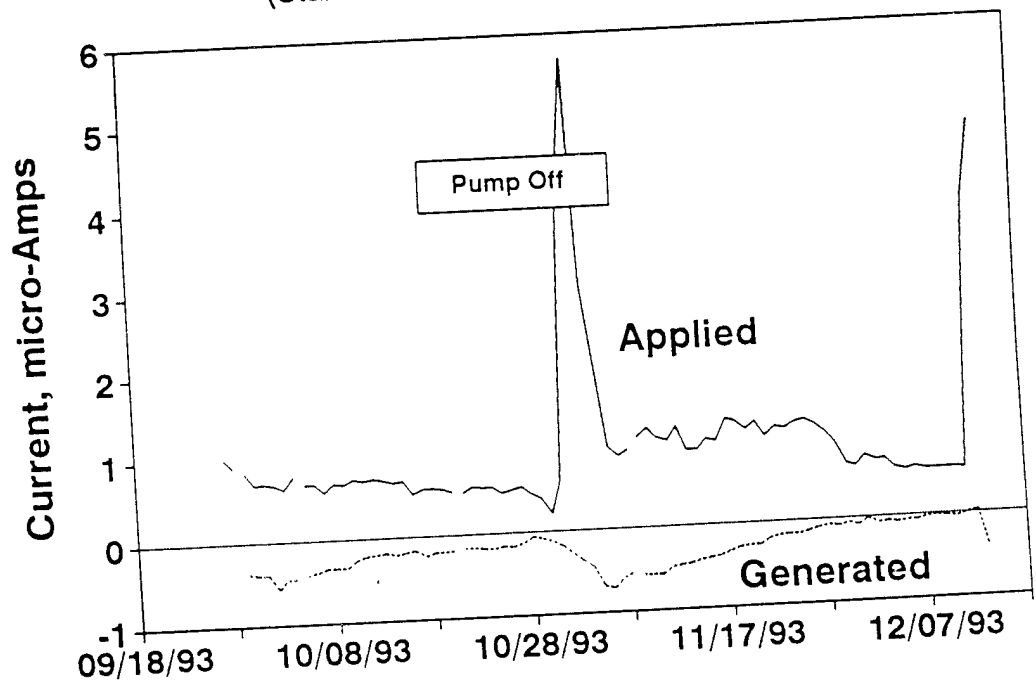
Figure 4. BlOGEORGE Probes Results from NSWC (Titanium, 200mV, Test #1)

The titanium probe exhibited very small applied currents (of the order of $1 \mu\text{A}$) and even smaller generated currents ($-0.4 \mu\text{A}$) as shown in Figure 4. The applied current remained very steady, until the eighteen day stagnant period. About ten days after the flow stopped, the applied current increased rapidly to a value in excess of $5 \mu\text{A}$, then gradually decreased to a steady value slightly higher than that which had been observed prior to the abrupt increase. Once the pump was restarted, the new, higher value persisted for 21 days. When the generated currents were plotted on an expanded scale, a very definite positive shift in generated current was observed five days after the start of the test, in exact agreement with changes in the generated current on stainless steel. While the pump was off, the generated current was much less stable. Once the pump was returned to service, the generated current again exhibited a positive shift.
