ARMY RESEARCH LABORATORY

# Battle Damage Assessment Telemeter (BDAT) System Impact Test

ARL-MR-398

May 1998

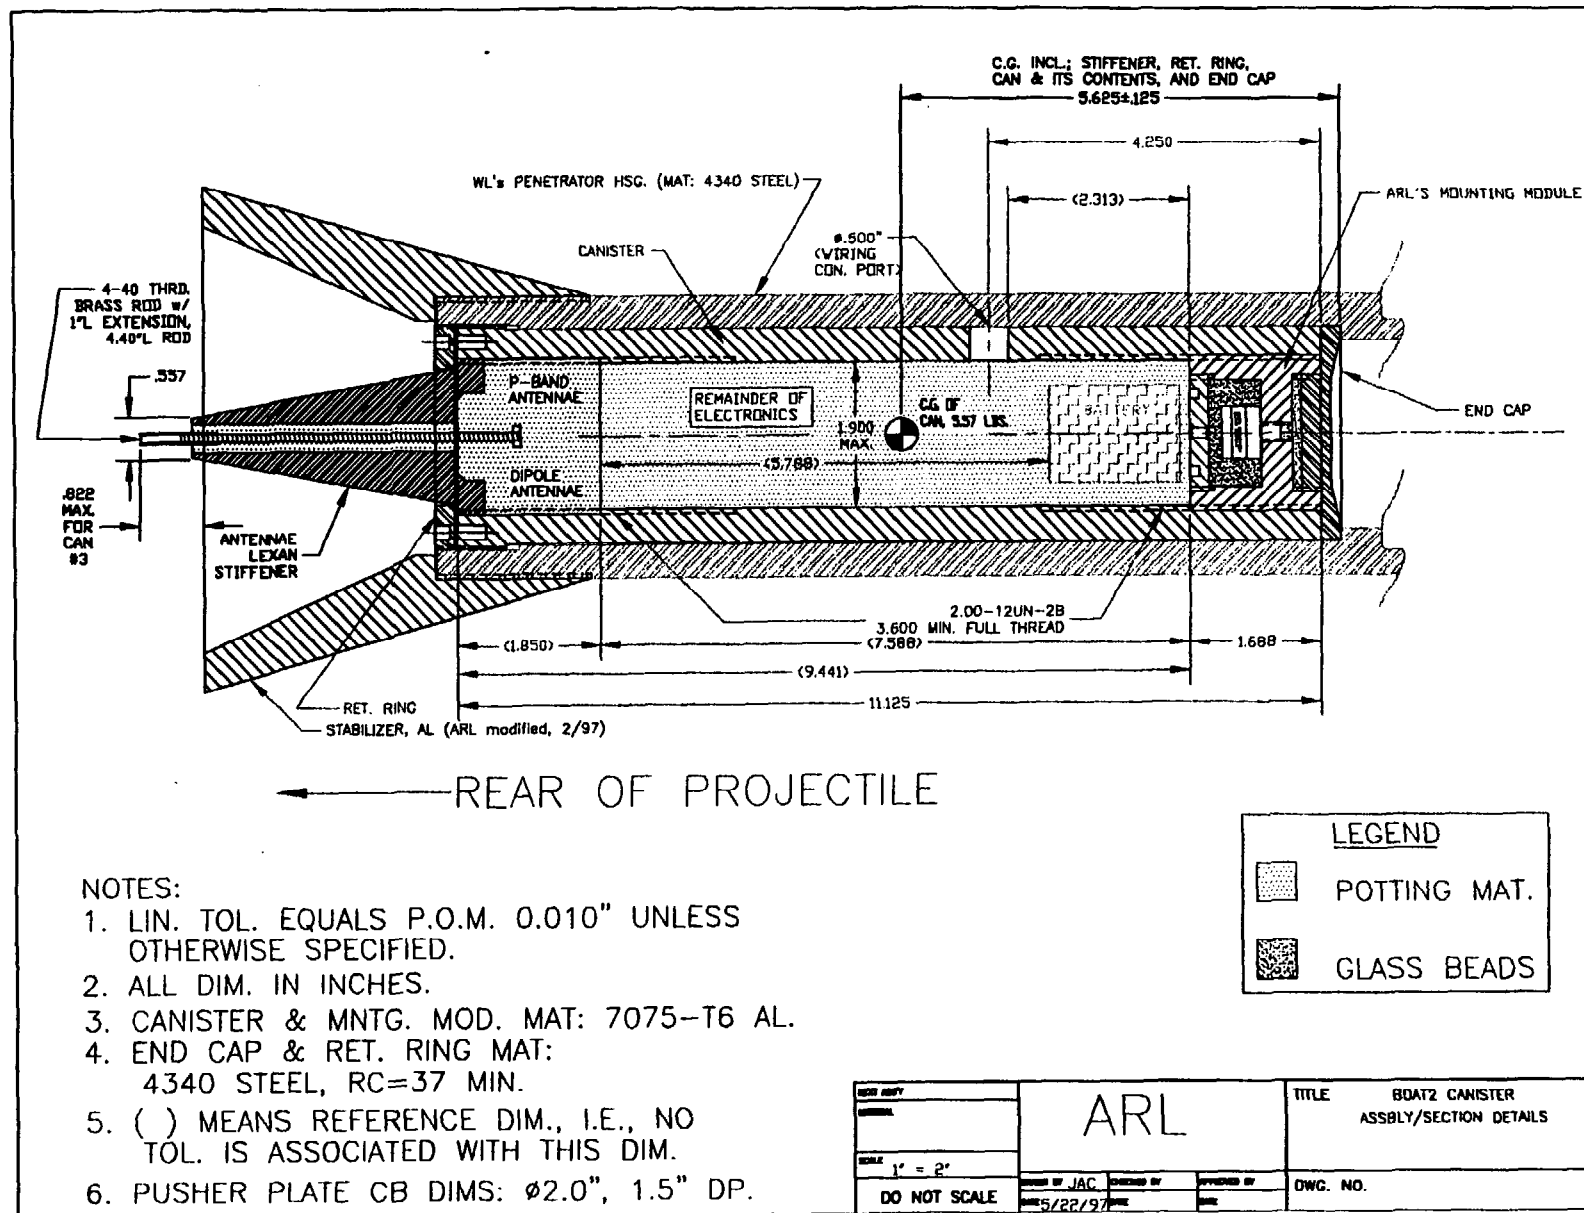
**Figure 1. Mechanical Drawing of the Telemetry Canister Inserted in the Projectile.**

Three aluminum canisters were instrumented with an ARL p-band telemetry system. The telemetry system utilized a nicad (nickel-cadmium) battery power supply, a signal-conditioning circuit (sensor input), a subcarrier oscillator, a transmitter, and an antenna. Each canister was to be screwed into the aft end of a penetrator vehicle and launched from a modified 155-mm howitzer (with a 170-mm smoothbore, 600–800-ft/s muzzle velocity, and 6–10-ksi breech pressure at launch) into a 1-ft-thick concrete target 500 ft from the gun muzzle. One canister had an Endevco 7072A accelerometer to sense shock. The other two had no accelerometer, but had the same electronic circuitry as the sensed canister. The sensor inputs in the two nonsensed canisters were wired to a constant reference voltage instead of an accelerometer. The telemetry receiving station would monitor and record data transmitted from the canisters. Data from the nonsensed units would

serve as a baseline, and the sensed unit would provide shock information during impact. Figures 1 and 2 show the telemetry canister and how it interfaces with the projectile. (Total canister/projectile mass at launch was approximately 50 lb<sub>m</sub>.)
