## Failure Modes of a Unidirectional Ultra-High-Modulus Carbon-Fiber/Carbon-Matrix Composite

15 January 1998

R. J. ZALDIVAR and G. S. RELICK  
Mechanics and Materials Technology Center  
Technology Operations

SPACE AND MISSILE SYSTEMS CENTER  
AIR FORCE MATERIEL COMMAND  
2430 E. El Segundo Boulevard  
Los Angeles Air Force Base, CA 90245

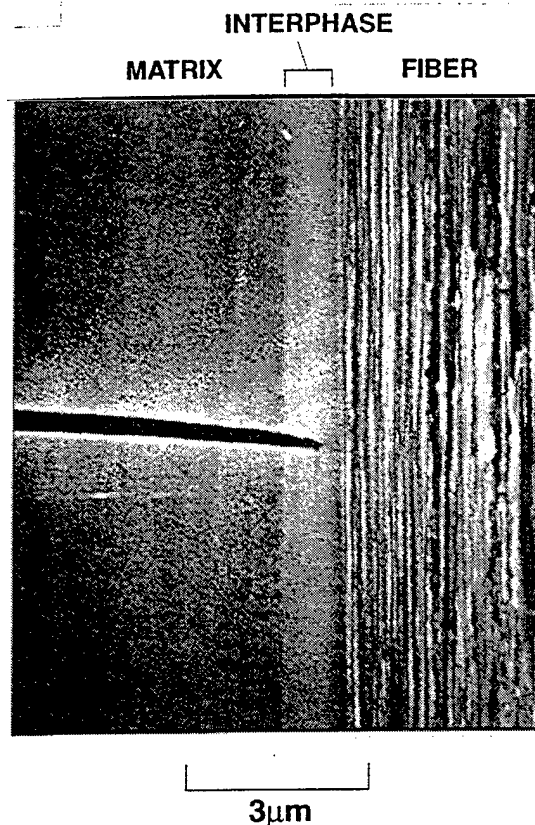
Fig. 5. High-magnification micrograph showing crack blunting in interfacial region of 2150°C heat-treated composite.

With heat treatment to 2150°C, we see the first clear evidence, at typical SEM magnifications, of a matrix interphase structure (Fig. 5). As discussed previously,<sup>20</sup> this interphase is a region of higher preferred orientation and enhanced crystalline development<sup>15</sup> as a consequence of matrix deformation during pyrolysis and carbonization. We have argued that the source of this deformation is the restraint of matrix shrinkage at the fiber surface resulting from attractive or frictional forces between fiber and matrix.<sup>20</sup> Independent measurements by TEM-selected area diffraction<sup>15</sup> of these same and similar composites have confirmed repeatedly that the zone of matrix around the fiber (from ~0.5 to 2.0  $\mu\text{m}$ ) is better graphitized and better oriented than the "bulk" matrix farther from the fibers. This is evident at HTTs as low as 1100°C.<sup>15</sup> For the case of the SEM of Fig. 5, the greater brightness of the sheath is most likely the result of its higher density,<sup>18</sup> which results in a higher electron emission. It is also possible that the contrast between interphase and "bulk" matrix is due to the differences in orientation. Also, because of the relatively low HTT of 2150°C, this matrix interphase "sheath"<sup>23</sup> structure is not well graphitized and, therefore, does not have the lamellar graphitic texture seen in the highly graphitized E130 fiber adjacent to it. This lamellar, or grooved, texture of etched graphite, as seen by standard secondary-electron images, is a consequence of topographic contrast. Whether due to ion bombardment or reactive etching, the less crystalline, more defective areas tend to erode more, leaving a topography of "hills and valleys."

and is almost indistinguishable from the graphitic E130 fiber (Fig. 9; compare to Fig. 5). Crack blunting at the graphitized matrix interphase sheath is also shown in Fig. 9. The high degree of orientation and lamellar graphitic structure of the sheath leads to significant delamination cracking in the sheath along the direction of the filament (Fig. 10). However, this intramatrix cohesive failure also reduces the load-carrying capabilities of the matrix. Figures 11(a-c) show the sequence of crack propagation through the 2400°C HTT sample. Note that the darker gray (and usually thicker) regions are nongraphitized, glassy-carbon-type matrix, whereas the sheath structure appears lighter gray like the fiber for the reasons discussed earlier. The extent of orientation and graphitization of the sheath region varies greatly over the length of the composite. The fracture path through the matrix is significantly more tortu-
