**UNITED STATES AIR FORCE
ARMSTRONG LABORATORY**

**463L PALLET AND DUNNAGE SYSTEM
EVALUATION**

October 1997

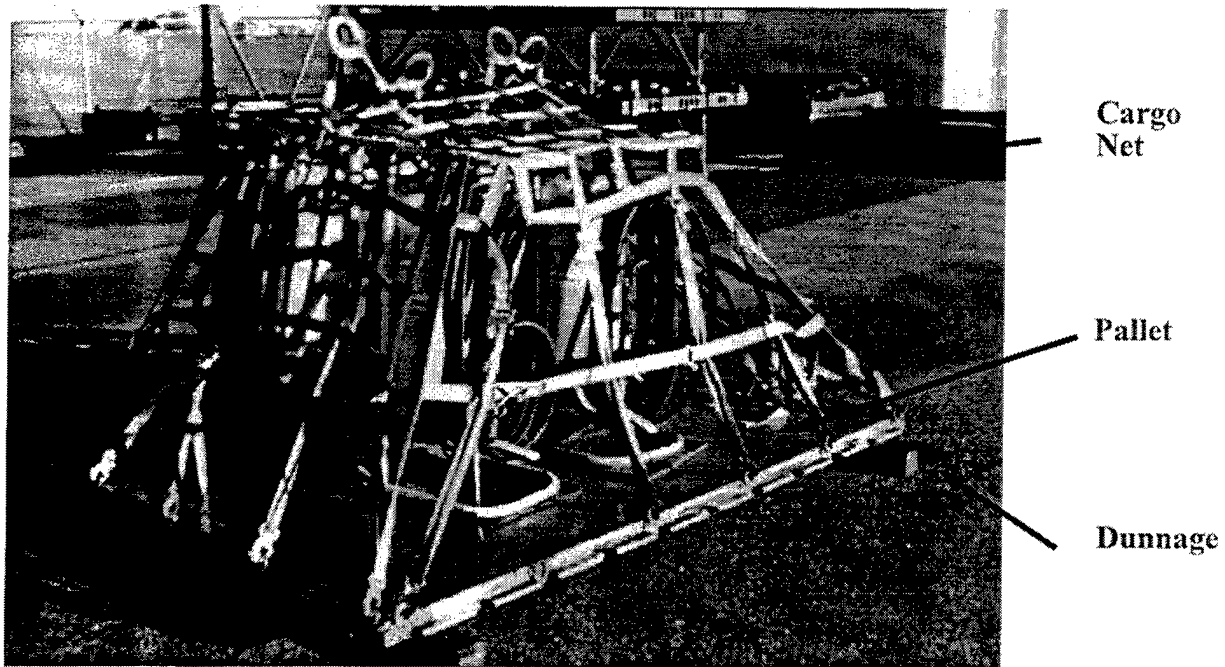
Figure 1: Loaded 463L Pallet

The 463L Pallet System consists primarily of the 463L pallet, dunnage, cargo netting, plastic cover, forklift, k-loader, aircraft rail system, and manpower. A combination of these components make up the entire system. Although, the concentration is on the pallet and dunnage, an understanding of all functional parts of the system and how they interact is important.

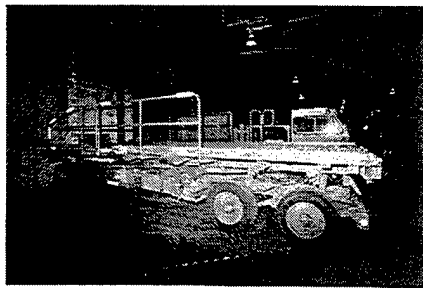
Figure 3: K-Loader

The K-loader is used to transport several pallets from the loading area to the aircraft. It contains a similar roller system to that of the aircraft's. The loader has the ability to carry the loaded pallets and lift them to the height required to push them into the aircraft.

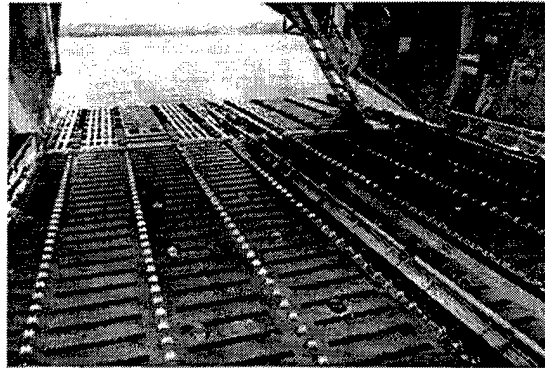
Figure 4: Aircraft Rail System

The aircraft rail system was specifically designed for the 463L pallet. The system contains rollers to ease the loading and removal of loaded pallets. Also, it contains a locking system to secure the loaded pallets during flight. The same rails are used on the k-loader.

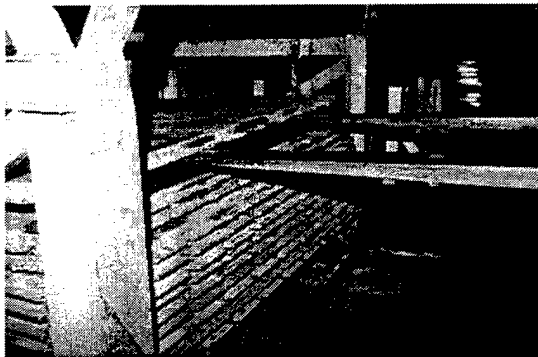
Figure 6: Pallet Removal From Stack

The interaction between each component of the system sheds light on how and where each component fits into the pallet system flow. New or reconditioned pallets arrive at an aerial port either from another aerial port or Cadillac Manufacturing via truck or aircraft. Usually the pallets are placed in the warehouse (or hanger) to be built up with cargo. Overflow pallets may be stored in a semi-permanent area with dunnage laid on the ground, referred to as the staging yard. Here, pallets may be stacked up to 50 high spaced by dunnage between every tenth pallet. If stacking for storage, the pallets must be stacked at a slant to allow drainage. As pallets are needed, they are removed from the stack by forklift and moved to the usage point. Incoming loaded pallets are broken down in the warehouse as well and then stored for rebuilding.

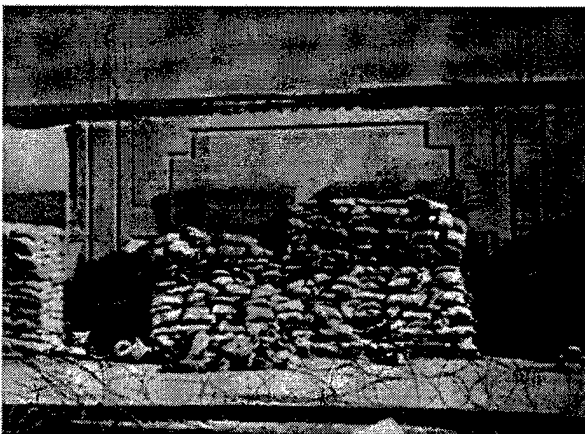
Figure 8: Pallets as Wall Supports

In addition to pallets being used to move cargo forward on the ground, they also get set aside at cargo forward-distribution sites because there is no mechanism for their return. This is usually true in humanitarian operations. Another condition is the unauthorized use of pallets as tent floors, bunker ceilings, building walls, walkways, etc. Pallets work well for these purposes and are generally used when other materials are not provided or lag behind the initial deployment. Many of these pallets are never returned to the air cargo system. This diversion of pallets will probably continue when there are no suitable building materials available. Since nets are attached to these pallets, they are often lost when the pallets are used in such non-traditional ways. As an example of the equipment losses associated with a contingency operation, Appendix C contains the losses for pallets, nets, and straps for certain time periods of the Bosnia effort.

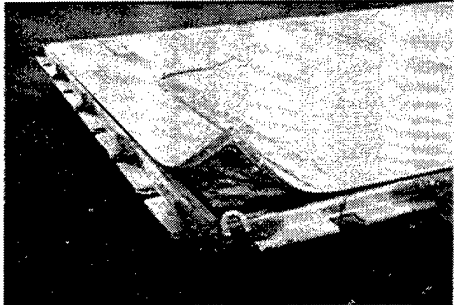
Figure 11: Pallet Skin Separation

Personnel must be trained to detect the various types of pallet damage. Before building cargo up on the pallet, the pallet top and bottom should be checked for serviceability. The most common types of damage to the pallet are skin separation, skin punctures, warping, and missing or damaged D-rings. Any time damage is found, the pallet cannot be used to ship cargo. Instead, it is tagged and moved to the damaged-pallet staging area. Whenever the aerial port accumulates at least 10 damaged pallets, they will ship the pallets back to their regional hub (Travis AFB, Dover AFB, etc.). When the hubs accumulate approximately 120 damaged pallets, they will ship them back to the manufacturer for repair.

Improper storage facilities, coupled with the pallet materials, account for a majority of pallet problems. The thin aluminum skin is glued to the side frames to keep the internal materials dry and give strength to the pallet. The glue bonding often separates under the normal stress of use. This separation allows water to seep into the balsa wood core, which expands with great force when wet. This expansion causes the skin to separate from the pallet frame (see Figures 13 and 14). Besides allowing water to seep in, outdoor storage near an ocean allows the salt air to corrode the pallet surfaces. Additionally, if nets are subjected to moisture, they must be thoroughly dried to prevent them from rotting.

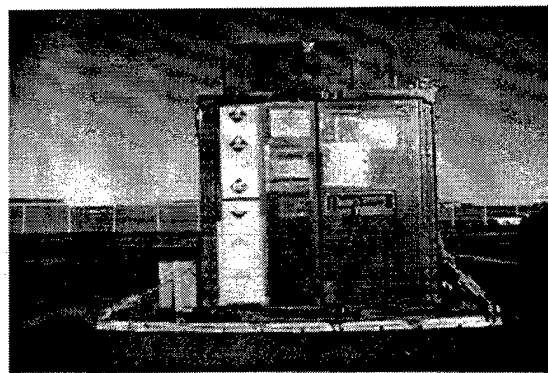
Figure 12: Heavily Loaded Pallet

Loads that sit on a concentrated part of the pallet (especially when heavy) are tied down with chains and straps to prevent movement. This action pulls up on the side of the pallets and may permanently warp them. To a lesser extent, nets put consistent upward pull on all pallet rings. The upward pull on the pallet with cargo pushing down in the middle of the pallet can contribute to bowing. A warped pallet is likely to jam in the K-Loaders and in the aircraft rail systems. Jamming will cause loading delays and will often further damage the side flanges of the pallet.

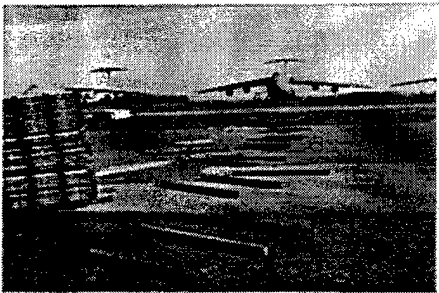
Figure 15: Marshalling Area

In the larger aerial ports, a large area will be semi-permanently set up for storage of transient pallets, referred to as the marshalling or staging area (Figure 15). These areas are often relatively flat blacktop lots where rows of dunnage (groups of 3 pieces appropriately spaced on the ground) are laid out on the ground. These pieces of dunnage are continually exposed to sun, rain, snow, heat, cold, etc., all of which deteriorates them. In addition, fork-lift trucks may run into the dunnage, splintering and breaking the wood (especially at night when the dunnage is hard to see.)

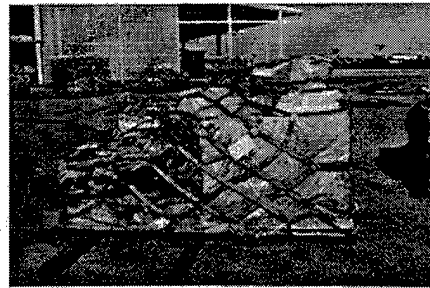
Figure 16: Wood Dunnage as Protective Flooring

Dunnage may also be used to distribute cargo weight, provide protective flooring, stabilize equipment, and build equipment ramps to aircraft. Wood used for these purposes is called "shoring". Dunnage is often diverted for shoring purposes and then not returned for dunnage use.

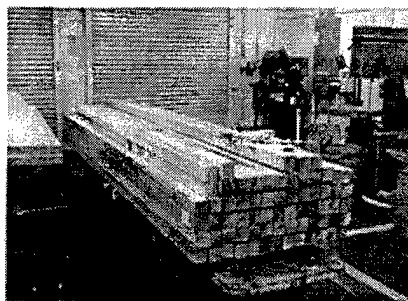
Figure 18: New Wooden Dunnage

Wooden dunnage accomplishes these tasks, but requires that three similar pieces of wood be available whenever the pallet is set on anything other than rollers. This approach requires additional personnel and other resources to move, store, position, and attach the dunnage to a pallet. If less than three pieces of dunnage are used, or if any one of the pieces is different from the others, the pallet may warp due to uneven weight distribution. Dissimilar pieces of wood is a common problem at aerial ports, especially smaller ones. However, if personnel inspect for uniformity before using the dunnage, damage to the pallet can be prevented.

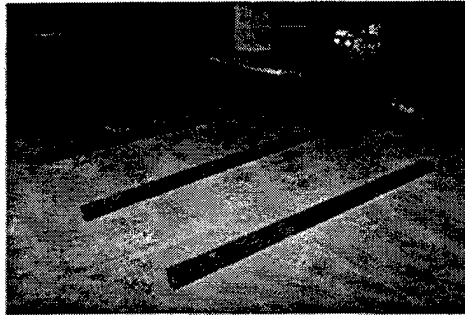
Figure 19: ReNew Plastic Dunnage

The ReNew pieces are made of a polyolefin-based plastic lumber called Perma-Poly™. A complete evaluation of Perma-Poly™ was carried out at Battelle Memorial Institute's

Industrial and Commercial Development Division, Polymer Product Center, in Columbus, Ohio. Appendix D contains the complete study plan, test procedures, and test results. The results are presented in a way that could be interpreted for application to other types of plastics suitable for dunnage. It should be noted that Black Rhino Recycling, Inc. currently has plastic lumber in various shapes and sizes available through government supply channels. Some aerial ports have already begun to use Black Rhino's 4"x4"s as dunnage.

The material property analysis found the plastic lumber to be essentially the same as or better than the wood in all cases except two: agent decontamination and density. After exposure to chemical warfare agents, decontamination may be more difficult for plastic than for wood. This scenario would be true if the contaminated dunnage needs to be disposed of. Wood is easily disposed of by burning. The polyolefin will also burn, but takes much longer. The plastic's higher density makes each piece significantly heavier than wood. A 4"x4"x88" piece of wood weighs around 15-20 lbs, compared to 25-30 lbs for the Perma-Poly™. However, Black Rhino also makes a hollow core dunnage which weighs only 13 lbs. Unfortunately, due to the limited scope of this task, the hollow piece was not analyzed for this study.

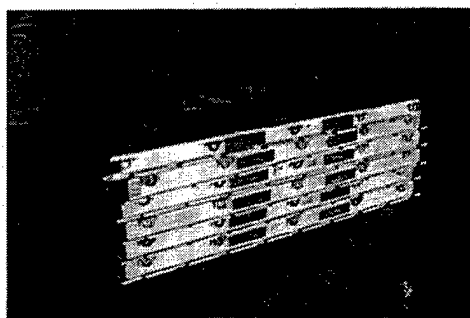
Figure 20: HCU-10/C Air Cargo Pallet

A modified design could also eliminate the need for dunnage, which is a labor and cost intensive resource. At the time the pallet was designed and deployed, there were more personnel resources available to handle dunnage. Today there are substantially fewer personnel resources available while the demand remains. One such design would be to build fork lift tines into the pallet. Figure 20 shows an example of this concept, the Air Cargo pallet, HCU-10/C. This modified pallet is manufactured by Cadillac and is 88"X54"X4-1/2". It has a maximum capacity of 5,000 lbs. This does not meet the requirements of the 463L, HCU-6/E, pallets, but the concept is functional.

Several issues arise with this recommendation. First, the bottom of the current 463L pallet is not durable enough to be placed directly on the ground. Therefore, punctures would occur and render the pallet unusable. Replacing the bottom skin with a harder material should eliminate this problem. Also, the forklift holes would raise the height of the pallet, thus limiting the height of the cargo that can be placed on it. Several aerial port personnel stated that such a height limitation would be unacceptable due to its adverse mission impact. Another concern is the addition of a time constraint to properly position the fork lift tines into the pallet slots.

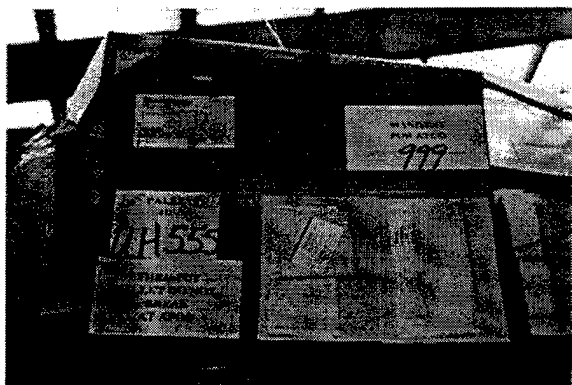
Figure 22: Identification Board with Laser Card

The US Army has a pilot program using SAVI technology that allows for the tracking of the pallet and its cargo. The Air Force is monitoring this program to determine its effectiveness. Other tracking methods currently used should be researched to determine their applicability to Air Force cargo transportation needs and the Total Asset Visibility concept.

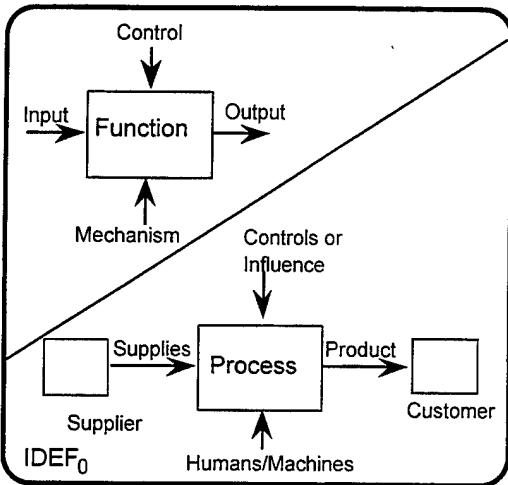
Basic model of an enterprise using the IDEF process.

The following figures provide a short description of how to interpret the Integrated Definition Methodology (IDEF) used to develop the model.
