**US Army Corps  
of Engineers**

USACERL Special Report 99/01  
October 1998

# **Shear Strengthening of Reinforced Concrete Beams Using Fiber-Reinforced Polymer Wraps**

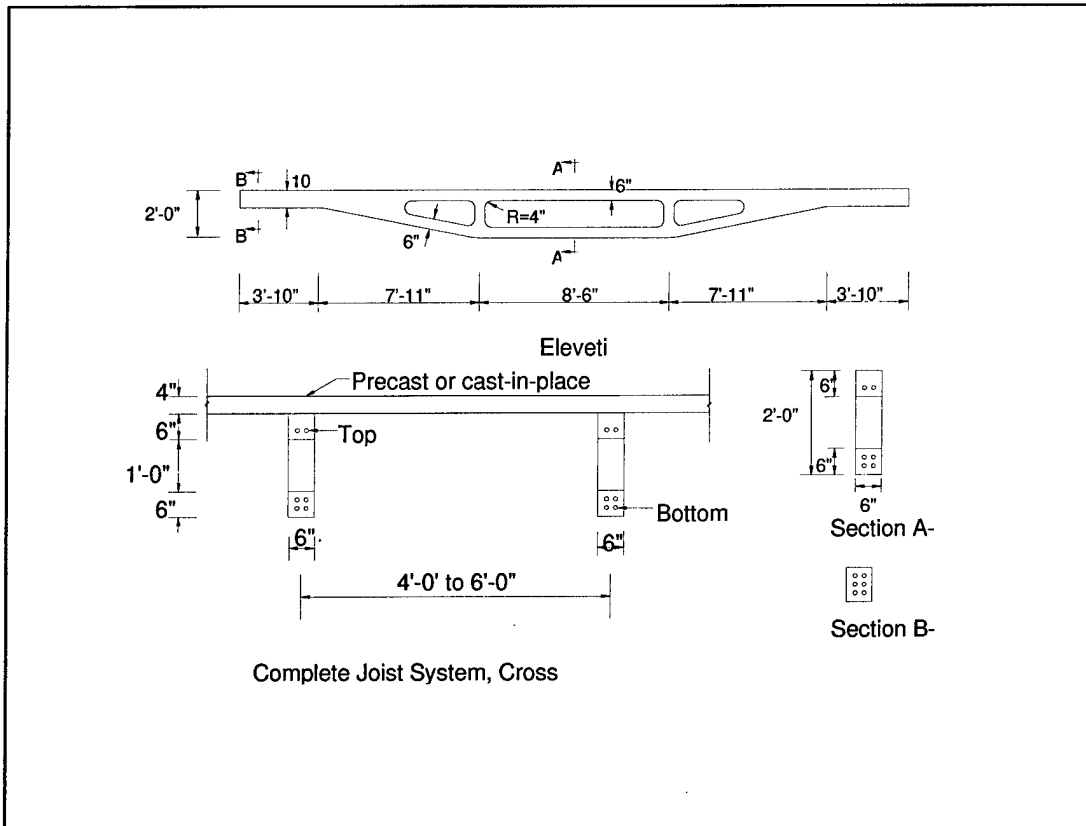
Figure 1. Joist configuration.

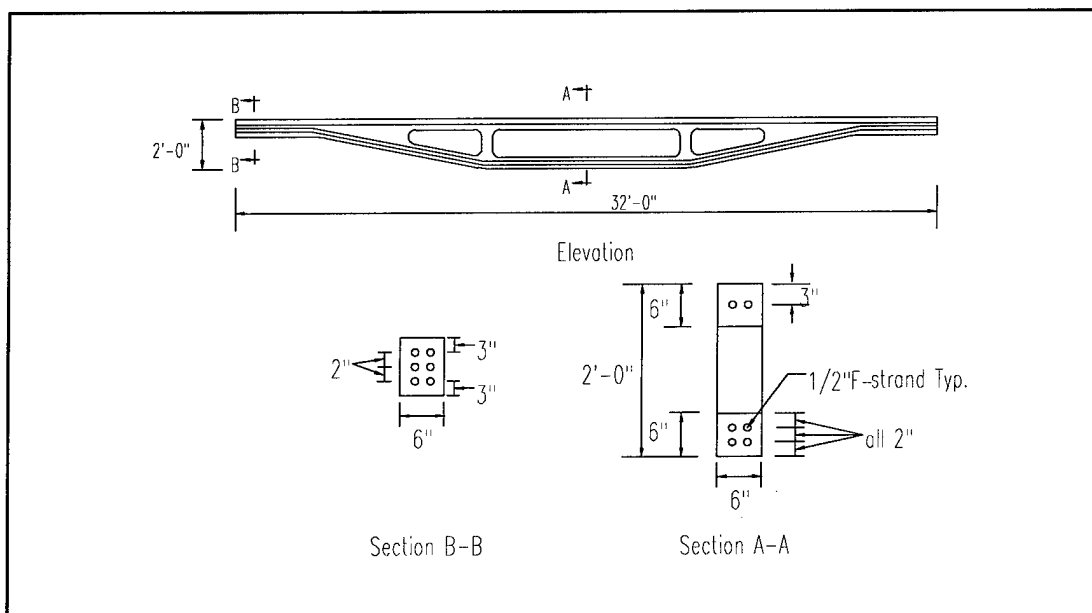
Figure 2. Joist prestressing tendon profile.

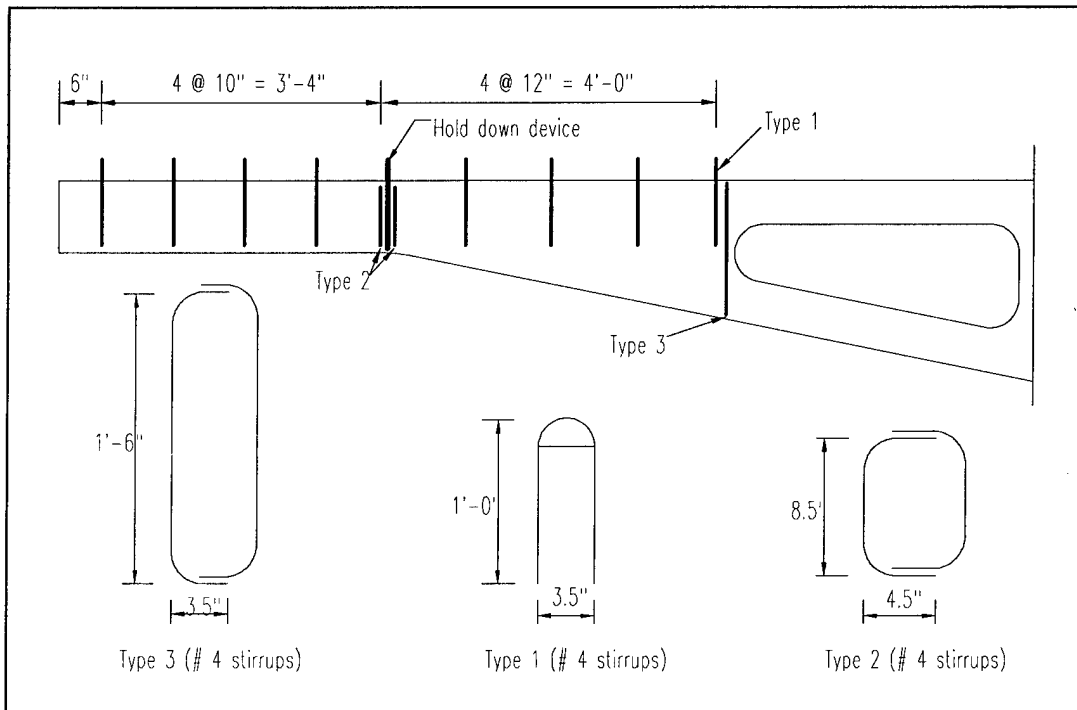
Figure 3. HJ-3 and HJ-4 web reinforcement.

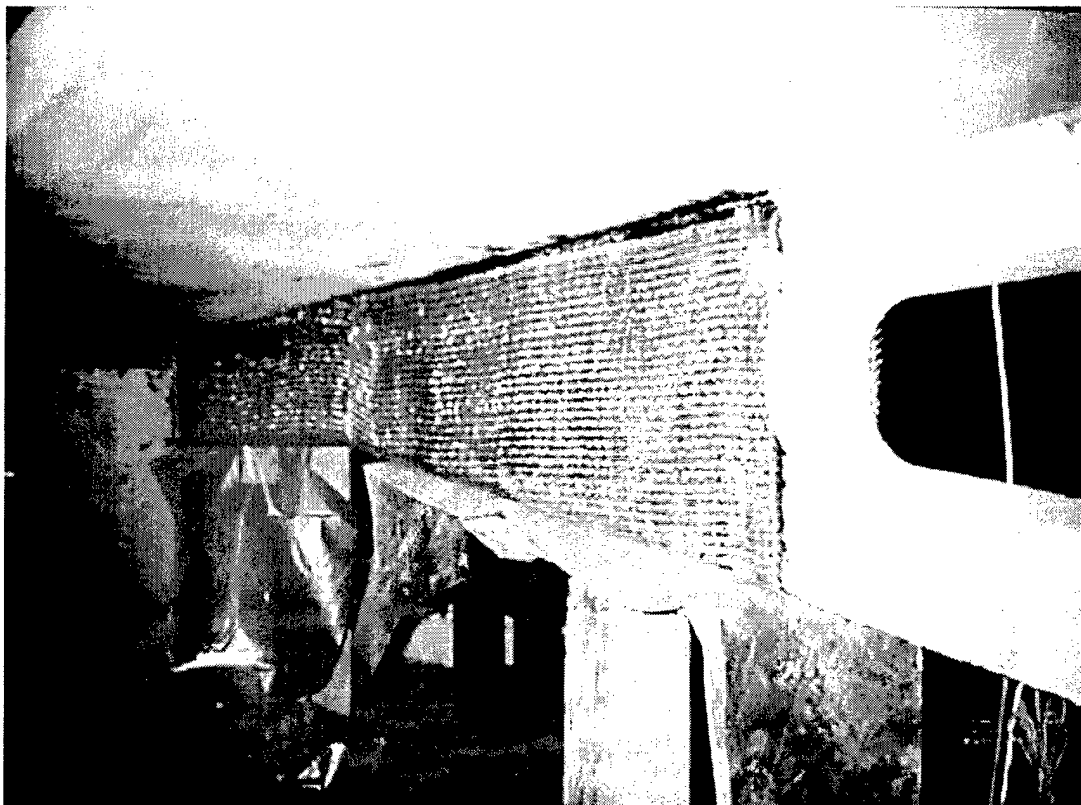
Figure 4. FRP joist repair.

Performance criteria were specified for the two joists to be repaired. It was required that their shear capacity be increased 15 kips over a length 3 ft-10 in. from each end and 10 kips over the following 4 ft. The two repaired beams were wrapped on three sides with Fyfe's TYFO S Fibrwrap<sup>TM</sup> along the outer 8 ft of each end of HJ-3 and HJ-4, Figure 4. The FRP repair design was based on the following material properties:

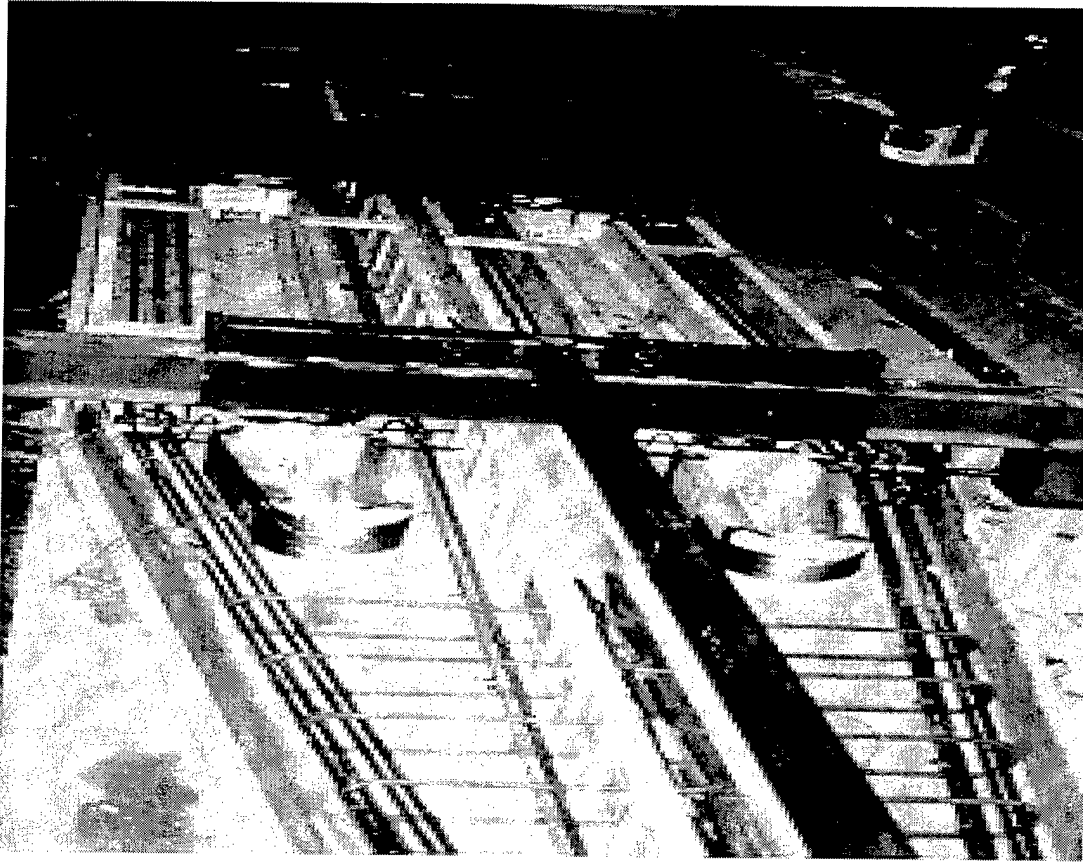
Figure 7. Prestressing and casting of hybrid joists.

The webs of the joists were prestressed and cast horizontally, i.e., on their sides as shown in Figure 7. Hold-down devices were used at the draping points to position the tendons and resist the prestressing forces. The concrete mix was placed in the forms and vibrated to ensure consolidation of the concrete. The specimens were covered with wet burlap that was kept moist for the first 3 days. The specimens cured at room temperature for 7 days. Cylinders measuring 4 in. diameter by 8 in. tall were cast and cured with the joists under the same conditions. The concrete strength was monitored by compression testing of cylinders to assess when the required release strength was achieved. When the strength

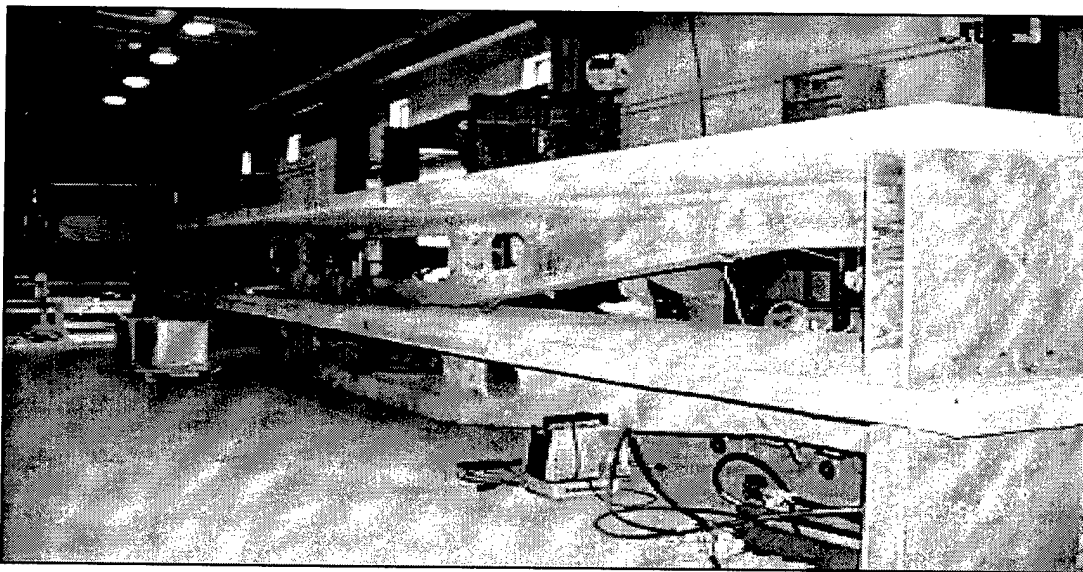
Figure 8. Completed hybrid joist construction.

reached 7000 psi the tendons were released by alternately torch cutting a tendon on each face at the joist ends. Casting and release dates for each specimen are shown in Table 7. The webs were then turned vertically and stored in the lab. The webs were then positioned vertically upright and level. The slab forms were then constructed around them. After concrete placement, the forms and test cylinders were covered with wet burlap followed by plastic sheets. The burlap was maintained moist for 4 days following casting. After 7 days the forms were stripped. Figure 8 shows the final shape of the joists.

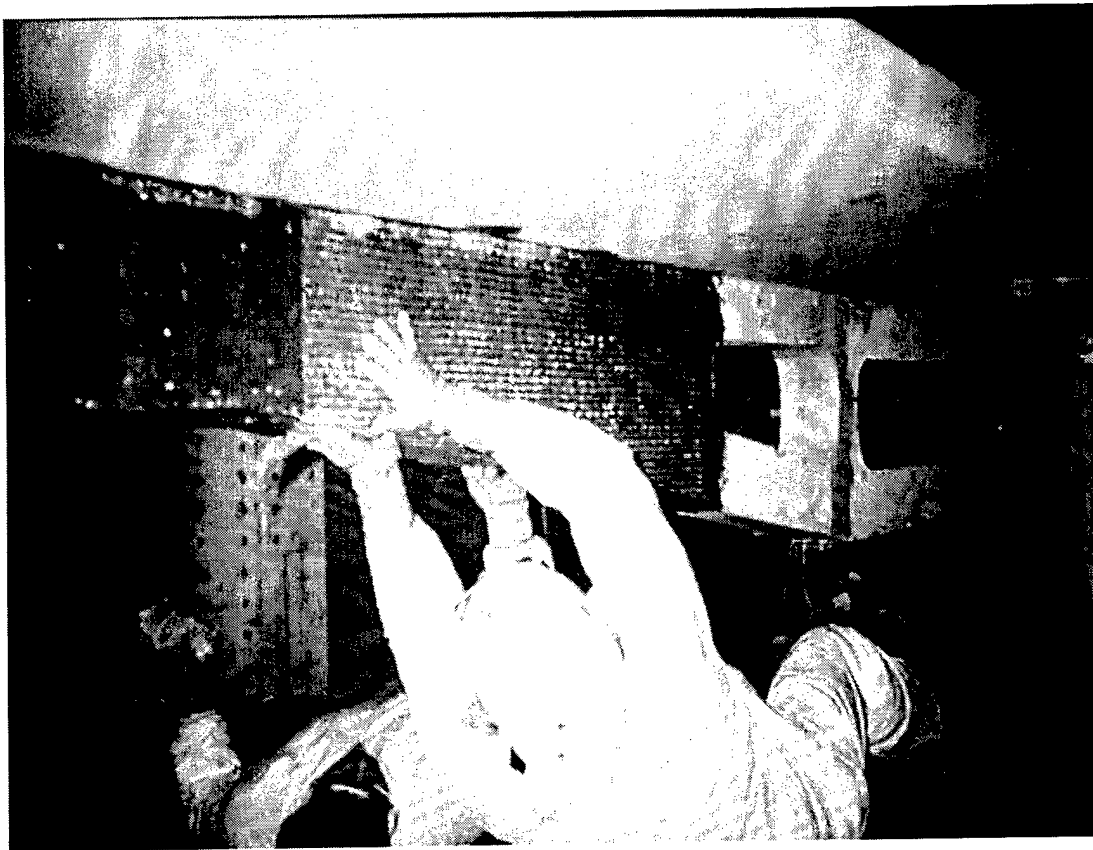
Figure 9. FRP application.

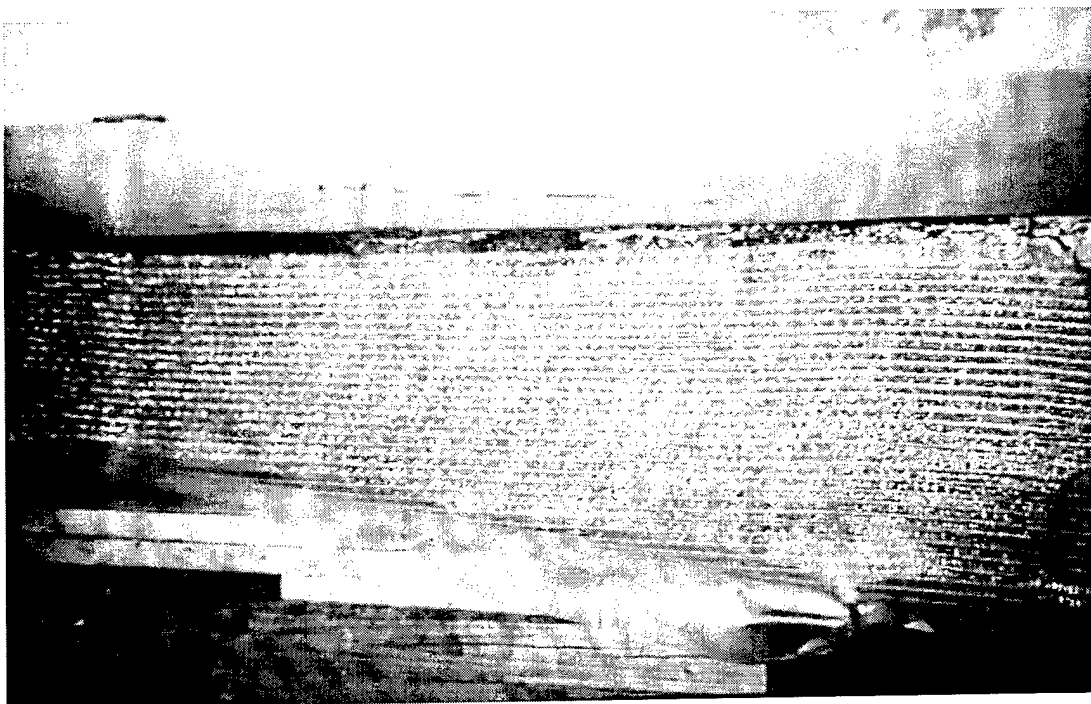
Figure 10. Gap in FRP upgrade of HJ-3.

shear mode failure of HJ-3 was initiated by a gap on the joist web where the FRP had slipped during curing. Its performance was not improved over HJ-6.

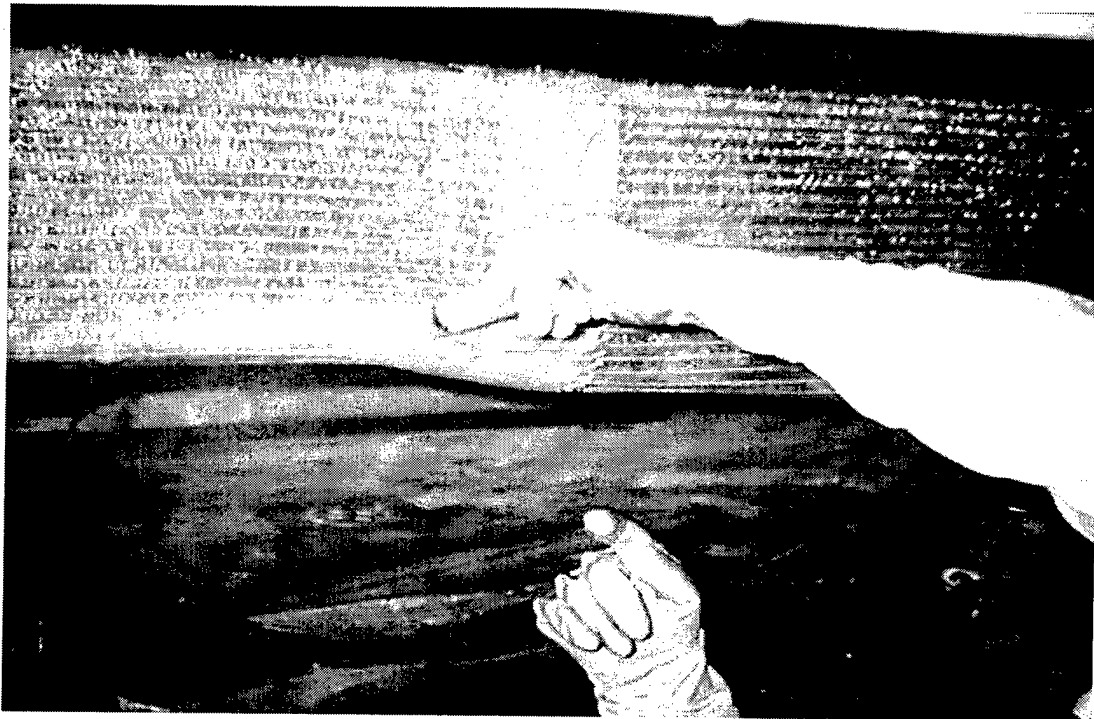
Figure 11. Epoxy injection of voids.

Because of lack of Cab-O-Sil™ in the tack coat, the system applicators had great difficulty getting the FRP system to adhere properly to the concrete prior to curing. The cure time was also slow because of high humidity. Upon cure it was noted that the FRP had slipped down on both HJ-3 and HJ-4. A gap, uncovered by FRP, existed beneath the bottom of the slab on the web. In most locations the gap was not significant; however, on the north end of HJ-3 the gap was observed to be 1.25 in., Figure 10. After curing, voids between the composite and the joist were filled with epoxy, Figure 11.

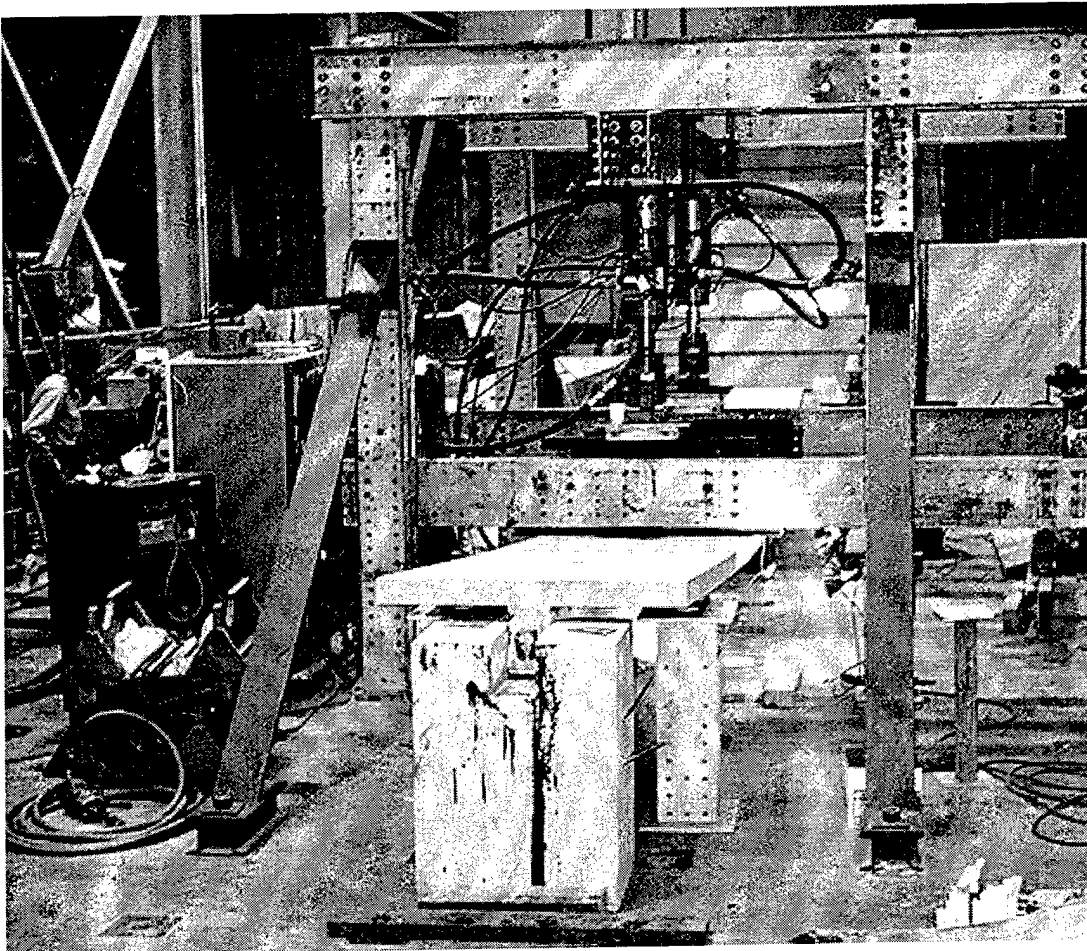
Figure 18. Test setup.

The loading system consisted of two CGS/Lawrence Model 307-50 electro-hydraulic actuators (controlled by closed-loop servo controllers) and a function generator. The actuators were operated in a displacement-control mode. In this mode, the function generator supplies a slowly changing command signal to the controllers. The controllers send a drive signal to each of the actuators, which causes the actuators to move until the displacement measured by LVDTs located inside each actuator is equal to the command signal. The actuators also include load transducers that measure the applied load.

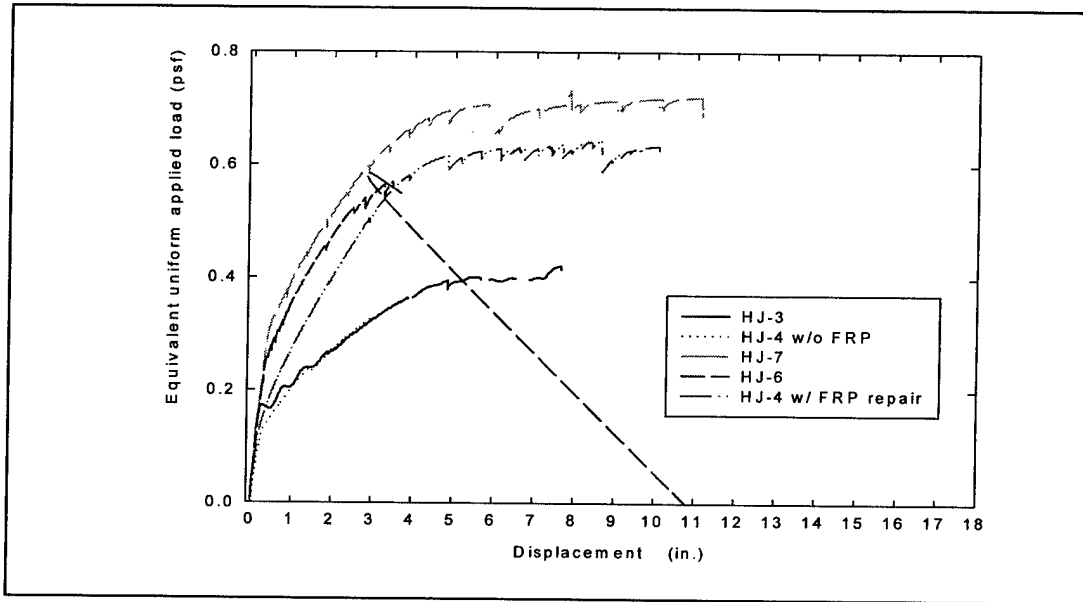
Figure 19. Load versus deflection for HJ-3, HJ-4, HJ-6, and HJ-7.

The experimental load versus midspan deflection curves for joists HJ-3, HJ-4, HJ-6, and HJ-7 are shown in Figure 19. Initial stiffness (below 0.2 psf) of all specimens is similar. After this point the stiffnesses of HJ-3 and HJ-4 were less than for either control joist. HJ-3 displayed more flexible response than the damaged or repaired joist HJ-4. HJ-4 was not able to achieve the performance of the control beam HJ-7 which had sufficient shear reinforcement. All joists were able to achieve their peak load repeatedly for several loading/unloading cycles. HJ-4 achieved the peak load for 5 cycles before the test was stopped. Its stiffness did not change significantly from cycle to cycle, Figure 20.

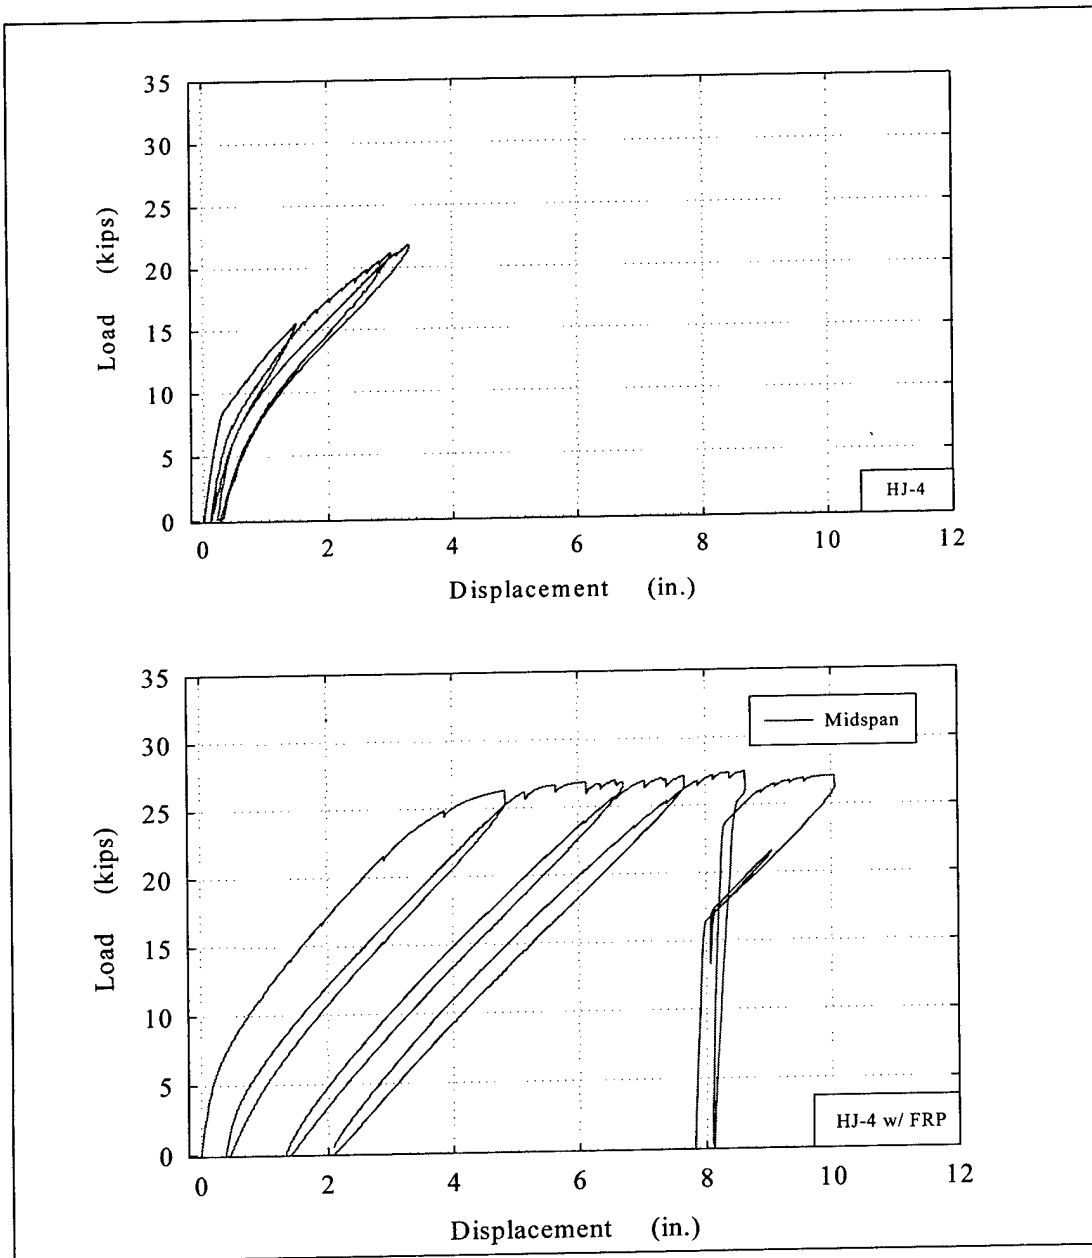
Figure 20. Load versus deflection cycles for HJ-4.

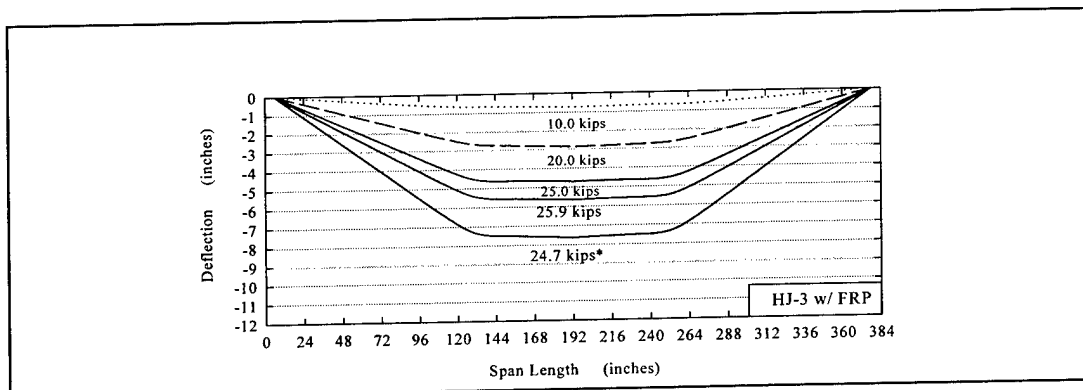
Figure 21. Deflected shape for HJ-3.

Deflection profiles along the joist length were approximated using potentiometer data as well as manual measurements from the joists' top flanges. A deflection profile is shown for HJ-3 with respect to load increments of a single actuator in Figure 21. Figure 22 shows deflection profiles for HJ-4 prior to repair and after the joist was repaired with FRP. HJ-3 deflected more than either the original or repaired HJ-4 for comparable load levels up to 25 kips. It also deflected much more than HJ-6. Similar plots for the other tested joists are shown in Figures 23 and 24. HJ-4, while able to deflect significantly was not able to match the performance of HJ-7. The shapes of HJ-3 and HJ-4 are much like that of the control joist, HJ-7. The shapes reflect the constant moment between load points and the

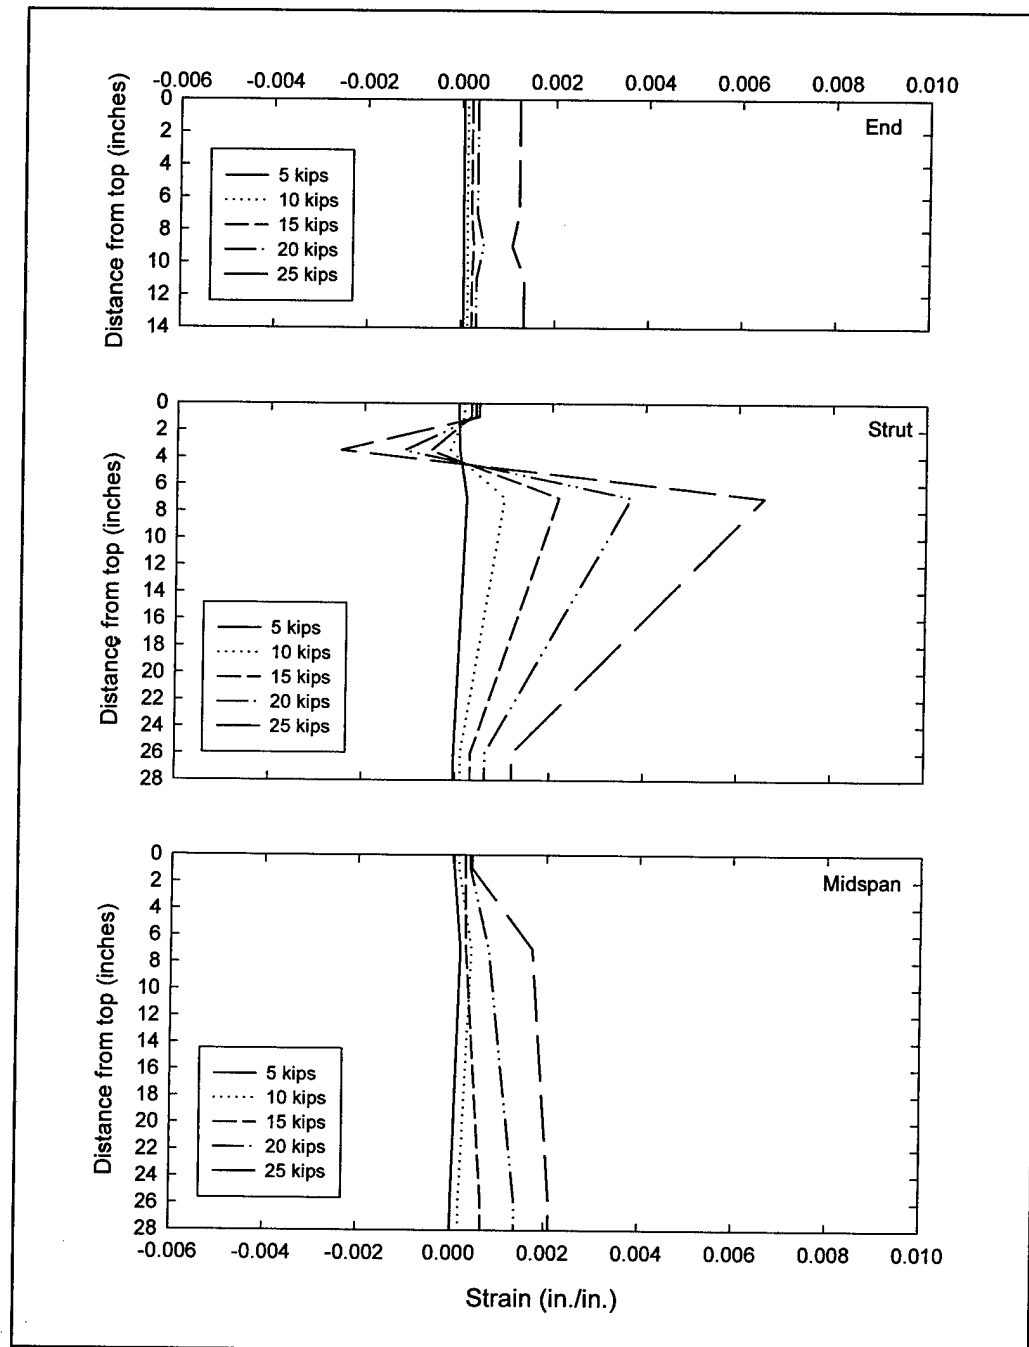
Figure 25. Strain distribution for HJ-3.

Strain distribution over section depth is shown in Figures 25 and 26 for three critical sections of HJ-3 and HJ-4 with FRP repairs. The distribution was approximated from concrete strain measurements near the top of the section and prestressing strand strains above and below the openings. Similar plots are shown in Figures 27 and 28 for HJ-6 and HJ-7, respectively. Strain along prestressing tendon length is shown in Figures 29 and 30 for HJ-3 and HJ-4 respectively. Figures 31 and 32 show strand strain measurements for HJ-6 through HJ-7.

Strains at the end and midspan of HJ-3 are similar in magnitude to those of HJ-6. It is apparent from Figure 25 that the full prestressing capacity could not be developed in these joists. This is further shown in Figure 29 where results of internal strain measurements along the strands for both top and bottom strands of repaired joist HJ-3 are presented. Strains in tendons were greatest in the shear span of this joist. In the constant moment region, strains are much less for both top and bottom tendons. From the strut section strain distribution, we can see that the neutral axis lies at a depth approximately 5 in. from the top of slab in HJ-3. From Figures 29 and 31 it is apparent that failure occurred before the full prestressing capacity could be developed in these joists.

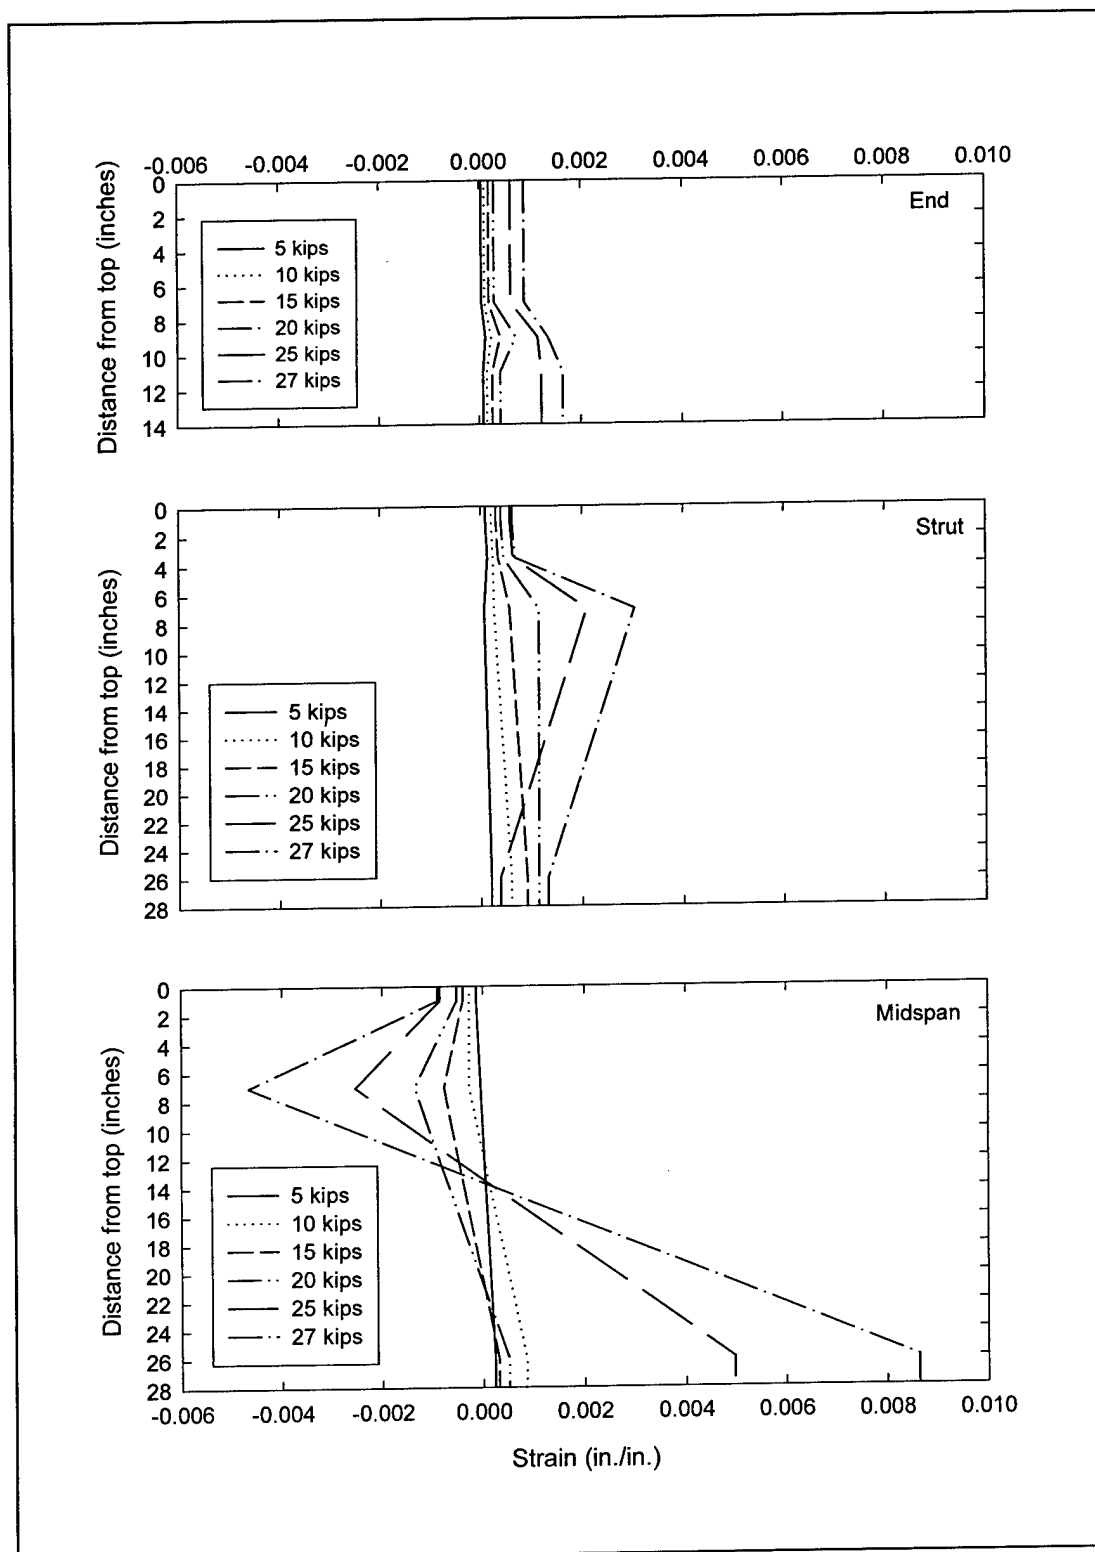
Figure 26. Strain distribution for HJ-4.

Comparing Figures 26, 25, and 28, strain distribution in the repaired joist HJ-4 is quite different from that of either HJ-3 or HJ-7. The neutral axis indicated by the midspan strain is located at the member midheight. Peak strains in top and bottom prestressing strands of HJ-4 were greater than those in HJ-7, Figure 30 versus Figure 32. However, strain distribution over bottom tendon length is

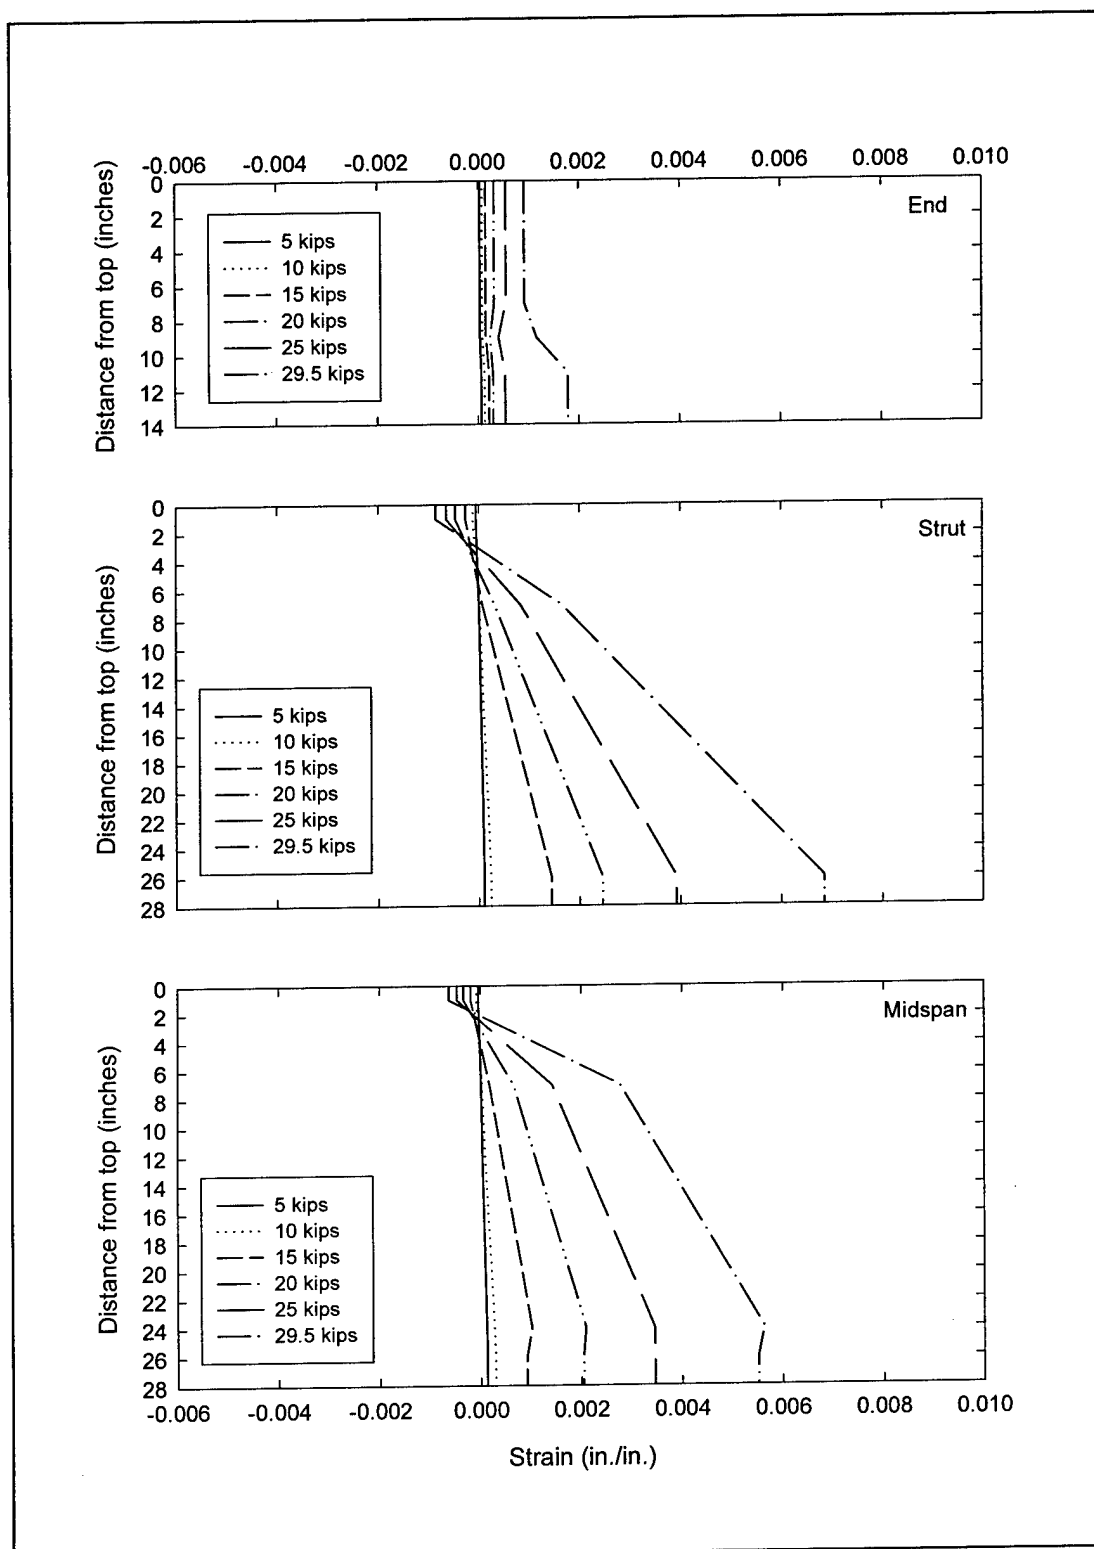
Figure 28. Strain distribution for HJ-7.

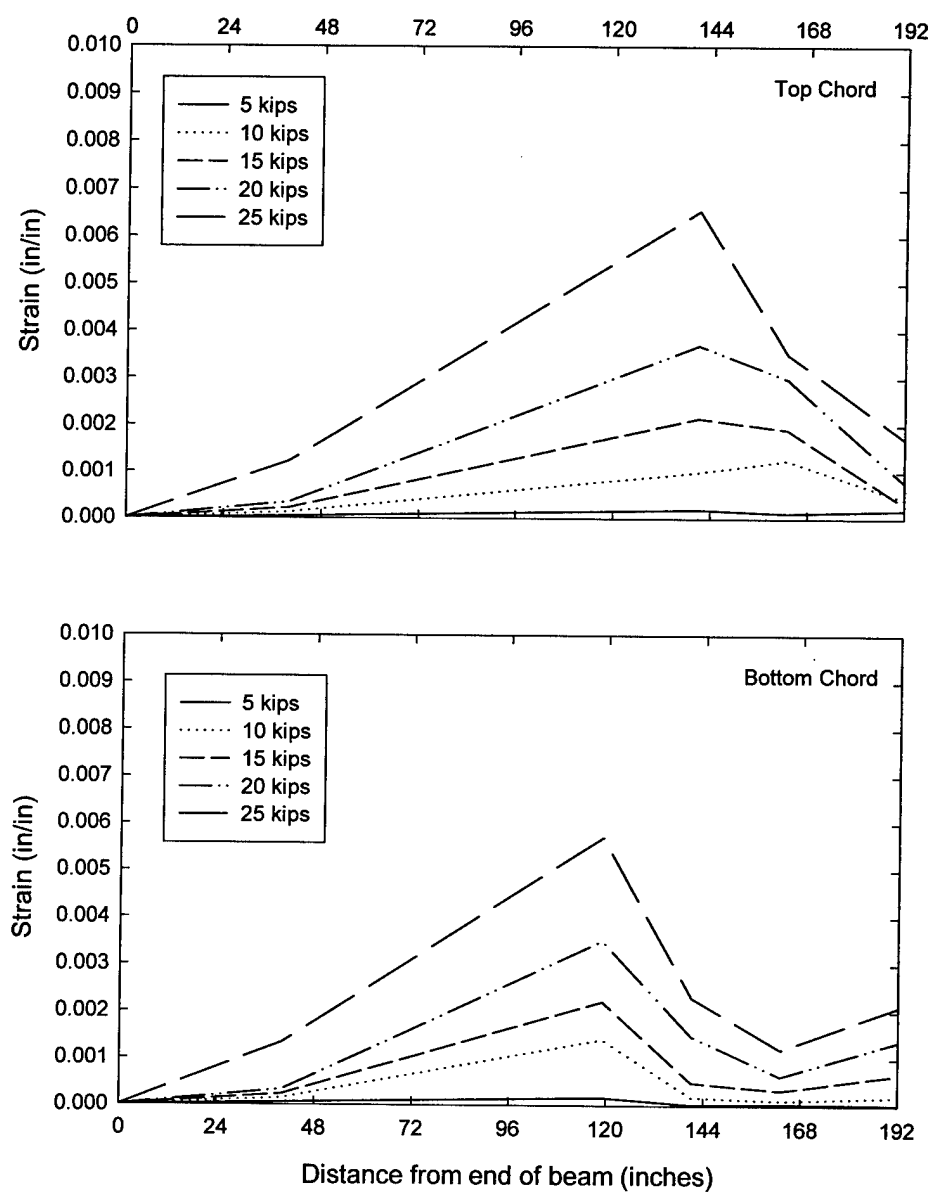
Figure 29. Strain distribution along strand length of HJ-3.

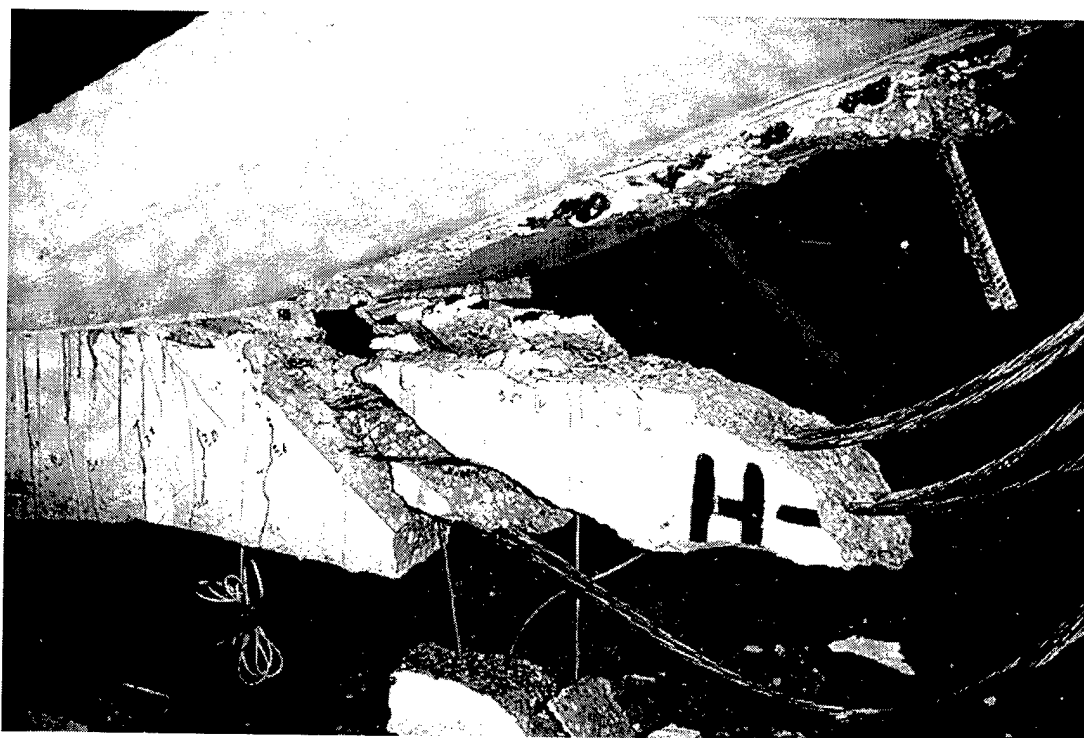
Figure 36. Failure of HJ-6.

None of the joists cracked when the prestressing tendons were released. During handling, specimen HJ-7 developed a crack across the slab through its depth near the south strut. Cracks were marked on each of the joists throughout testing. Cracking and failure mechanisms resulting from testing of HJ-6 and HJ-7 were compared with those of the two hybrid joists upgraded or repaired with FRP. Early in the test series, limited cracking occurred in the bottom chord of HJ-6. As actuator stroke was increased, cracking in the shear spans became evident but the cracks in the bottom chord did not develop further. In HJ-6 an inclined crack developed near the support and progressed upward along the web/slab interface (Figure 35). This crack progressed into the slab and failure ultimately occurred in this North end of the joist (Figure 36).

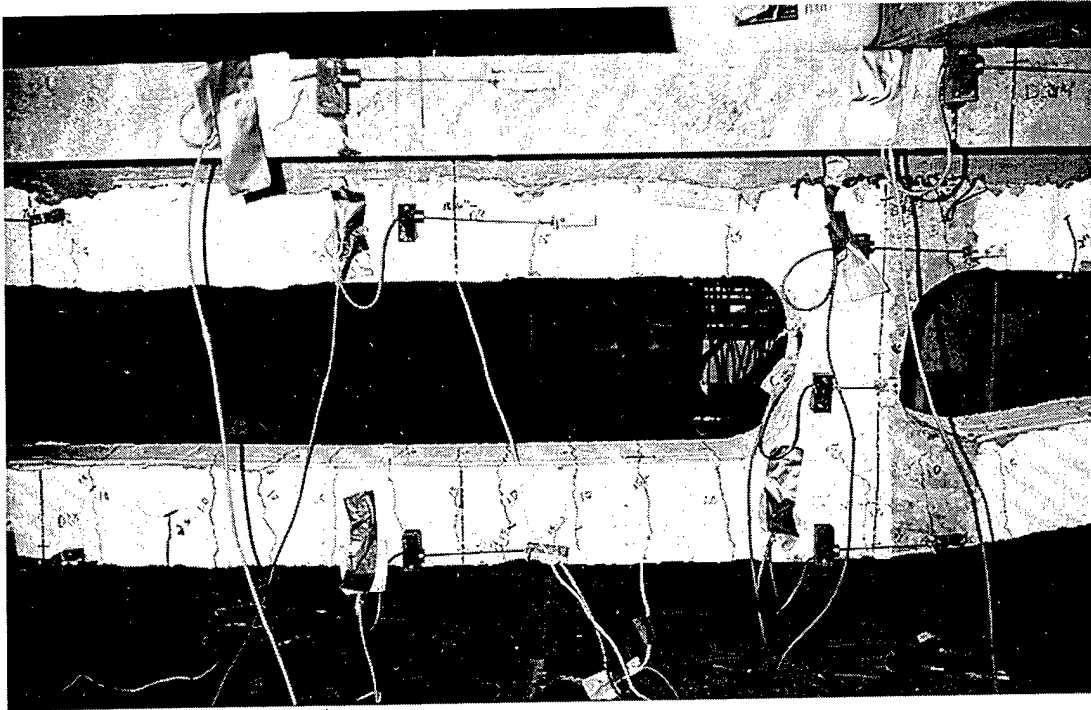
Figure 37. Crack patterns for HJ-7.

Figure 37 shows crack development for HJ-7. Initial flexural cracks formed along the bottom chord at midspan. Cracks were regularly spaced, and they became more numerous and closely spaced as the displacement was increased. Near the end of testing, when the load was not increasing but the specimen was

able to deflect significantly more, inclined cracks developed in the shear spans of the members. No actual failure was observed in specimen HJ-7. The joist continued to deflect after reaching an ultimate load capacity.

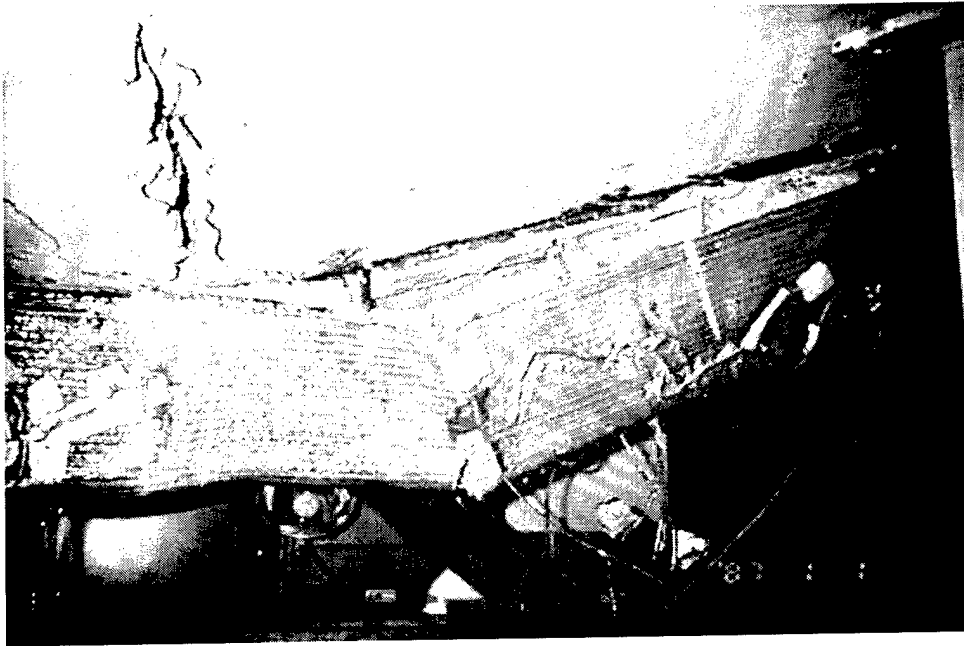
**Figure 39. Failure of HJ-3.**

a. Failure at north end of HJ-3

b. Detail of crack and separation at slab/web interface at failure of HJ-3.

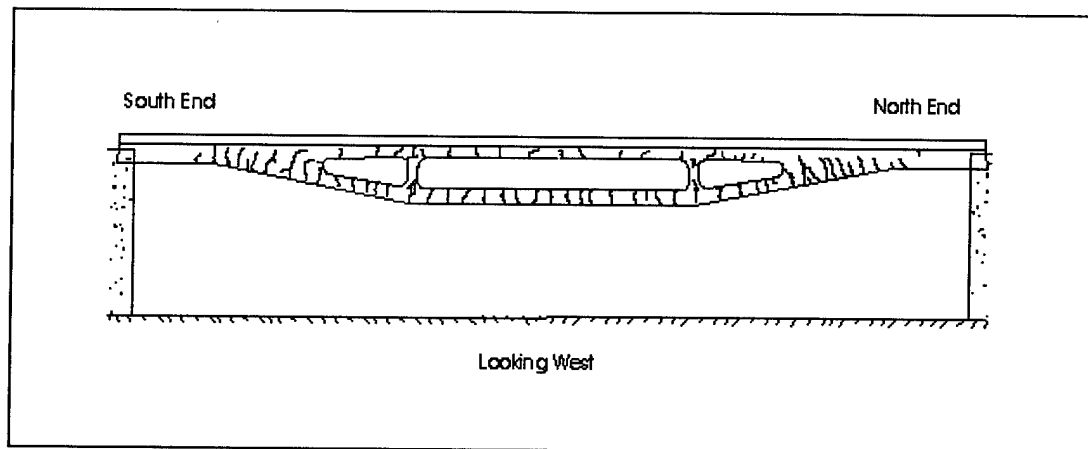
Figure 40. Crack Patterns of HJ-4 prior to FRP repair.

Initial testing of HJ-4 without FRP repair produced crack patterns similar to those for HJ-6, Figure 40. After repair testing began again, existing cracks between struts increased in size and additional cracks were observed to develop near the edge of the FRP repair area, Figure 41 (a) and (b). The test had to be stopped when there was no further vertical space between the web bottom chord and the floor for the joist to deflect. The joist did not fail. At the test conclusion, the FRP repair showed no signs of damage. The beam exhibited ductile response throughout the test.
