**US Army Corps  
of Engineers**

USACERL Special Report 99/01  
October 1998

# **Shear Strengthening of Reinforced Concrete Beams Using Fiber-Reinforced Polymer Wraps**

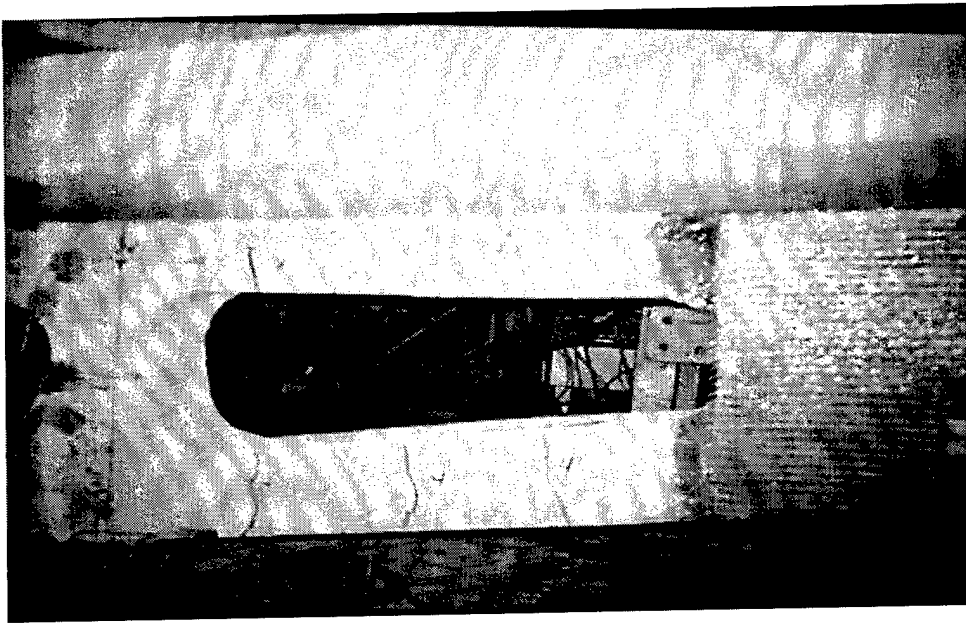
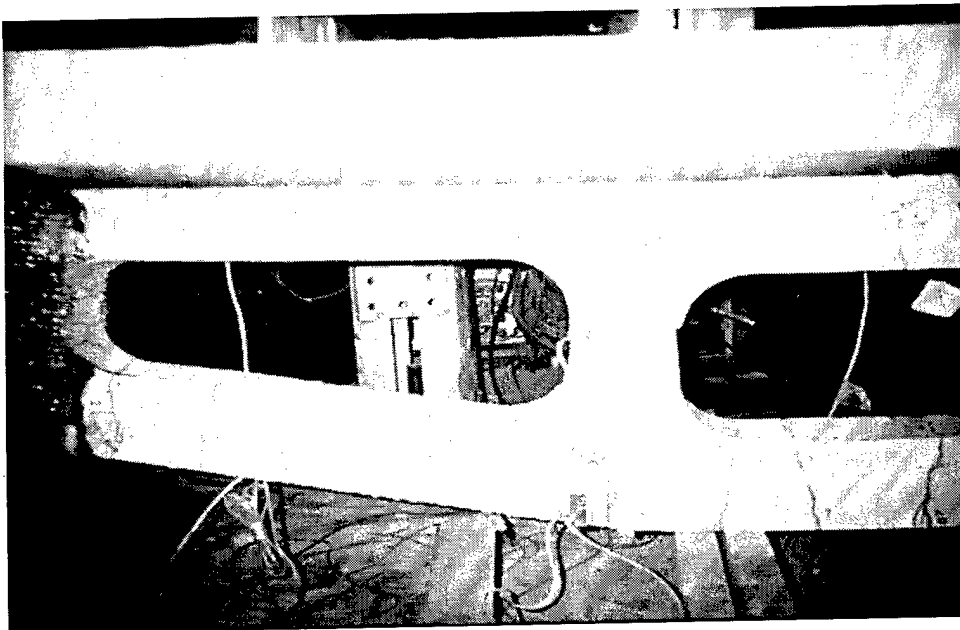
**Figure 41. Crack patterns for HJ-4.**

a. Cracks at north end of joist

b. Cracks at south end of joist

Initial testing of HJ-4 without FRP repair produced crack patterns similar to those for HJ-6, Figure 40. After repair testing began again, existing cracks between struts increased in size and additional cracks were observed to develop near the edge of the FRP repair area, Figure 41 (a) and (b). The test had to be stopped when there was no further vertical space between the web bottom chord and the floor for the joist to deflect. The joist did not fail. At the test conclusion, the FRP repair showed no signs of damage. The beam exhibited ductile response throughout the test.
