AFRL-PR-WP-TR-1998-2110

**THIN DENSE CHROME BEARING
INSERTION PROGRAM
Pyrowear 675 and Cronidur Wear Testing**

**GE Aircraft Engines
Advanced Engineering Programs Department
One Neumann Way
Cincinnati, Ohio 45215-6301**

OCTOBER 1998

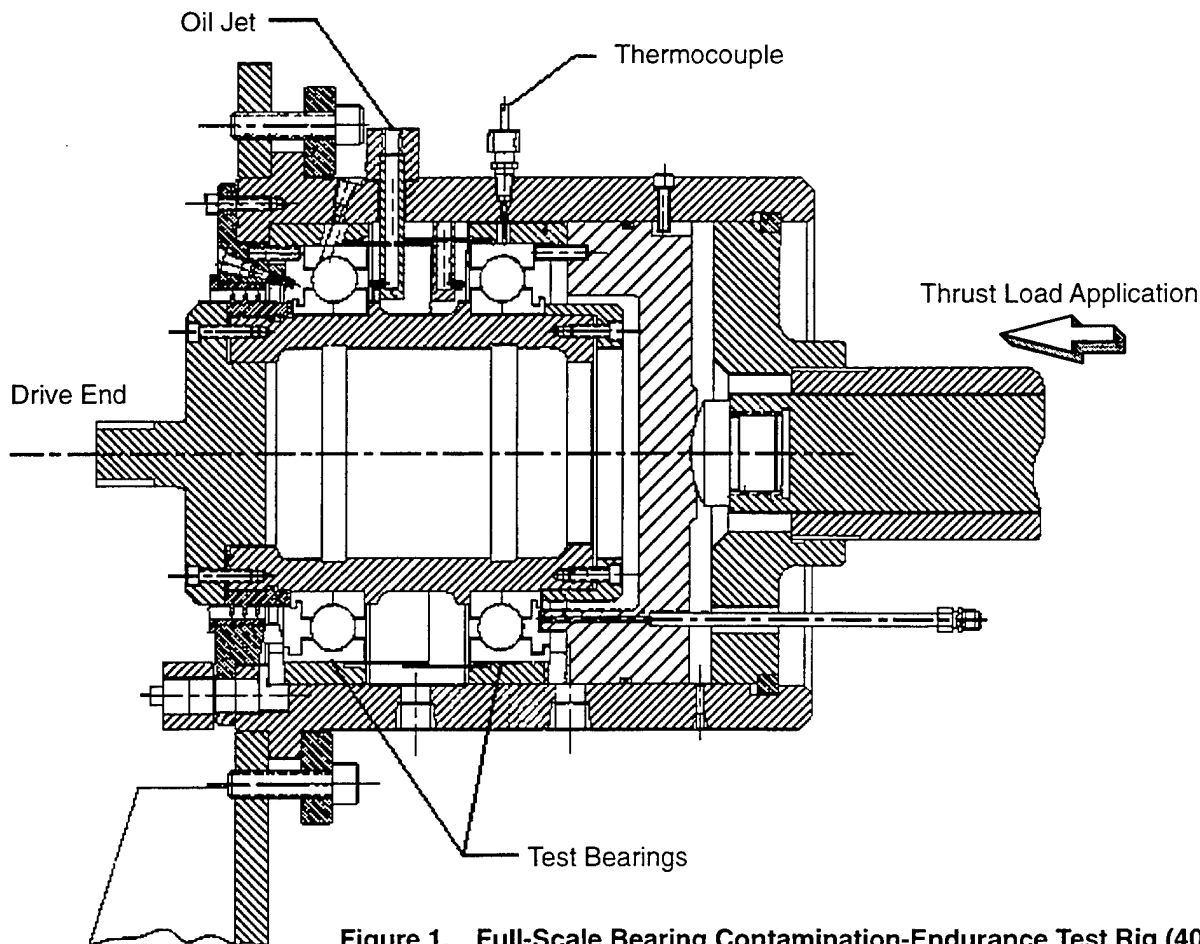
Figure 1. Full-Scale Bearing Contamination-Endurance Test Rig (4013417-860)

Rig operation simulated the F110-GE-129 No. 3 ball bearing startup with severe contamination and full-speed operating conditions. A hydraulic cylinder and load cell were used to apply an axial load of 6000 ± 100 lbf. No radial load or intentional unbalance were applied to the bearing. The outer race temperature, regulated by oil-supply temperature and monitored by thermocouples, was maintained at $375 \pm 25^\circ\text{F}$. The oil was MIL-L-7808J. The shaft speed was set at $14,250 \pm 250$ rpm. Figure 1 shows the test rig arrangement.

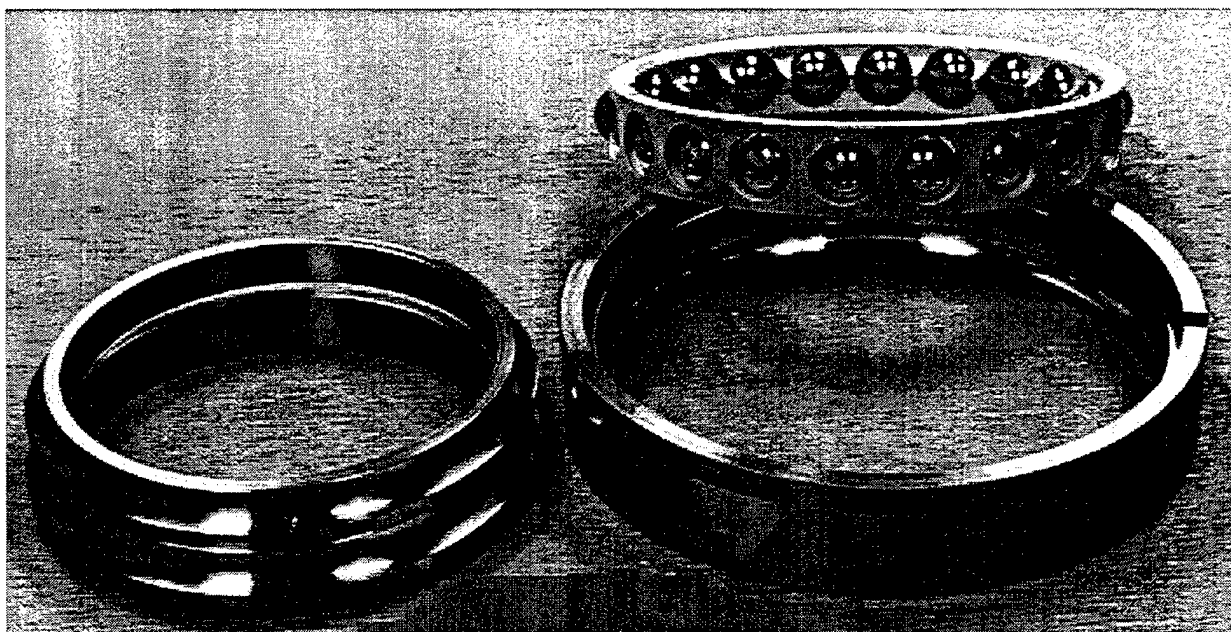
Figure 2. Cronidur 30 "Hybrid" (S/N FCAB0971) – Bearing Pretest Condition

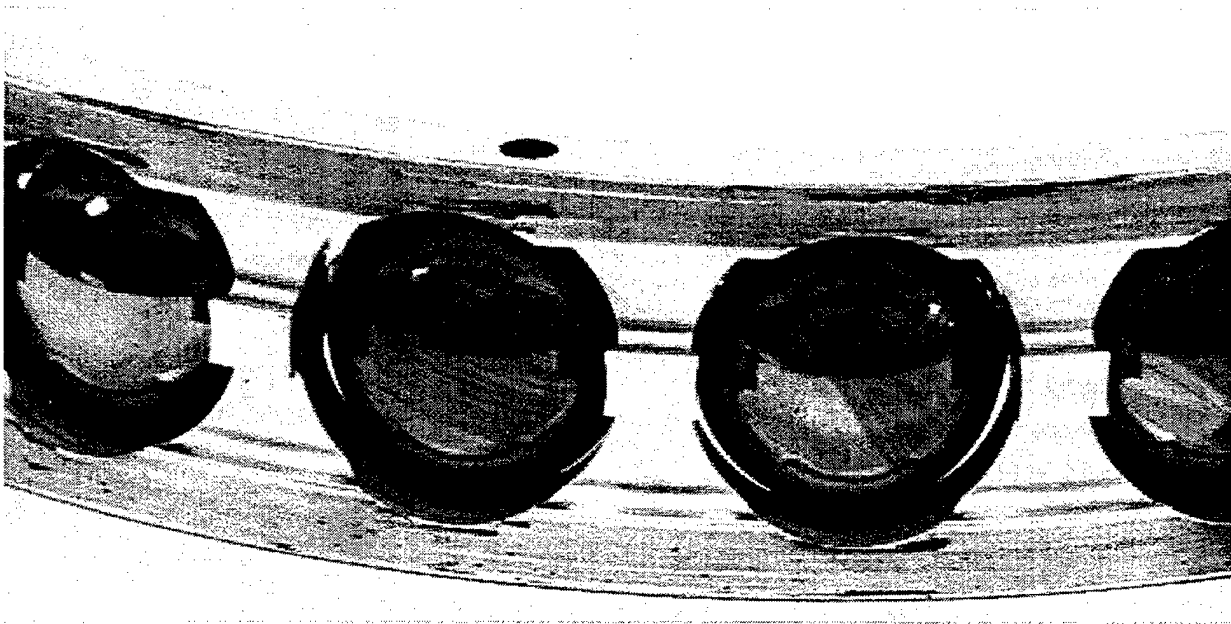
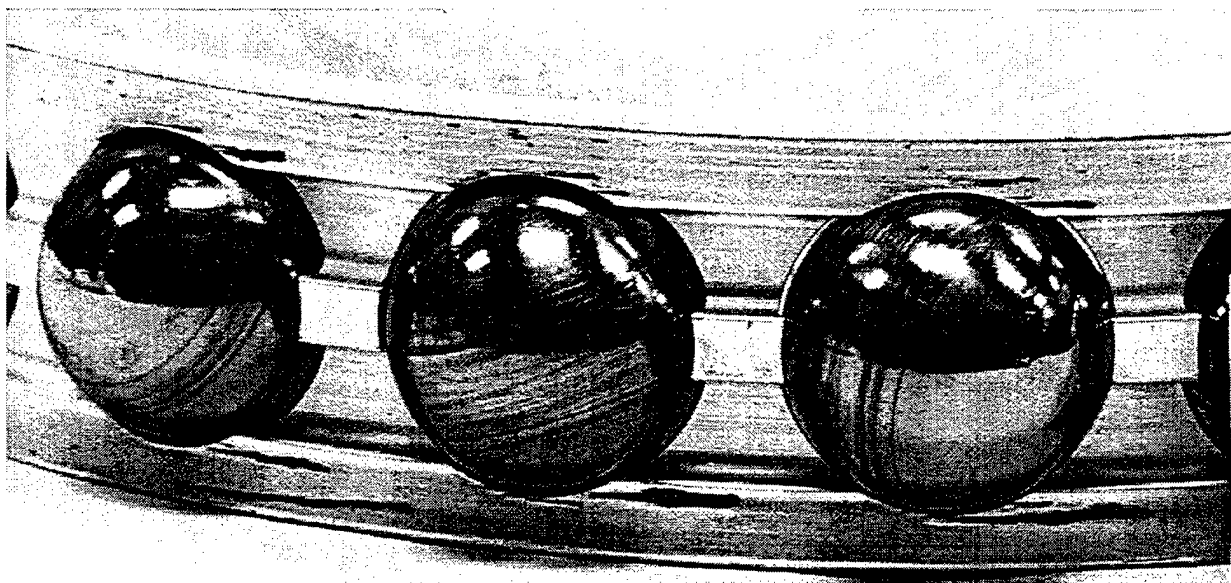
Figure 3. Cronidur 30 "Purebred" Cage and Ball Midtest Wear

Both bearings showed similar evidence of wear initiation. The balls had scratches, and some could be felt with a 0.030-inch radius scribe. The cage rail outer surfaces had circumferential scratches and local dark streaks. The cage pockets had aluminum oxide imbedded in the silver. The outer raceway curvatures had some pitting and denting on the puller groove side (the loaded side). The outer race shoulders showed some circumferential polishing. The inner raceway also had pitting and denting on the loaded half. Figures 3 and 4 show the bearings at this midtest point.

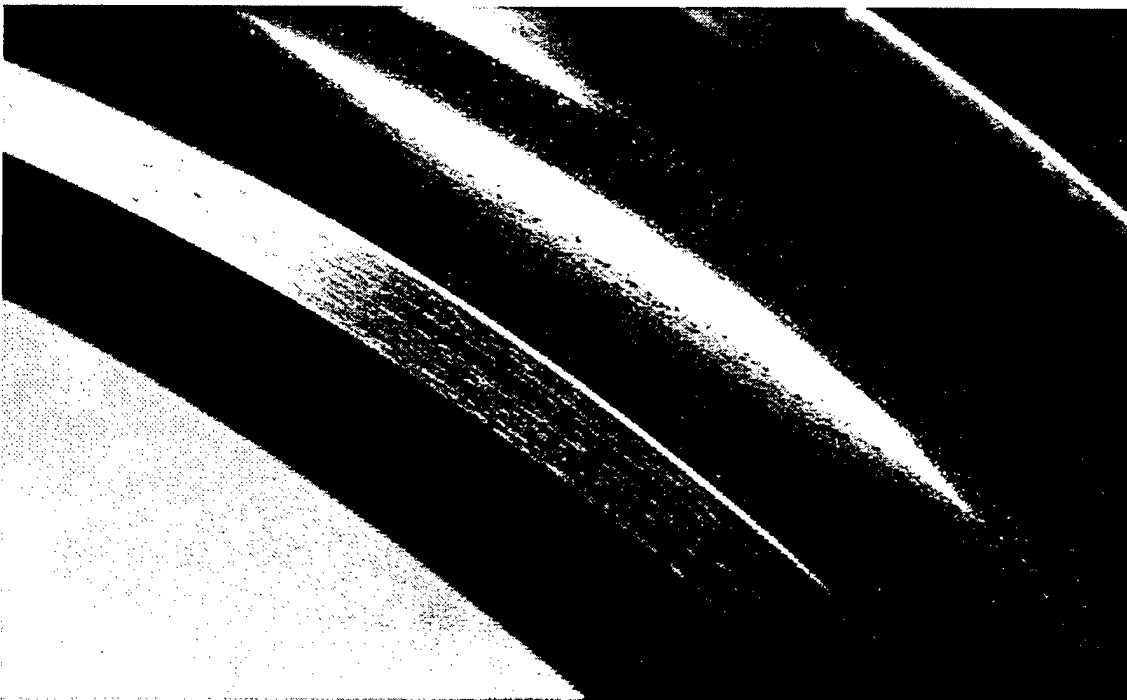
Figure 4. Cronidur 30 "Purebred" Outer Race Shoulder Midtest Wear

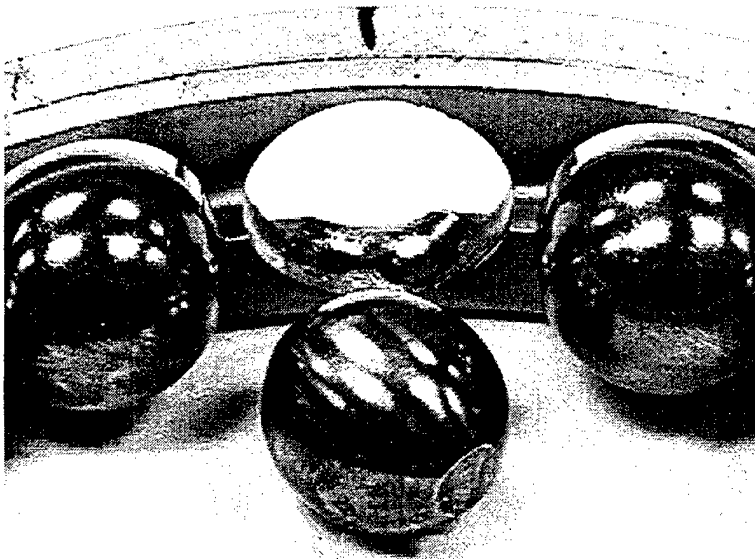
**Figure 5. Cronidur 30 “Purebred”
(S/N FCAA7068) Ball
Ellipsoidal Wear**

At teardown, the condition of the two bearings was reviewed. Several balls in one bearing, S/N FCAA7068, were severely worn — the worst ball being ellipsoid in shape. Table 2 lists ball diameter measurements. A few balls had debris denting. The second bearing, S/N FCAA7069, did not experience this severe wear but did have scratches on the balls. The cage rail outer surfaces had local dark streaks. The outer race of both bearings had some wear on the cage guiding shoulders. The outer race shoulders were measured before and after the test to reveal a radial wear depth of 0.001 inch. The loaded half of the inner race had fine pitting and denting. The raceway-to-shoulder corner appears distorted and raised. Figures 5 through 14 show the posttest “purebred” bearings.

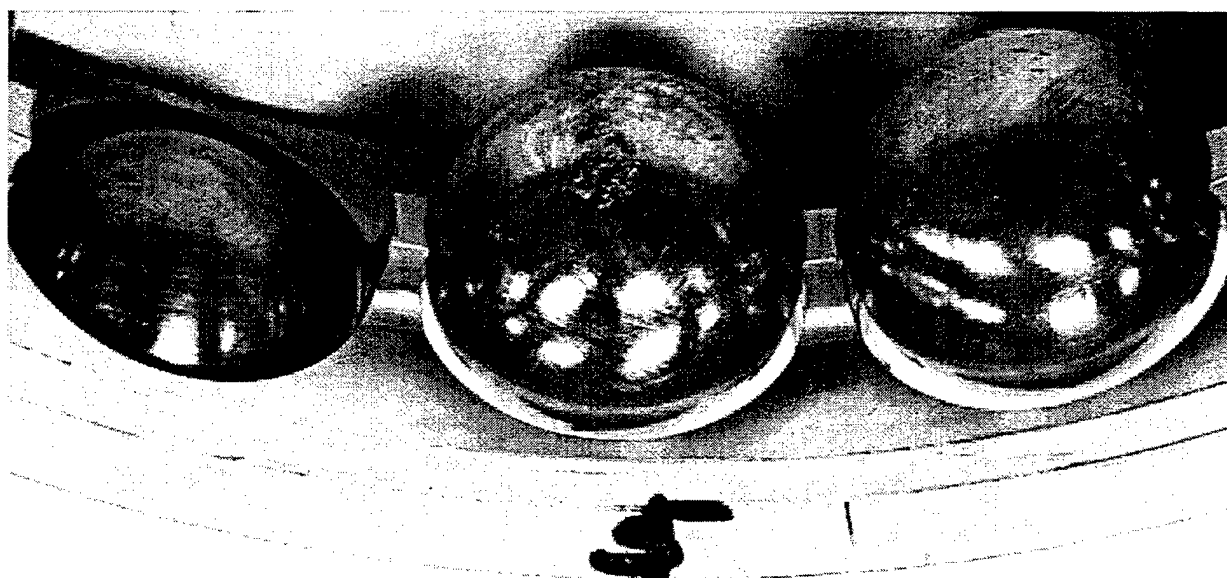
Figure 6. Cronidur 30 “Purebred” (S/N FCAA7068) Ball Debris Denting

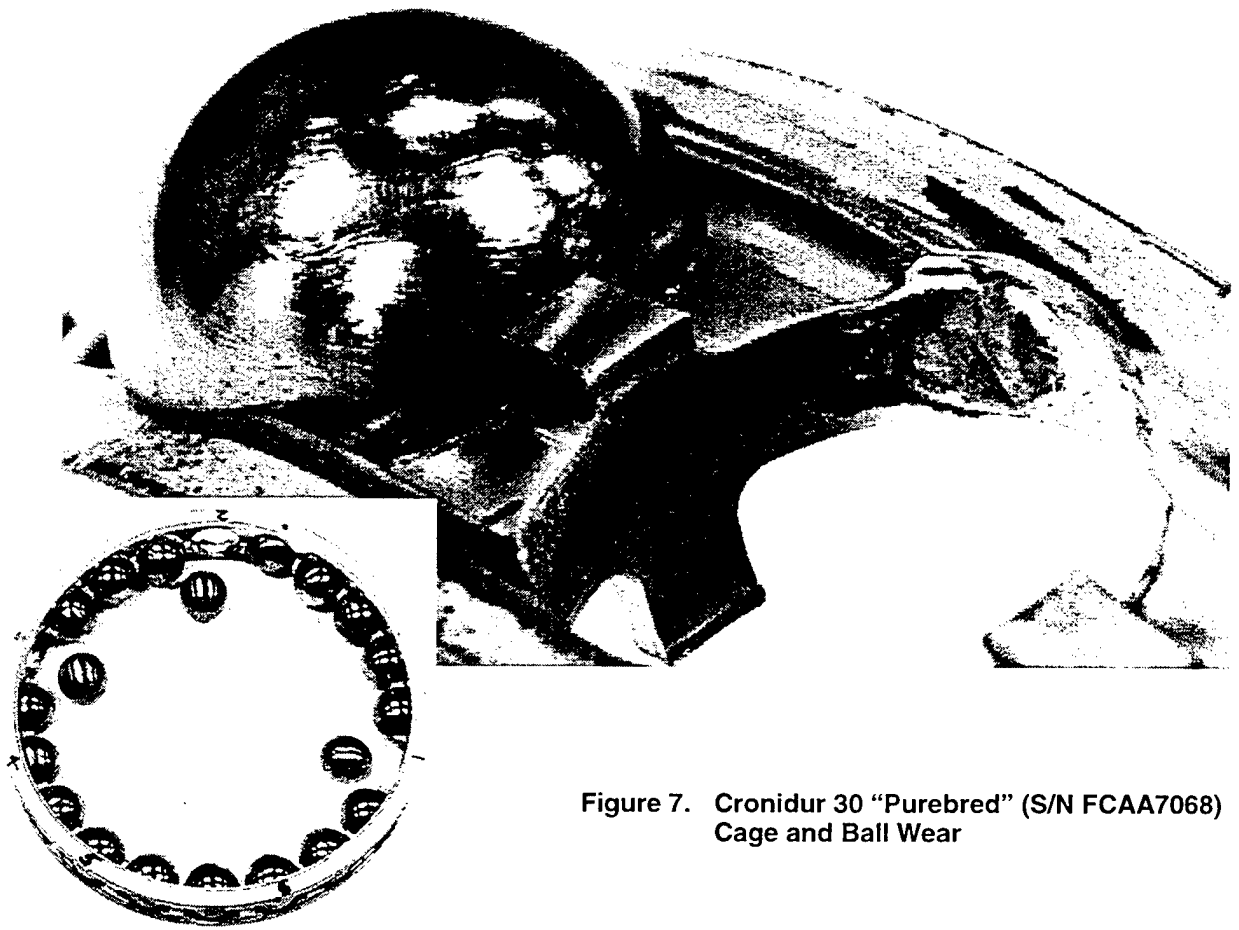
Figure 7. Cronidur 30 "Purebred" (S/N FCAA7068) Cage and Ball Wear

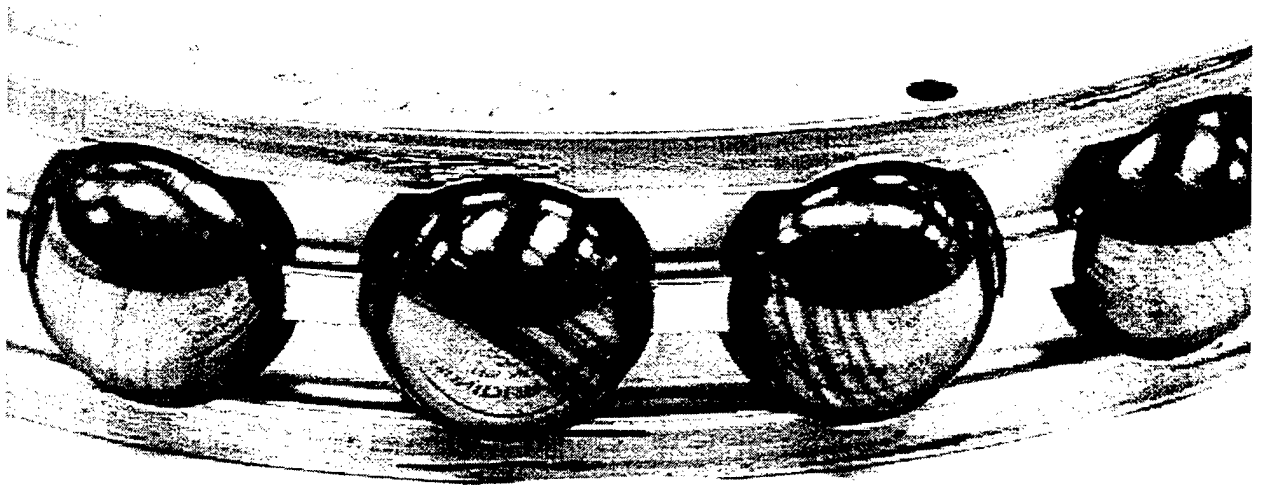
Figure 8. Cronidur 30 "Purebred" (S/N FCAA7069) Cage and Ball Wear

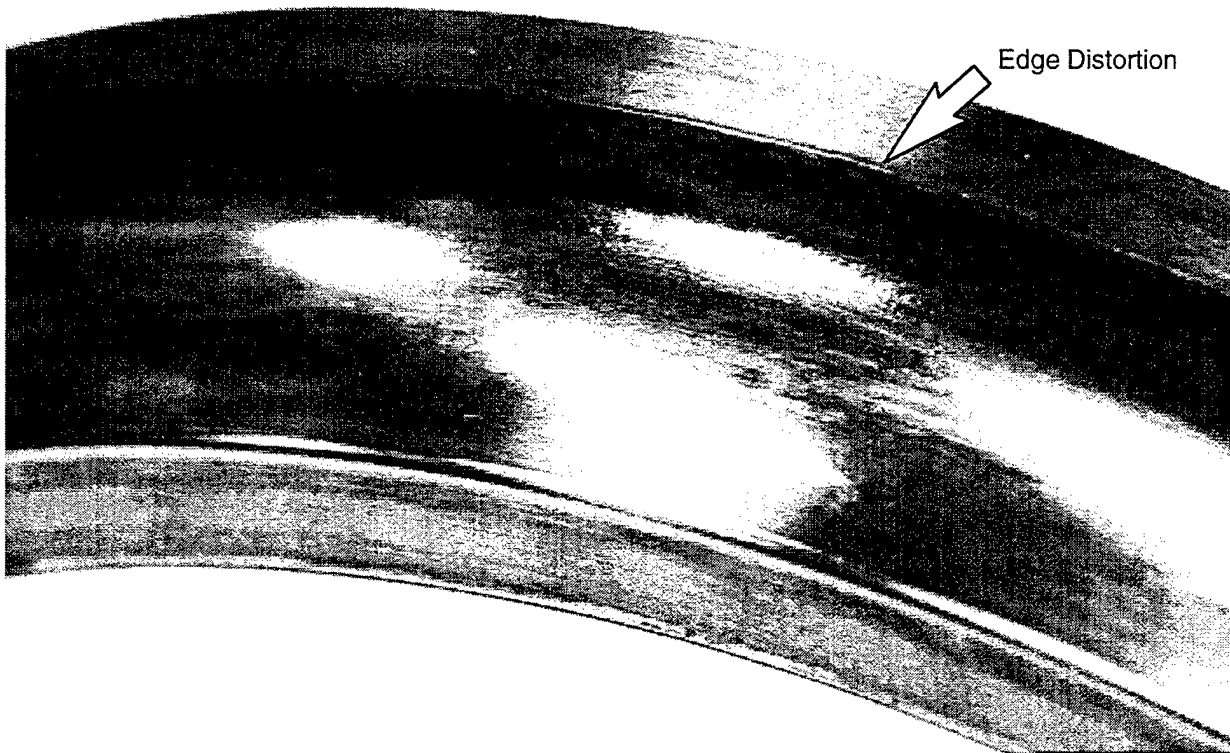
Figure 9. Cronidur 30 "Purebred" (S/N FCAA70680) Inner Race (Loaded Half) Posttest Condition

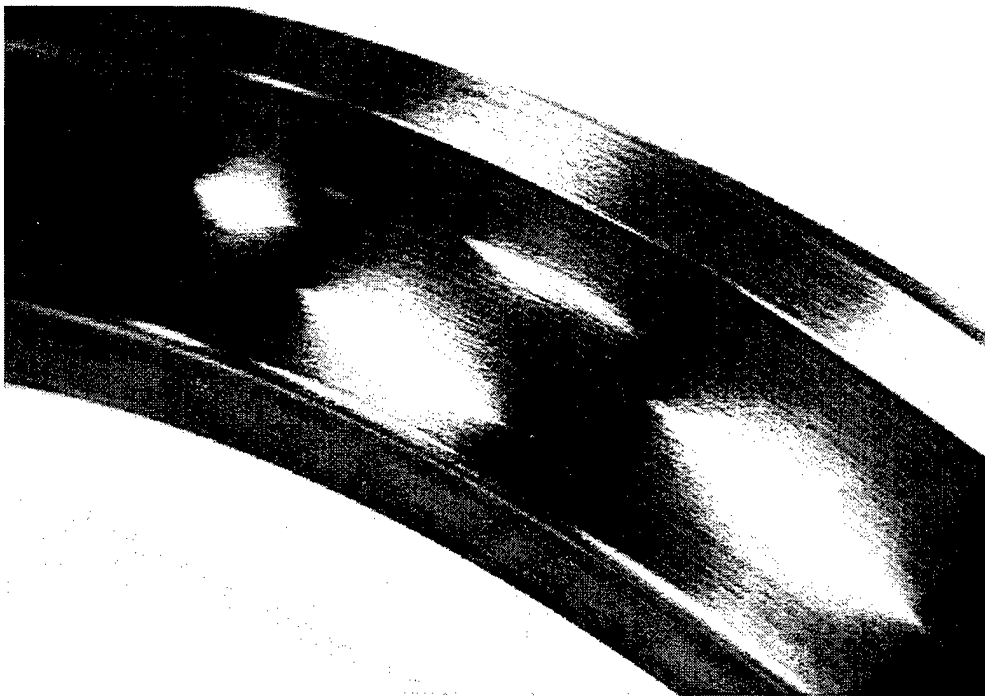
Figure 10. Cronidur 30 "Purebred" (S/N FCAA7068) Inner Race (Unloaded Half) Posttest Condition

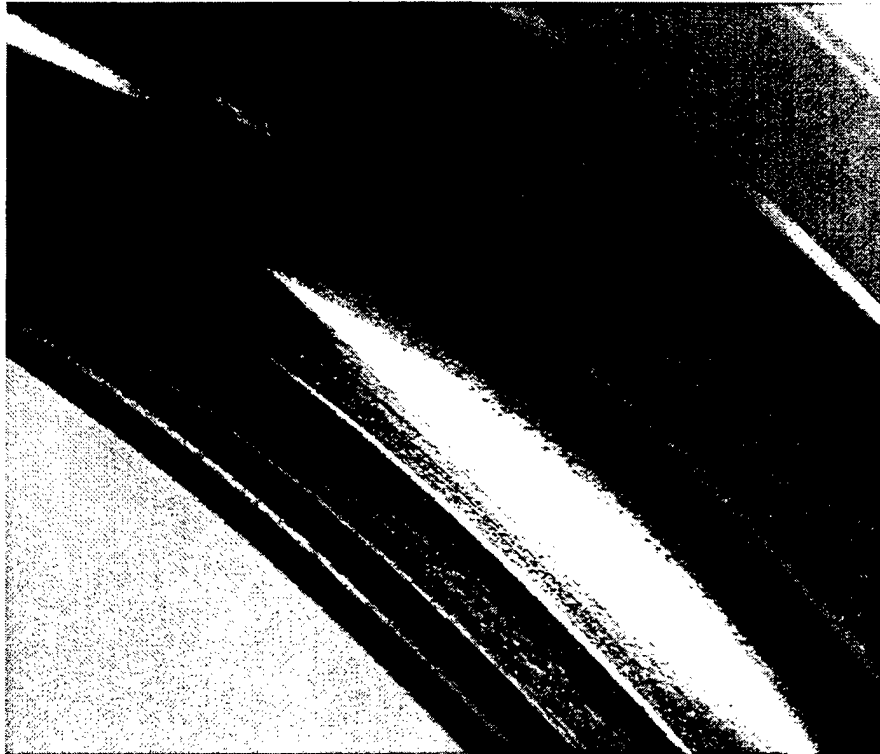
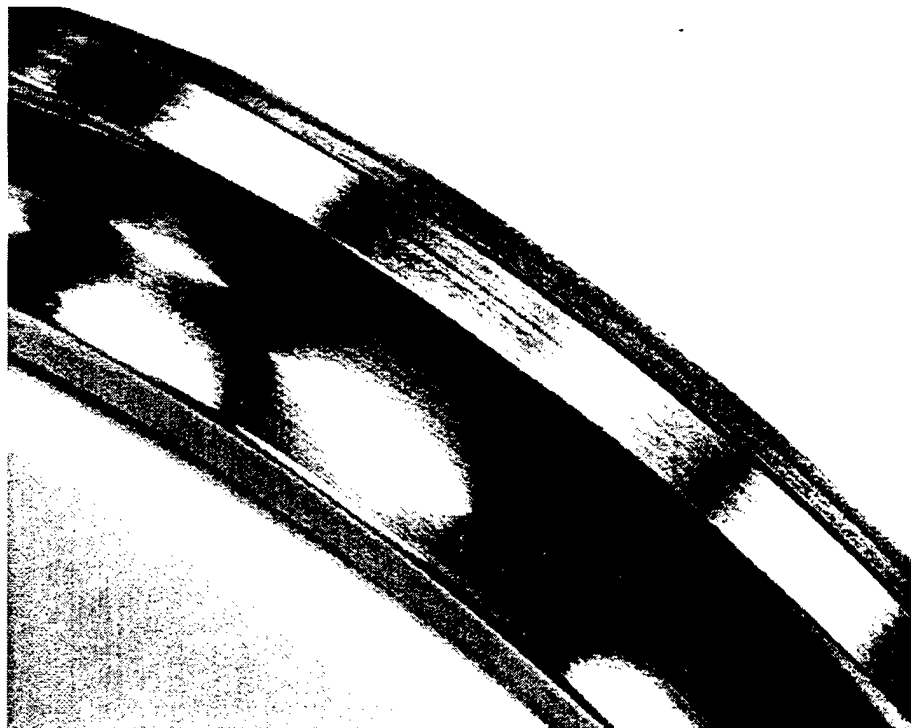
Figure 11. Cronidur 30 "Purebred" (S/N FCAA7069) Inner Race Posttest Condition

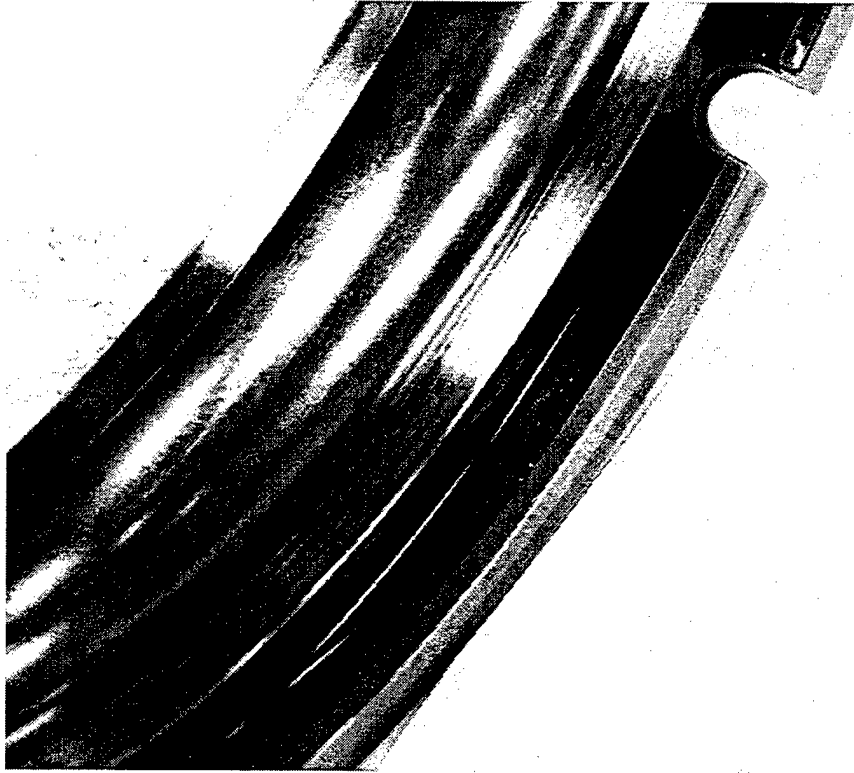
Figure 12. Cronidur 30 "Purebred" (S/N FCAA7068) Outer Race Shoulder Wear

Both bearings had shoulder wear to a depth of 0.001 inch on the outer race shoulders, and both had the local dark streaks on the cage rail outer surfaces. The excessive damage to the balls was a concern. Both bearings were subjected to material evaluation to further examine the microstructure. The wear characteristic of the Cronidur 30 “purebred” bearing was deemed unacceptable.

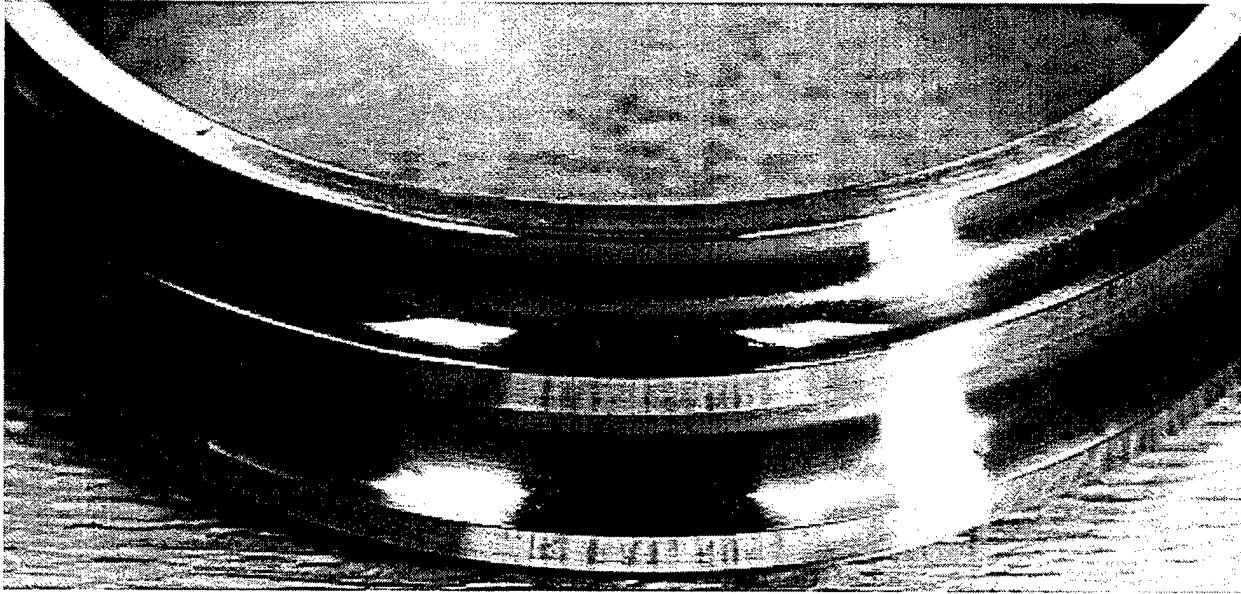
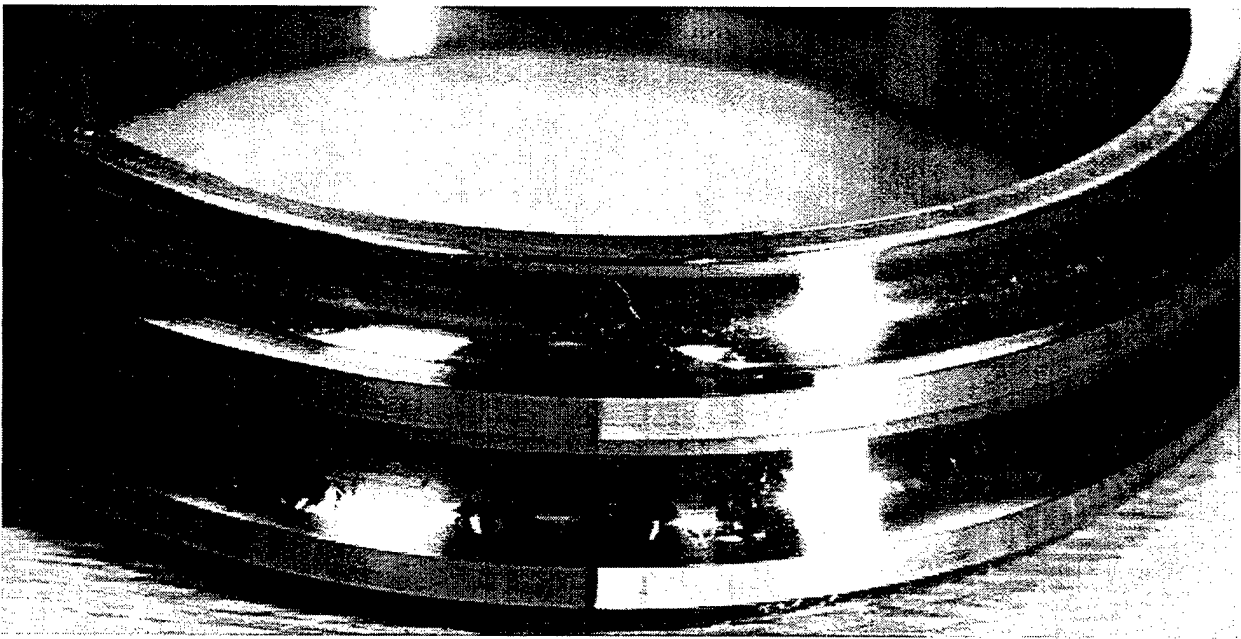
Figure 15. Cronidur 30 "Hybrid" Inner Race Shoulder Wear

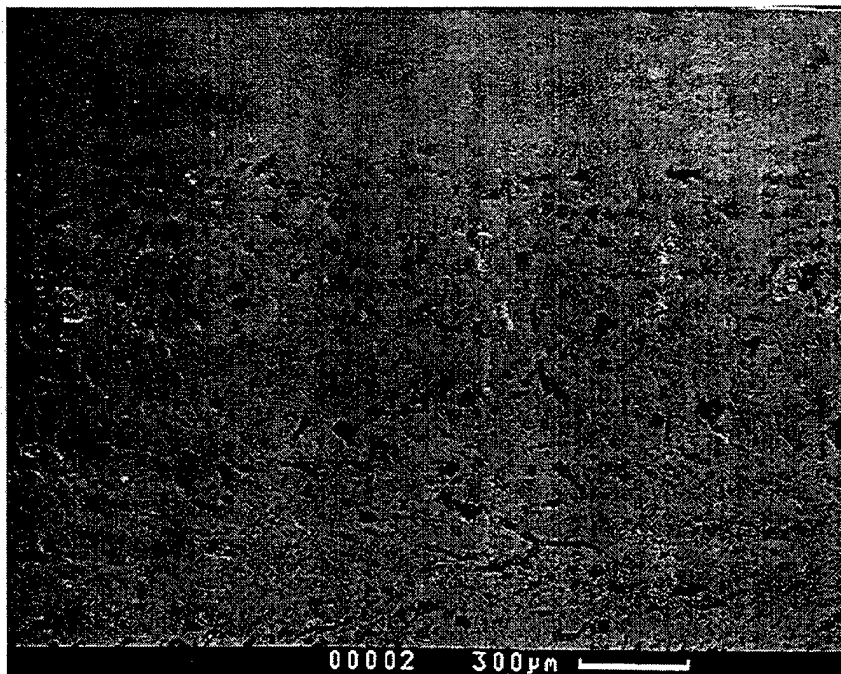
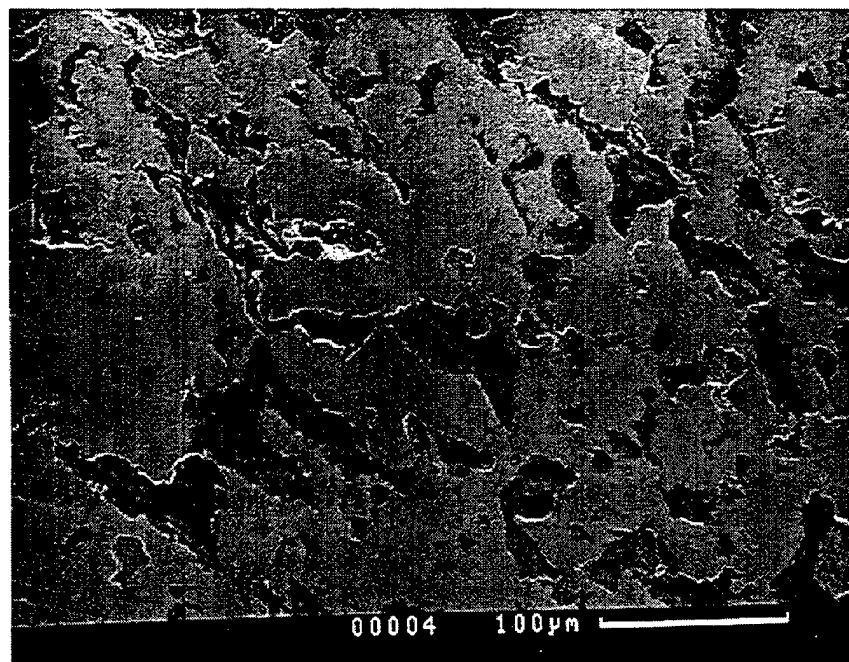
Figure 16. Cronidur 30 "Hybrid" Inner Raceway Microspalling *(Page 1 of 3)*

Figure 16. Cronidur 30 "Hybrid" Inner Raceway Microspalling (Page 2 of 3)

Surface dents from test
contamination

Figure 16. Cronidur 30 “Hybrid” Inner Raceway Microspalling *(Page 3 of 3)*

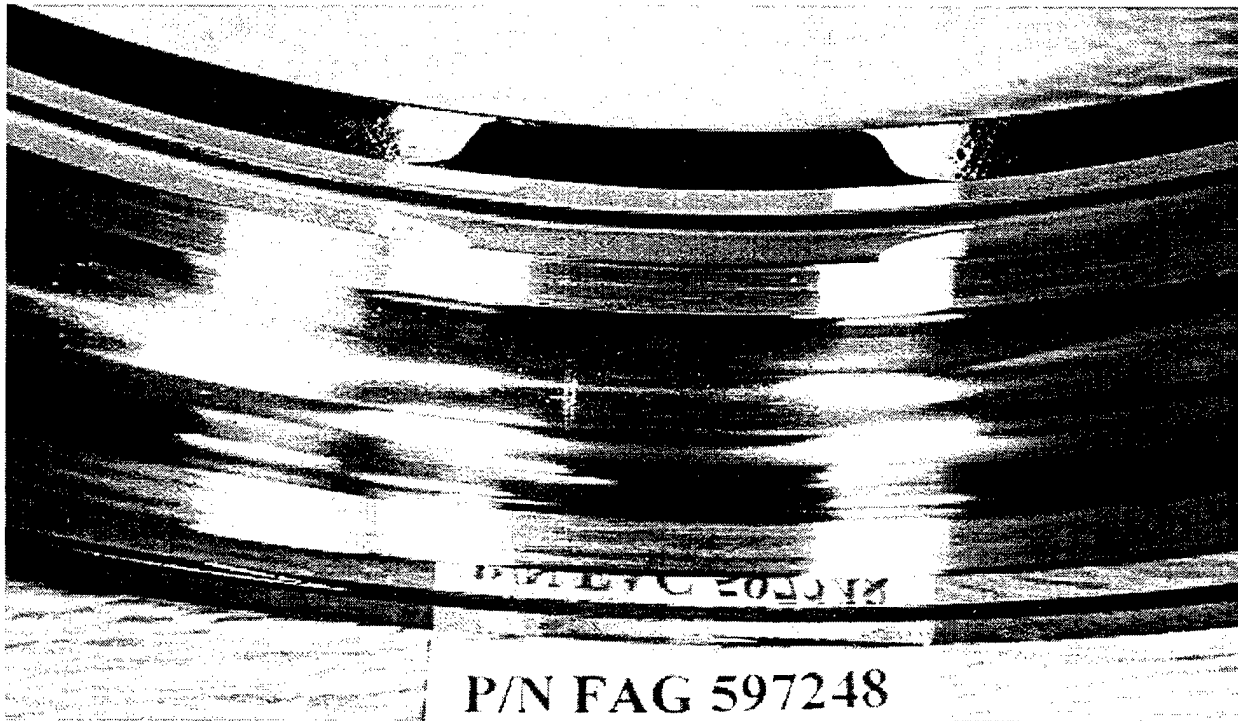
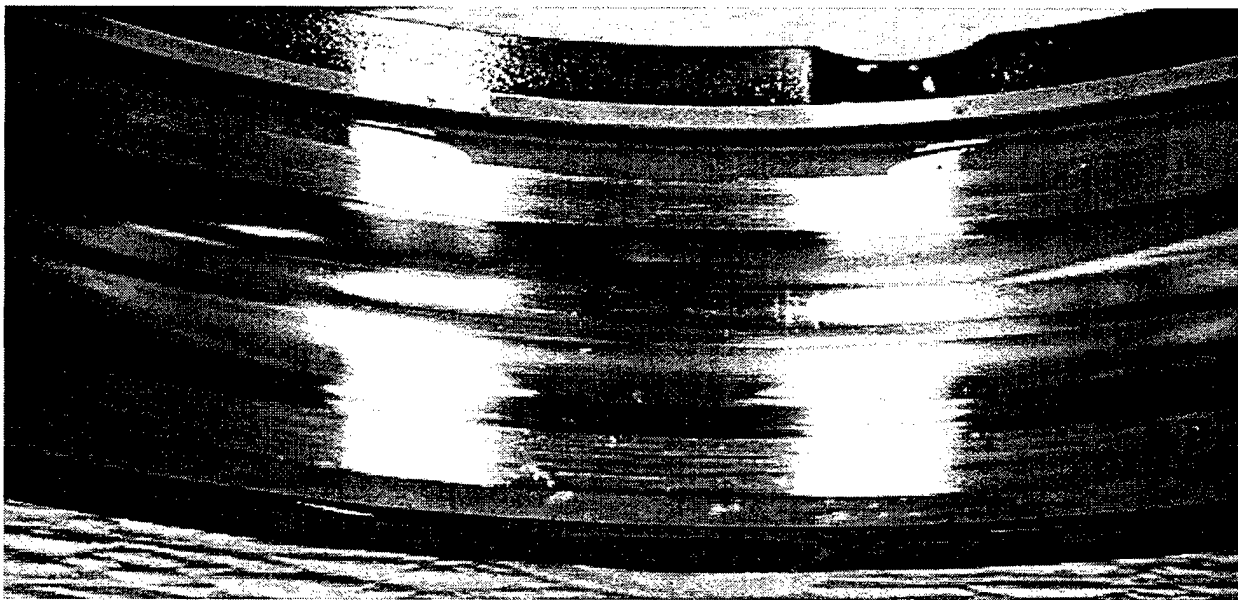
Figure 17. Cronidur 30 "Hybrid" Outer Race Shoulder Wear

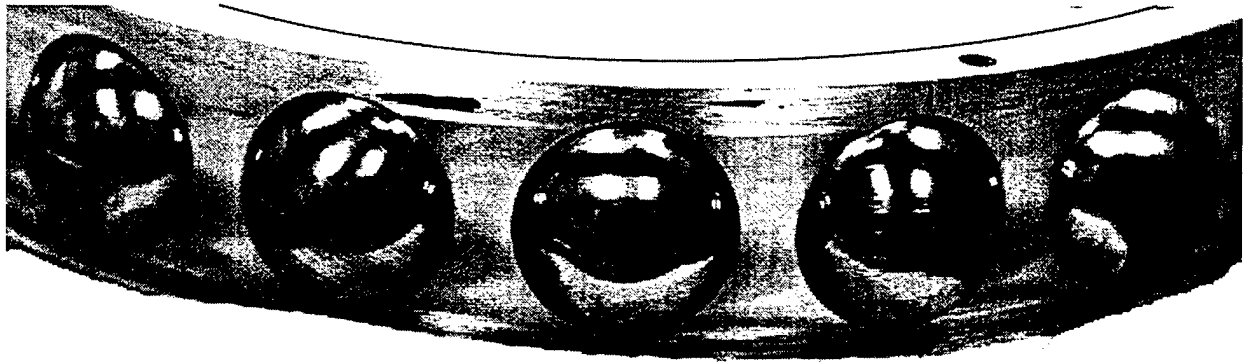
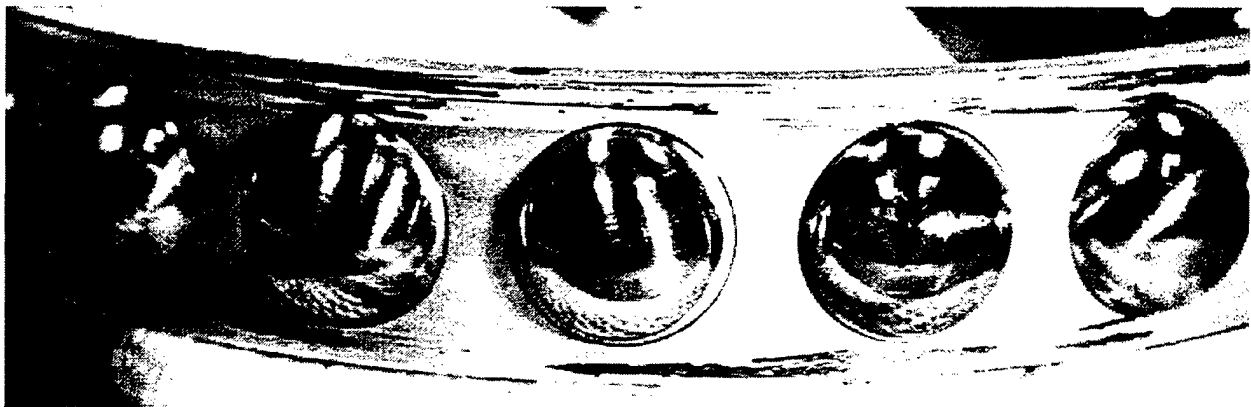
Figure 18. Cronidur 30 “Hybrid” Cage and Ball Wear

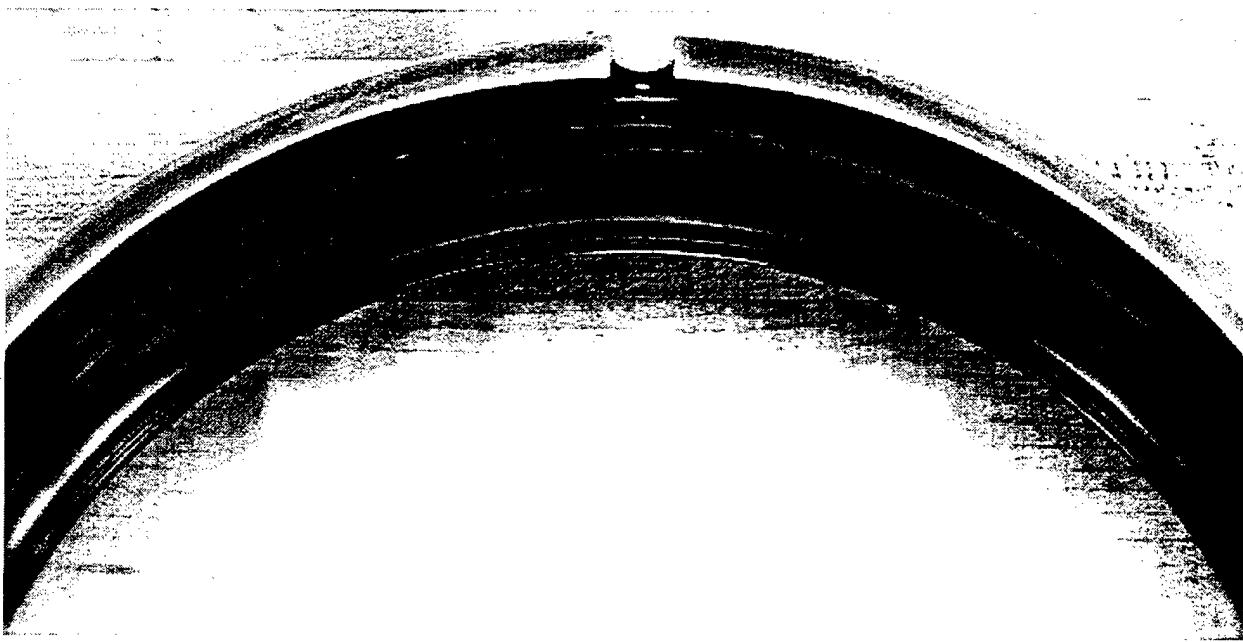
Figure 19. Pyrowear 675 “Hybrid” Outer Race Shoulder Wear

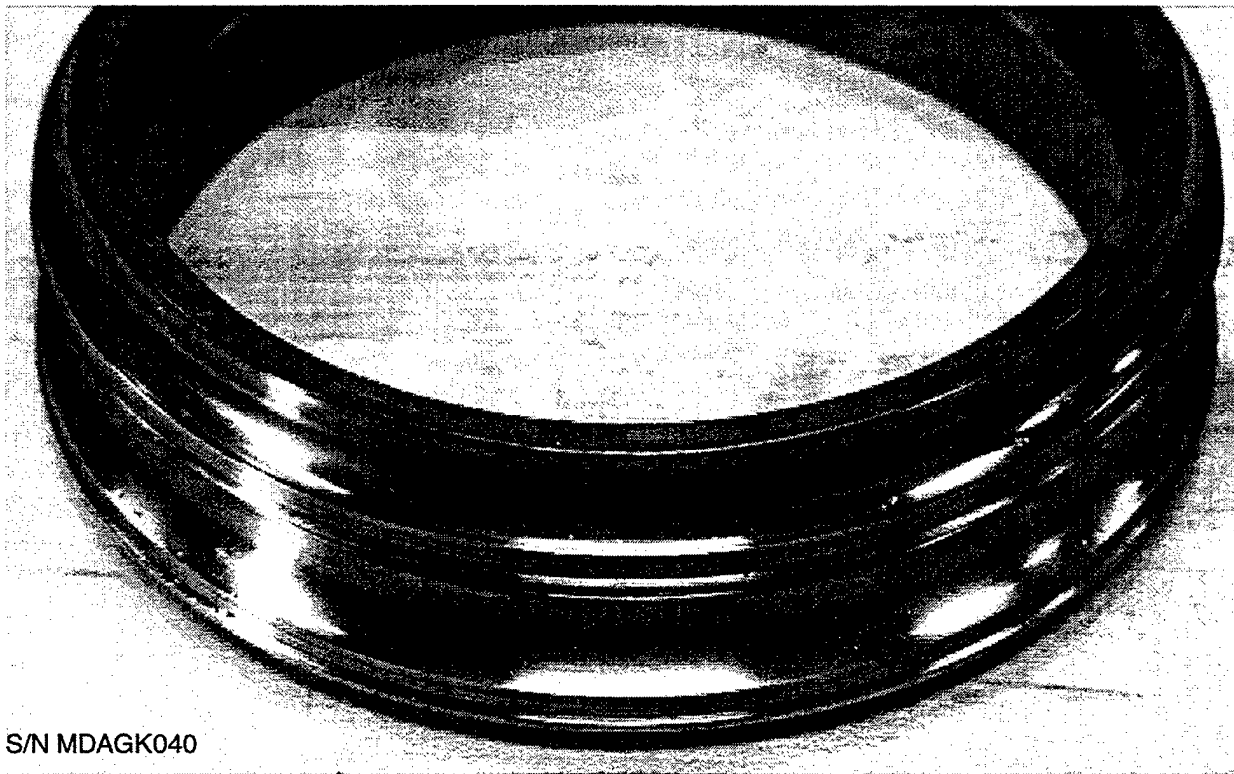
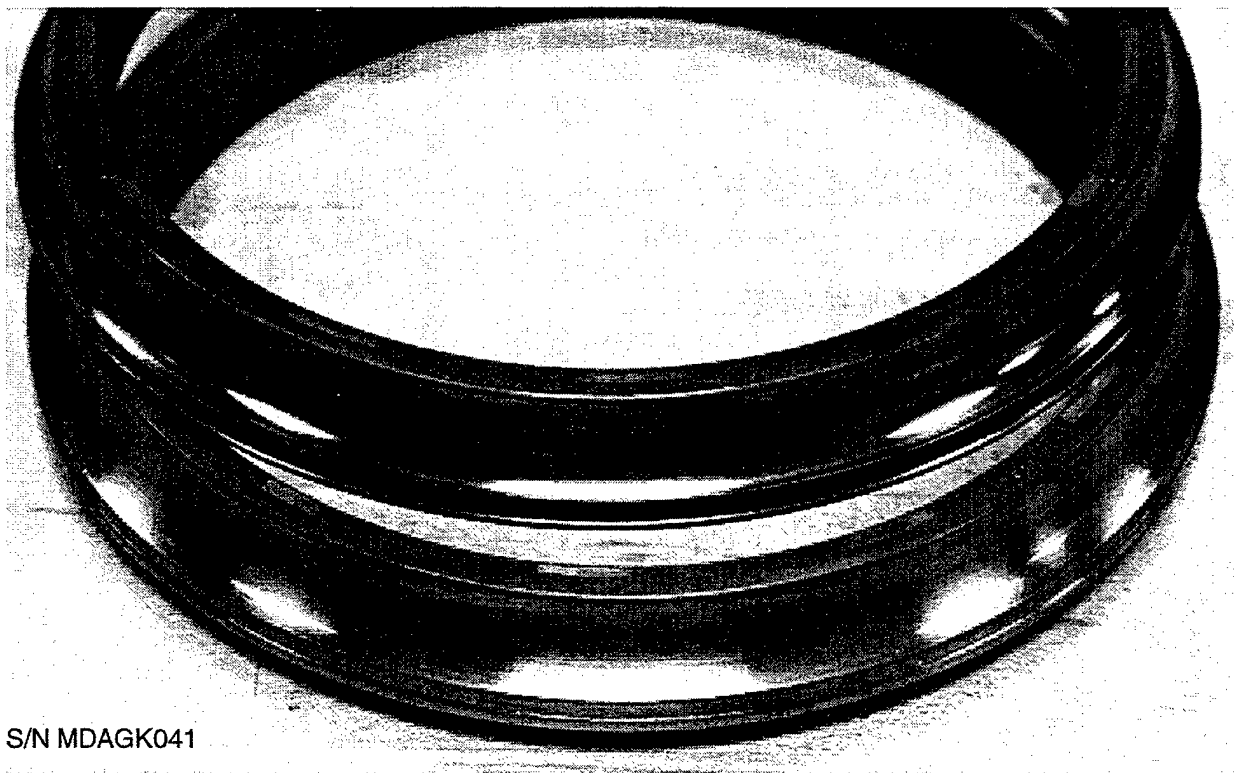
Figure 20. Pyrowear 675 "Hybrid" Inner Race Shoulder Wear

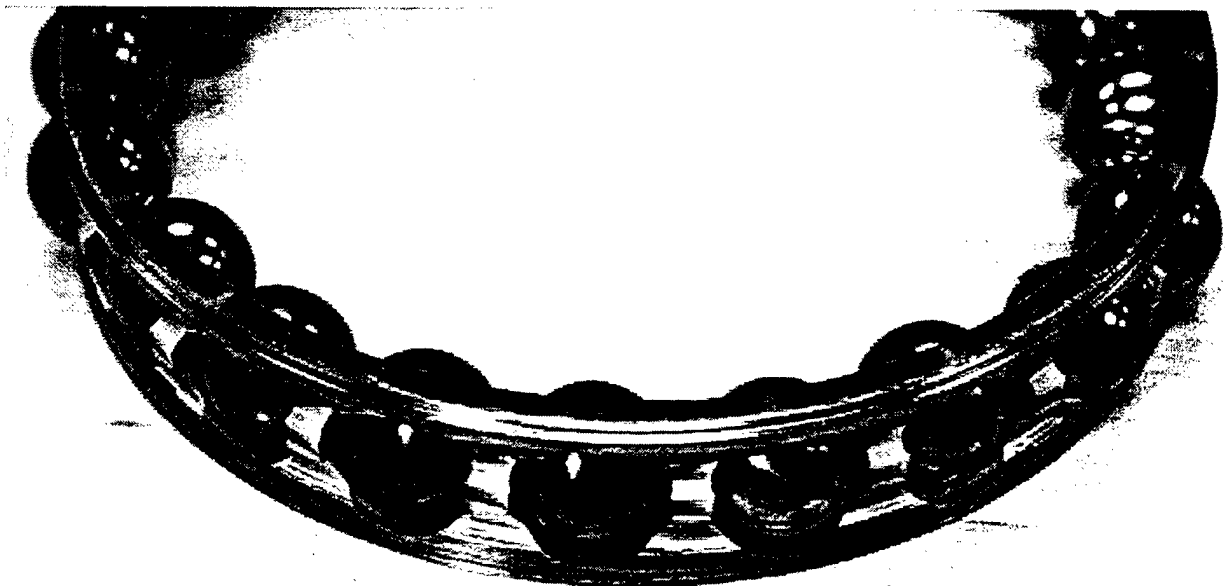
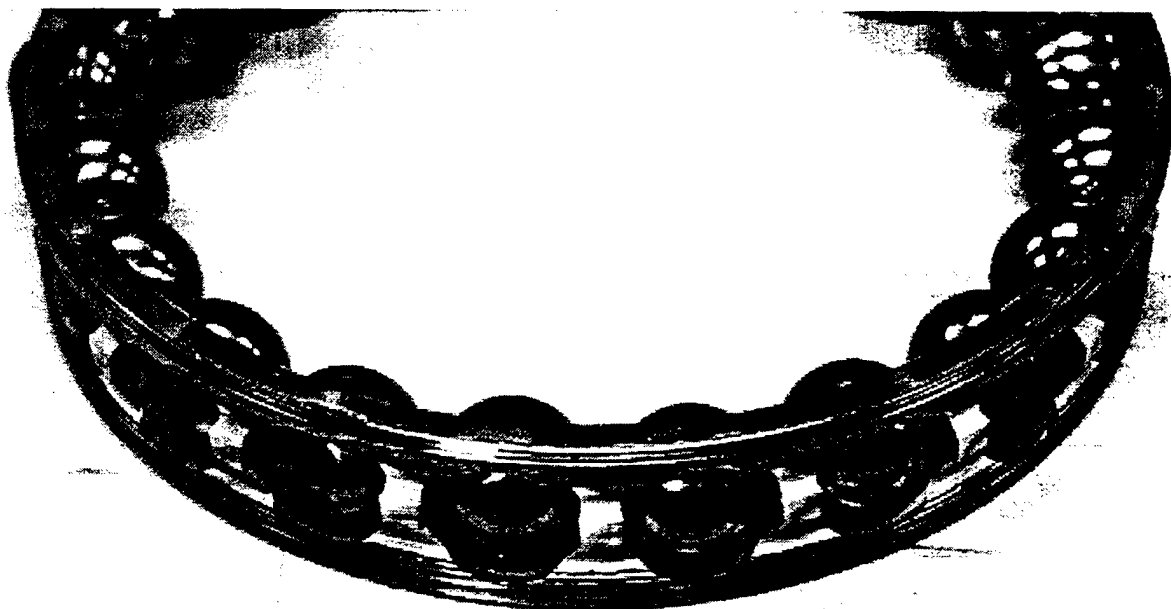
Figure 21. Pyrowear 675 "Hybrid" Cage and Ball Wear

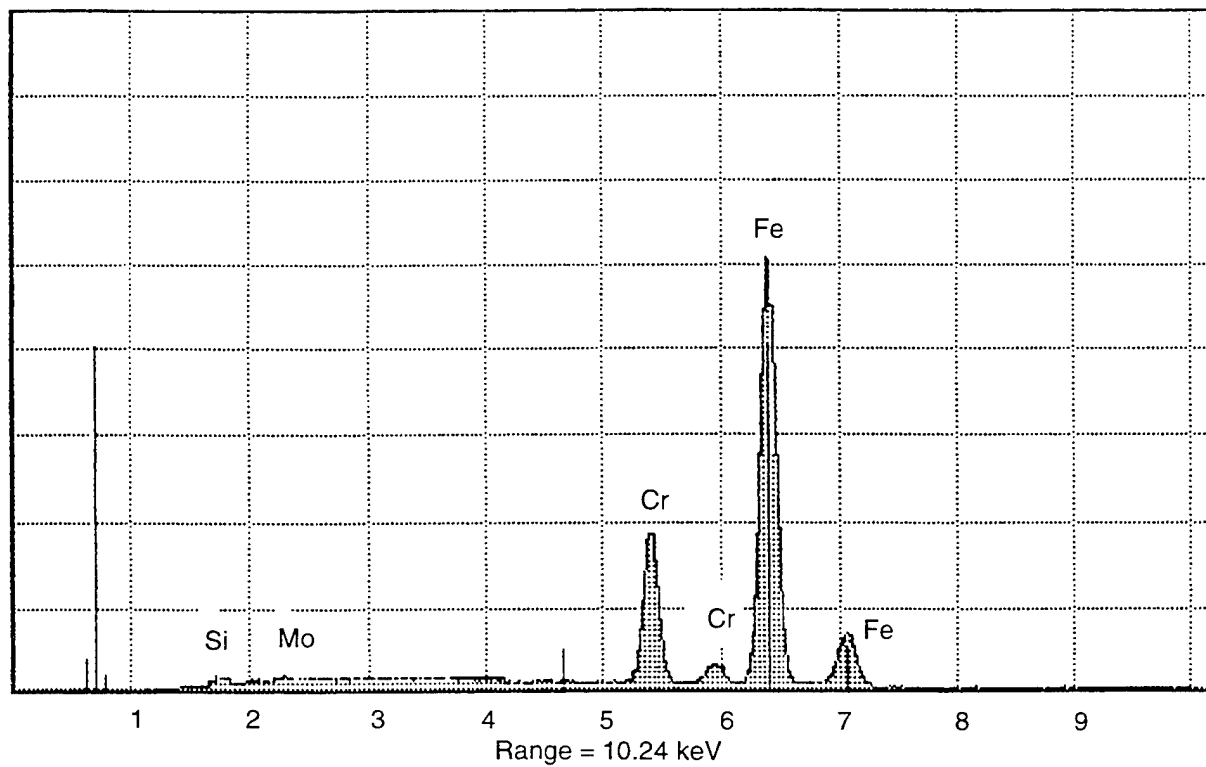
Figure 24. SEM EDS of Cronidur 30 Inner Race

Microstructure analyses of radial cut sections of the bearing races compared the microstructures of Cronidur 30 and Pyrowear 675. The Cronidur 30 microstructure consisted of very fine-grain martensite and was void of eutectic carbides. Fine nitrides are visible in the microstructure at 500× in Figure 23. The electron-dispersive spectra (EDS) are illustrated in Figure 24.

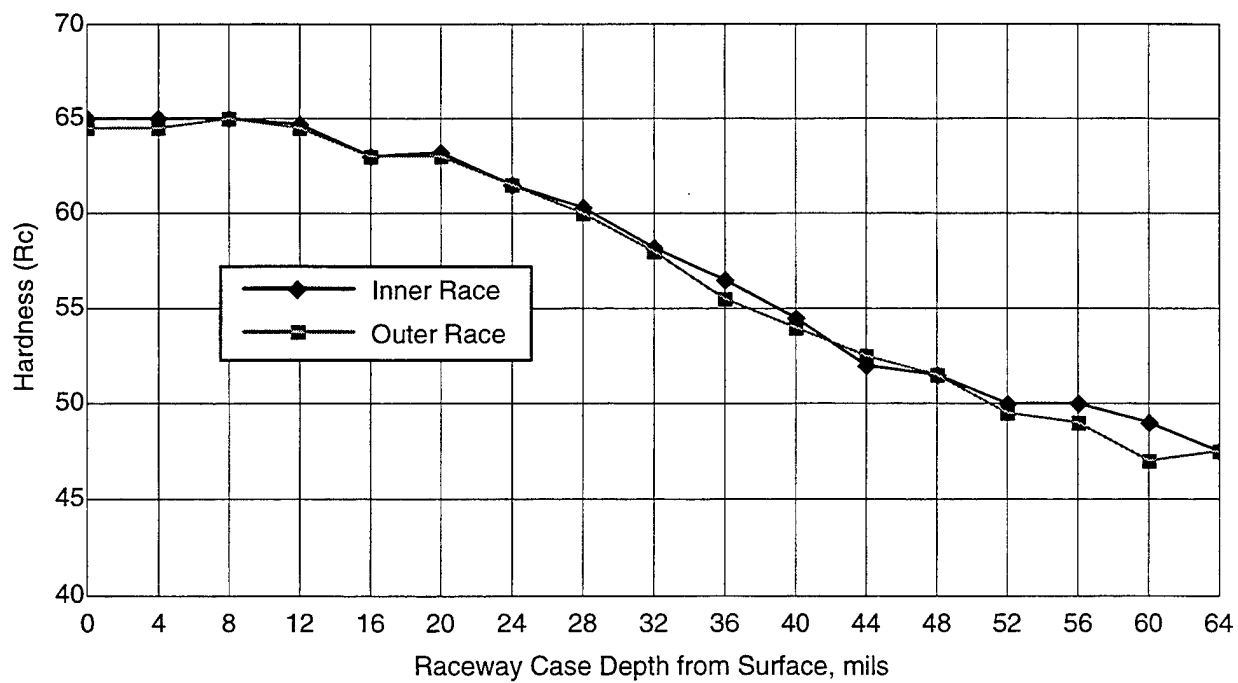
Figure 30. Microhardness Case Depth Profiles of Outer and Inner Races Following Pyrowear 675 Contamination-Endurance Test
