AFRL-PR-WP-TR-1998-2110

**THIN DENSE CHROME BEARING
INSERTION PROGRAM
Pyrowear 675 and Cronidur Wear Testing**

**GE Aircraft Engines
Advanced Engineering Programs Department
One Neumann Way
Cincinnati, Ohio 45215-6301**

OCTOBER 1998

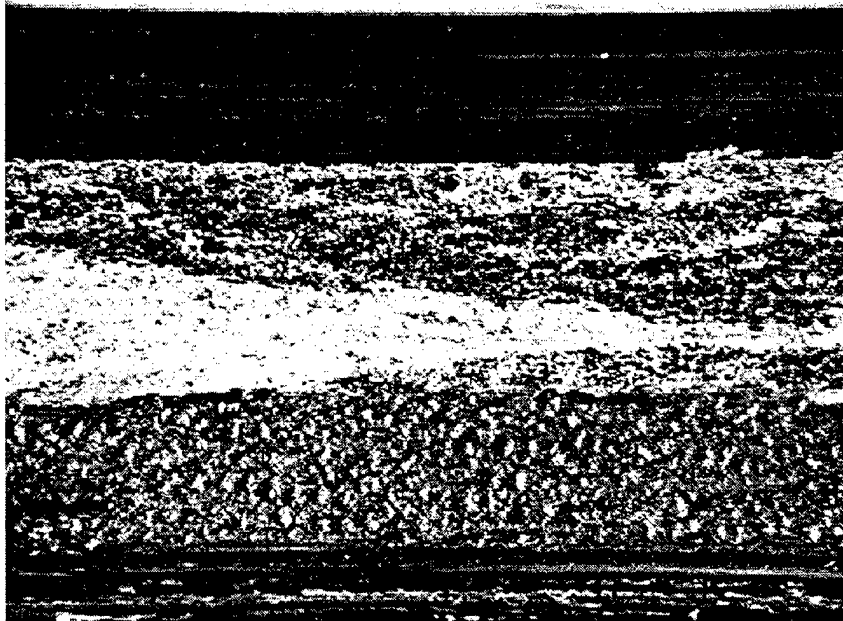
Figure 35. Cage Outer Diameter from Pyrowear 675 "Hybrid" Bearing Contamination-Endurance Test (12.5X)

Pyrowear 675 and mechanically alloyed particles rich in chromium and vanadium (Figures 35 through 39).

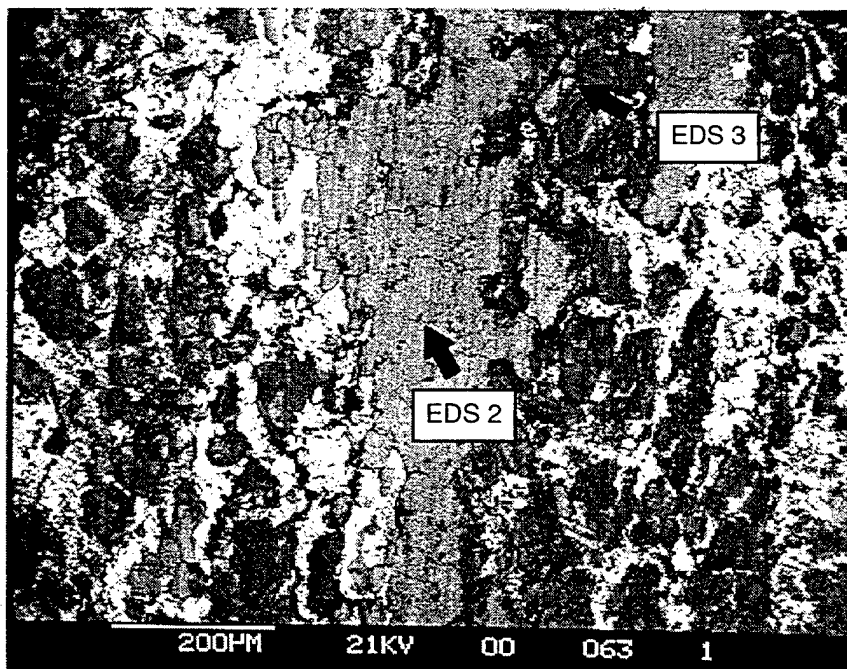
Figure 36. SEM Photograph of Bearing Cage Outer Diameter (110X)
Arrows indicate areas of EDS analysis.

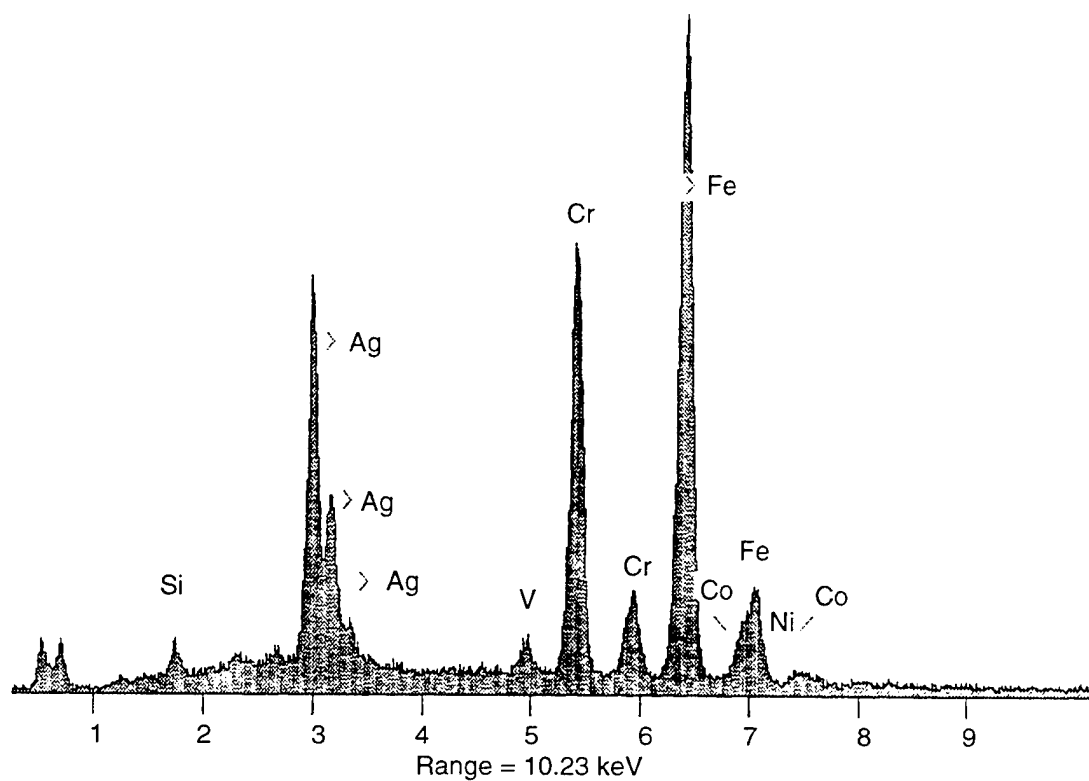
Figure 37. EDS Signature of Frame Analysis of Fig. 36

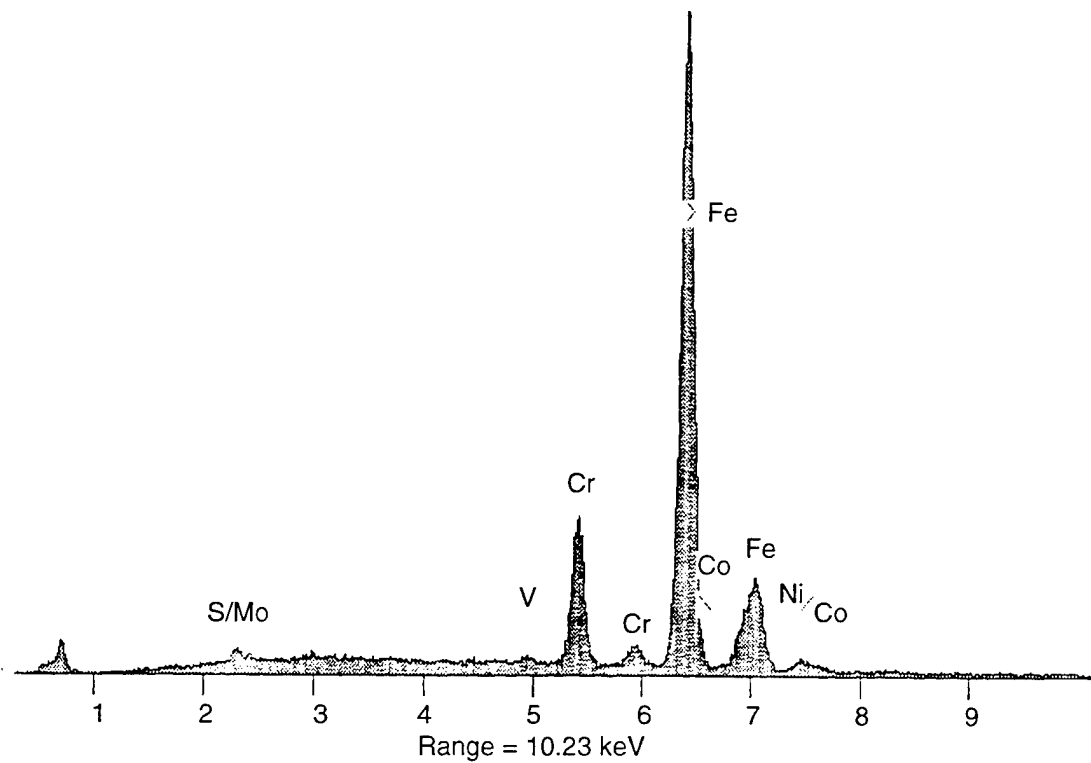
Figure 38. EDS 2 (Fig. 36) Signature Indicating Pyrowear 675 Wear Particles

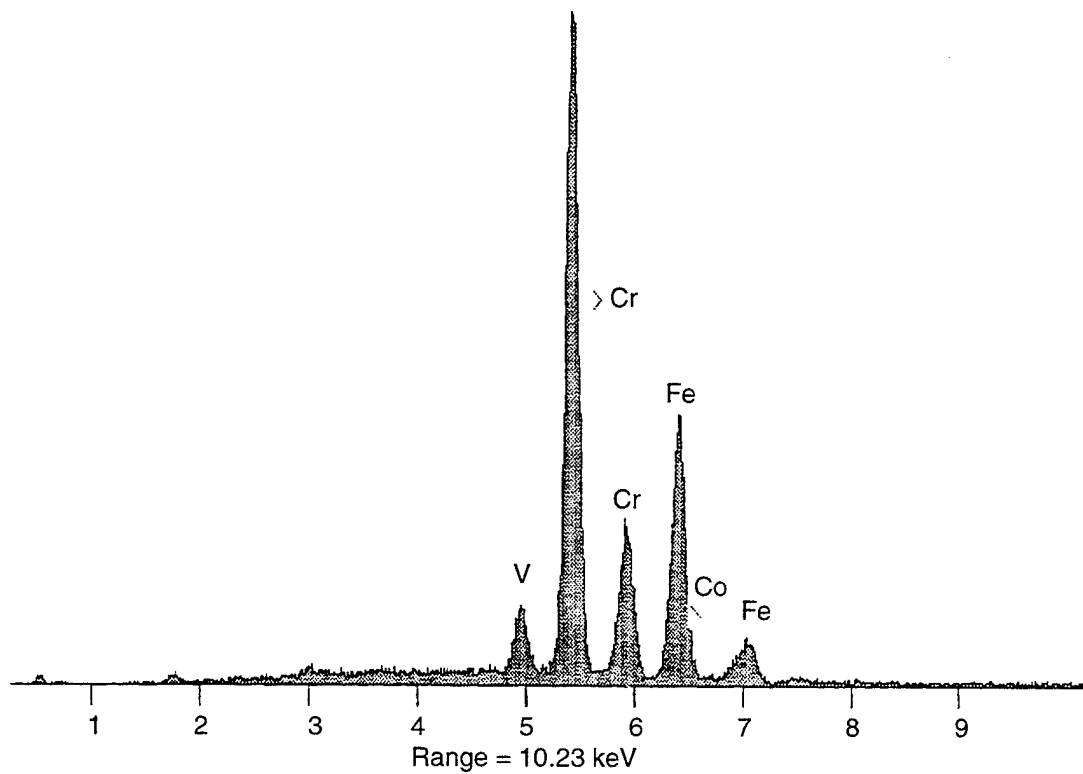
Figure 39. EDS 3 (Fig. 36) Signature Indicating Elevated Chromium and Vanadium in the Wear Product with Reduced Iron Content

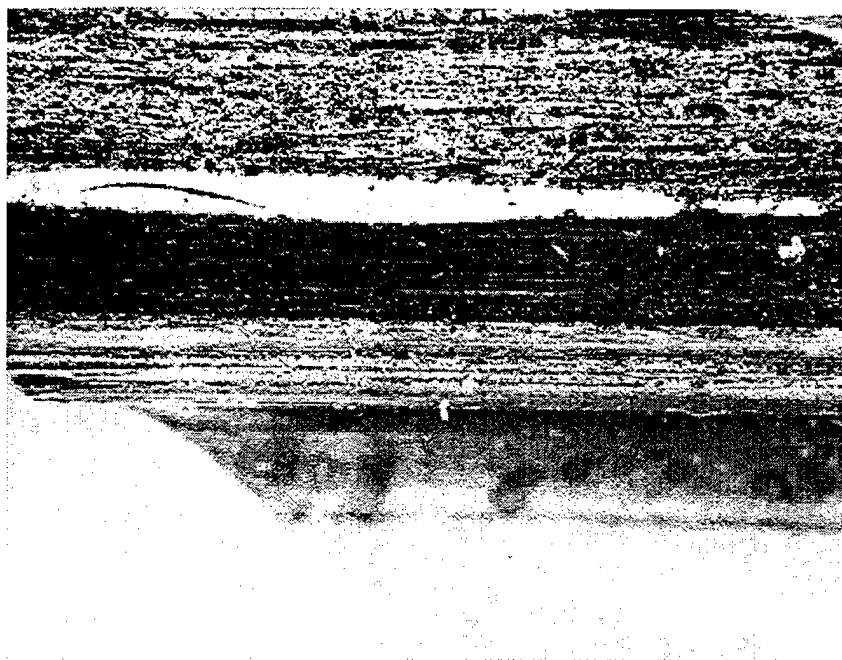
Figure 40. Cage Outer Diameter from Cronidur 30 "Purebred" Bearing Contamination-Endurance Test (12.5X)

SEM EDS analysis of the Cronidur 30 wear products embedded in the silver plating indicated wear particles of Cronidur 30 and mechanically alloyed particles, rich in chromium and silicon (Figures 40 through 44). These embedded wear products are very similar to those found in cages from shoulder-worn M50NiL bearings — from this same test and from field-service bearings. The M50NiL wear products are high in chromium, vanadium, and silicon (Figures 45 through 47).

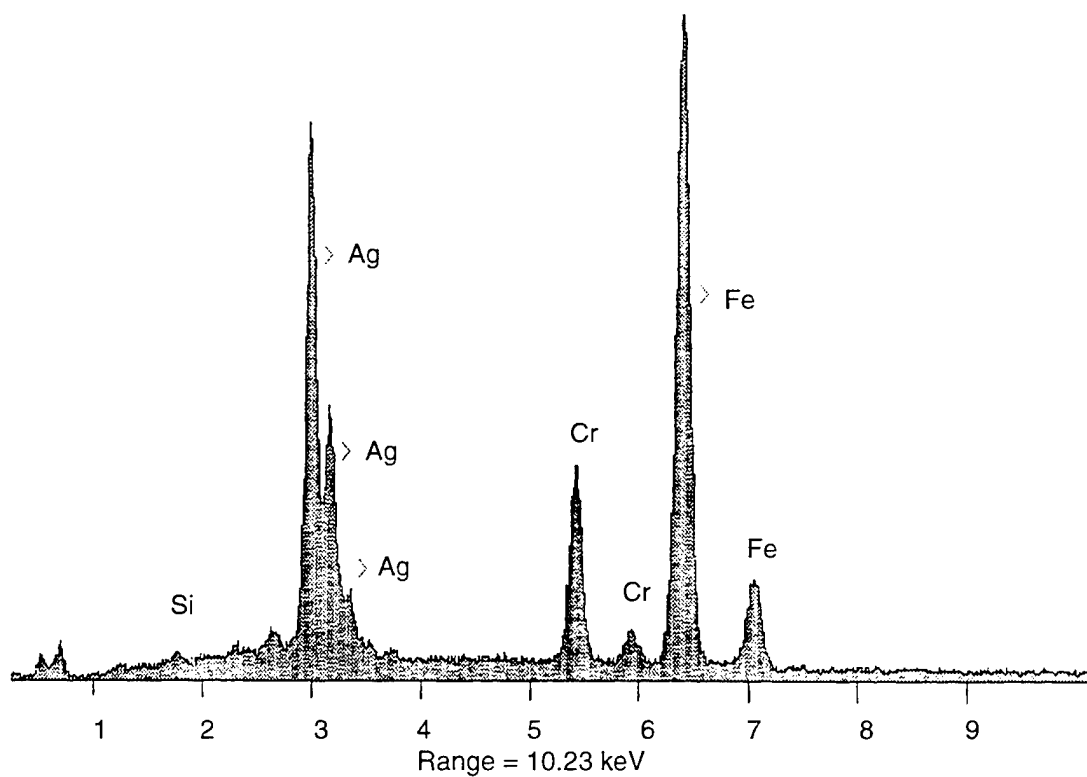
Figure 42. EDS Signature of Frame Analysis of Fig. 41

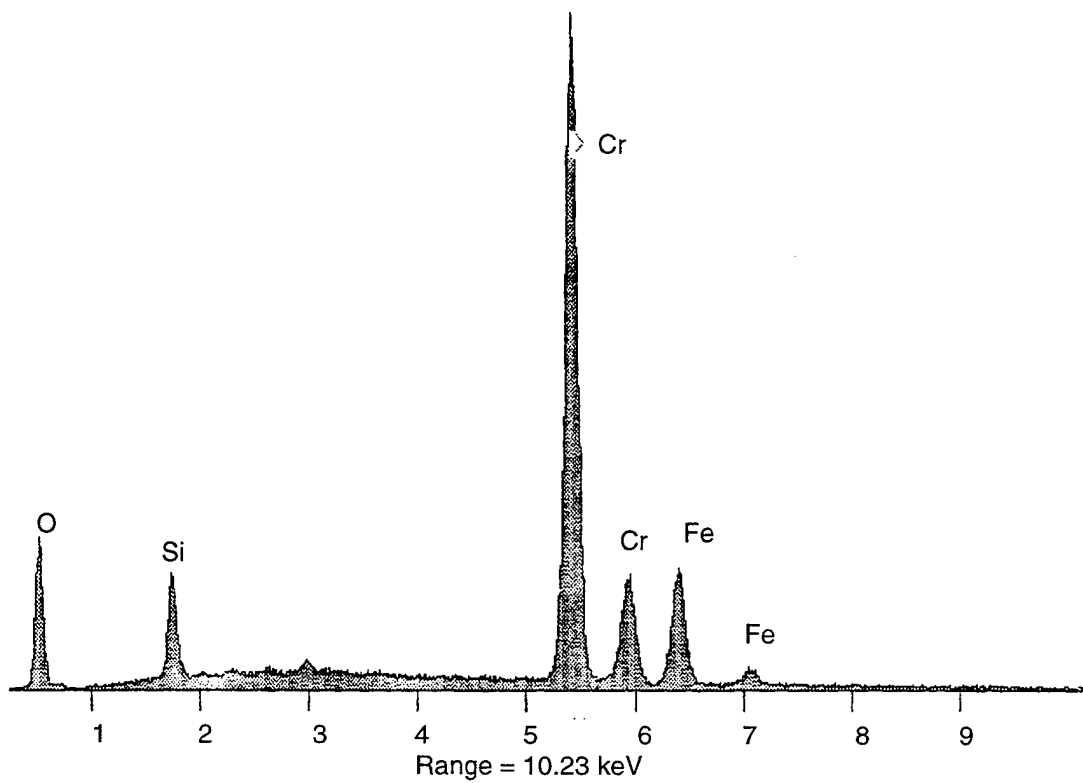
Figure 43. EDS 2 (Fig. 41) Signature Showing Elevated Chromium, Silicon, and Oxygen in the Wear Product

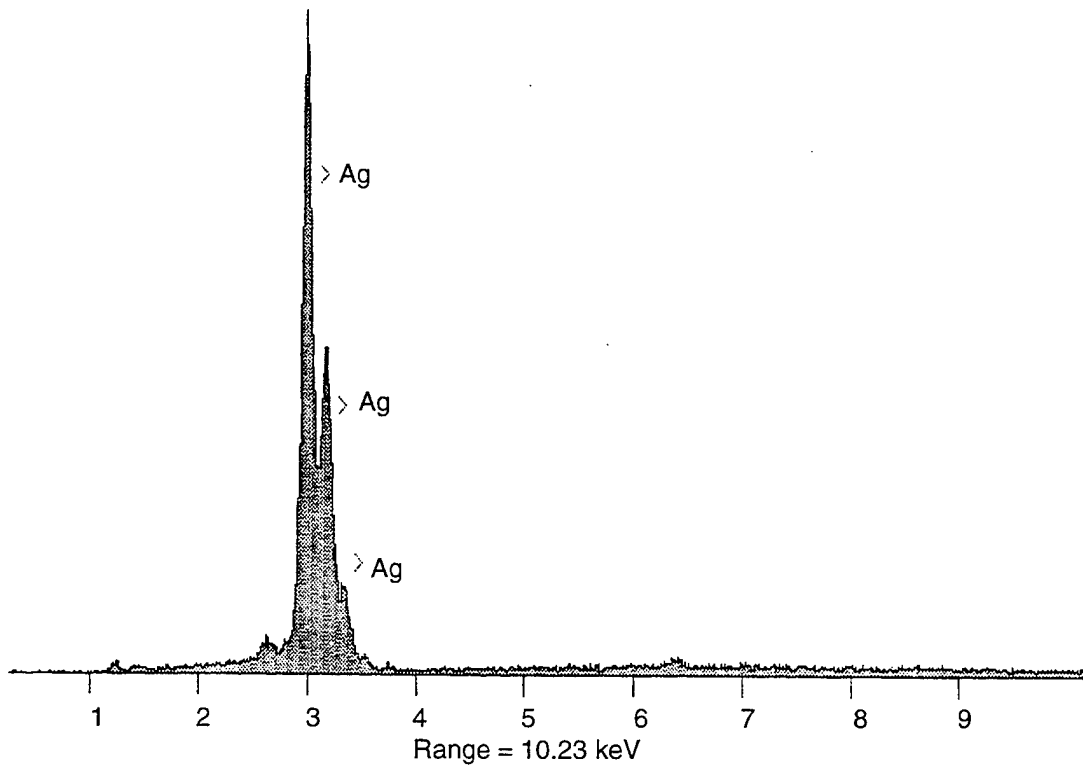
Figure 44. EDS 3 (Fig. 41) Signature Indicates Silver Plating

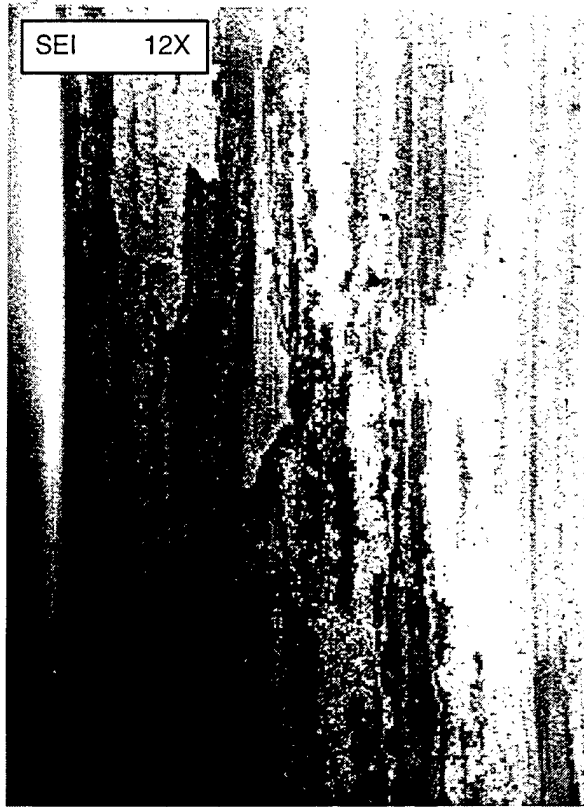
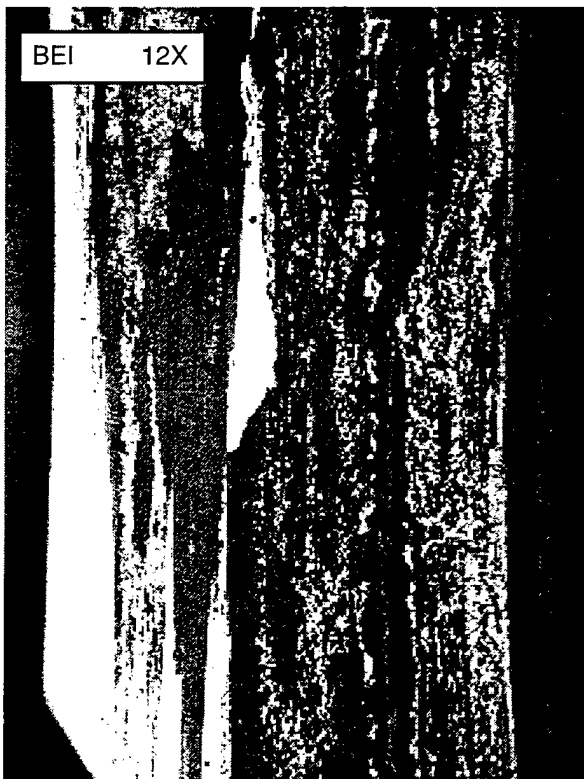
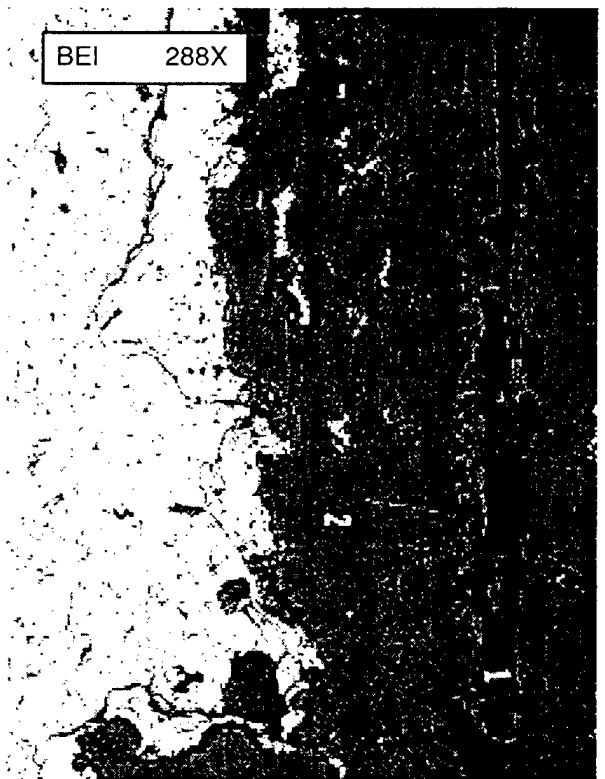
Figure 45. SEM Photographs of M50NiL Bearing Cage Outer Diameter

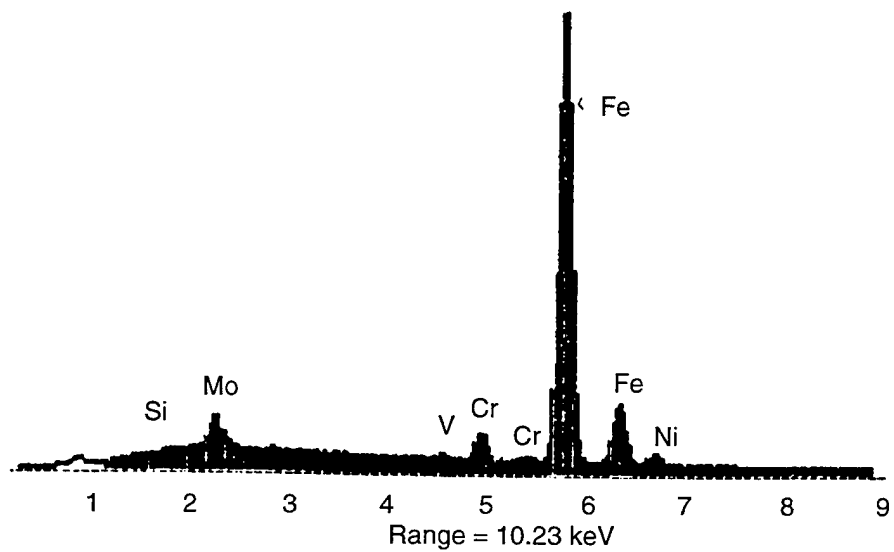
Figure 46. EDS Spectra for Cage Land Wear Products Typical of M50NiL

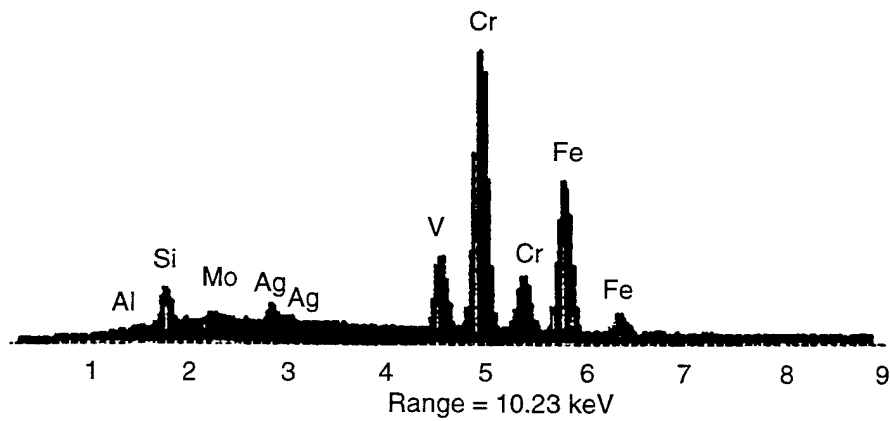
Figure 47. EDS Spectra Showing High Cr, Si, and V Wear Debris

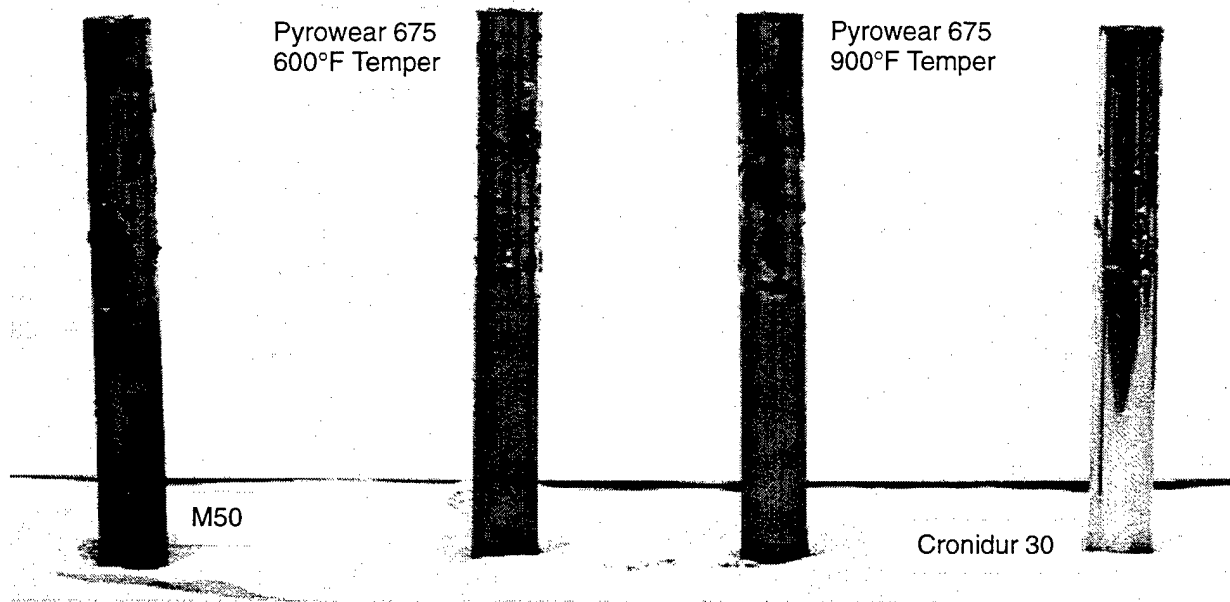
Figure 48. Corrosion Resistance Test: Tap Water

From this testing, it is apparent that, although the Pyrowear 675 material offers an improvement in corrosion resistance over M50, Cronidur 30 is superior in corrosion resistance.

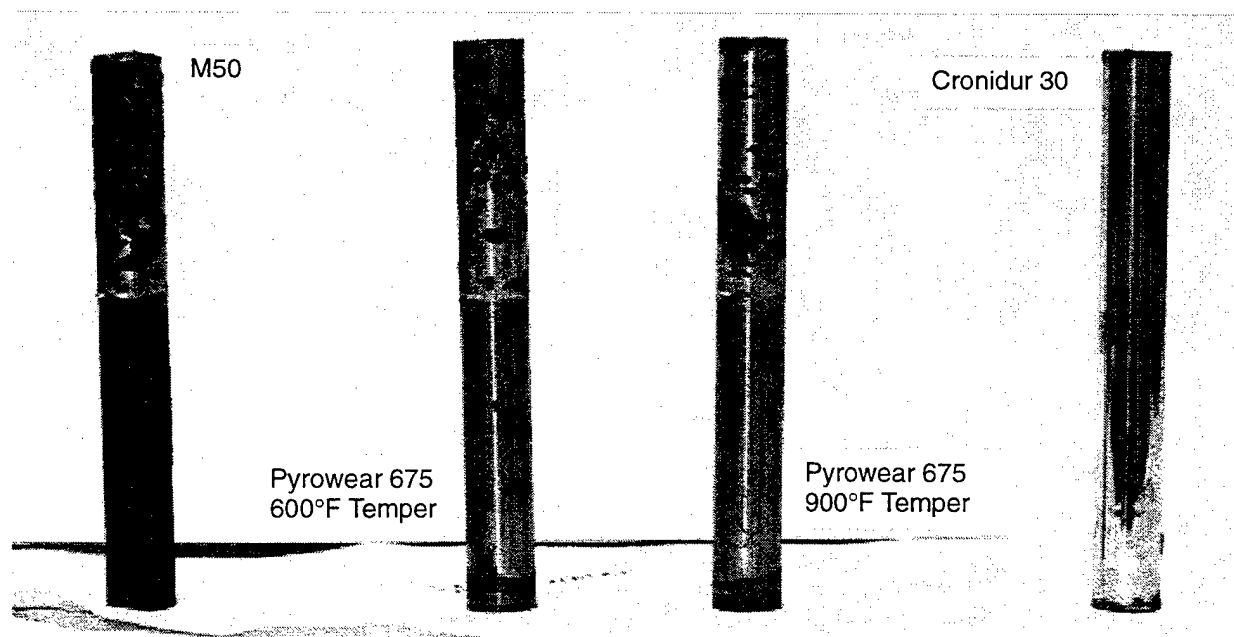
Figure 49. Corrosion Resistance Test: Synthetic Sea Water

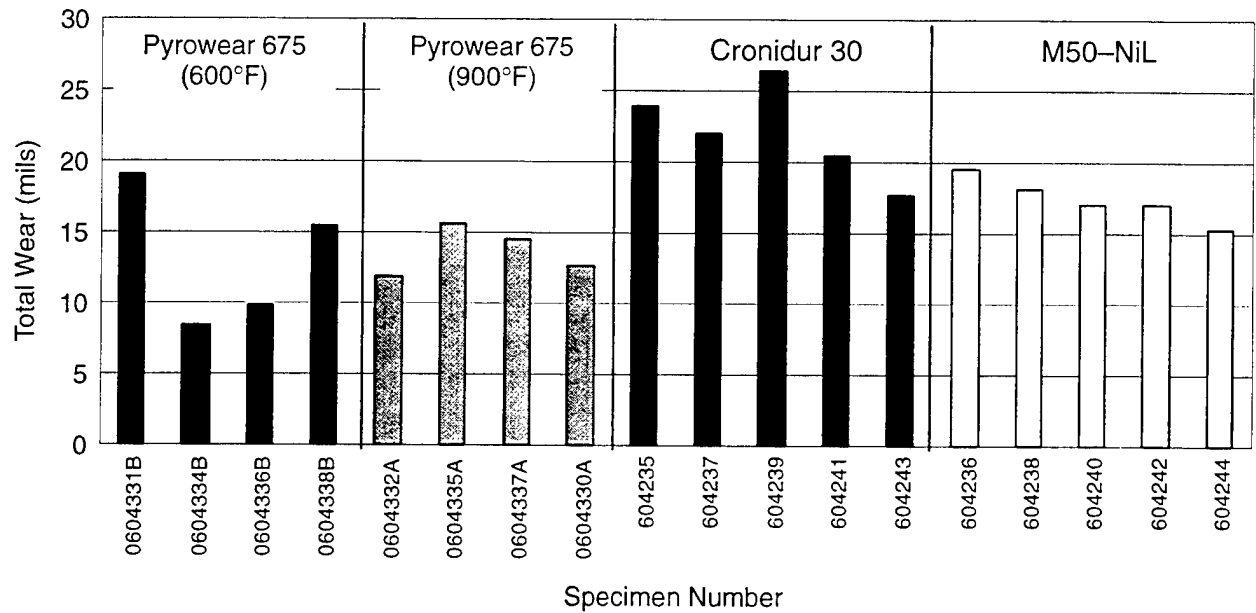
Figure 50. Total Wear from Specimens (Results Reported by Falex Corporation)

This subscale wear testing indicated that Cronidur 30 has wear properties similar if not a little inferior to those of M50NiL. Pyrowear 675 is somewhere between M50 and M50NiL, but it is not known if further work on developing a more wear-resistant case is warranted. Full-scale rig or engine tests with the developed wear-resistant case in the shoulders are needed to indicate how this material would perform in a full-scale contaminated environment.

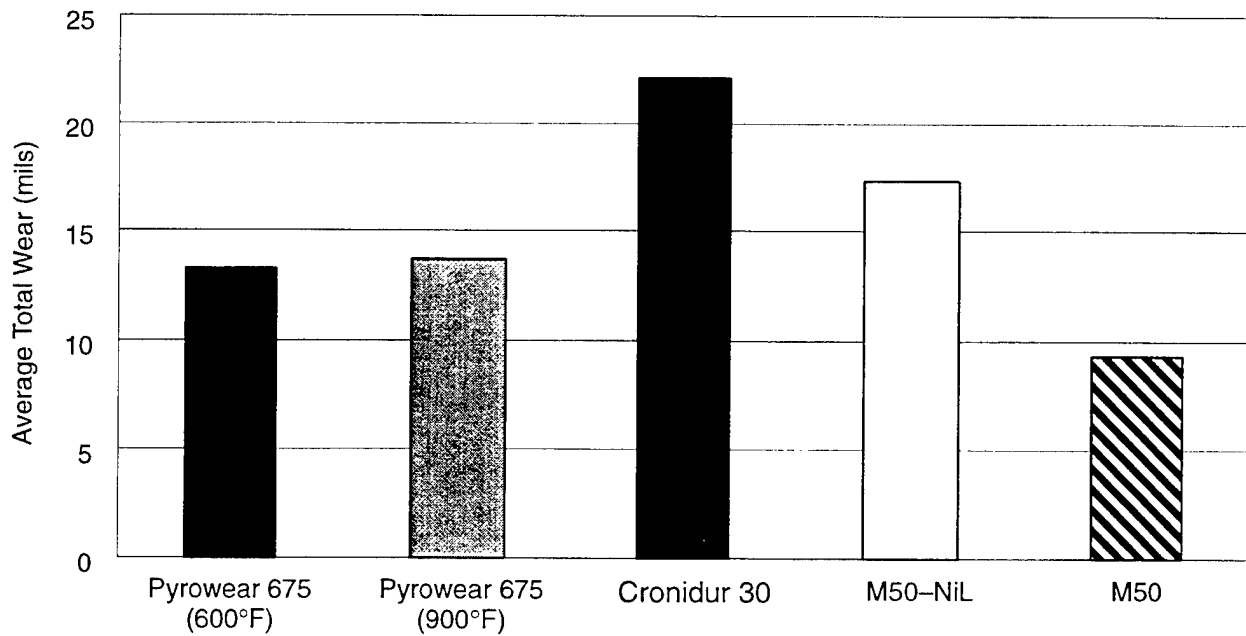
Figure 51. Average Total Wear from Specimens (Results Reported by Falex Corporation) Compared with Historical Results
