**DOT/FAA/AR-99/6**

# **Fiber-Reinforced Structures for Turbine Engine Rotor Fragment Containment**

September 1999

Final Report

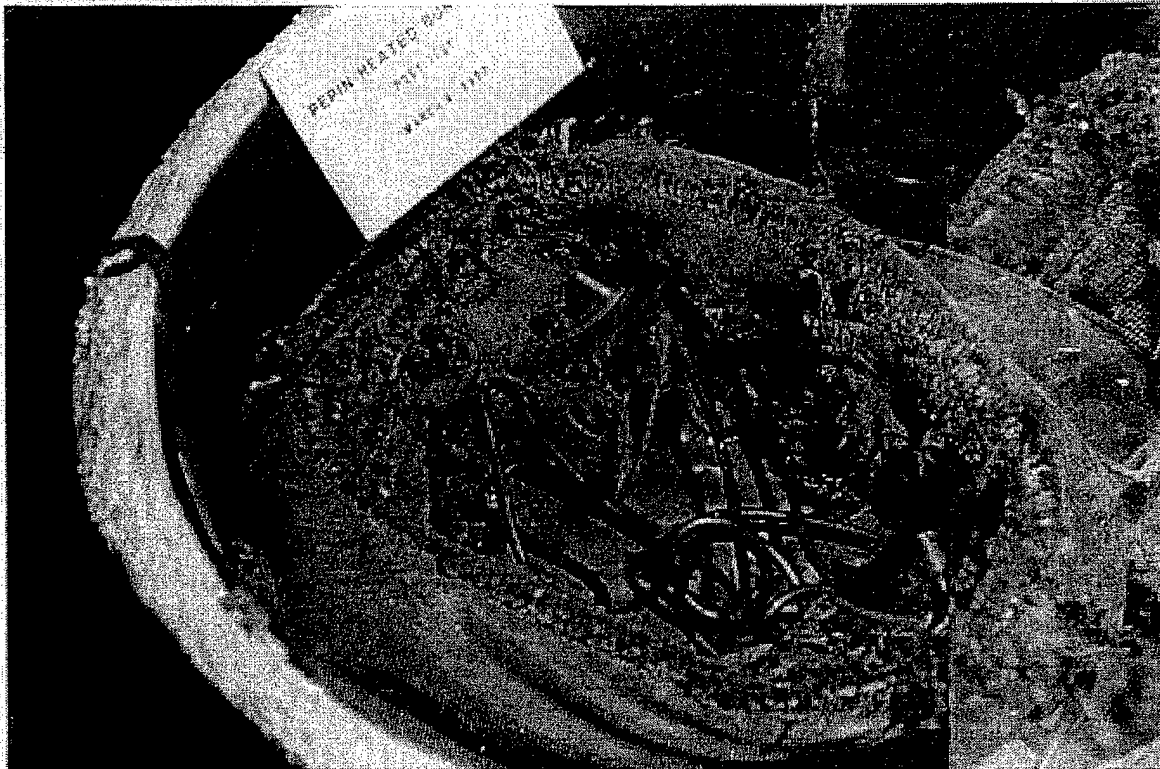
The rotor failed at 20,200 rpm and the ring contained all the fragments. The deepest penetration by one of the disk segments was 41 plies leaving only 2 plies undamaged. Thus, this design at the 200°C temperature was close to the threshold of containment. Figures 36 and 37 show the posttest condition of the PBO thermal test ring.

FIGURE 36. POSTTEST PHOTO SHOWING PBO RING, FRAGMENTS, AND HEATING ELEMENTS

FIGURE 37. CLOSE-UP OF PBO RING AFTER TESTING
