**Cold Regions Research
and Engineering Laboratory**

ERDC/CRREL TR-00-4

Evaluation of Photovoltaic Panels at the South Pole Station

Christopher R. Williams and John Rand

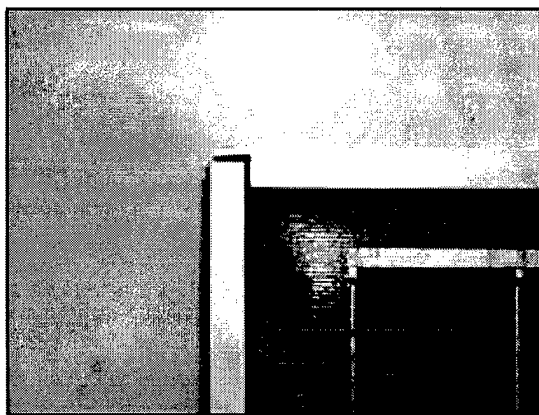
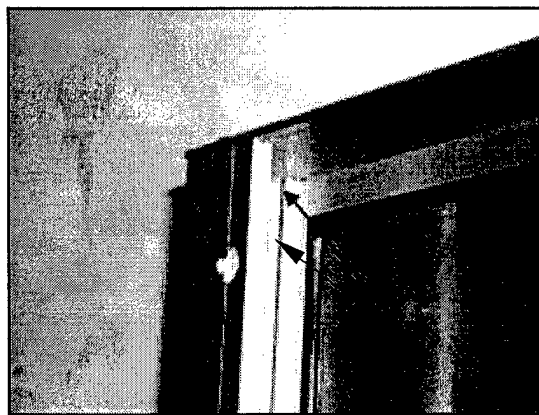
Figure 4. Details of PhotoComm, Inc., panel.

a. Top view of corner connections (pan head sheet metal screws).

b. Front view of corner connections.

c. Back view of corner connections (arrow points to sheet metal screw in open extruded channel).

On all four of the PhotoComm, Inc., panels that we inspected, the gasketed seal between the glazing and aluminum frame showed signs of failure. The gasketed seal was pulling out of the corners between the glazing surface and aluminum frame. Each panel showed some signs of aluminum frame weakness. The corner connections of the frame were loose and allowed considerable movement when a twisting motion was applied. Three of the frames showed signs of abuse; they had dents and or were bent. The glazing, panel back, and junction box were all free of defects.

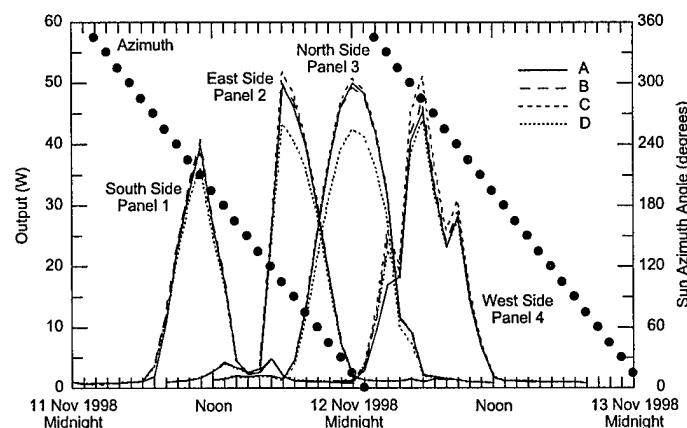
A 24-hour period on a high-visibility day (11–12 January 1998) was selected to compare the PV panels' performance (Table 4). Figure 11 begins with the south side of ARO receiving the unobstructed sunlight. As the 24-hour period progressed, peak PV panel performance changed as each side of ARO received direct sunlight (Table 5). The available PV power output levels listed in Table 4 were chosen when the sun azimuth angle was approximately perpendicular to the sides of ARO. For three out of the four peak periods, PV panel C produced the highest available output power. PV panel D consistently produced the lowest available PV output power, while panels A and B flip-flopped between second and third, with the exception of the south side of ARO, when PV panel B was first and A was second.

Figure 11. PV panel performance on the high-visibility day (11 to 12 January 1998) over 24 hours.
