**Navy Phase I SBIR Report: Topic Number N00-002**

**Phase I  
FINAL REPORT**

**Compressor Impeller Erosion Resistant Surface Treatment**

**Contract No.: N68335-00-C-0336  
Start Date: 3 April 2000**

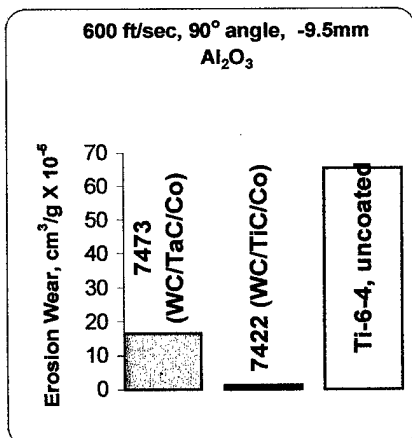
Wear test comparative data

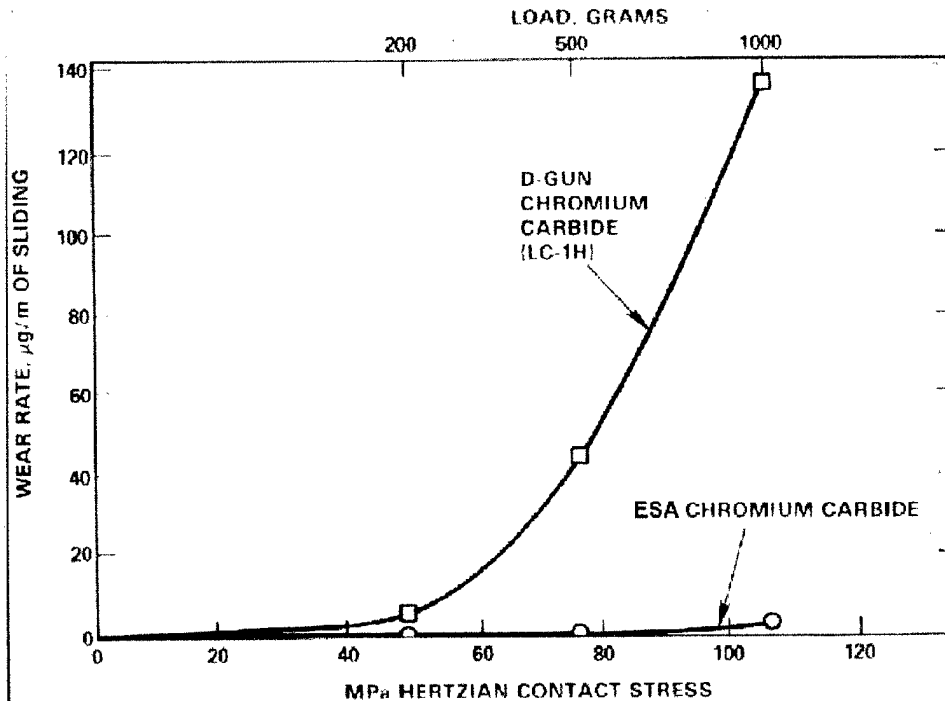
**Figure 6.** Wear data comparing chromium carbide (on stainless steel) coatings produced by ESA vs. detonation gun.

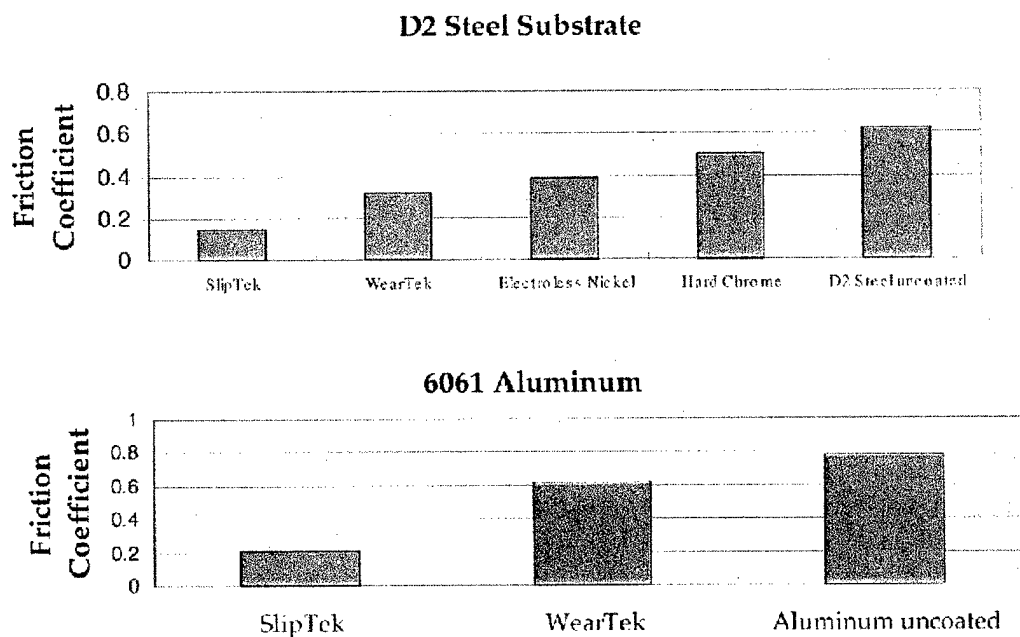
**Figure 8.** Coefficient of friction of ESA coatings "Wear-tech" and "Slip-tech".

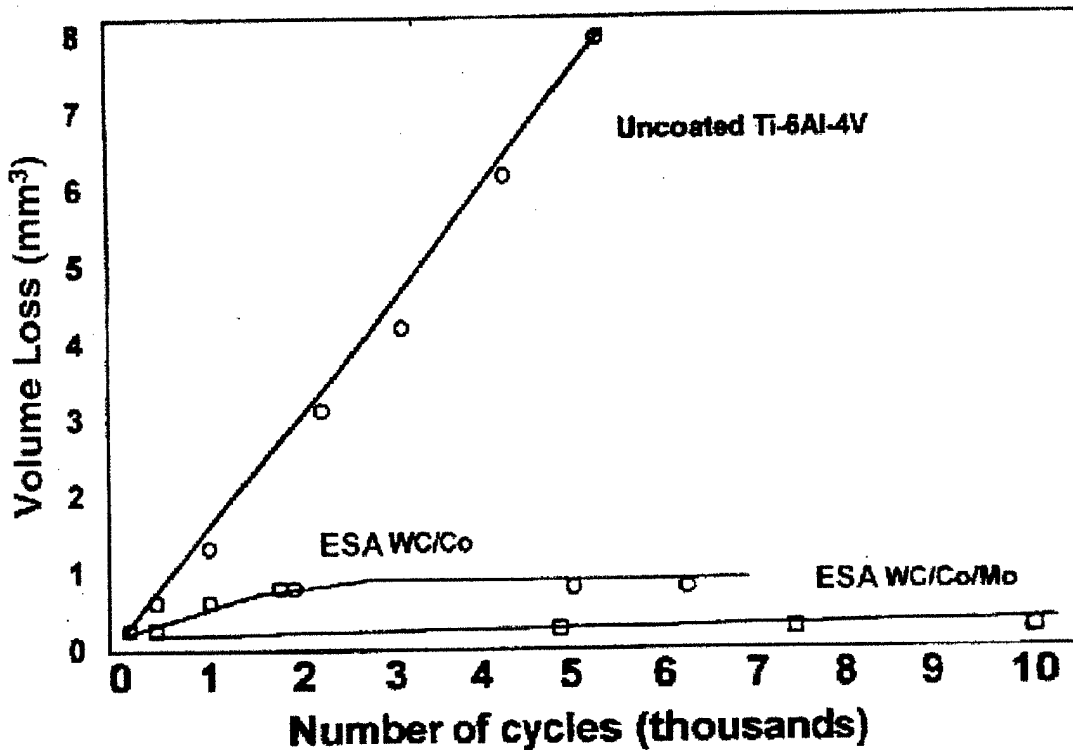
**Figure 9.** Sliding friction wear comparison of base Ti-6-4, and ESA tungsten carbide/cobalt and carbide/cobalt/molybdenum coated Ti-6-4. Note that the wear essentially becomes a flat-line out to ten thousand cycles.

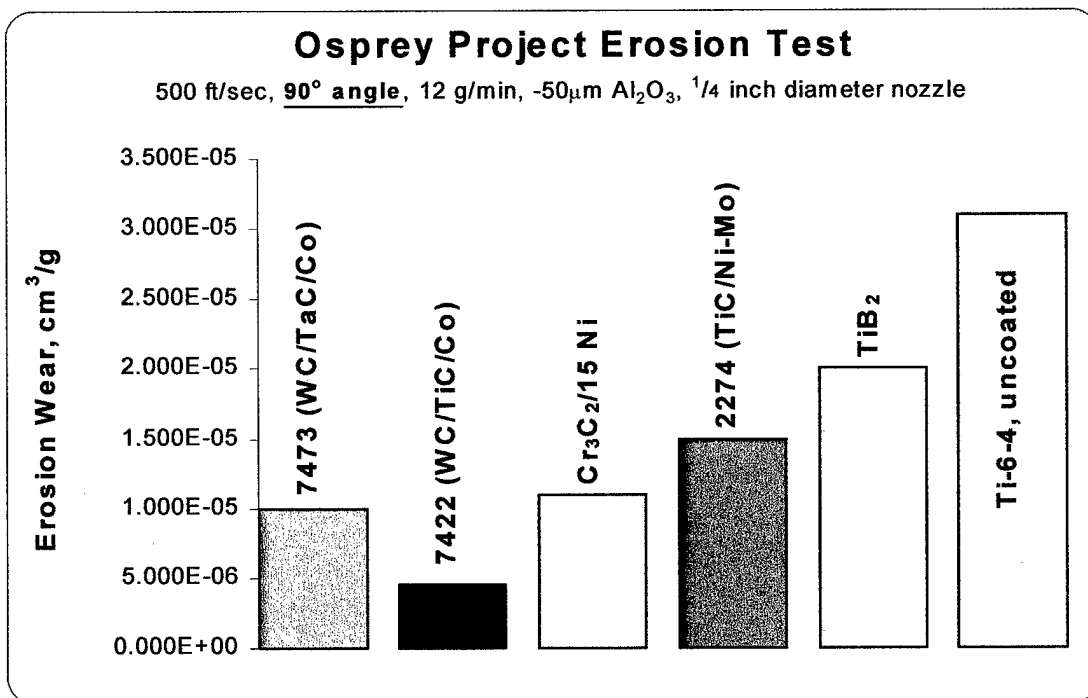
Figure 11. Results of the 1-minute erosion test at 90 degrees impact angle.

As supplied, the raw data from the University of Cincinnati wind tunnel tests was subject to wide ranging interpretation. The ST2 team converted this data from weight loss into volumetric loss, since the density of the ST2 applied coatings were much higher than the density of the Titanium alloy. Using this approach, the wind tunnel Series 1 data is shown in Table 2 as provided by the University of Cincinnati. Then in Figures 15 and 16, the same data is presented in volumetric form. The numbers provided here correlate nicely to the volumetric wear data generated using our own in-house alumina grit-blast tests also conducted at 90 degrees (Figure 11). Although the impact particle loading is low

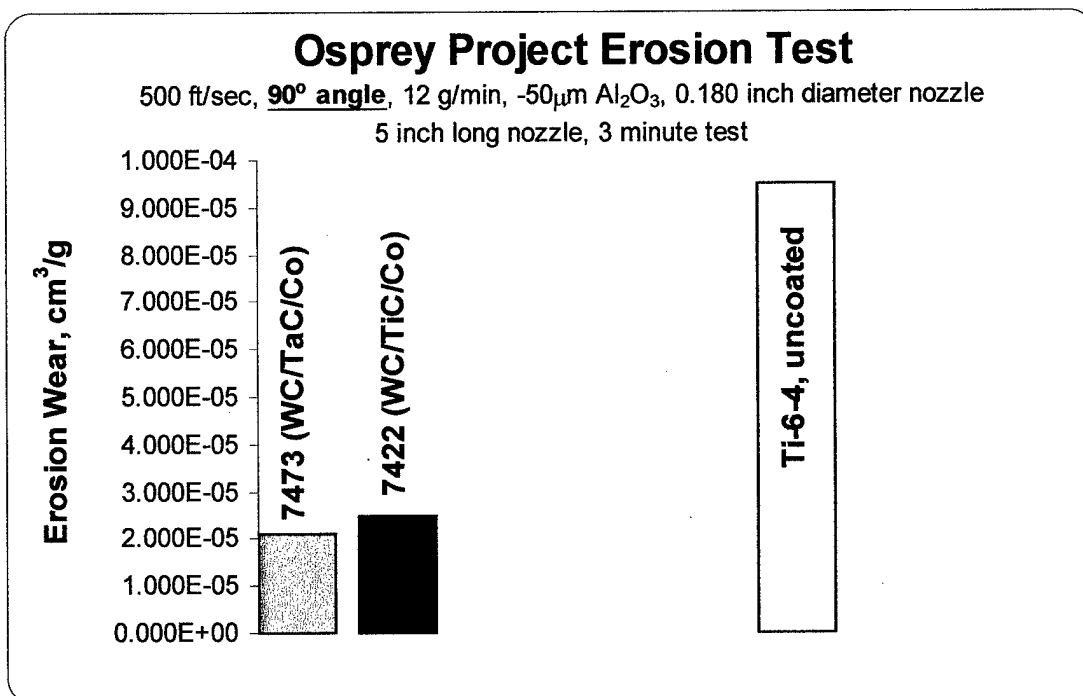
**Figure 14.** Three-minute erosion data, 90 degree angle, for base Ti-6-4, 7422, and 7473 electrode materials.

In the second test series, the two best performers were evaluated under the same test conditions, but for a three-minute exposure. The results are presented in Figure 14. Based upon these results, the two best candidates: tungsten carbide/tantalum carbide/cobalt, and tungsten carbide/titanium carbide/tantalum carbide/cobalt were processed and provided to the University of Cincinnati for independent erosion testing.

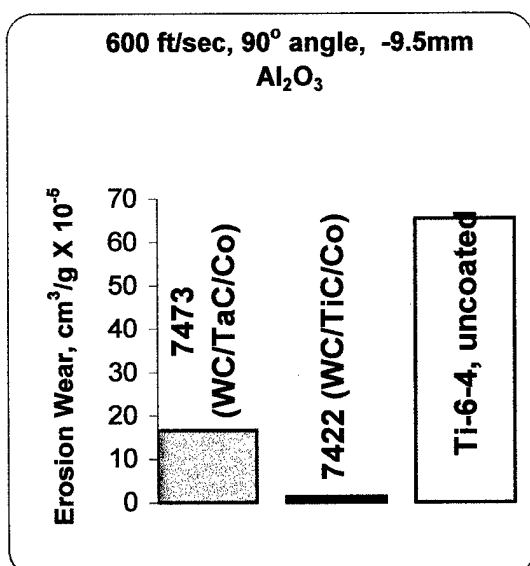
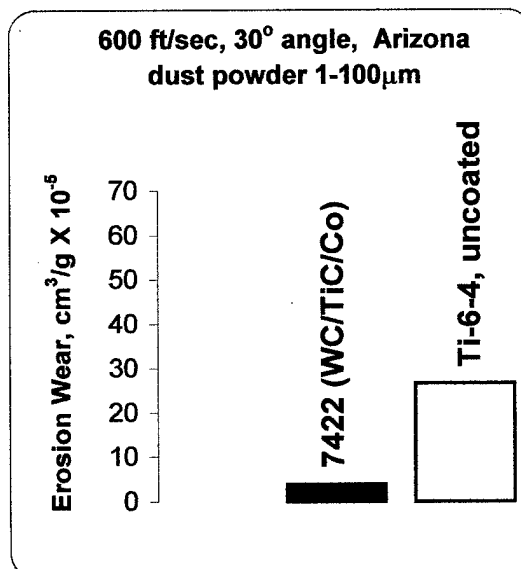
**Figure 15.** Volume-specific analysis of wear data from Round-1 of wind tunnel testing at the University of Cincinnati Wind Tunnel test facility.

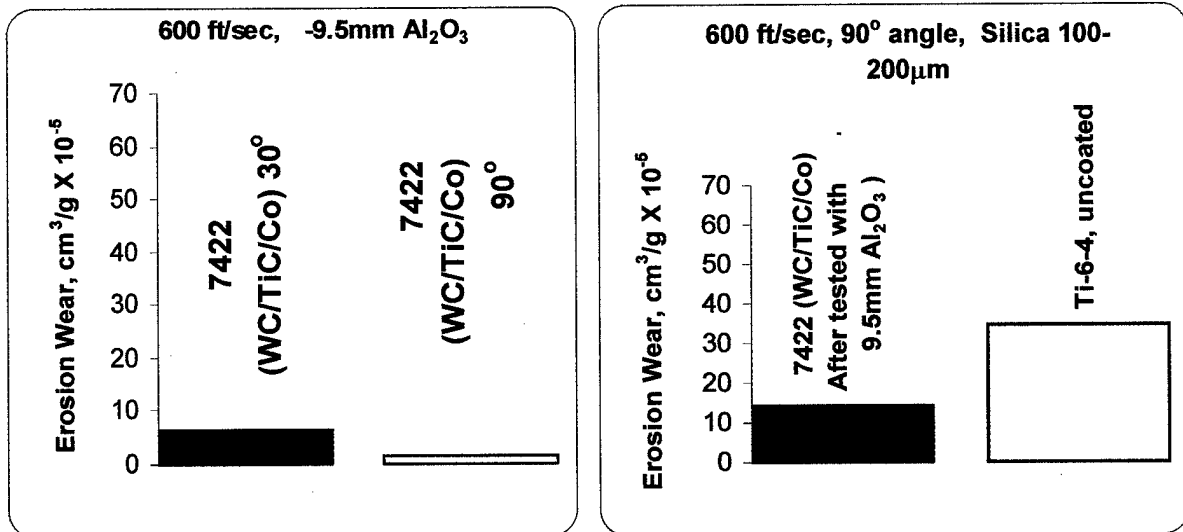
**Figure 16.** Volume-specific analysis of wear data from Round-2 of wind tunnel testing at the University of Cincinnati Wind Tunnel test facility.

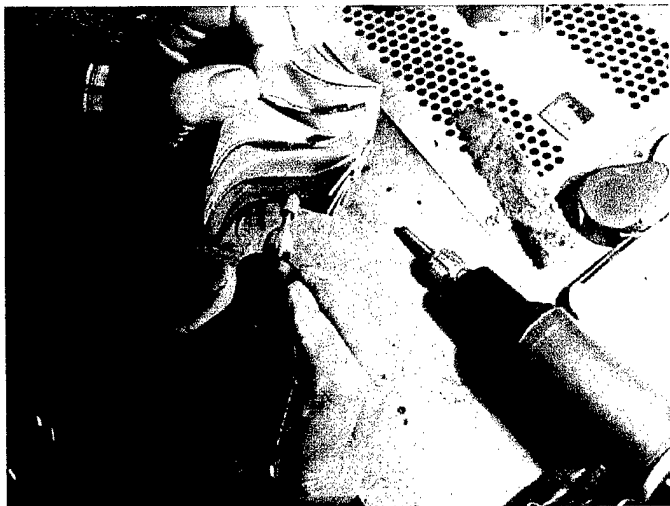
Grinding the "contaminated" surface
