**INSIDE A SOVIET ICBM SILO COMPLEX: THE SS-18
SILO DISMANTLEMENT PROGRAM AT DERZHAVINSK,
KAZAKHSTAN**

John R. Matzko

Technical Report

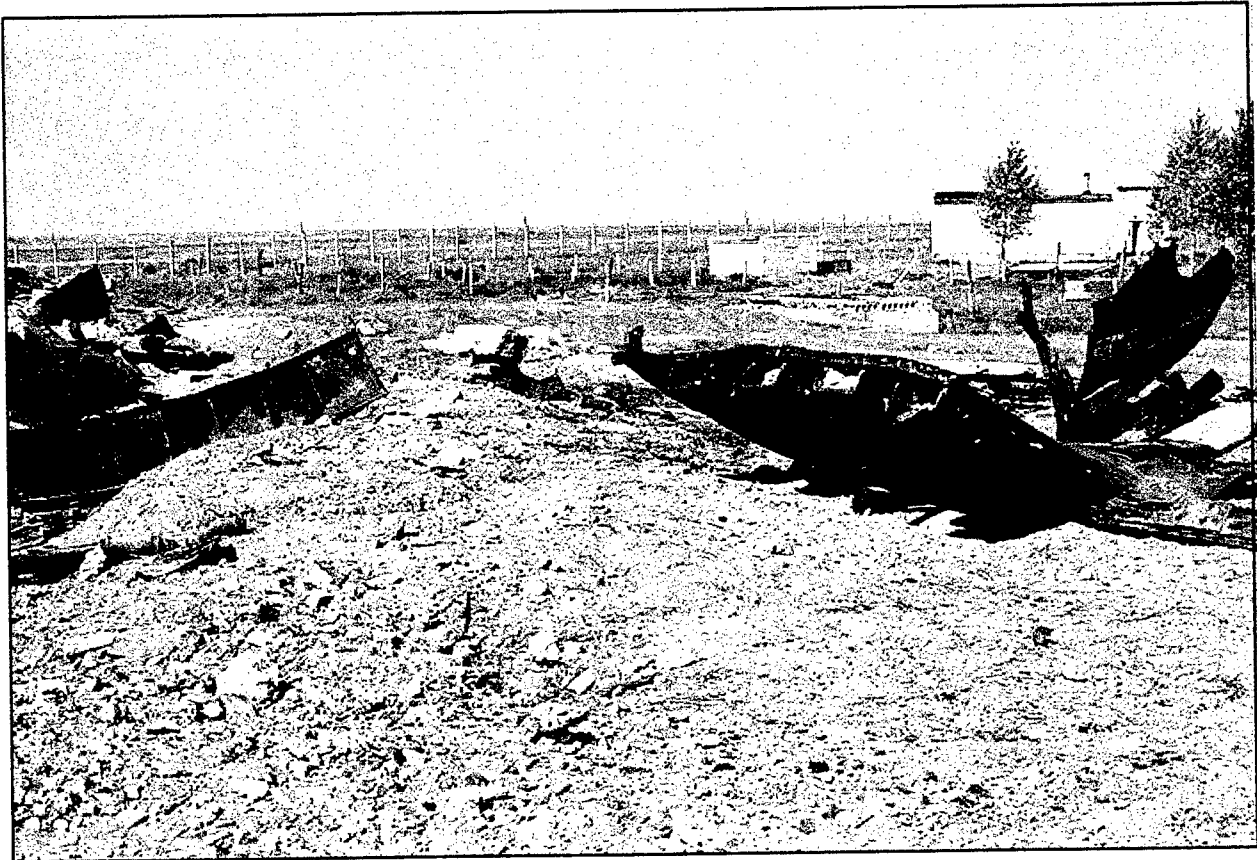
Figure 8. Metal and concrete debris on the crater rim. The ribbed metal plate on the right may be part of the headworks wall. The transformer substation is in the right background. Derzhavinsk, Regiment 2, Silos 5/7.

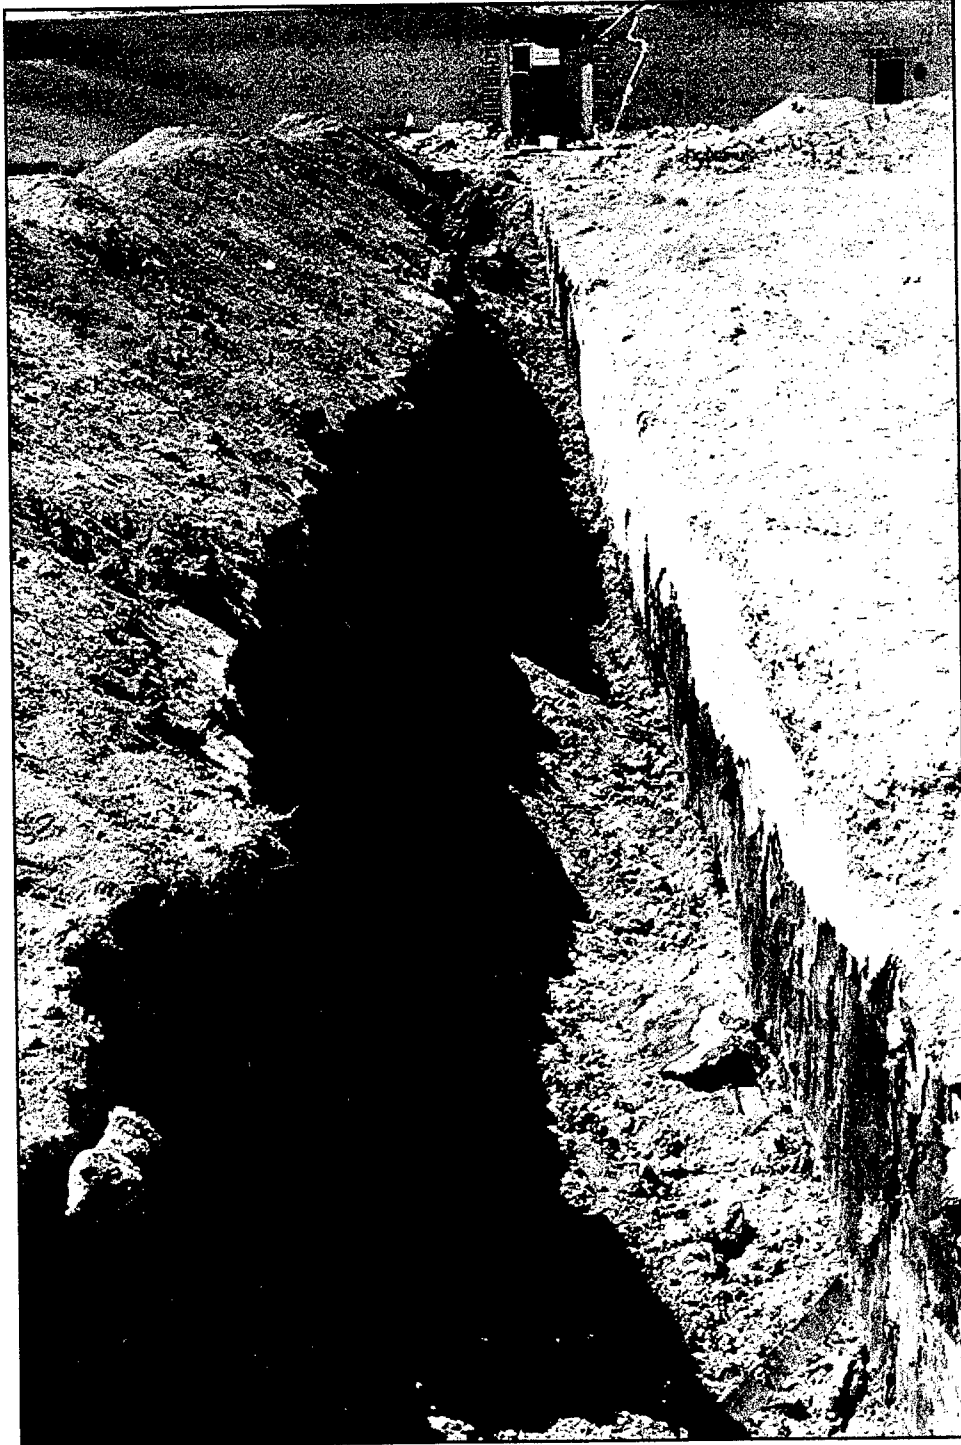
Figure 15. Partially excavated shallow buried tunnel between the cooling system building (in background) and the Launch Control Center (LCC) silo. Derzhavinsk, Regiment 3, Silo 7.

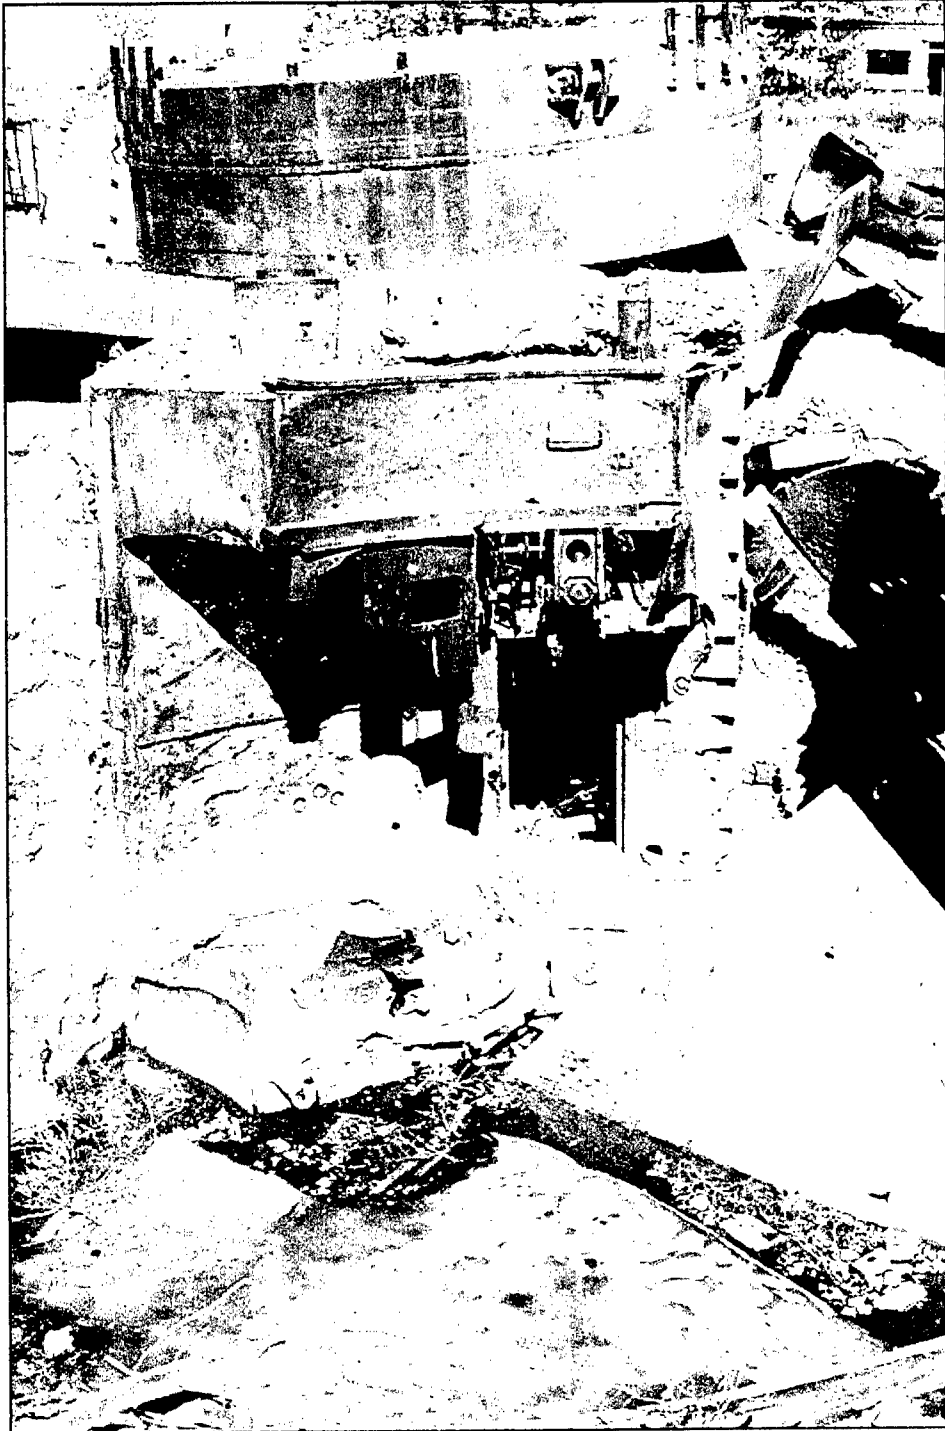
Figure 16. Underground tunnel entrance into the LCC silo headworks revealed in the crater. The round silo door rests on the crater rim. Derzhavinsk, Regiment 2, Silo 7.

Generally, the initial blasting by the Russians to destroy the silo left the silo door, silo door pocket, and headworks wall in large pieces. The heavy silo doors were only rarely broken up by the blasts (see Figures 13, 14, 16, 32, and the relatively intact door pocket/headworks wall in Figure 37). Because these pieces were commonly too large and heavy to handle with the available equipment, they were blasted again into smaller pieces by *Almatypromstroy*, a subcontractor to Brown & Root/ABB SUSA, using anti-tank mines. Some larger pieces were also cut up into fragments of about 1.5 x 2 meters (about 25 tons). The metal debris from the blasted headworks, antenna structures, and other metal from the site, was collected at a rail spur and shipped to a foundry for recycling.

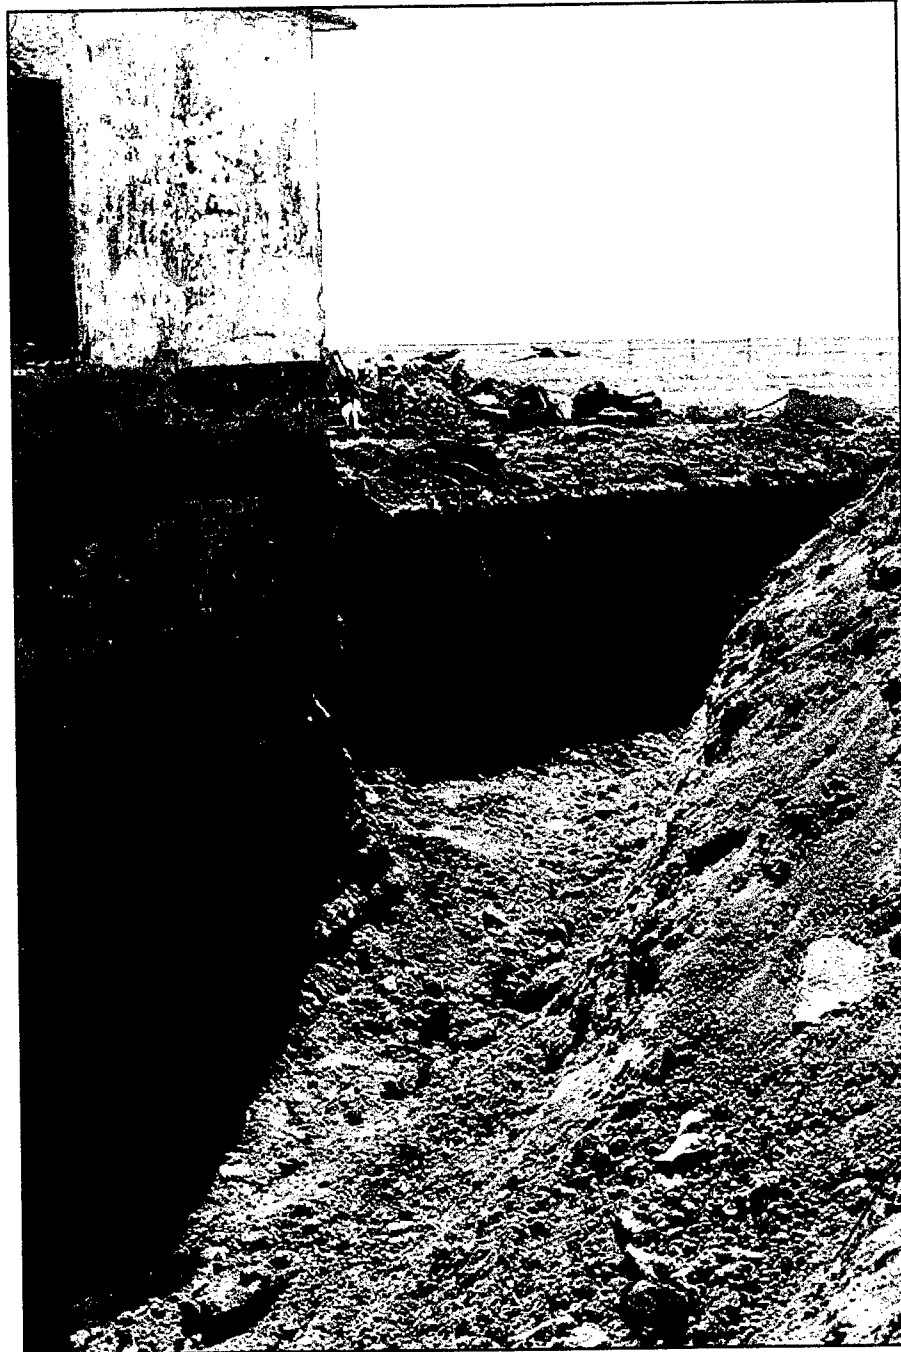
Figure 21. Trenching along side the "Force Protection" security building has exposed the subterranean level of the building and the associated shallow buried tunnel. The buried structures are lined with red clay brick. The excavation is about three meters deep in dry fine-grained silt and clay. Derzhavinsk, Regiment 2, Silo 2.

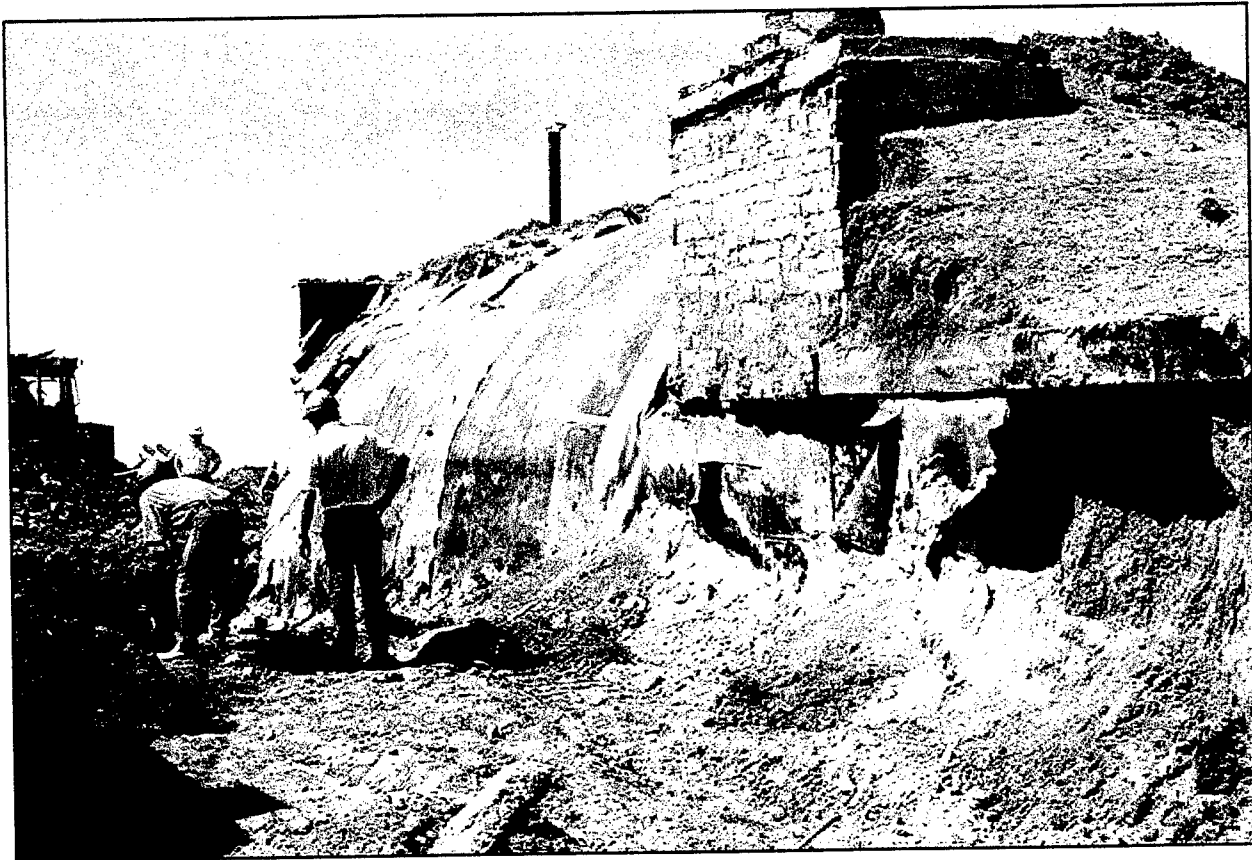
Figure 33. Bermed storage facility being exhumed for destruction and disposal. A black tar paper-like material covers the reinforced concrete. Derzhavinsk, Regiment 2, Silo 3.

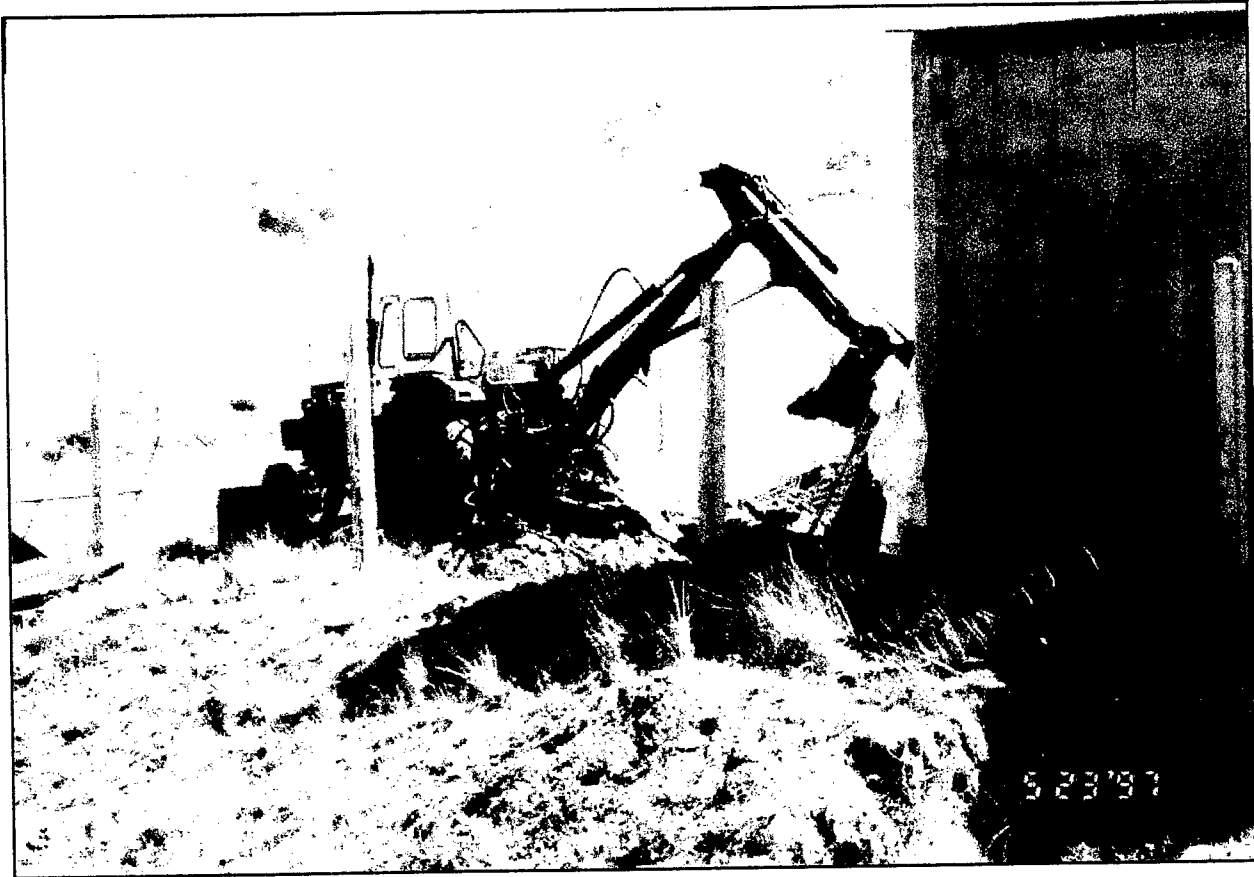
Figure 35. Abatement contractor crew removing PCB contaminated soil near a transformer building. Zhangiz Tobe. Photo courtesy of Brown & Root/ABB SUSA.

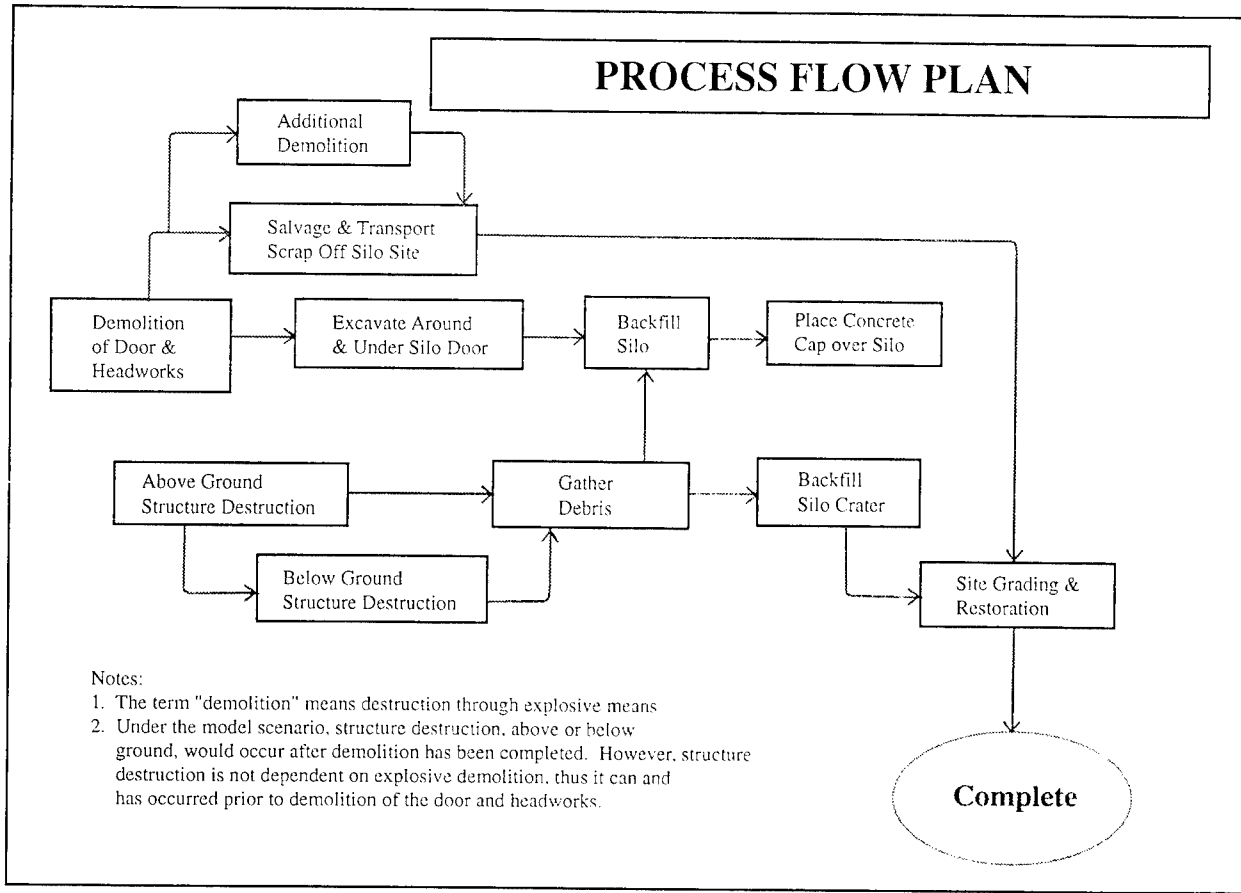
Figure 36. Process flow chart for site dismantlement. Courtesy of Brown & Root/ABB SUSA.

The dismantlement process was tailored to the conditions and requirements of the specific site. There was no regular order of progression in the dismantlement; above ground and below ground structure destruction could occur nearly simultaneously, or one after the other. Similarly, destruction of the structures could proceed before the demolition of the silo door and headworks, and simultaneously with metal salvaging and cable trenching (see the Process Flow Plan in Figure 36).

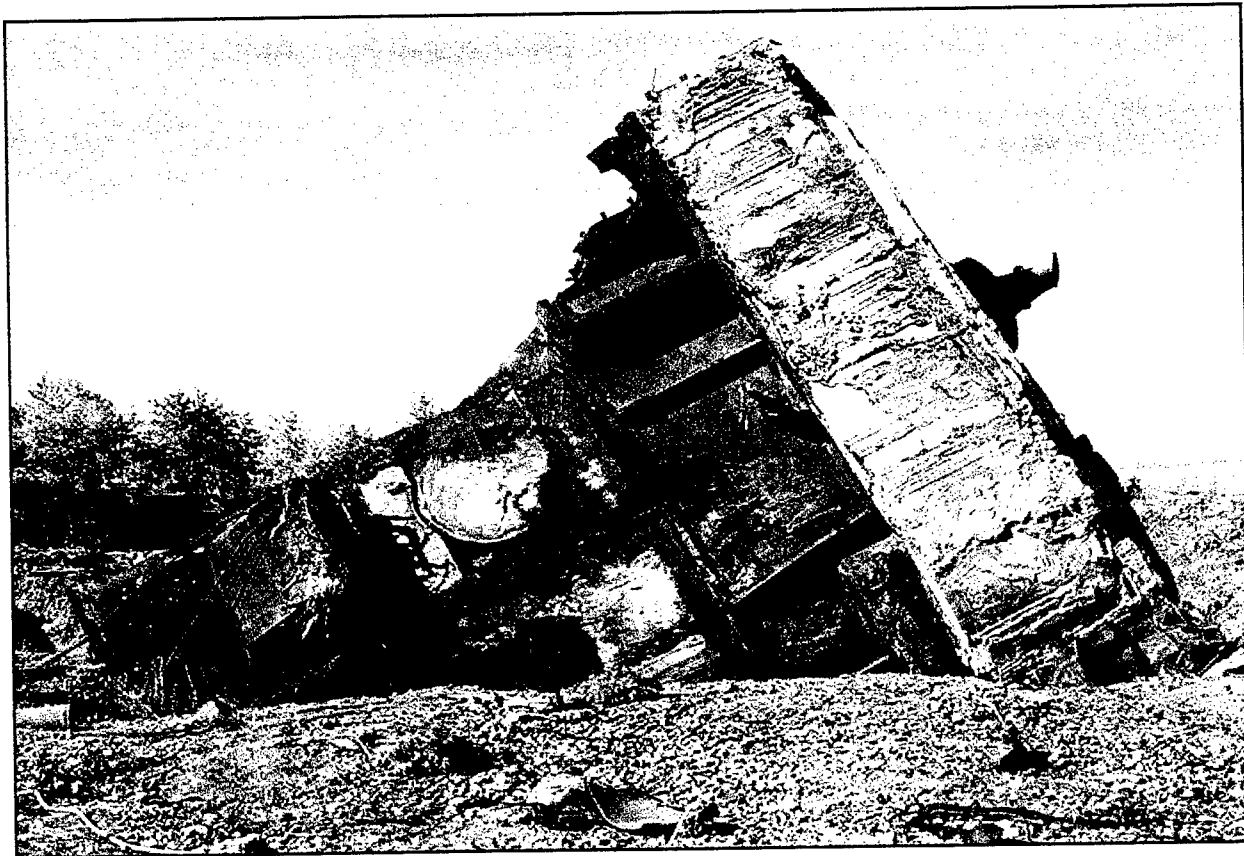
Figure 37. Relatively intact LCC silo door pocket still attached to part of the headworks wall.
Derzhavinsk, Regiment 2, Silo 7.

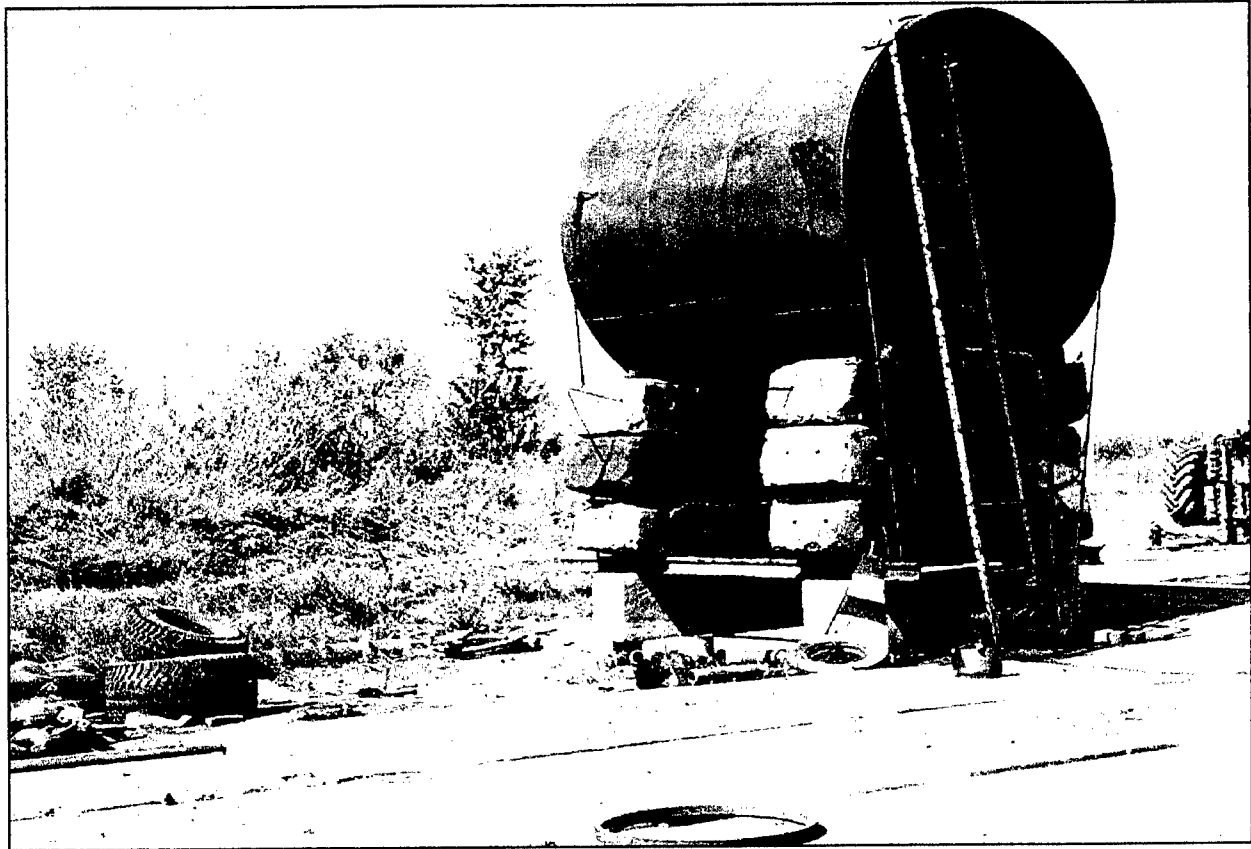
Figure 38. Salvaged sections of the "barbette" reinforced concrete walls used to support a water tank on a local farm. Note the salvaged concrete pads on the ground surface. Derzhavinsk.

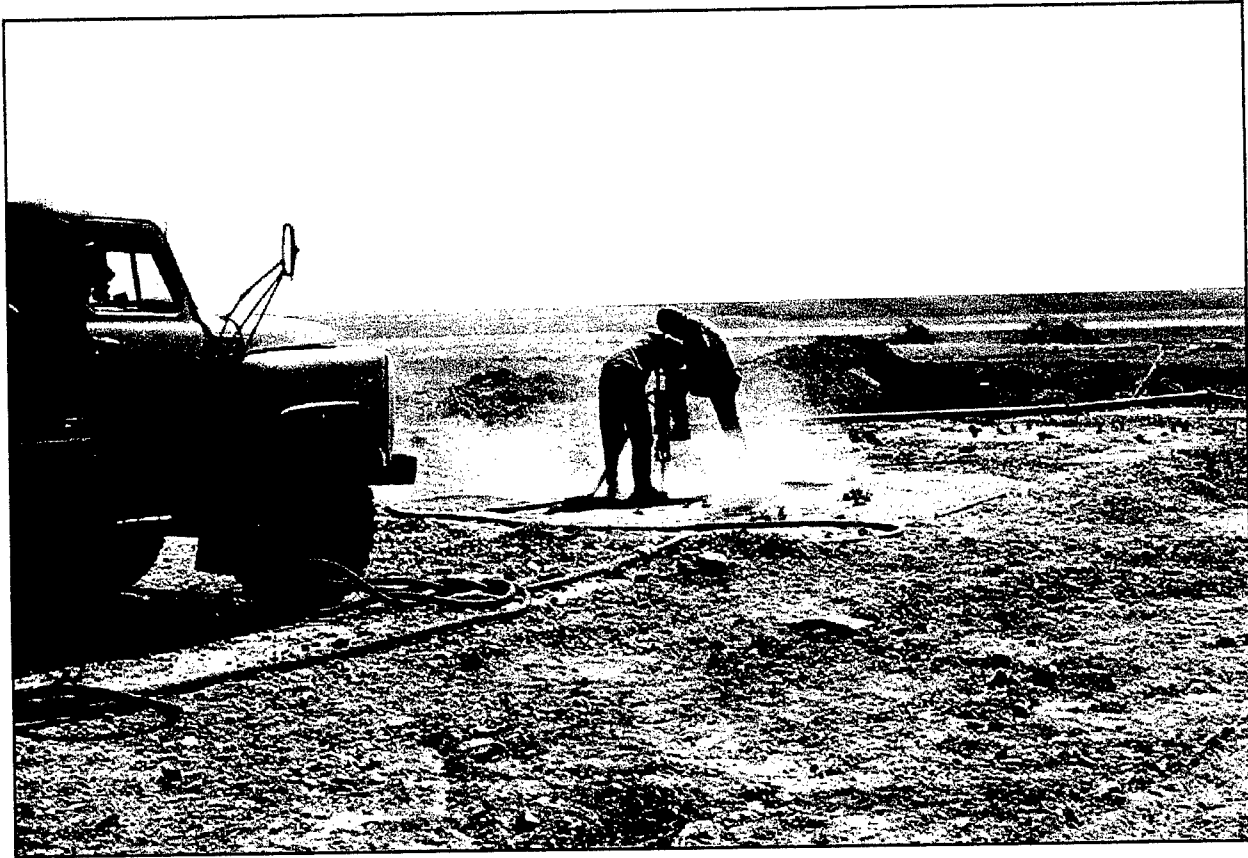
Figure 39. Drilling dynamite emplacement holes in the two-meter thick reinforced concrete support blocks of the transporter loading ramp. Derzhavinsk, Regiment 2, Silo 2.

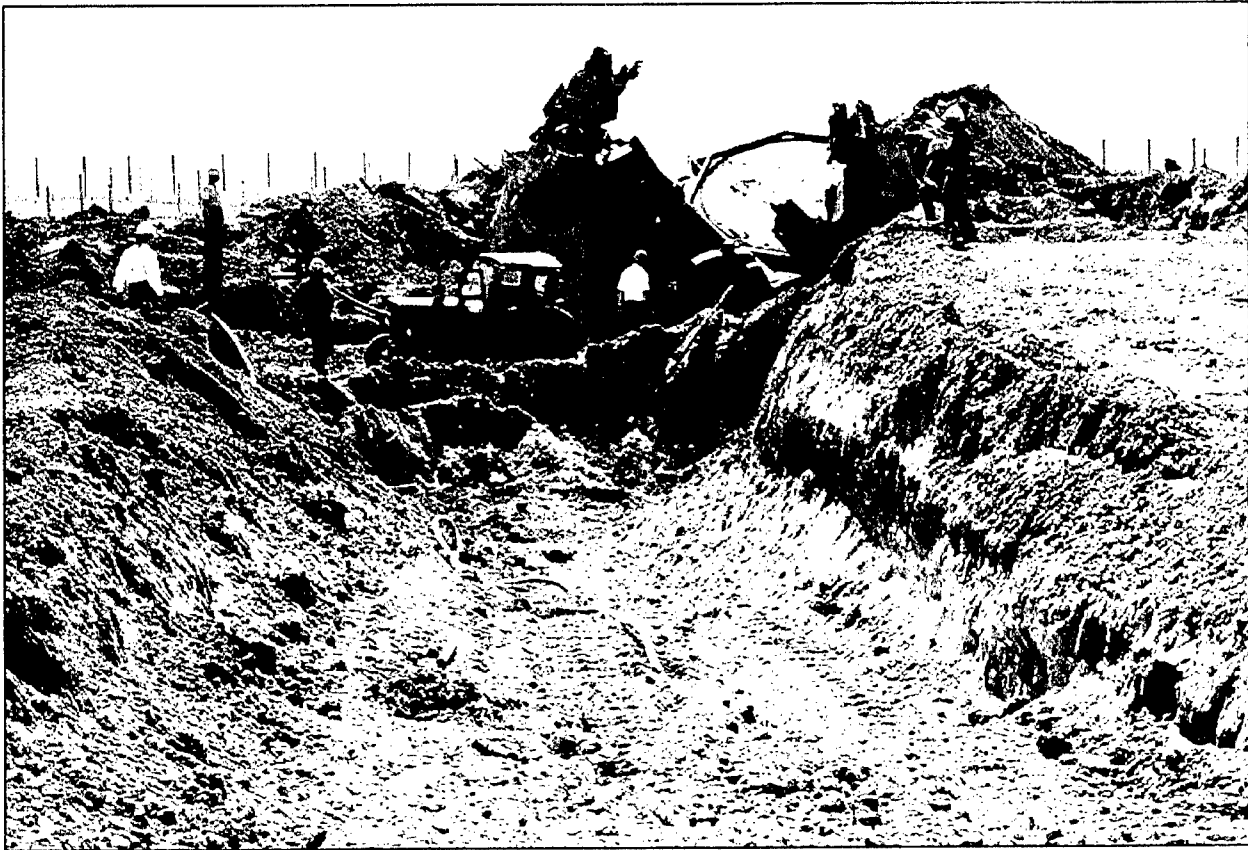
Figure 40. Ramp partially dug down to the silo crater for removal of metal and concrete, and backfilling of the silo tube with debris. The silo door pocket is on end. Derzhavinsk, Regiment 2, Silo 4.

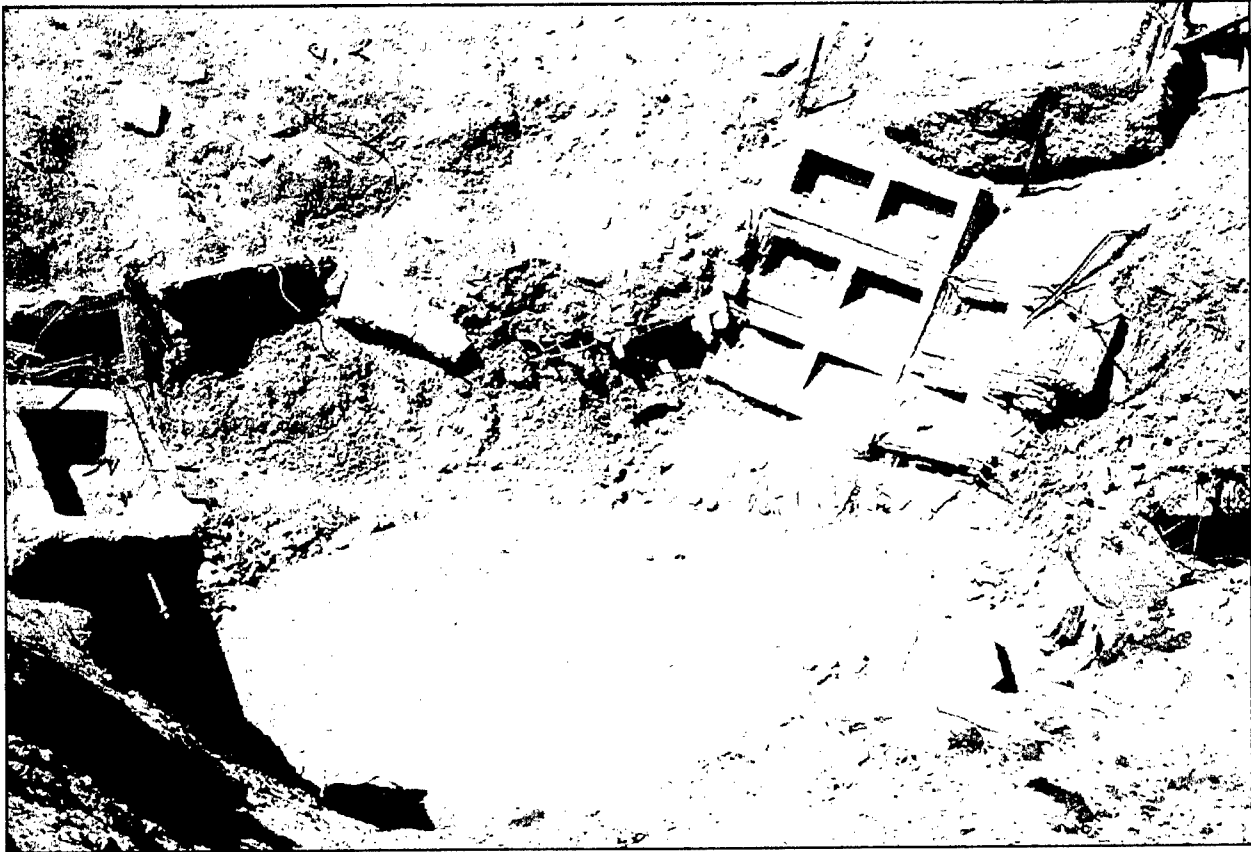
Figure 42. Poured reinforced concrete cap in place over the filled silo tube. Part of the "barbette" wall is exposed in the crater. Derzhavinsk, Regiment 3, Silos 5/7.

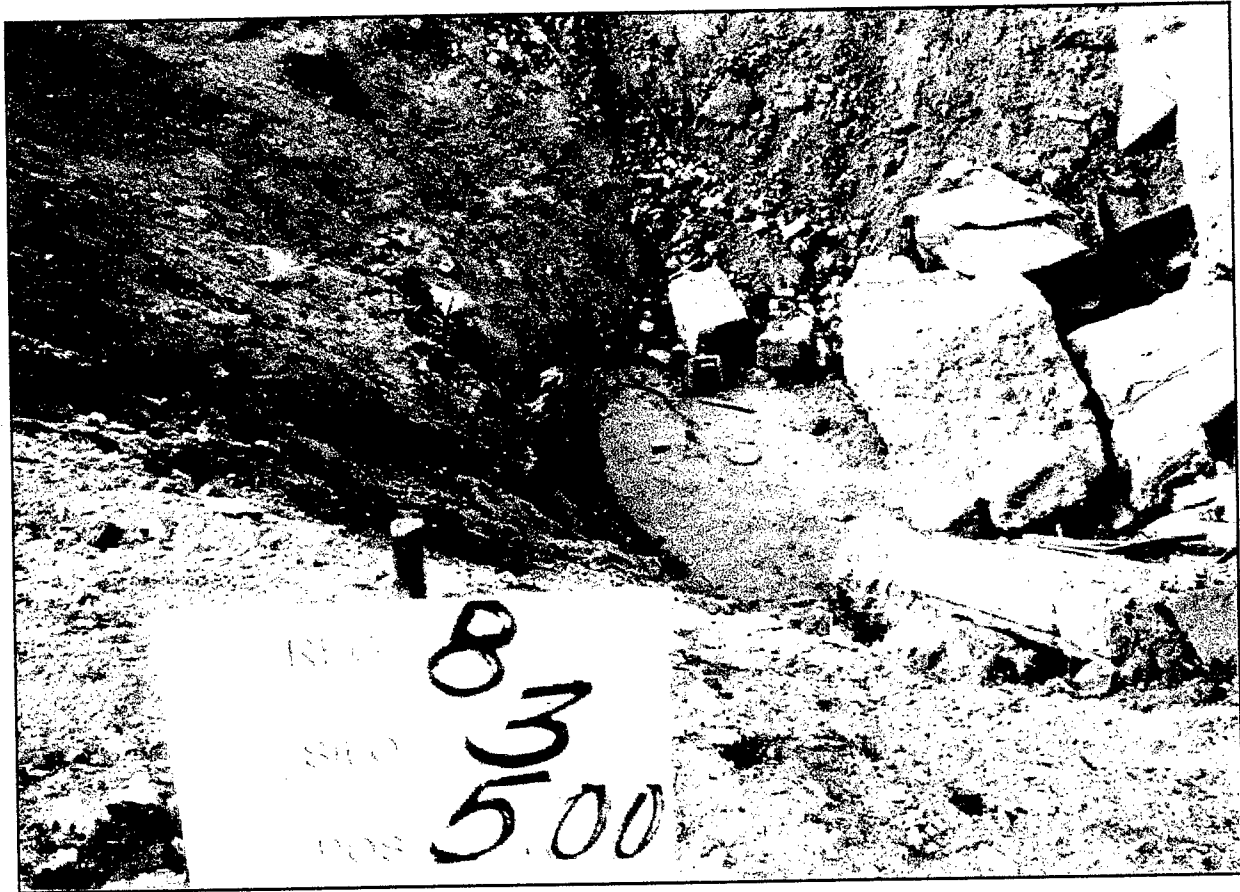
Figure 43. After the silo tube has been capped, additional rubble is pushed into the crater over the cap. Zhangiz Tobe, Regiment 8, Silo 3. Courtesy of Brown & Root/ABB SUSA.

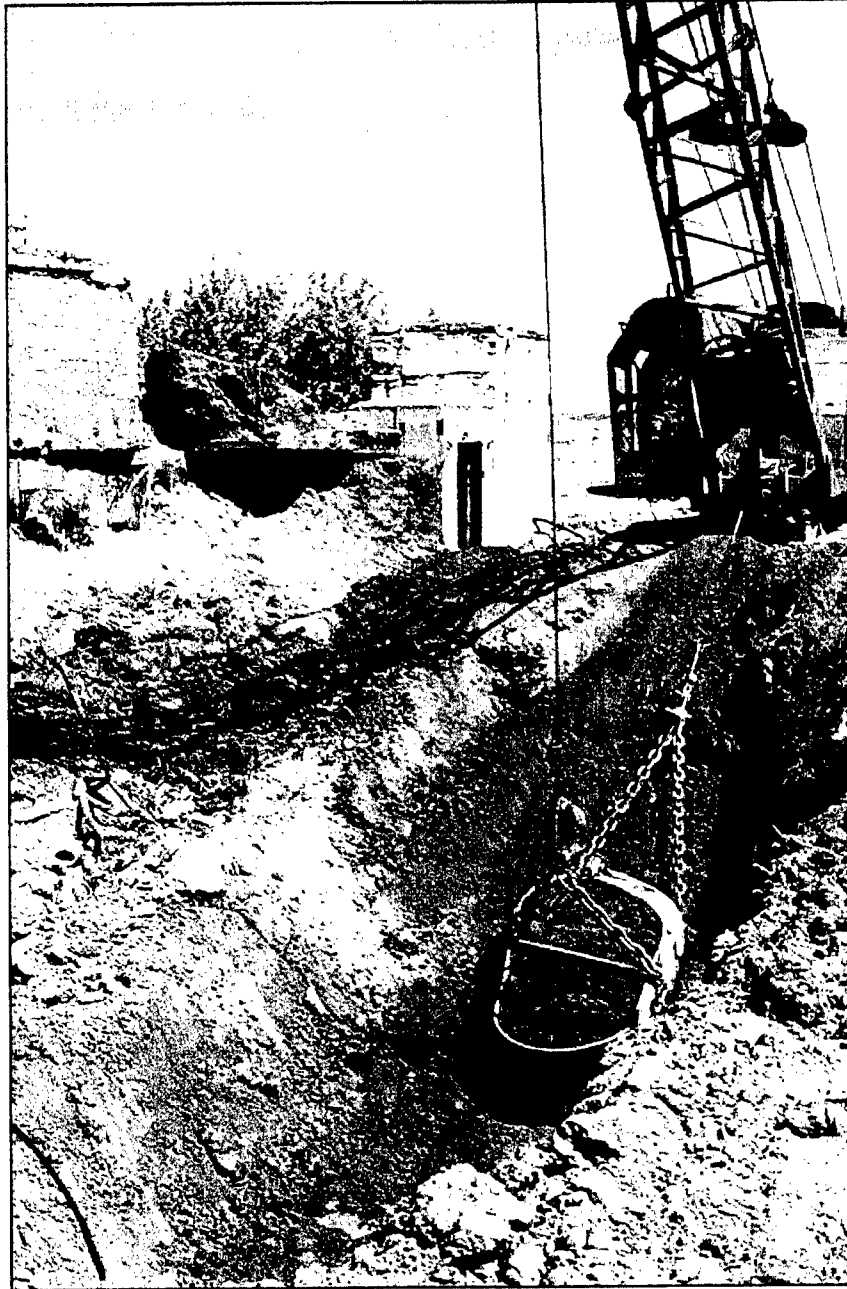
Figure 46. Excavating a pit along side a bermed storage bunker for the disposal of the bunker. The earth is brown, fine-grained silt and clay; the gray-white material is poorly sorted sand, possibly dumped in place during construction. Derzhavinsk, Regiment 2, Silo 3.

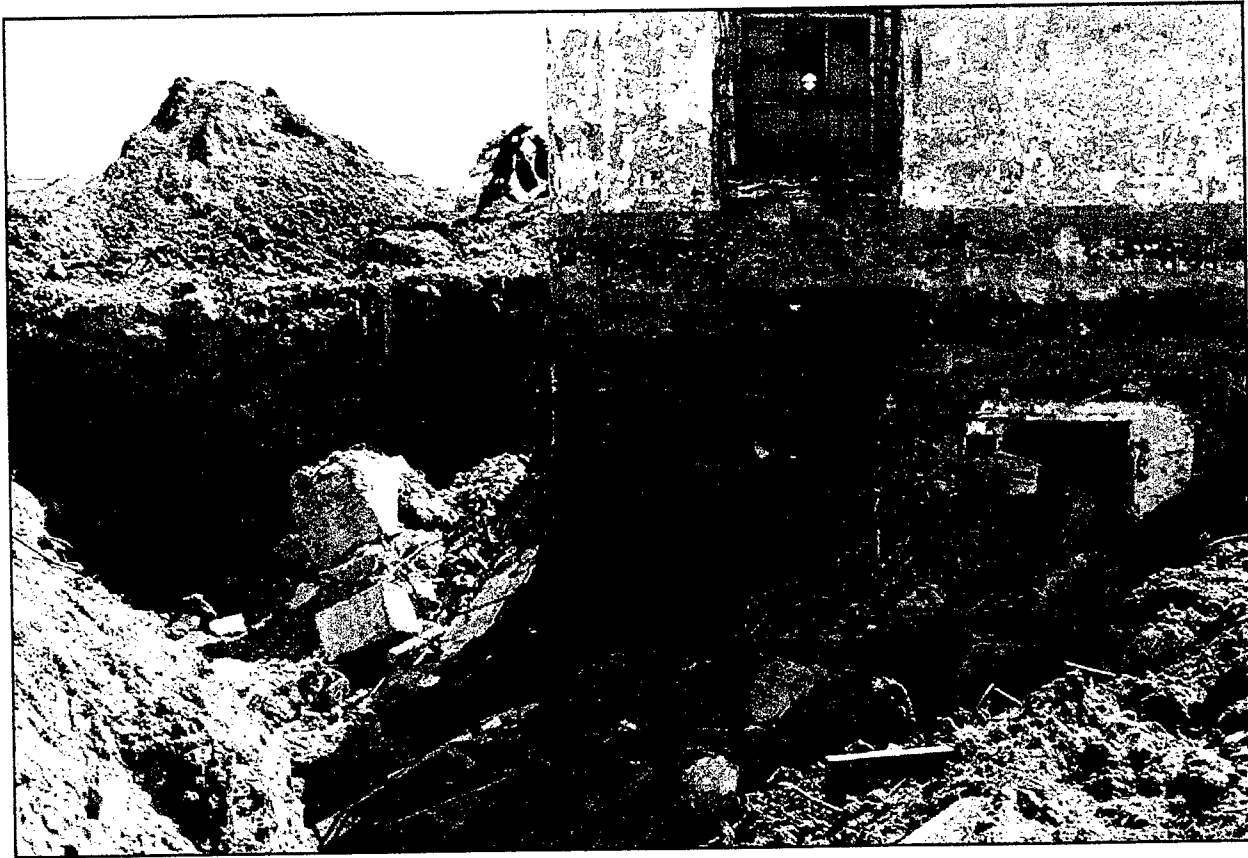
Figure 47. A pit has exposed the subterranean section of the "Force Protection" security building. The pit is partially filled with building rubble. Derzhavinsk, Regiment 2, Silo 2.

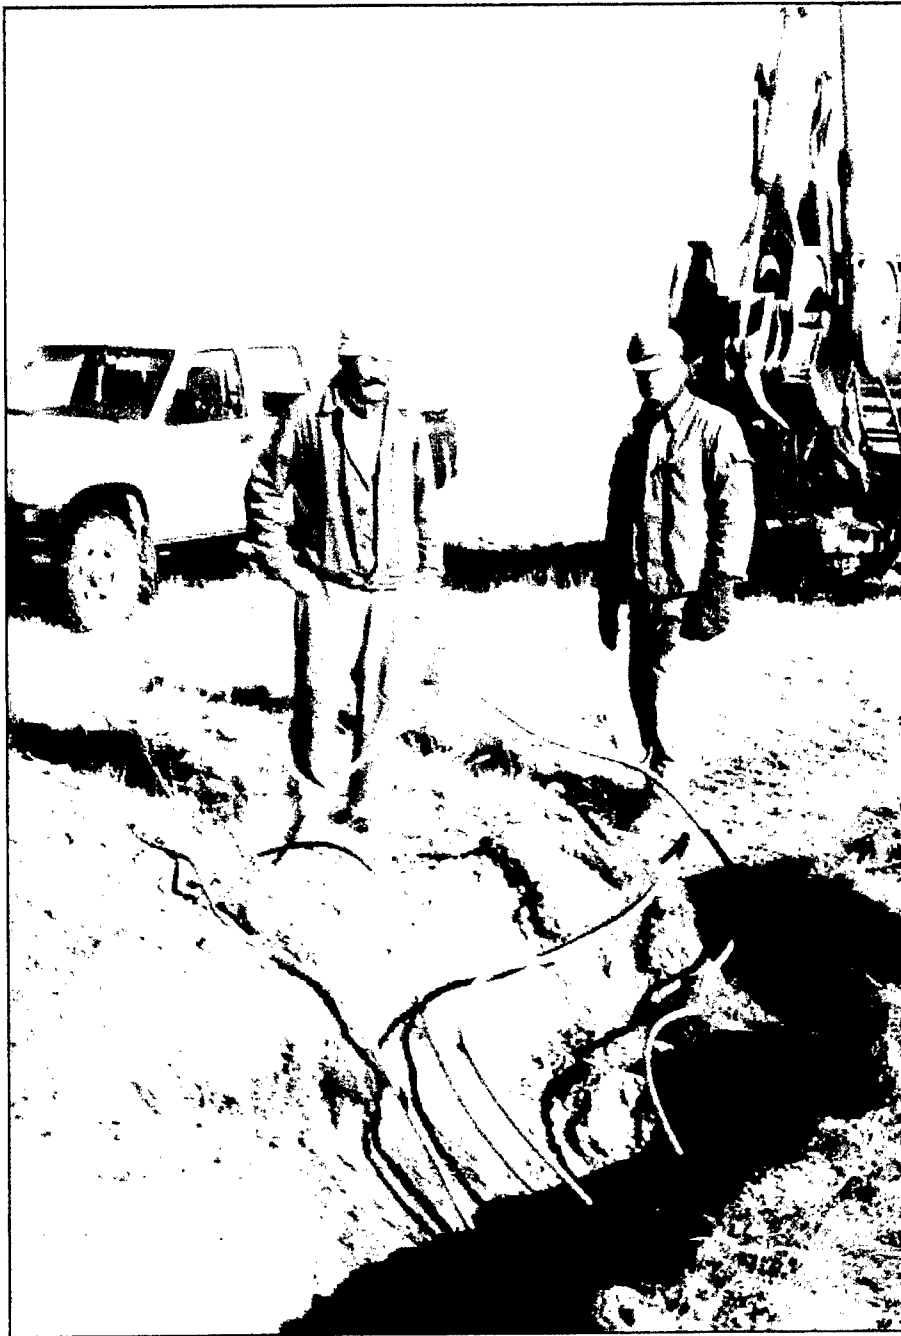
Figure 48. Cable salvaging operations. Four cables are being retrieved from one trench. Zhangiz Tobe. Courtesy of Brown & Root/ABB SUSA.

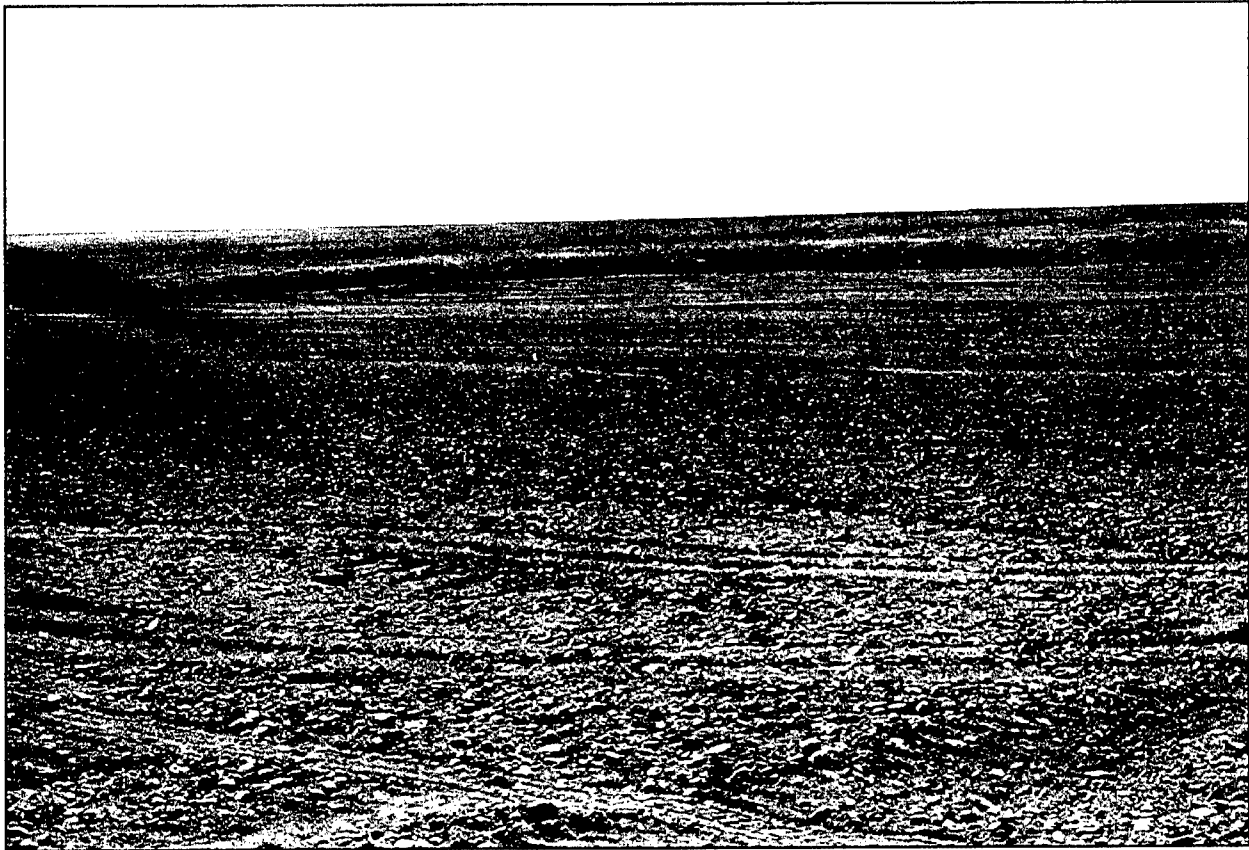
Figure 50. A completed, graded site ready to be turned over to the Kazakhstan State Land Commission. Derzhavinsk, Regiment 1, Silo 4.
