**A Cursory Examination of a Parachute Bag Knife,  
P/N 71172**

**ARL-TR-3892**

**September 2006**

**Marc Pepi and Victor Champagne**  
**Weapons and Materials Research Directorate, ARL**

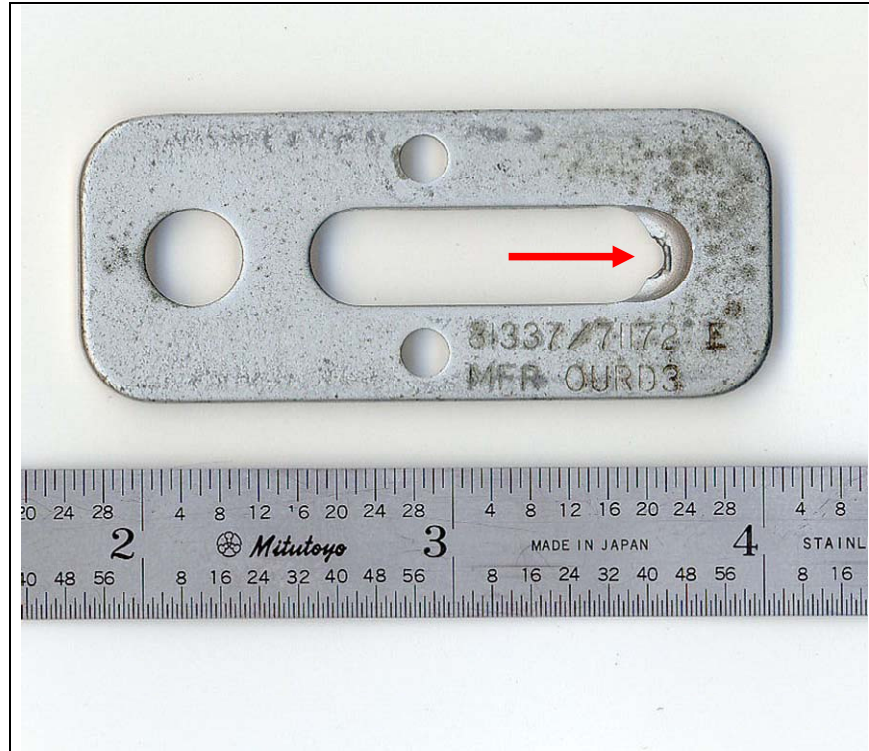
The as-received knife was photographed for documentation purposes (figures 1 and 2, representing the top and bottom of the part). As shown in the photographs, damage to the cutting edge was incurred. This anomaly is magnified in figure 3. The damage consisted of rolled metal, giving the appearance of a softer than nominal knife edge.

Figure 1. Top view of parachute bag knife, as-received. Note the damage to the knife edge (arrow) (magnified 1.75×).

- The damage to the blade tip is evidence that the steel was softer than optimal for the intended purpose.
-

In general, knives are manufactured from quenched and tempered steel, resulting in a fine lath martensite microstructure. This is a much harder and tougher microstructure than pearlite and ferrite. It is recommended that future production of this component entail quenching and tempering of this alloy (per acceptable industry standards) to produce a part with a hardness in the upper 30's to lower 40's HRC. Heat treatment and hardness requirements should be added to Engineering Drawing 71172 to ensure quality components in the future. The U.S. Army Research Laboratory can provide assistance in this area if the U.S. Army Natick Research, Development and Engineering Center so chooses. In addition, it should be a requirement that the blade tip be ground after heat treatment. This would prevent decarburization from softening the tip.

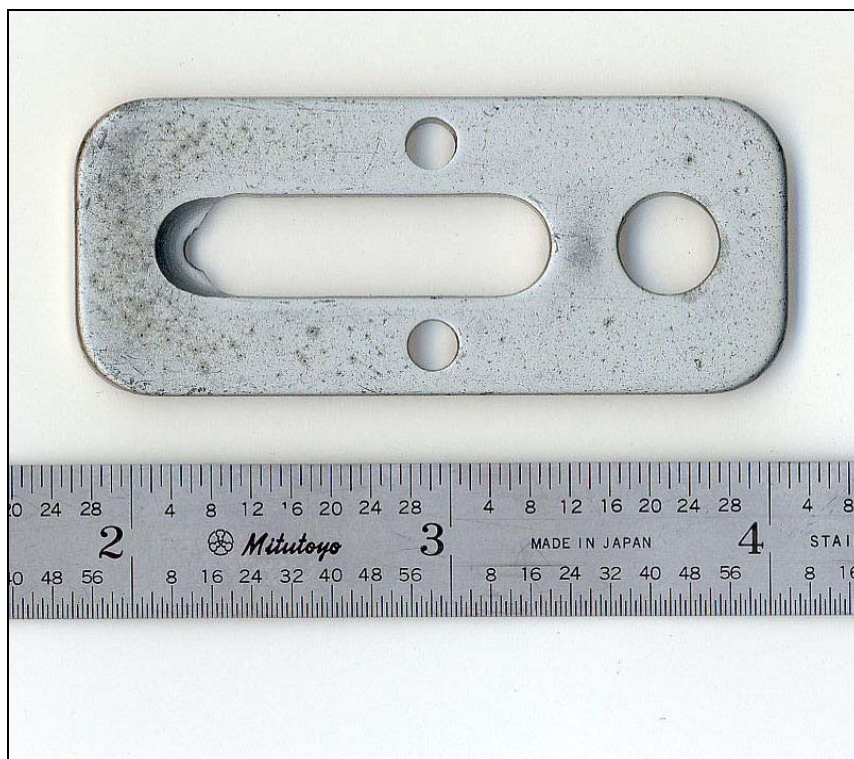
Figure 2. Bottom view of parachute bag knife, as-received (magnified 1.75×).

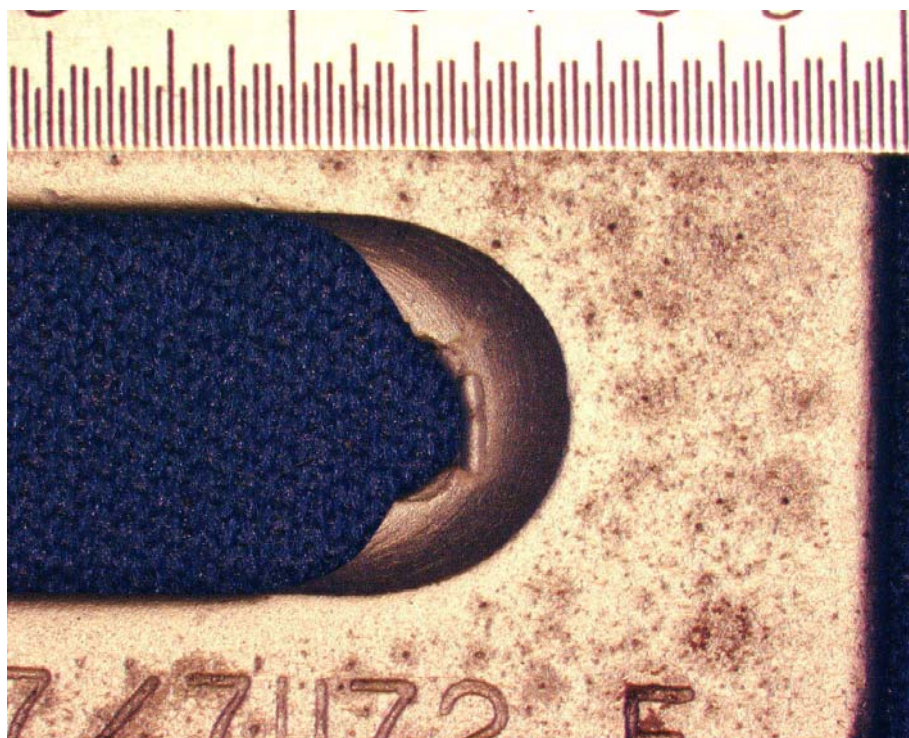
Figure 3. Damage to cutting surface, as-received (magnified 5×).

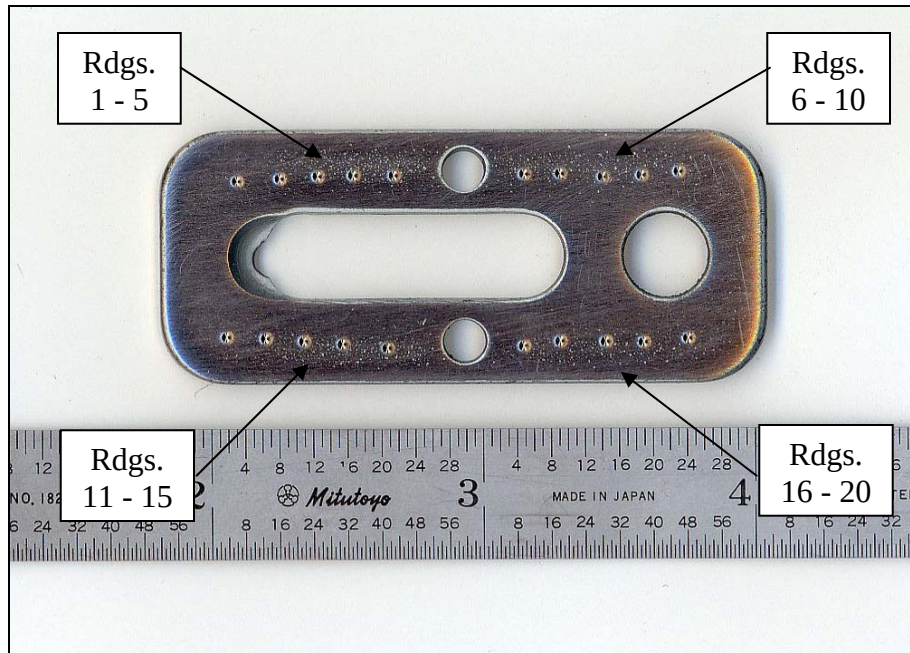
The part was lightly sanded utilizing 180-grit silicon carbide paper to remove the zinc coating. Care was taken not to heat the part, so as not to affect the structure of the steel. Hardness measurements using the Rockwell “C” scale (150 kgf) were taken along the periphery of the component, as shown in figure 4. As the results in table 1 indicate, this part was rather soft for an ultrahigh-strength steel alloy (AISI 4130). There is no hardness requirement on the engineering drawing.

Figure 4. Hardness measurements taken directly on the component (magnified 1.4×).

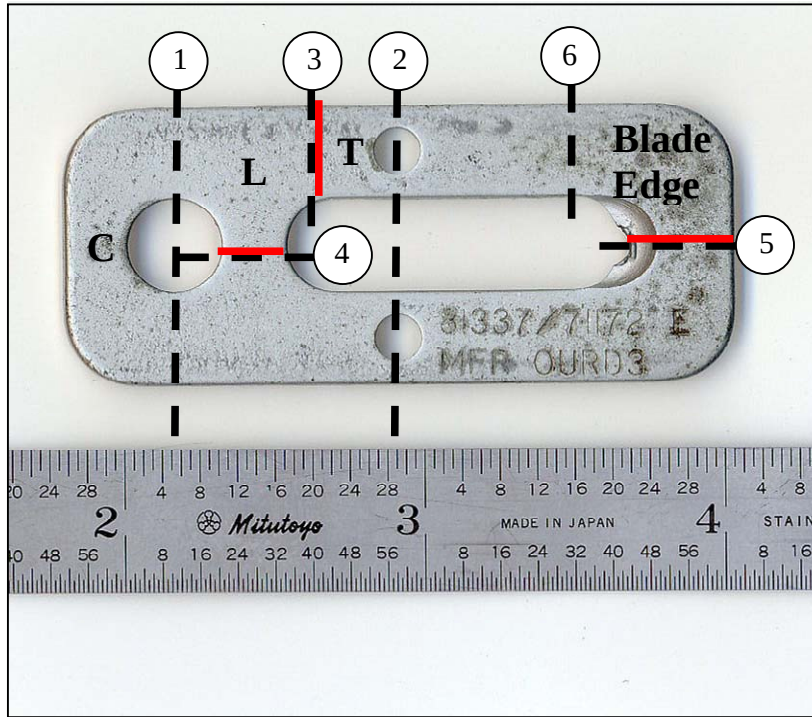
A section of the component (sectioning diagram shown in figure 5) was analyzed for chemical composition using wet chemistry techniques. The carbon and sulfur were detected utilizing the Leco combustion method, while the remaining elements were detected through direct current plasma spectroscopy. Governing specification SAE-AMS 6370<sup>1</sup> requires the chemical composition listed in table 2 for the AISI 4130 steel. As shown, the part met the requirements for AISI 4130.

Figure 5. Sectioning diagram showing chemical analysis sample (C), longitudinal metallography sample (L), transverse metallography sample (T), and blade tip metallography sample. Dashed lines represent sectioned areas, red lines represent prepared planes (magnified 1.75×).

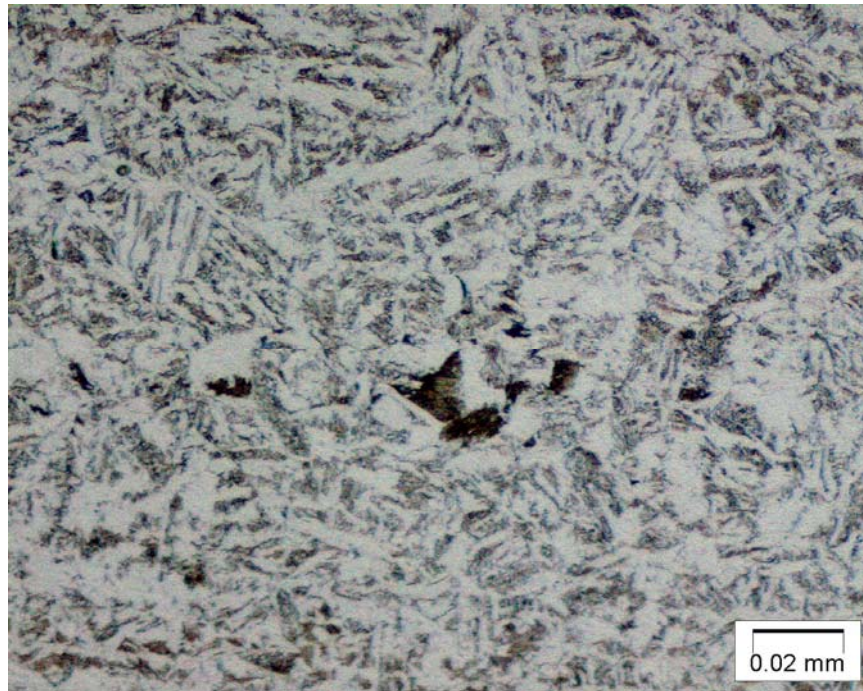
suspension was following by final polishing using 0.05- $\mu\text{m}$  alumina. The samples were analyzed in the as-polished condition and found to contain no gross defects or anomalies. The samples were subsequently etched in 2% nital to reveal the microstructure shown in figure 6. The structure showed evidence of lamellar pearlite and islands of ferrite, as well as possible evidence of martensite. This structure may indicate that the component was inadequately heat treated.<sup>2</sup>

Figure 6. Microstructure of the component consisting of lamellar pearlite (dark areas) and ferrite (white areas), as well as possible martensite. Etchant: 2% nital. (Magnified 500 $\times$ .)

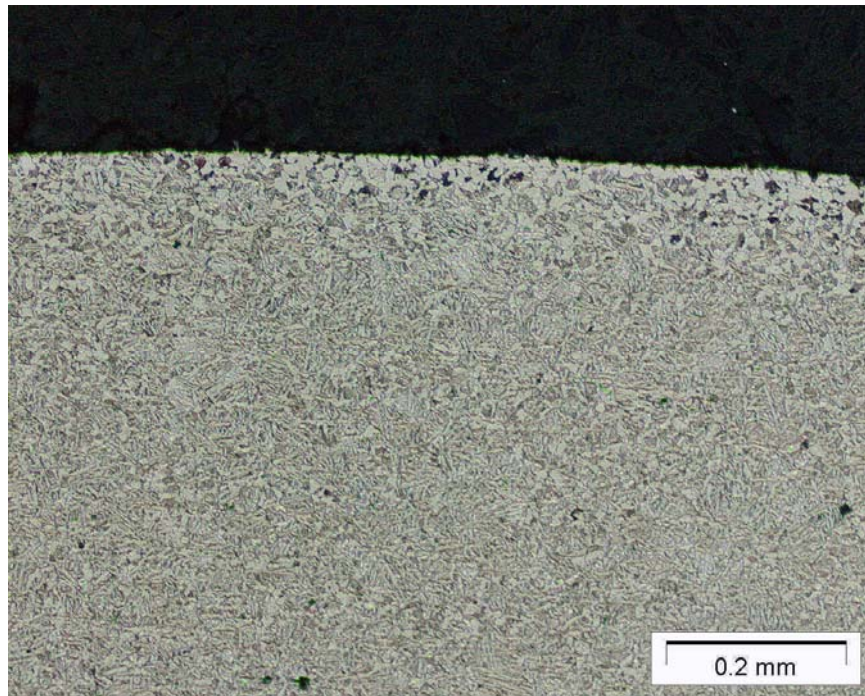
The grain size was measured using the micrograph in figure 7 (100 $\times$ ) in conjunction with overlay slides conforming to ASTM E112. The average grain size was found to be approximately ASTM No. 9.5. Evidence of decarburization existed, as shown in figure 8. This condition (denoted by a predominance of ferrite at the surface) was prevalent around the periphery of the entire part.

Figure 7. Micrograph used to measure grain size. ASTM E112 overlays were used to determine an average grain size of ASTM No. 9.5. Note evidence of banding. Etchant: 2% nital. (Magnified 100 $\times$ .)

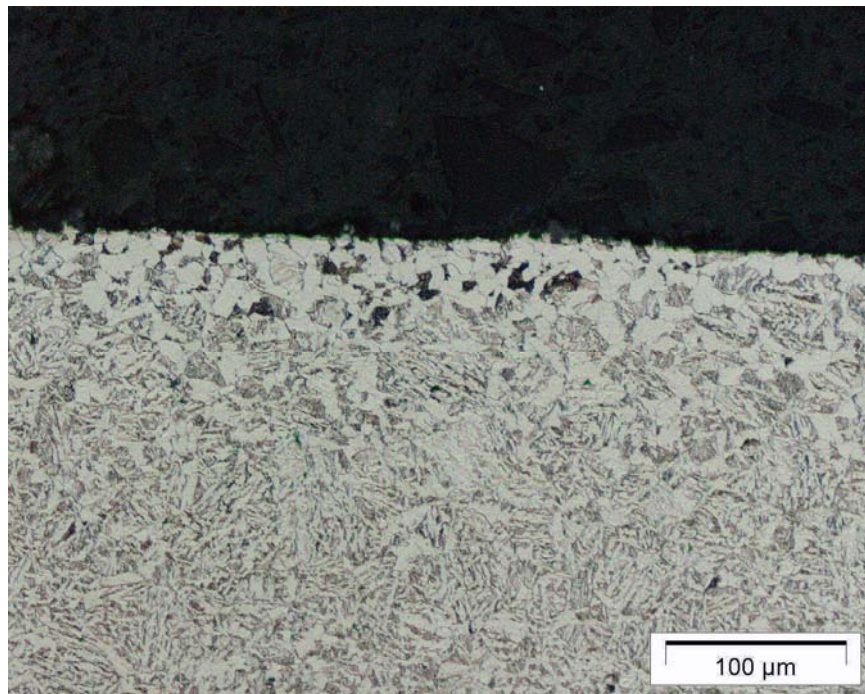
Figure 8. Evidence of decarburization at the surface of the component (white, blocky structure). Decarburization is characterized by ferrite structure at the surface. Etchant: 2% nital. (Magnified 100 $\times$ .)

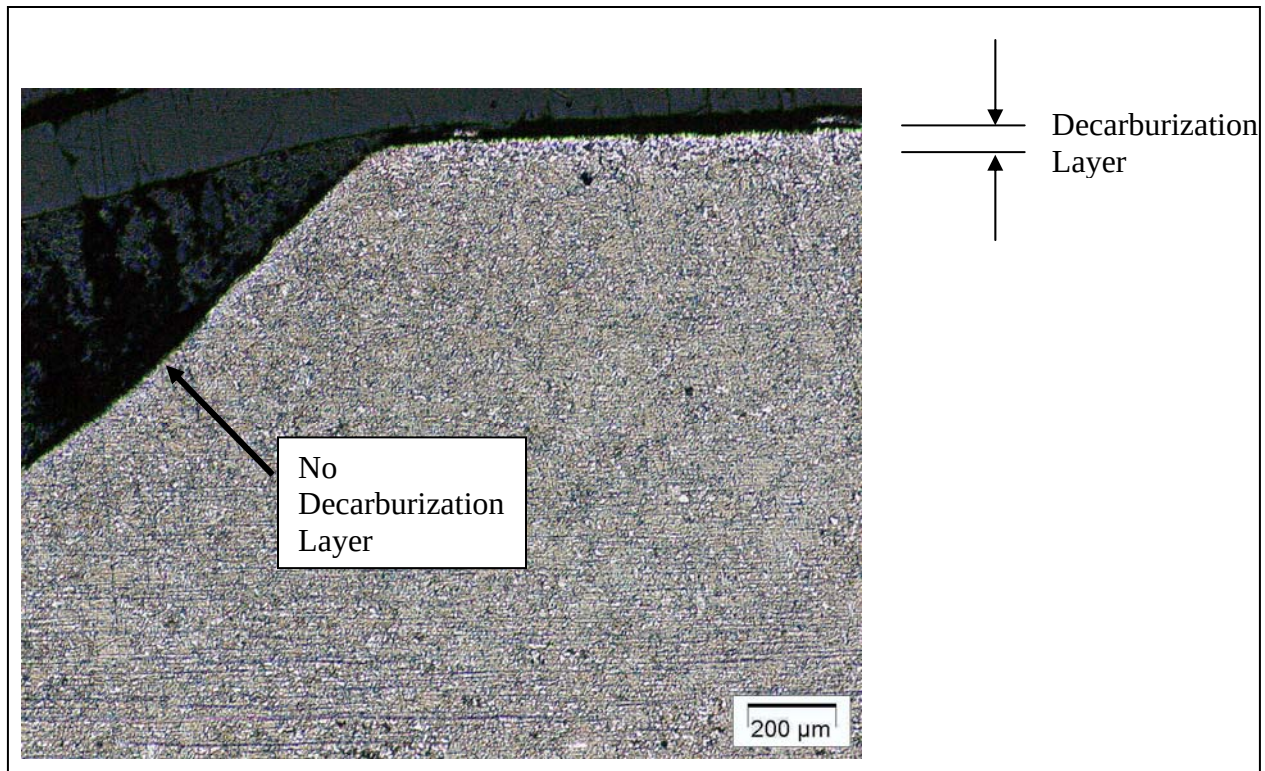
The sample consisting of a section made directly through the tip of the blade was also metallographically prepared as previously described. The intent was to determine if the manufacturer had ground the blade after heat treatment. Figure 9 shows the interface between the exterior surface of the knife and the blade tip. Note the layer of decarburization along the surface of the component, which ends where the blade begins. This was evidence that the manufacturer did indeed grind the blade after heat treatment. Figure 10 shows the deformed tip of the blade, while figure 11 (magnified view of figure 10) shows the grain flow within the tip.

Figure 9. Decarburization at the surface of the component, but not on the blade edge. This shows manufacturer ground the blade after heat treatment. Etchant: 2% nital. (Magnified 50×.)

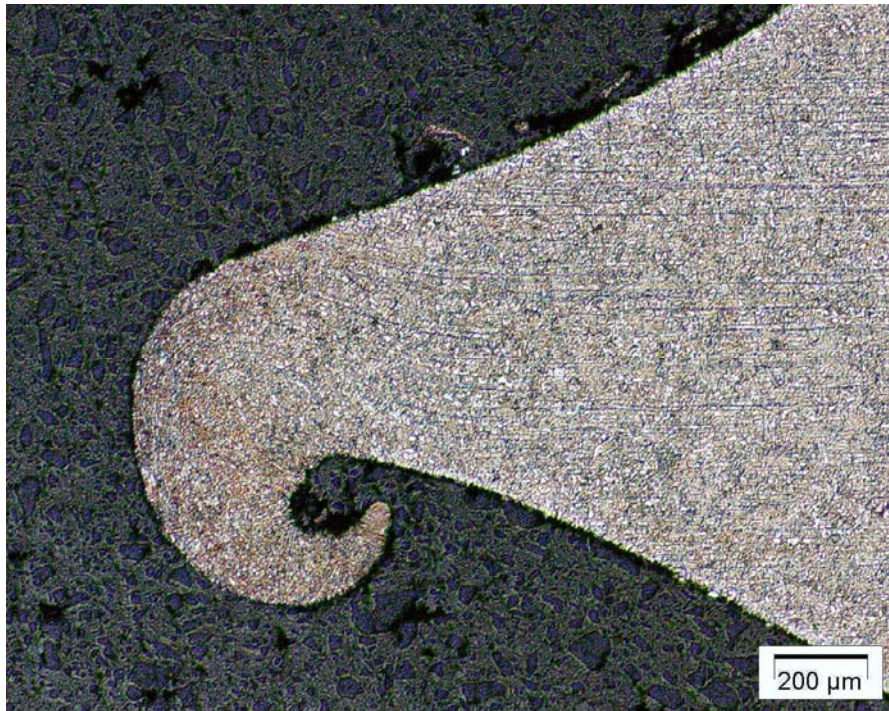
Figure 10. Deformed tip of the knife blade. Etchant: 2% nital. (Magnified 50×.)

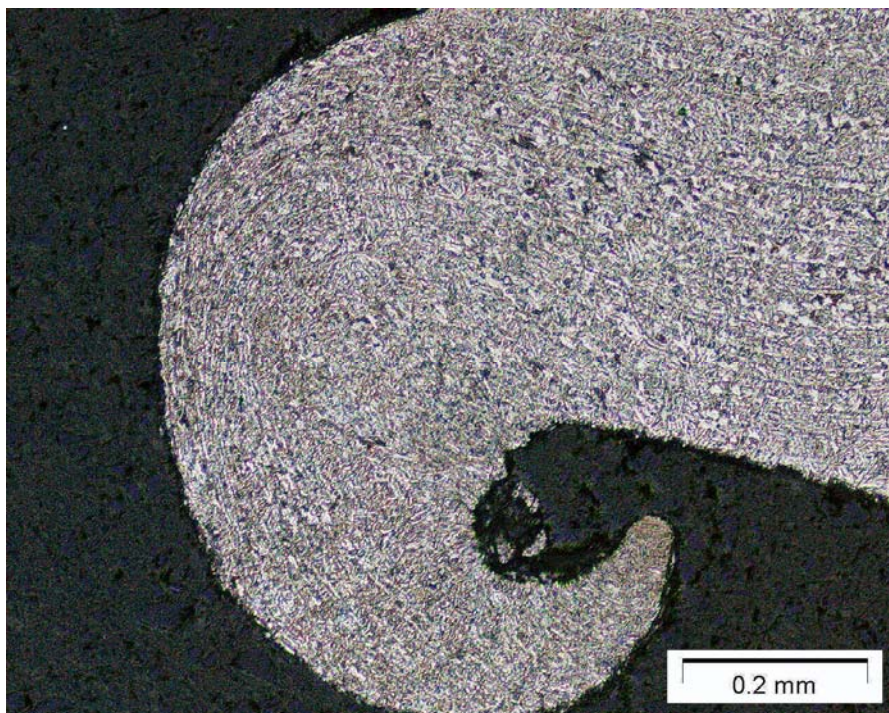
Figure 11. Magnified view of figure 10. Note the grain flow conforming to the contour of the swirl. Etchant: 2% nital. (Magnified 100×.)

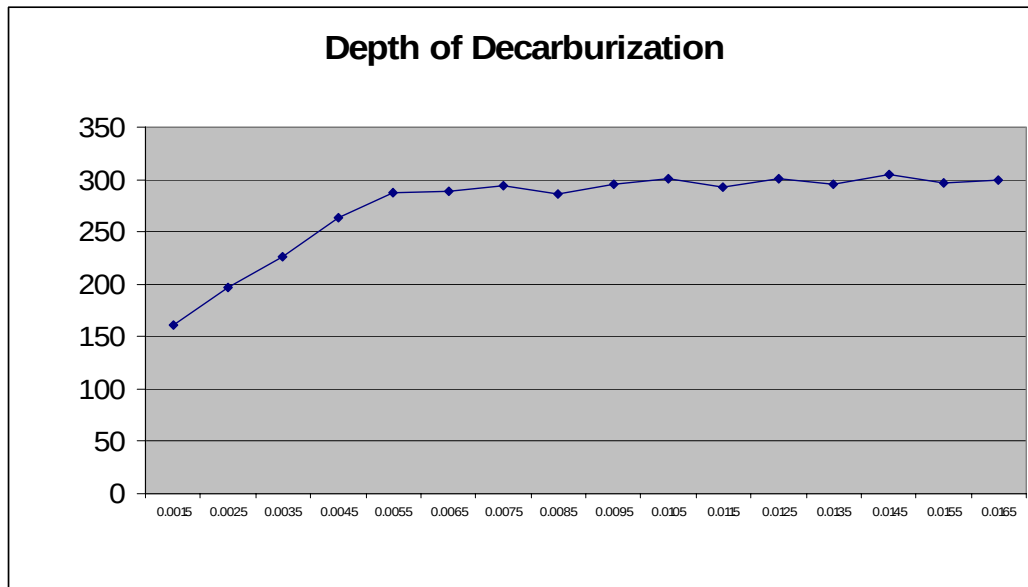
A metallographically prepared sample was subjected to Knoop microhardness to determine the extent of the decarburization layer. As the governing specification indicates, the total depth of decarburization shall not exceed 0.010 in for parts with a nominal distance between parallel sides less than 0.375 in (3.3.4.3). Table 3 contains the results of microhardness testing. As shown, the first four hardness readings were well below those of the remainder of the part (highlighted in red), indicating a depth of decarburization of ~0.0055 in. This was well within the 0.010-in requirement. Figure 12 shows a graphical representation of the Knoop microhardness readings, while figure 13 shows Knoop microhardness indents through the decarburization into the core.

Figure 12. Plot of Knoop microhardness vs. depth below surface. Decarburization was determined to be ~0.0055 in deep.

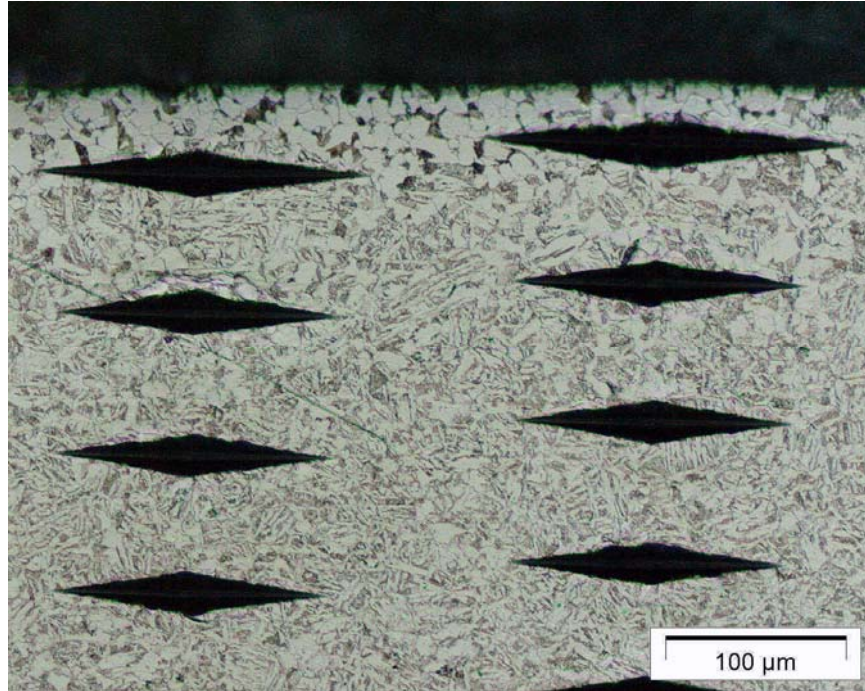
Figure 13. Knoop hardness indentations through the layer of decarburization at the surface of the component. Note the larger indents (indicating a softer material) within the decarburized region at the surface. Etchant: 2% nital. (Magnified 200×.)
