# **THE NATIONAL SHIPBUILDING RESEARCH PROGRAM**

## **1987 Ship Production Symposium**

### **Paper No. 19: Evaluation of Commercially Available Wet Welding Electrodes for Potential Repair of U.S. Navy Ships**

# Evaluation of Commercially Available Wet Welding No. 19 Electrodes for Potential Repair of U.S. Navy Ships

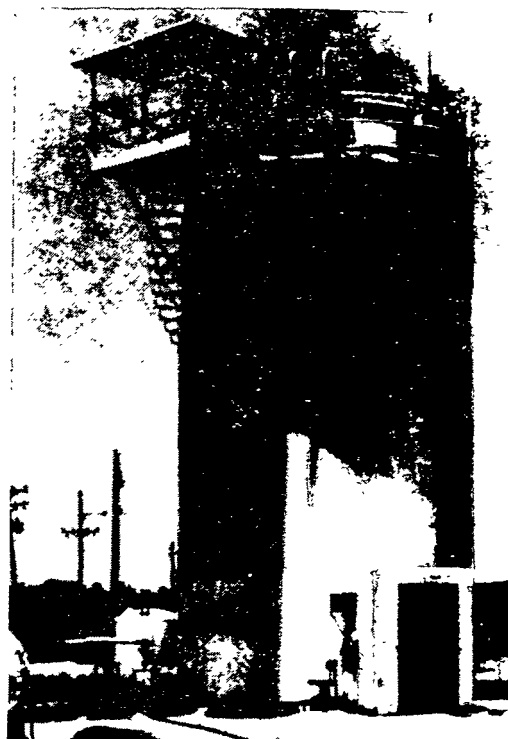
FIGURE 1. Global Divers Test Tank

Diving and welding facilities were provided by Global Divers and Contractors of New Iberia, Louisiana; The Global test tank is shown in Figure 1. The wet welding tank was 36 feet high, 20 feet in diameter, and contained sea water. The filtering system maintained clear water throughout the welding operations. The air compressor and volume tank were adequate for the support of two welder/divers working at the same time. The welding machines were both 400 ampere Miller diesel driven generators.

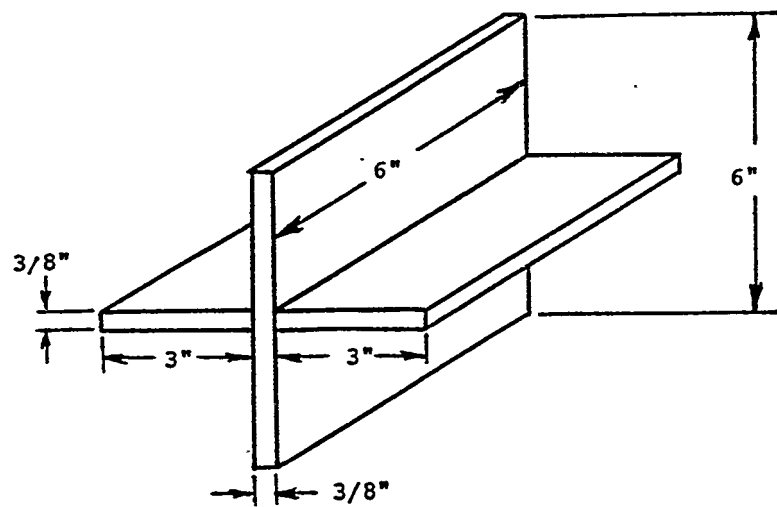
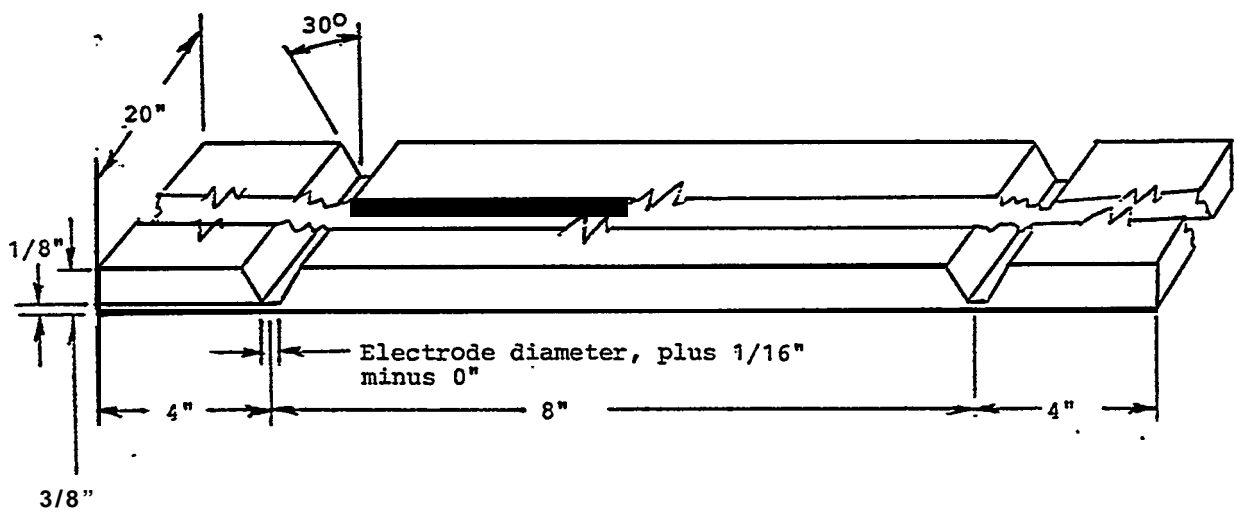
FIGURE 2. Screening Test Plates

CRUCIFORM SPECIMEN

GROOVED PLATE SPECIMEN

2.4.2 Screening tests. All screening tests were accomplished at a 33 foot water depth using two welder/divers. This allowed duplication of all tests, reducing the chances of accepting an electrode which would run successfully only when a unique style of welding was utilized. Test plates consisted of cruciform specimens and grooved plate specimens, the design of which is shown in Figure 2. DH 36 steel, 3/8" thick, was used for the cruciform specimens following the welding sequence shown in Figure 3. The object of the welding sequence was to induce relatively high restraint to allow determination of any propensity for cracking in either the weld or base metal heat-affected-zone. The cruciform specimens were liquid penetrant inspected after welding. They were then sectioned to provide two MACRO sections, 1 1/2" from each end; the MACROS were sanded to a 120 grit finish, etched, and examined at a magnification of 7x. The welding electrodes which were found acceptable were further evaluated using the grooved plates.

The grooved plates were prepared to allow both a vertical and an overhead weld to be made in each plate. Both high CE (DH 36) and low CE (A36) steel

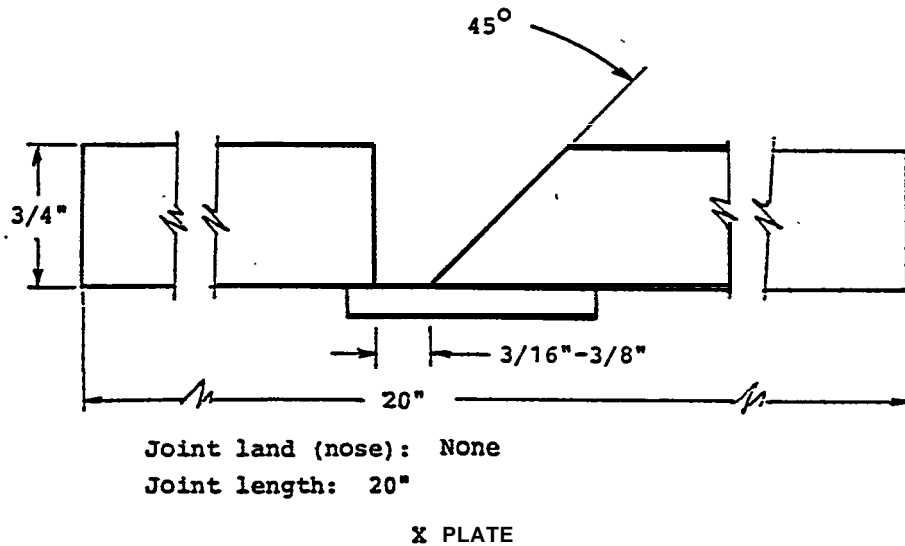
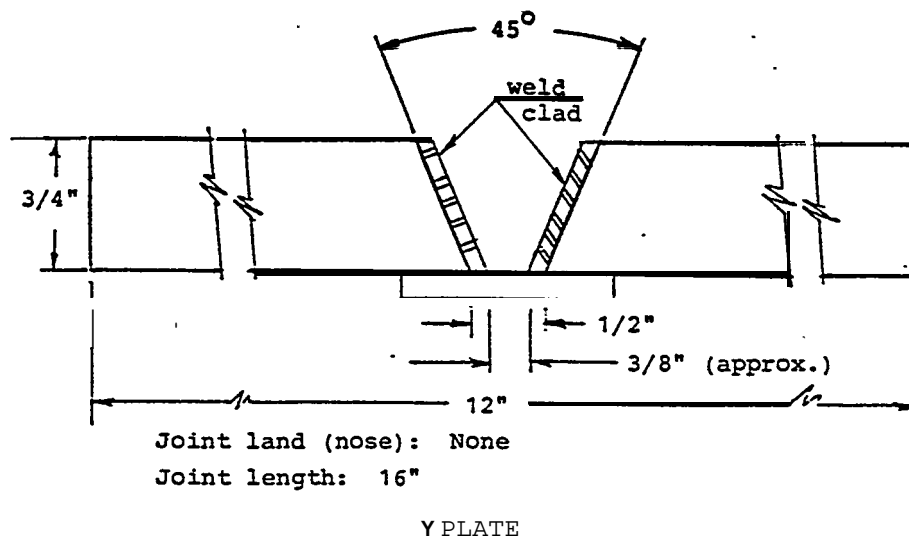
FIGURE 5. Qualification Test Plates

2.4.3 Qualification tests. Test plates consisted of 3/4" ASTM A36 steel. Test plate X, which was 20" long, was used to obtain two reduced section tensiles, four side bends, one VICRO section with Vickers hardness readings, five weld metal Charpy impact specimens, and five base metal heat-affected-zone Charpy impact specimens. Charpy impact test temperature was 28F. Test plate Y, which was 16" long, was used to obtain two all-weld-metal tensile specimens and weld metal chemistries. Test plate X and Y designs are shown in Figure 5.

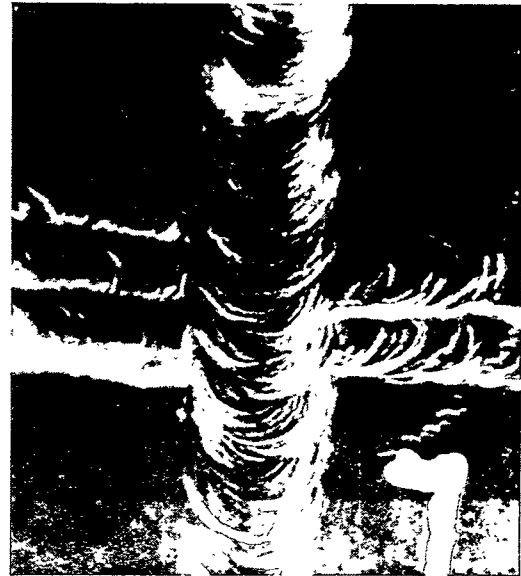
FIGURE 31. In-Air Butt Weld  
(E7018, Single Pass Cap)  
Intersecting a Wet Butt  
Weld (Electrode No. 3)  
Vertical, 33 FSW
