# Aircraft Fuel Cell Repair Equipment

After Initiative Report  
AMB-05-005

Air Force Air Mobility Battlelab

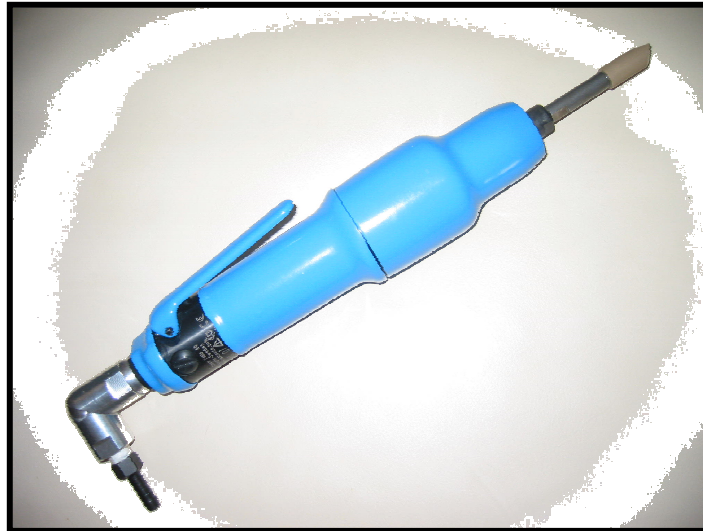
Rapid Desaler on work bench

**2.3.2. Results.** The RDS was very efficient. Sealant was removed from a seam in 30 seconds. Normally it would have taken an hour using current methods to remove this sealant. The RDS is a pneumatic, reciprocating hand tool approximately 16 inches in length. A replaceable plastic tip threads onto the arm. This tip has a point with two different angles. These can be sharpened for reuse, until worn past a certain threshold.

The access panel for the wing tip tank was removed from the aircraft and desealed on the workbench. A training board was also used. Sealant was removed from a .25 inch wide horizontal seam, a corner with rivets, a vertical seam on a horizontal joint and a 6 inch test strip. After all areas were desealed, only minor areas around fasteners and corners required conventional cleanup.

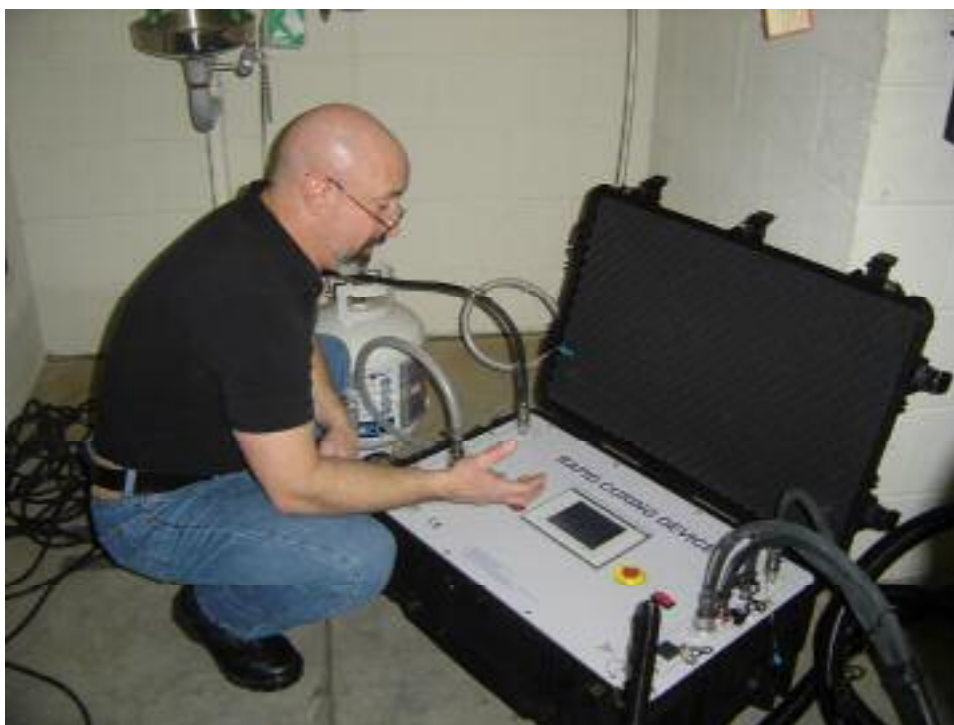
**RCD control box with propane, power, and air inputs**

The RCD required approximately 15 minutes set-up time. This time was used to connect 3 inputs, 2 outputs, and 2 probes. Inputs are 110 volt power, air (50 cfps) and propane. Outputs are 28vDC and an air/propane mixture. The 2 probe leads provide temperature input from the sealant and the structure. Once equipment was in position a 10 minute start-up cycle initiated.

The RCD was demonstrated on the training board because the control box is not intrinsically safe and not rated to be within 50 feet of the aircraft. Additionally, the hoses connecting the control box to the emitter heads are not long enough to keep the box outside the safe area. The emitter head/thermoreactor is intrinsically safe and certified for fuel cell environments.

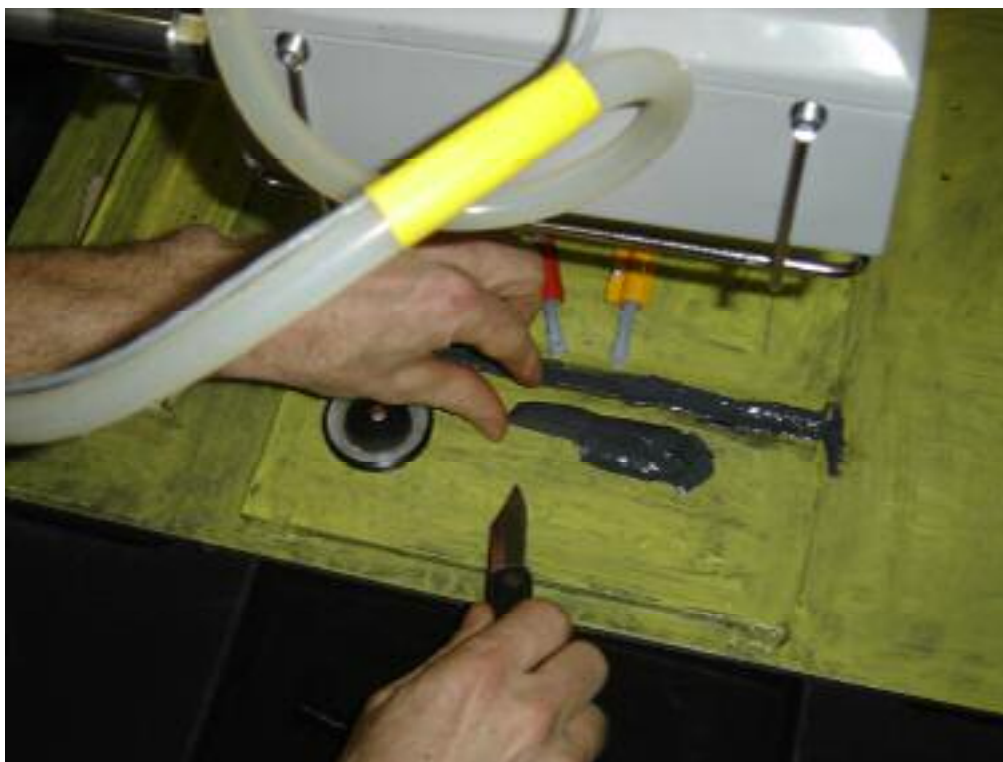
**Sealant being evaluated after curing**

**2.5.2. Results.** There was no skin formation or trapped air bubbles. The sealant was cured throughout the entire body. The temperature applied to the sealant ranged from 120° to 130° Fahrenheit. The RCD thermoreactor emission spectrum is nearly identical to the absorption spectrum of paints and sealants. It is this frequency concentration, not the heat, that accelerates the sealant curing.

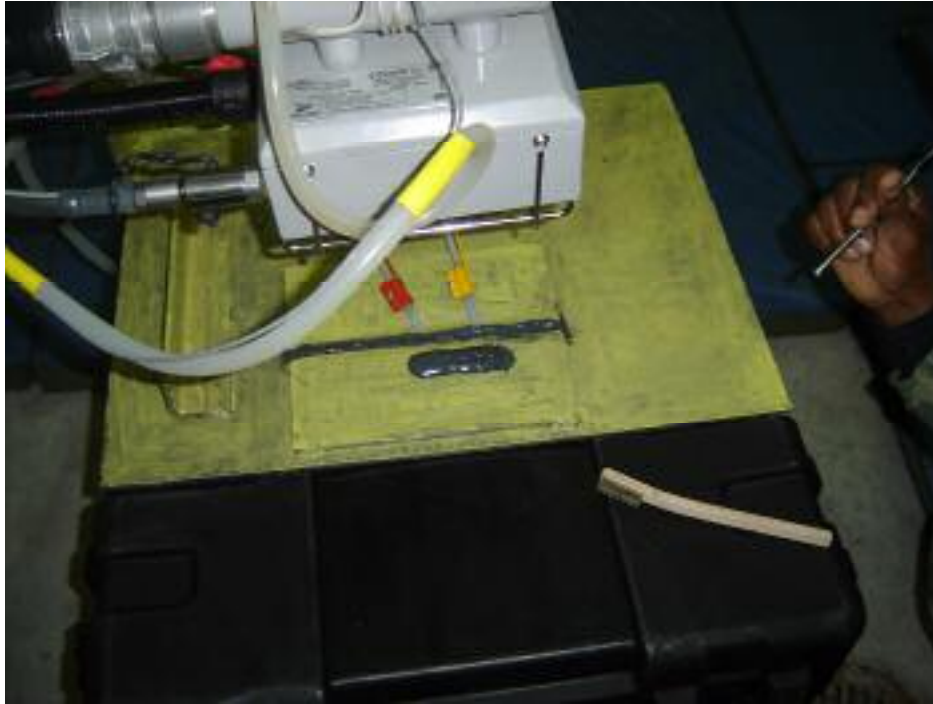
RCD positioning over training board

**2.6.2. Results.** Positioning the emitter head within most heavy aircraft will be possible. The emitter head was positioned with zero angle of deflection and ten inches from the sealant. The emitter head was suspended from a structure above the training board. The manufacturer procedures require line of sight and 8 to 12 inches for maximum effectiveness. Maximum distance recommended is 36 inches.
