**Ranger Station 2**  
**Determination of Eligibility**  
**for the National Register of Historic Places**

**Fort Bragg, North Carolina**  
**Heather McDonald and Jeffrey Irwin**  
**Fort Bragg Cultural Resources Management Program**  
**May 2006**

Determination of Eligibility for the National Register  
of Historic Places

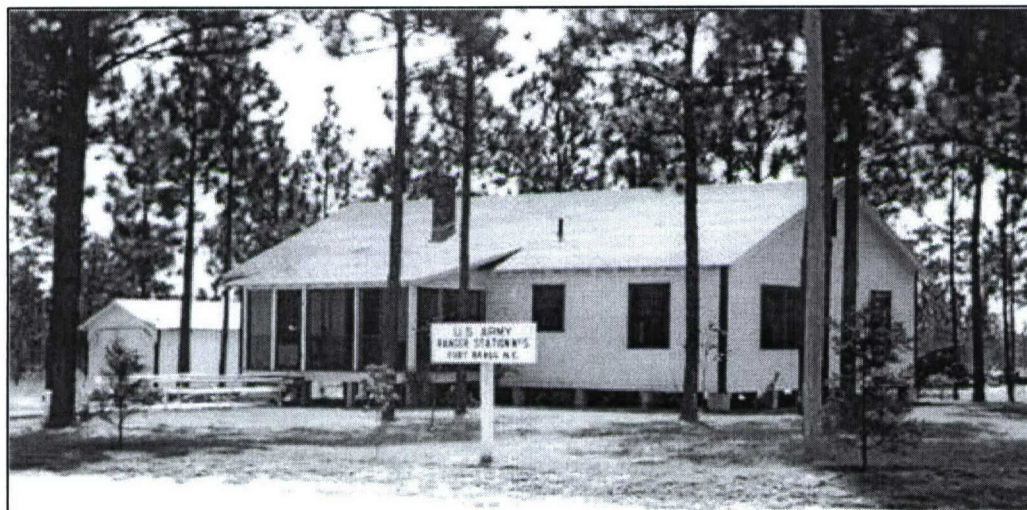
*1938 Photo of Ranger Station after its completion, Quartermaster Records*

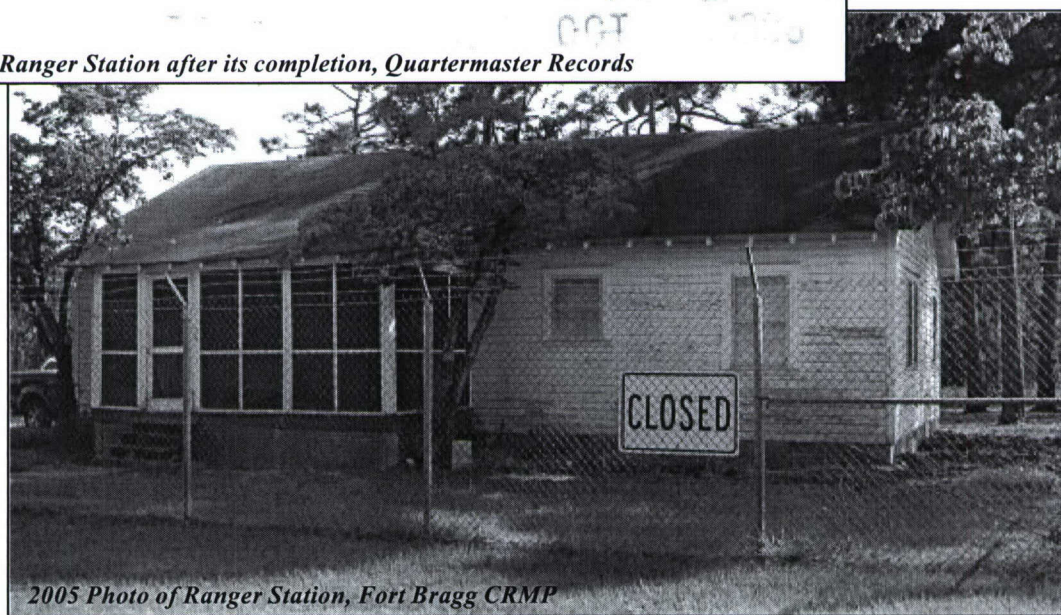
*2005 Photo of Ranger Station, Fort Bragg CRMP*

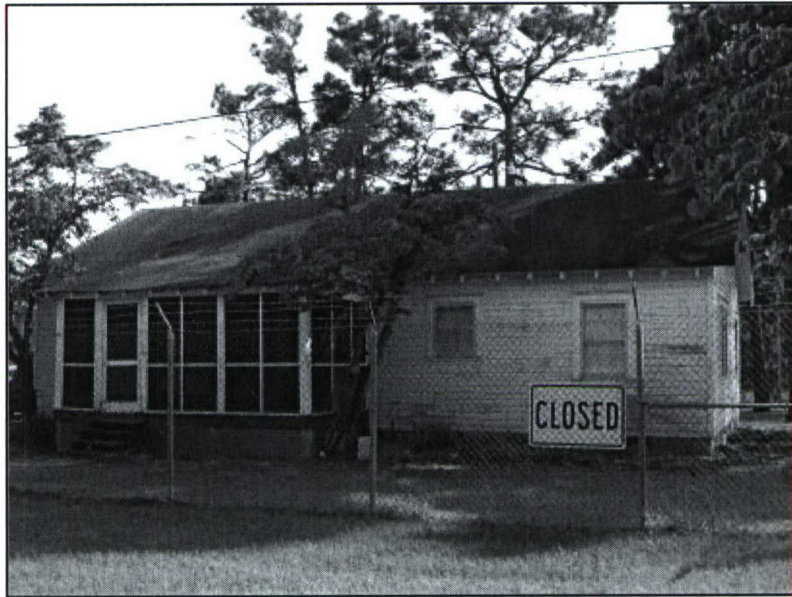
The façade (north) is five-bays with one entrance bay and four window bays (see Figure 1). A partially engaged screened porch is on the northeast corner of the façade enclosing the front door and the paired window. Wood steps and a wooden screen door provide entry onto the porch. The front door is a six-paneled steel door which replaced the original half-glazed wood door, which had six lights and three horizontal panels.

*Figure 1. Façade (north elevation). Fort Bragg CRMP. 2005.*

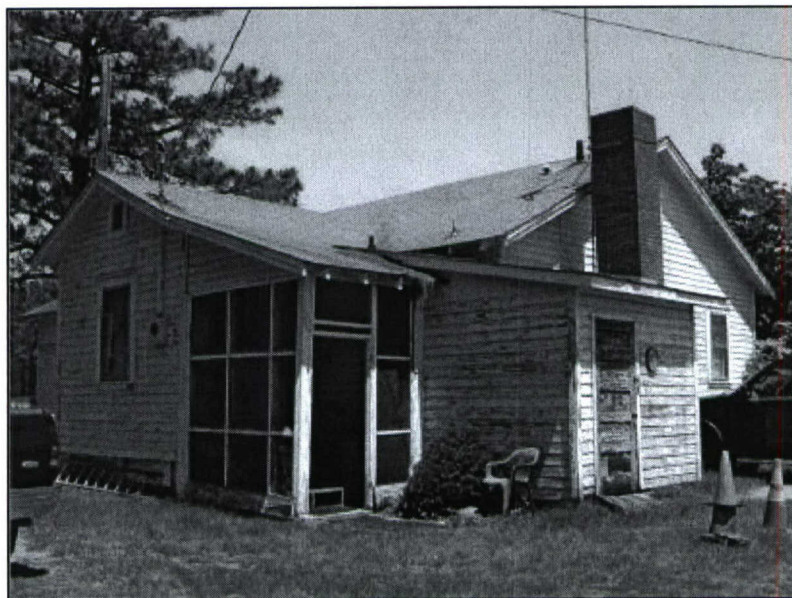
The east elevation is five bays with two entrance bays and three window bays (see Figure 2). Originally there was a partially engaged screened porch on the rear ell. Today, only a small portion of the screened porch remains. The porch has wood supports and an entry opening which originally contained a wood screen door. Wood steps lead to the back door. The back door is a six-panel steel door which replaced the original half-glazed wood door with six lights and three horizontal panels. The remainder of the porch has been enclosed for a small interior laundry room accessed from the kitchen and a shed addition accessed from the outside. The addition extends to the east and has drop siding with an asphalt shingle roof. A five paneled wood door provides entry into the shed addition. Also on this elevation is a simple, square brick chimney of stretcher bond attached to the shed addition. This chimney is not original to the building. Originally, there was a centrally located interior brick chimney with a decorative cap. The chimney and the shed addition were probably added when the boiler heating system was installed in the building in 1954.<sup>2</sup> The south elevation contains three window bays with a single window on the rear ell and a single as well as a paired window on the main block of the building (See Figure 3). The west elevation also contains three window bays with a single short window on the rear ell and a single and a paired window on the main block (See Figure 4). The west

*Figure 2. East Elevation. Fort Bragg CRMP. 2004.*

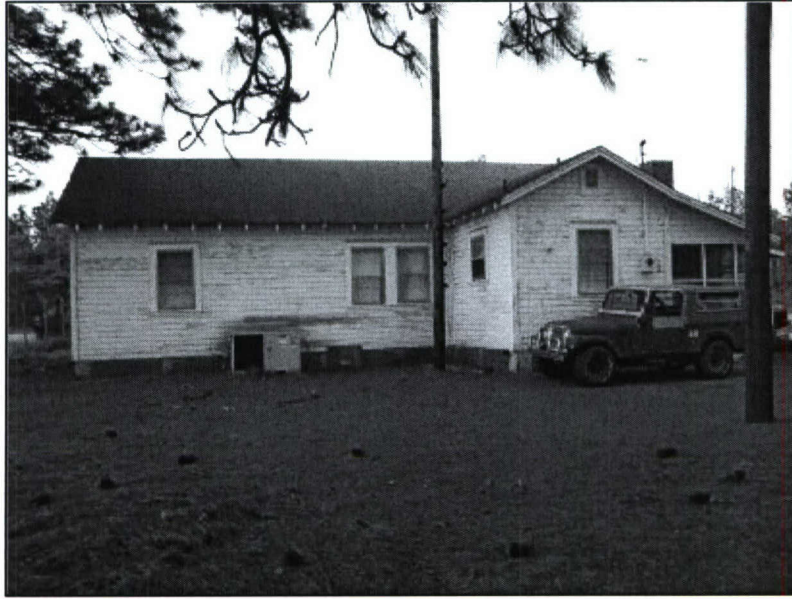
*Figure 3. South Elevation. Fort Bragg CRMP. 2006.*

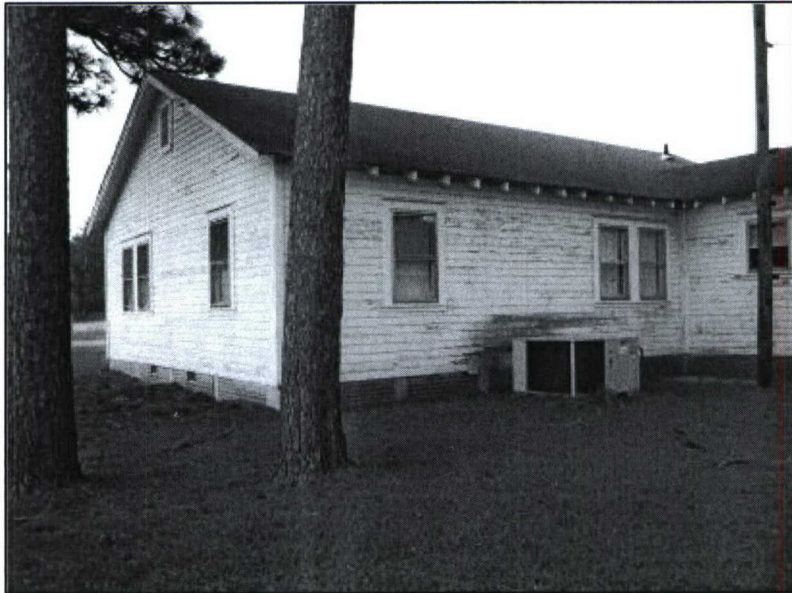
elevation of the rear ell has one window bay. The west elevation of the main building is two window bays with a paired window on the northwest corner and a single window on the southwest corner.

*Figure 4. West Elevation. Fort Bragg CRMP. 2006*

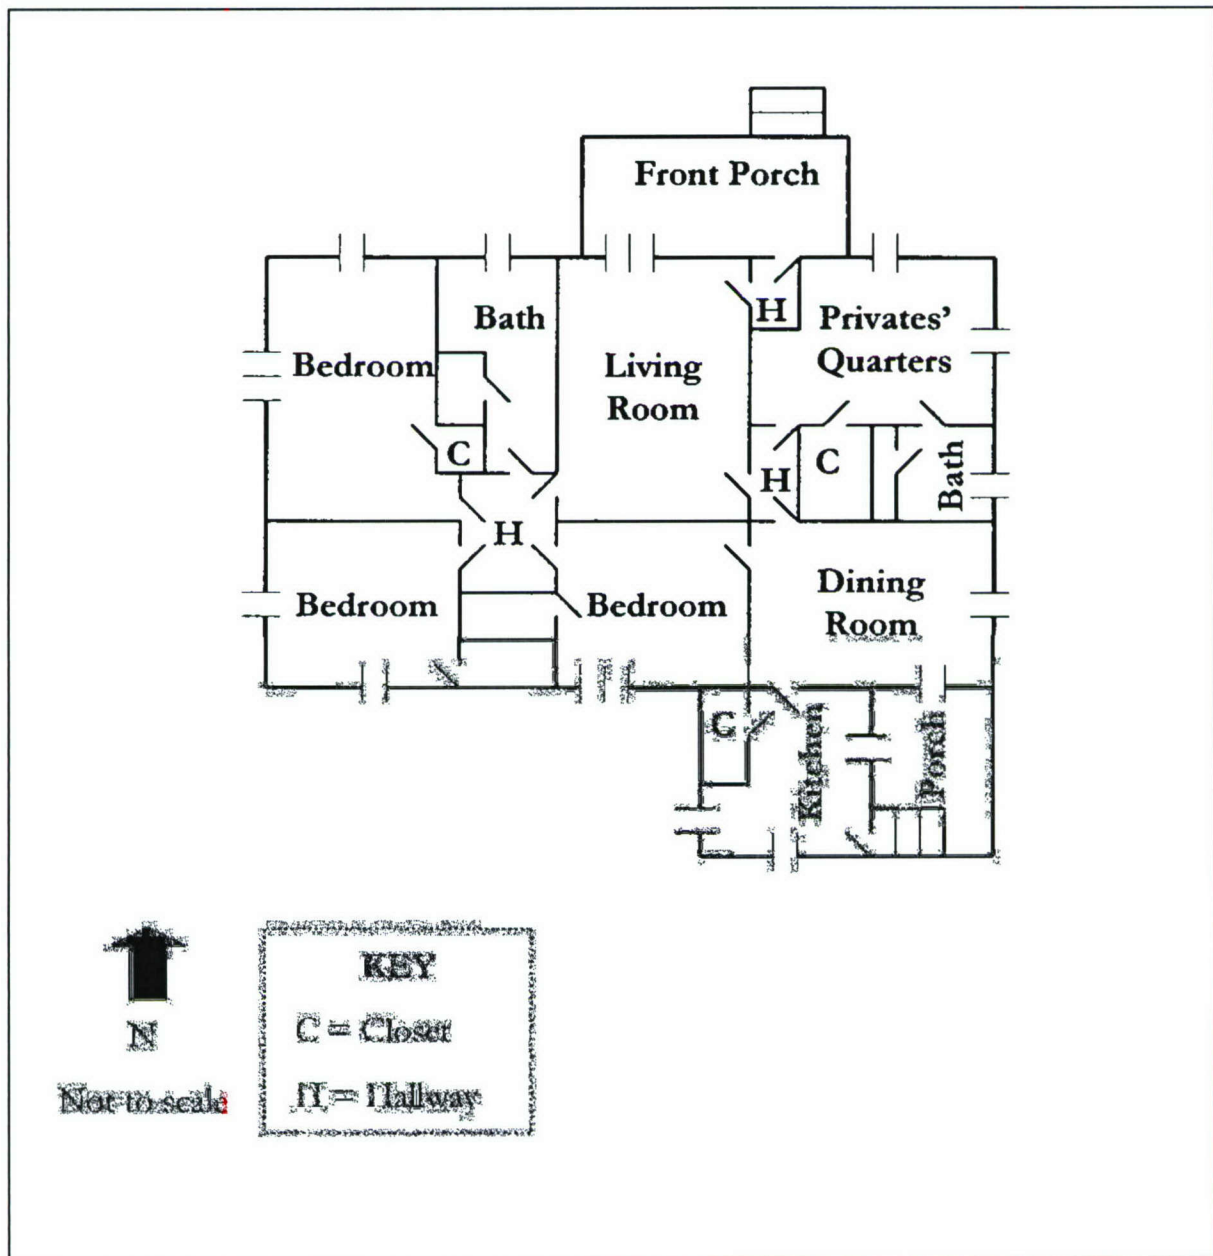
Figure 5. Original floor plan from the 1938 Quartermaster Records

The original floor plan of Ranger Station 2 is largely intact with a few minor changes (See Figure 5). This floor plan was unique as it was specially designed to accommodate the typical ranger staffing order in 1937. This order combined a NCO family with subordinate soldiers who lived with the family and worked for the NCO ranger. The floor plan of Ranger Station 2 was designed to offer separate sleeping quarters for the NCO's family and the subordinate soldiers. Three family bedrooms and a full bath were located on the west side of the building while the soldiers' quarters, with full bath were located on the northeast corner. The living room divided the sleeping areas. The remaining common areas (dining room and kitchen) were on the southeast corner with the kitchen in the rear ell. With access from the rear porch and a wall separating the living room, the floor plan effectively sectioned off a portion of the house where the soldiers could access their room and the kitchen and dining rooms without entering the

family living room or bedroom area. All three of the Ranger Stations built in 1937 shared similar organizational aspects. Ranger Station 1 had an identical floor plan to Ranger Station 2. Ranger Station 3 had a similar floor plan to the other ranger stations except for a slight modification in which the soldier rangers had their own exterior access into their quarters via a door located on the front porch.

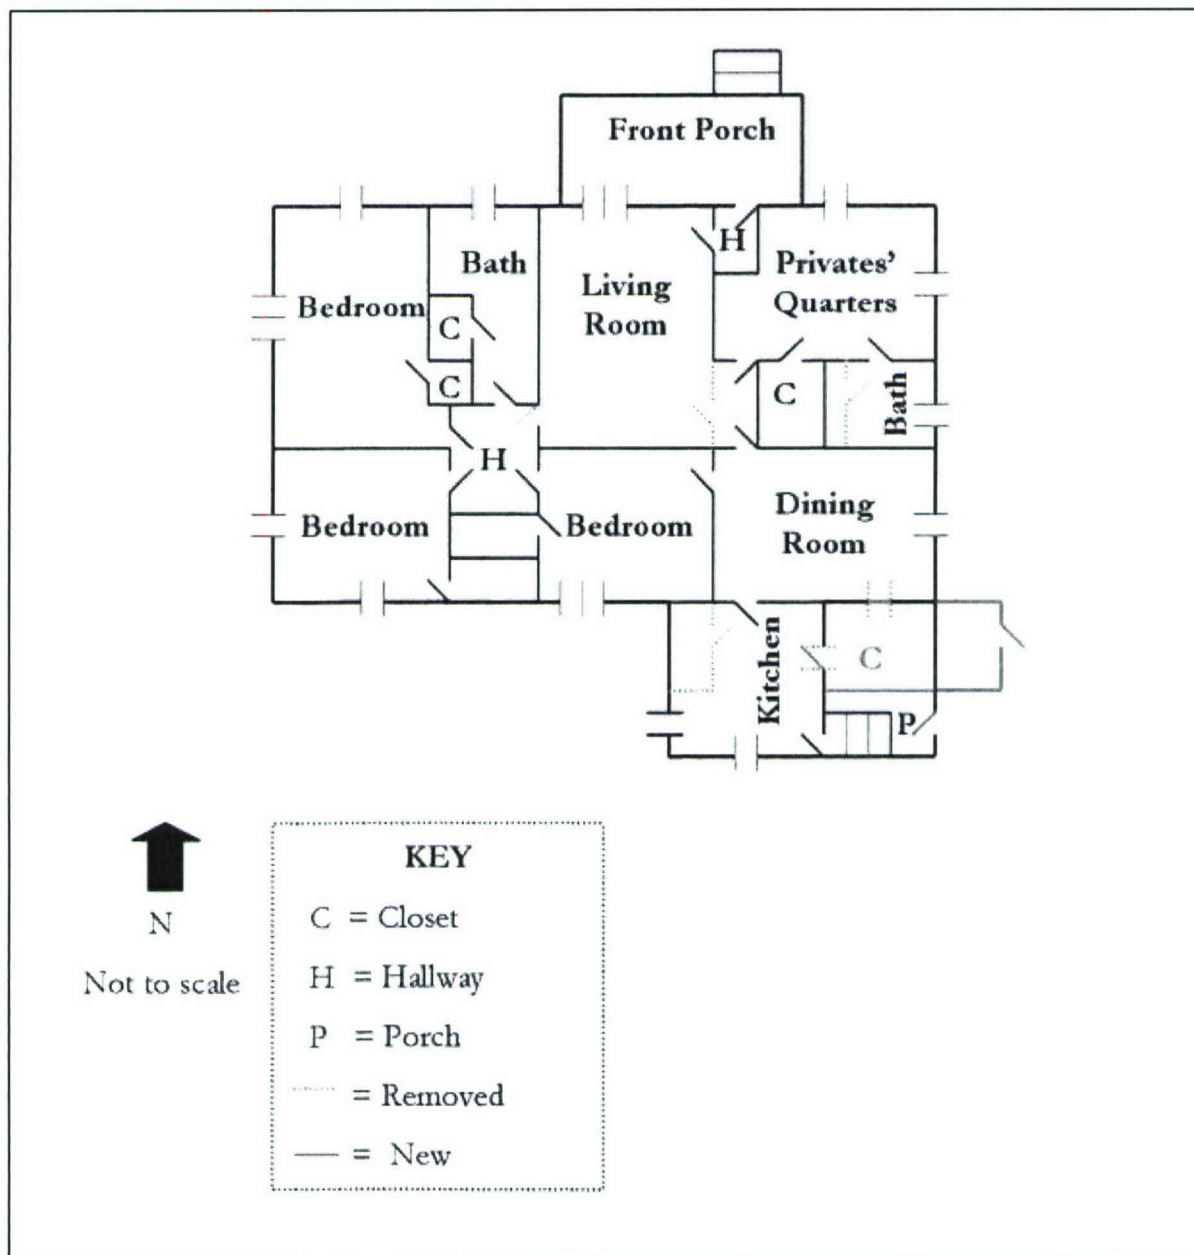
Figure 6. Alterations to original floor plan

The room layout has not been altered, but portions of walls have been removed and walls added. First, originally in the living room the east wall extended to the south wall with a door on the east wall providing entry into a small hallway. The hallway allowed access into the subordinate soldiers' quarters and also the dining room. Today, portion of the east wall was removed and the small hallway no longer exists. Another change was the transformation of part of the screened-in porch into a laundry room, described above with respect to the exterior. To accommodate this change on the interior, the window on the south wall of the dining room was enclosed and the window on the east wall of the kitchen was changed into a door. The kitchen has been renovated and a closet along the west wall has been removed. In addition to the kitchen being renovated, the bathrooms have all been renovated as well. See Figure 6 for changes to the original floor plan of the station.

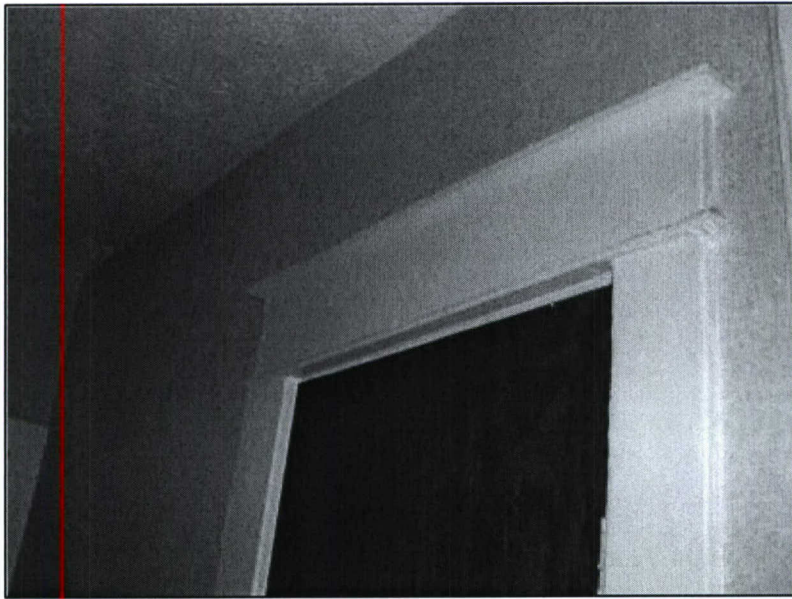
All of the baseboards and door surrounds have been replaced except for the baseboard and closet door surround in the bathroom on the west side of the building (See Figure 7 and 8). The molded door surrounds have been replaced with simple and flat surrounds and the baseboards with a simpler smaller molding. The window surrounds are original. Overall, the interior has

*Figure 7. Close-up of original door surround. West Bathroom Closet.  
Fort Bragg CRMP. 2006.*

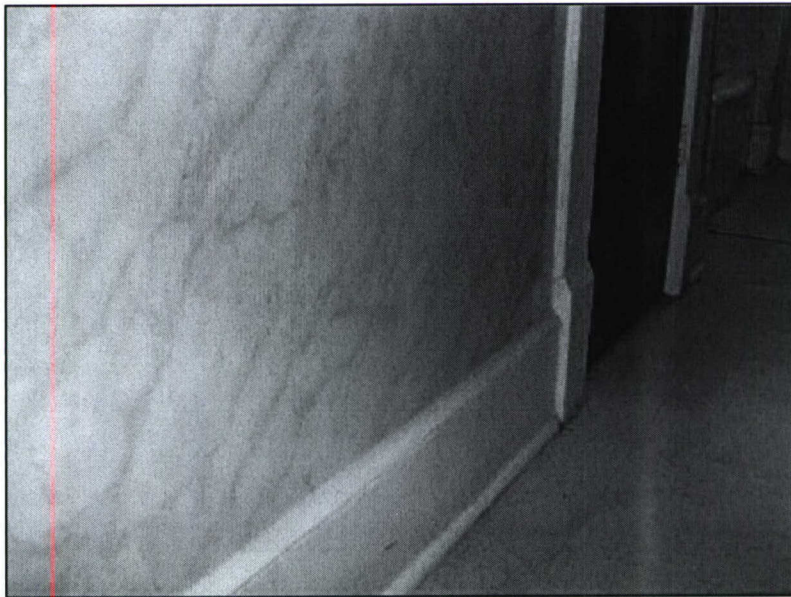
*Figure 8. Close-up of original baseboard molding. West Bathroom.  
Fort Bragg CRMP. 2006.*

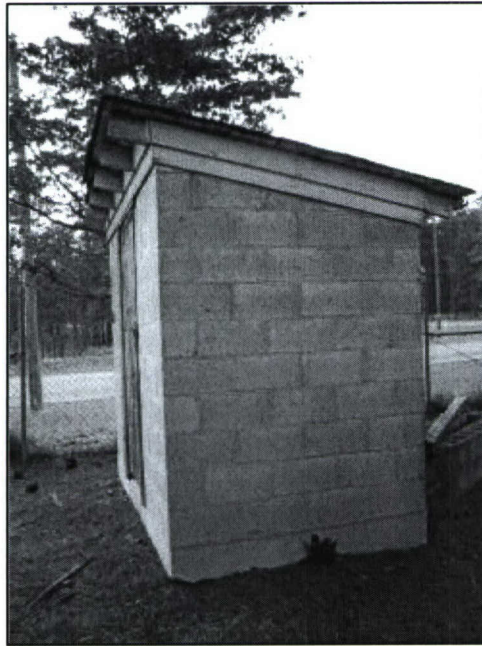
There are three outbuildings on the property in addition to the station building (See Figure 9 and 10). A concrete block pump house with a shed roof is located near the rear of the property on the northeast corner. The remaining outbuildings are located to the east of the station building and consist of a one entrance bay wood shed with a front-gable asphalt shingle roof and a one entrance bay concrete block building with a flat roof. The concrete block building was constructed in 1994 as a communication equipment building. The date of construction for the pump house and wood shed is unknown but they were likely built after the construction of the ranger station.

*Figure 9. Pump house. East and South Elevations. CRMP. 2006*

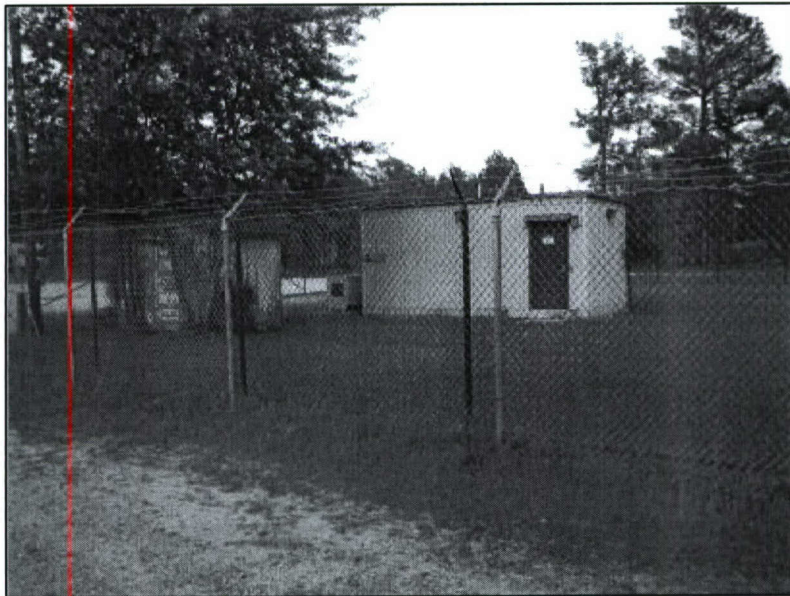
*Figure 10. Wood Shed (left) & Communications Equipment Building (right) West Elevations. CRMP. 2006*

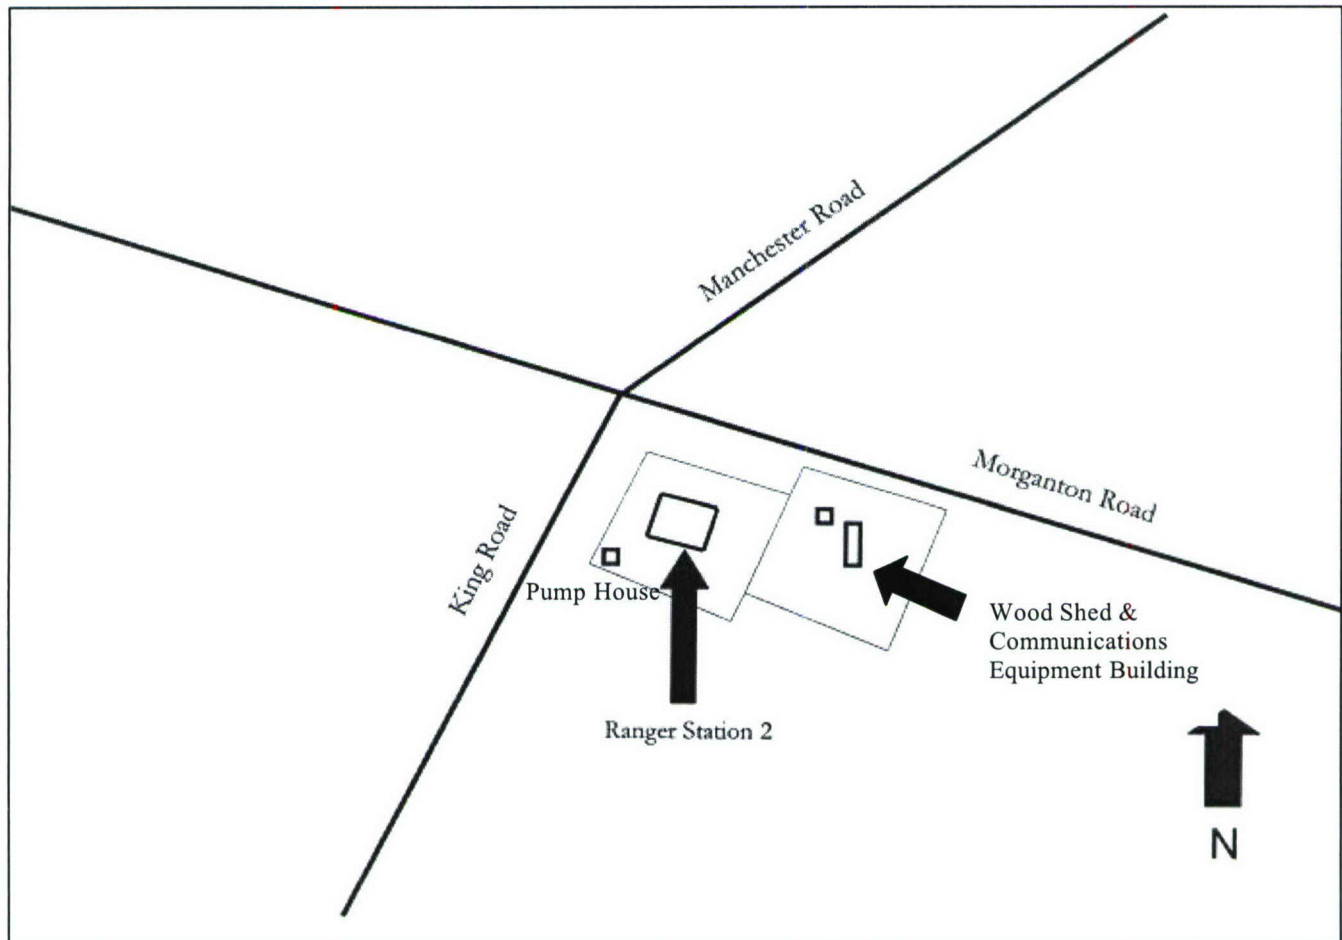
## APPENDIX B – SITE PLAN

In addition, the property has several concrete foundations scattered around which could have been the locations of the original wood garage, elevated water tank and pump house which are recorded on the 1938 Quartermaster Records for Ranger Station 2.<sup>3</sup> The garage appears in the 1938 photograph in the Quartermaster Records to be located to the east of the ranger station. It is also possible that the property contained a barn to house the horses used by the rangers similar to the barn at Ranger Station 1, which was constructed at the same time as Ranger Station 2.
