**Environmental Baseline Survey for
Proposed Lease and/or Transfer
Fort Devens - Basewide**

Volume II of II

**Base Realignment and Closure Environmental
Evaluation (BRAC EE)
Fort Devens, Massachusetts**

March 1996

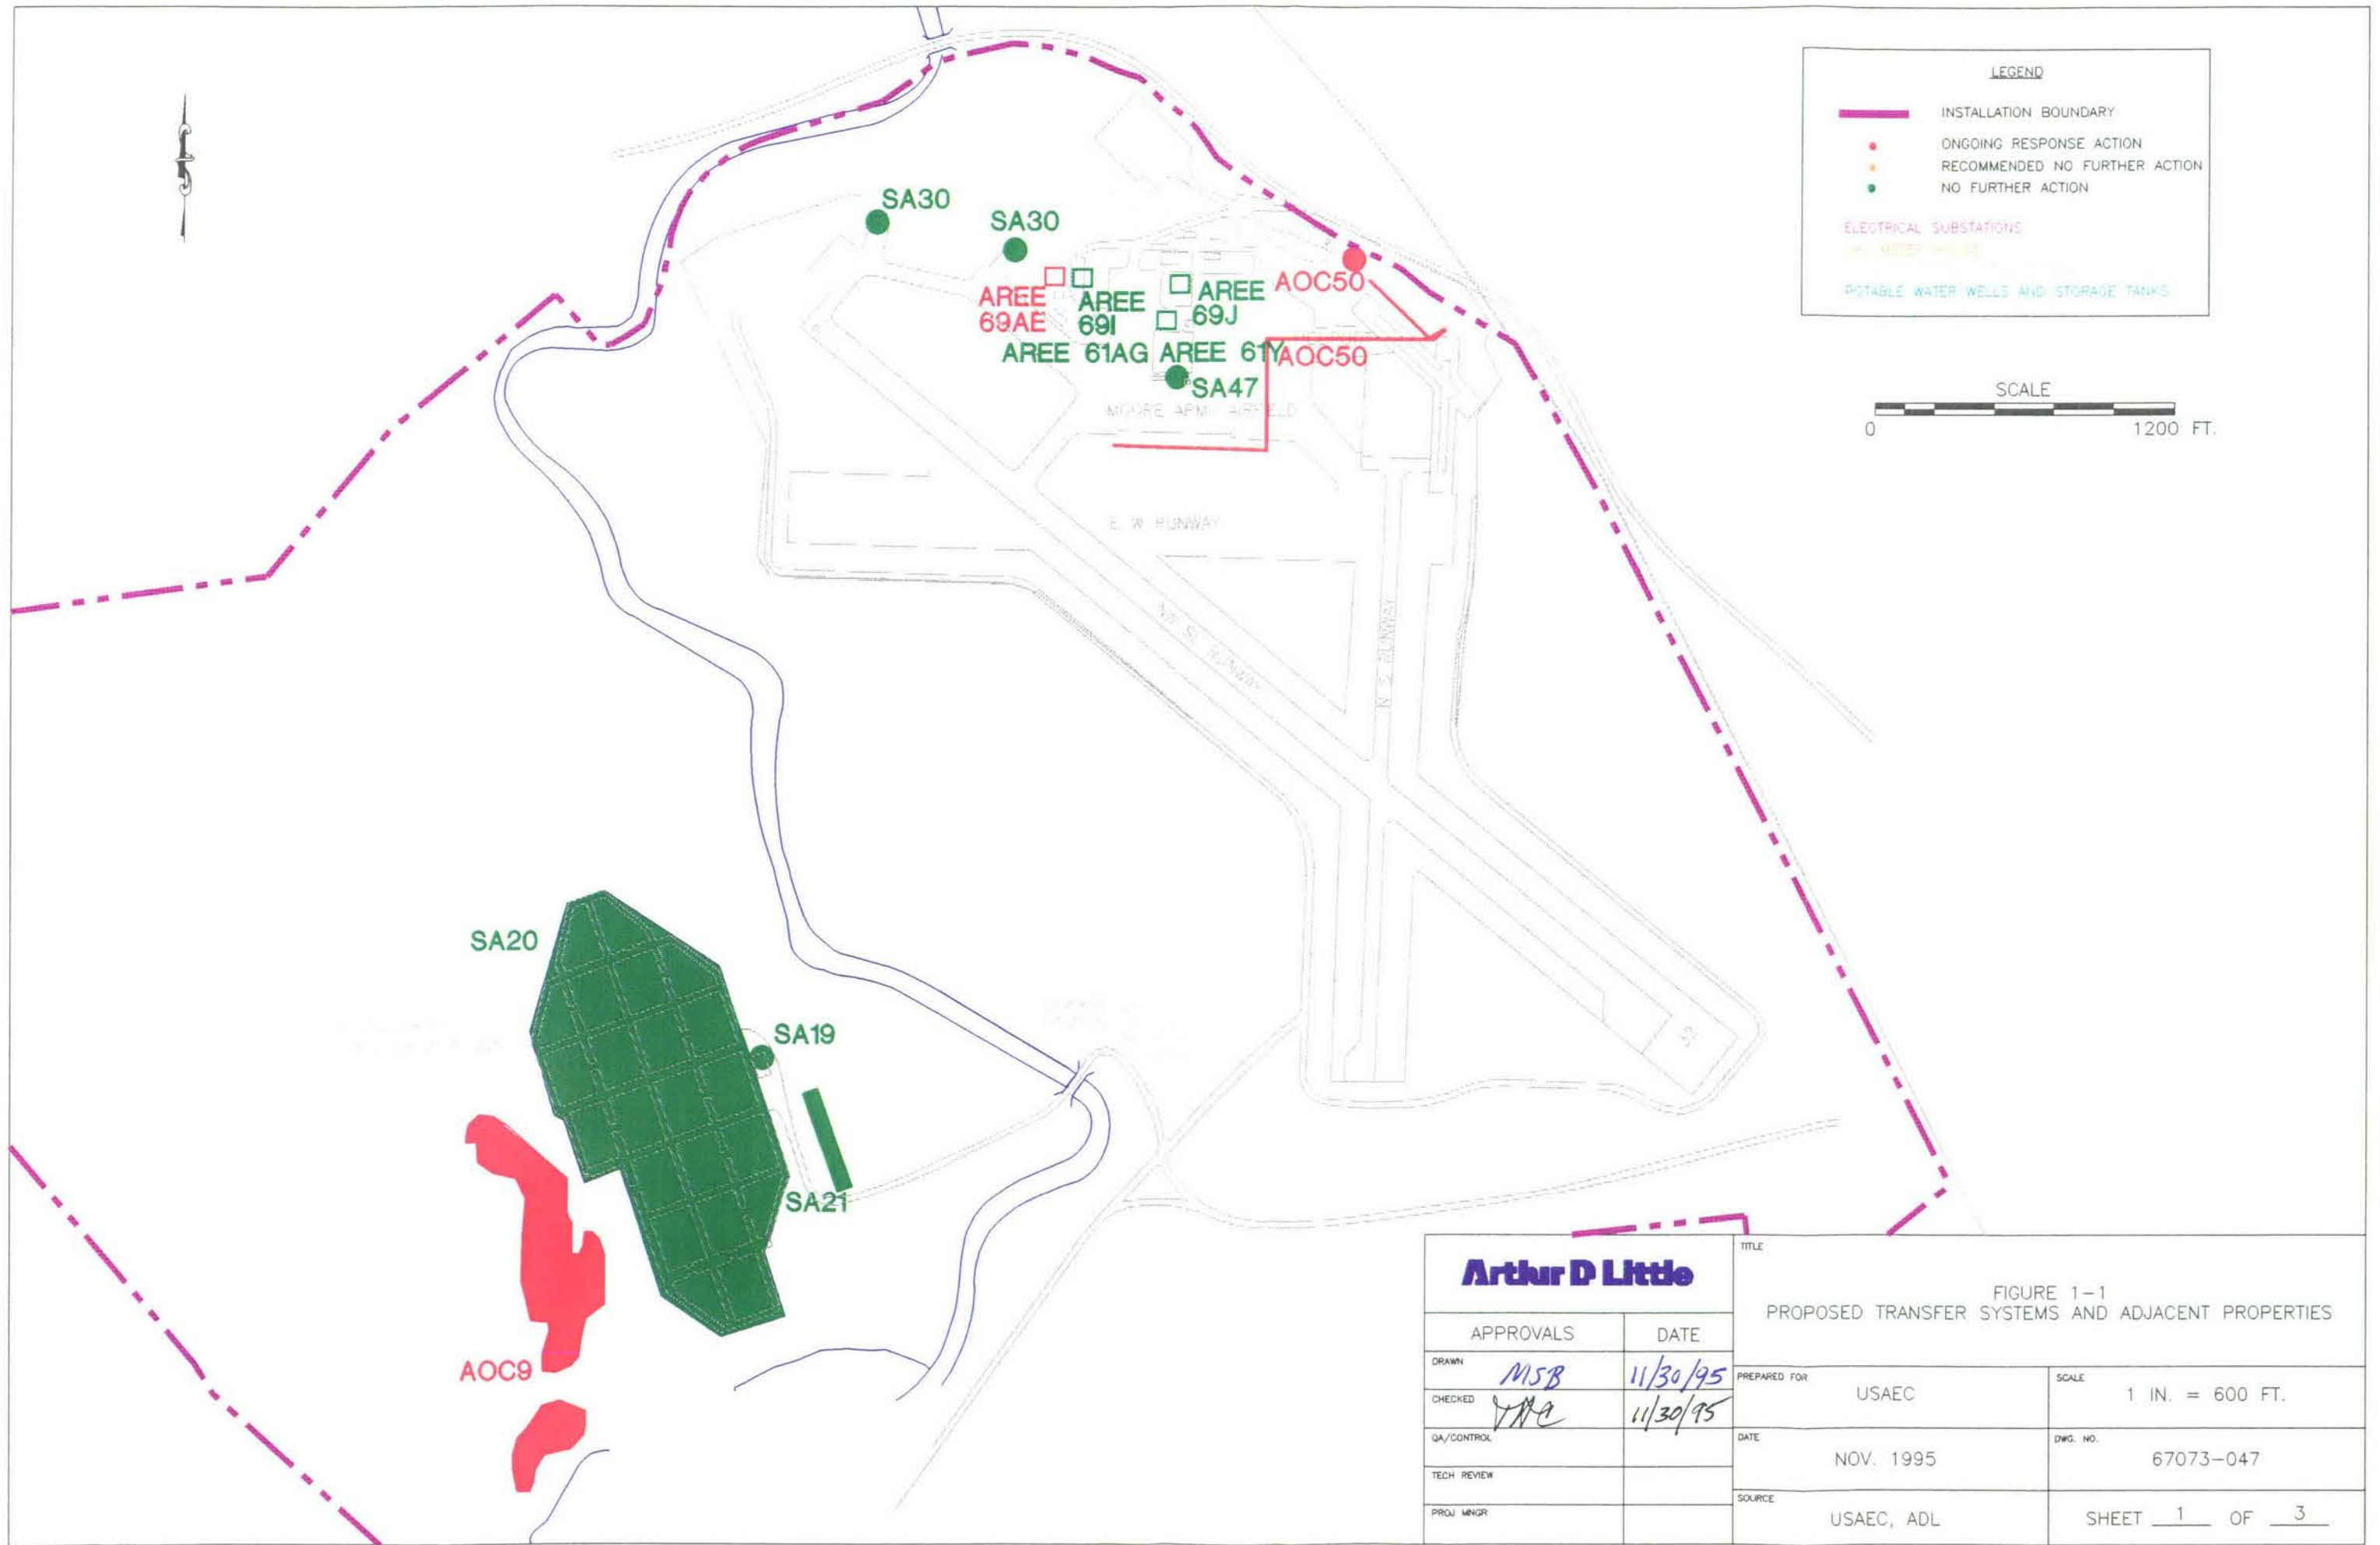
- - - INSTALLATION BOUNDARY
- ONGOING RESPONSE ACTION
- RECOMMENDED NO FURTHER ACTION
- NO FURTHER ACTION
