NRL/MR/5673--07-9091

# Fiber Optic Strain Sensors (FOSS) to Monitor Strains on a Navy Vessel During Operations

# Report of Fiber Optic Strain Sensors (FOSS) to Monitor Strains on a Navy Vessel During Operations

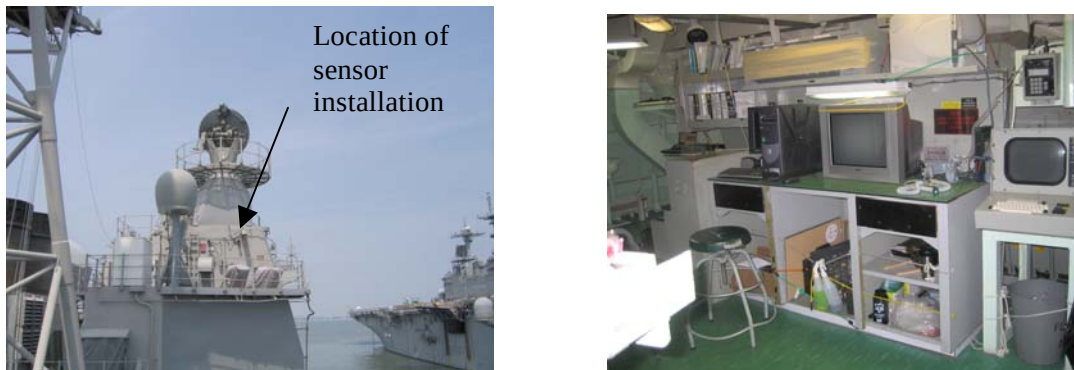
Installation of the sensing system was performed during a single day, 15 May 2007. Four fiber Bragg grating (FBG) rosettes were installed in the overhead of #4 Radar (05-316-0-C) where the ship had previously experienced cracking. This space houses mission critical equipment (both communications and weapons) and was therefore deemed an ideal candidate for monitoring. Additionally, this particular location allowed for the simplest, most un-intrusive installation of all potential areas surveyed. Figure (1) shows the radar room from both the outside and inside.

Figure 1: (left) Outside view of #4 radar room showing rough location of the installation. This room houses both communications and weapons equipment. (right) Inside #4 radar room. Communications equipment located directly below location where cracks have been observed.

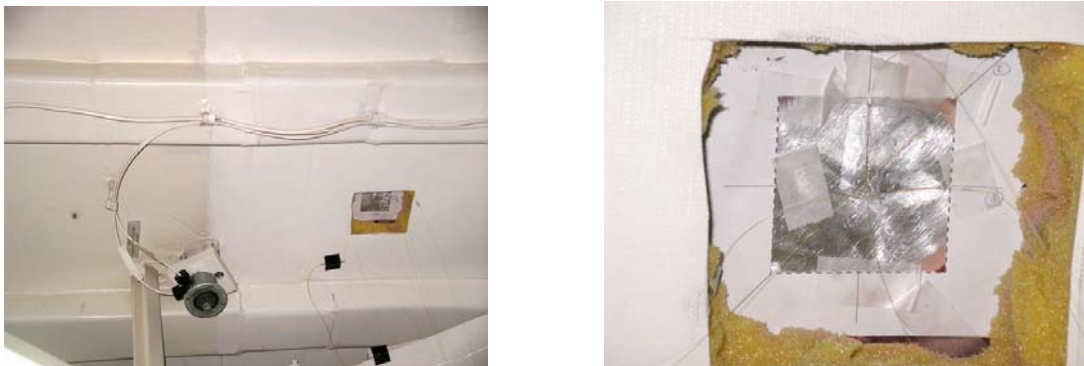
Figure (2) shows one of the FBG rosettes. In order to access the deckplate the foam insulation was removed, the paint was sanded away, and acetone wipes were used to provide a proper surface preparation for mounting. Once the gratings were installed, the insulation was replaced. The only visible sign that the sensing system was installed were two fibers protruding from the overhead.

Figure 2: One of the FBG rosettes installed on the deckplate below the foam insulation. Insulation was removed with a knife, the deckplate was sanded down to create a bare aluminum surface. Each FBG rosettes consists of 3 gratings measuring strains at 0, 45, and 90 degrees relative to the longitudinal axis of the ship ( $0^{\circ}$ ).
