# Report on the Mine Clearing Rake Test

**October 2006**

Prepared by  
Institute for Defense Analyses  
4850 Mark Center Drive  
Alexandria, VA 22311-1882

# **Operational Evaluation Test Report on the Mine Clearing Rake**

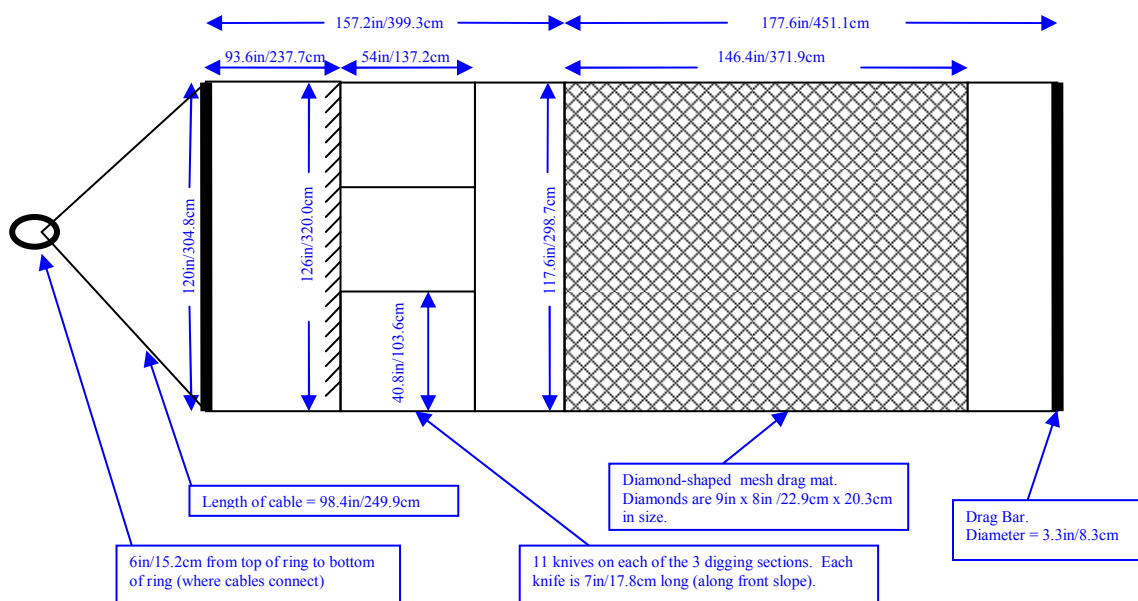
The MCR is comprised of three digging knife units and a drag mat/chain harrow. The MCR, as tested, is shown in Figure 1. This configuration, with the digging knives in a straight line across the front of the MCR, was selected during familiarization runs with the MCR as the one offering the best MCR performance and control of the

Figure 1. Mine Clearing Rake (MCR)

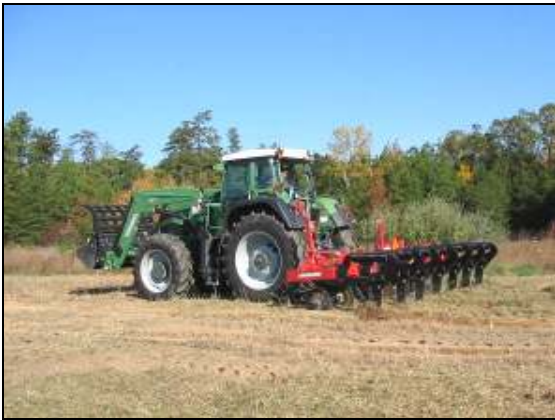
**Figure 4. Krause Chisel Plow**

MCR while towing and turning. The tools used in the MCR test were a Fendt 918 Vario tractor (Figure 2), a Loftness 918 Timber Ax Extreme vegetation cutter (Figure 3), a Krause 4830-730F Chisel Plow (Figure 4), an Unverferth Perfecta II Spring Cultivator (Figure 5), and the MCR (Figure 6).

**Table 4. Krause Chisel Plow**

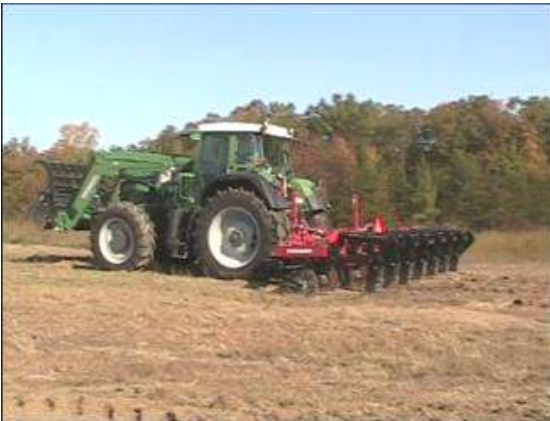
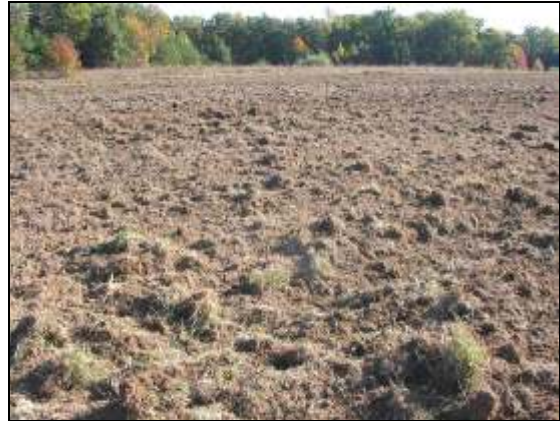
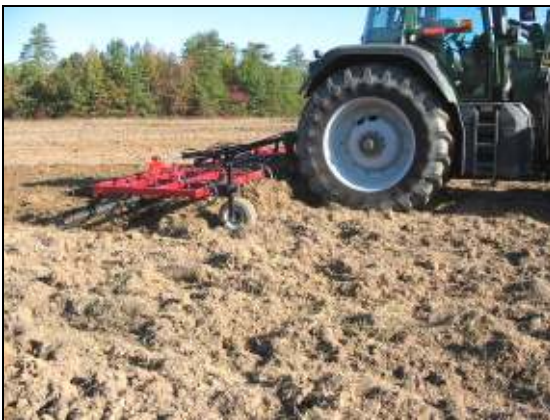
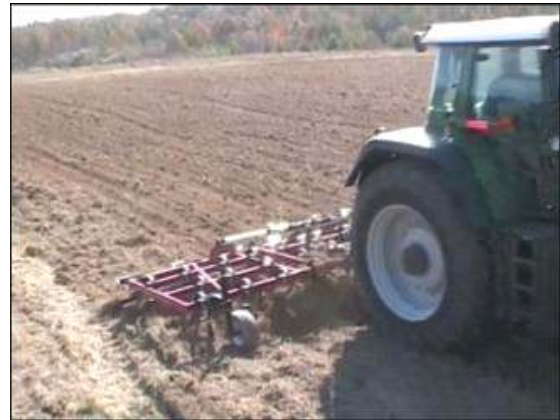
Test Site 1 (141m x 70m) allowed 25 - 30 meters at each end for 180° turns with the MCR between successive passes over the test area. While the vegetation in the total 141m x 70m area was cut with the Loftness vegetation cutter, only the central 70m x 70m MCR test area was plowed and cultivated prior to testing the MCR. Photos of the area preparation process of the first test site are presented in Figures 7 through 12. By the time the test site was considered ready for MCR testing, the test site surface was primarily powdered loam, free of surface grass and shrubs, ready for crop planting. However, the soil still contained pieces of shredded grass and root systems mixed into the soil by the plow and cultivator.

Mowing of the 135m x 70m area took 2 hours 10 minutes. Average mowing speed was 1.5 mph (2.5 kph). Plowing the MCR test area (75m x 70m) took 3 hours 4 minutes until the soil was judged to be sufficiently broken up to be ready for working with the spring cultivator. Plowing speeds ranged from very slow to a maximum of 5 mph (8.3 kph). The MCR test area was worked with the spring cultivator for 3 hours 21 minutes to insure that the test area was free clumps of sod at speeds of 1.5 to 5 mph (2.5 to 8.3 kph). At this point in the preparation process, the test area resembled mine-cleared areas ready for final quality assurance testing. Figure 16 shows the prepared Test Site 1 field.

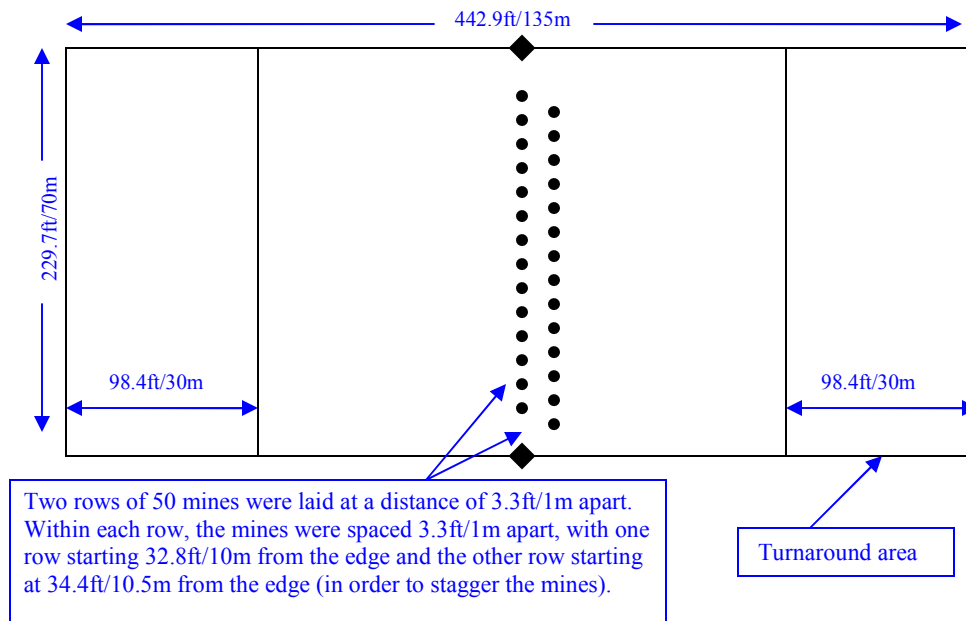
A layout of Test Site 1 is shown in Figure 14.

**Figure 14. Layout of Test Site 1 Showing Mine Location and Pattern**

A drawing of Test Site 1 area is shown in Figure 14. The area devoted to the actual test of the MCR was 75m x 70m, with 30m at each end set aside to allow adequate room to perform 180° turns without tipping the MCR between successive passes through the prepared test area.

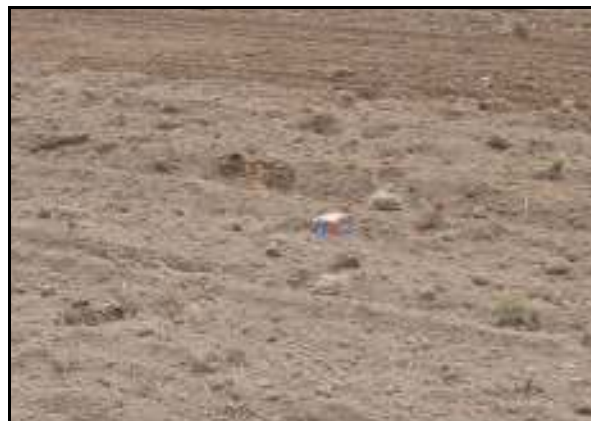
After testing the MCR on buried mines, a test of surface-laid anti-personnel mines was performed within the Test Site 1 field. Two mines were laid on top of the prepared field and within the path of the MCR, cleaned of debris prior to this test. The mines were placed at a point 40m and at 50m from the start of the MCR run. Figure 21 shows the condition of the field and the placement of the mines in the field.

**Figure 21. Surface-Laid Mine**
